## Characterization and Development of Organic Coatings for Steel Rebars in Concrete

R. Selvaraj,\* B. Bhuvaneshwari

Central Electrochemical Research Institute, Karaikudi-630 006, India

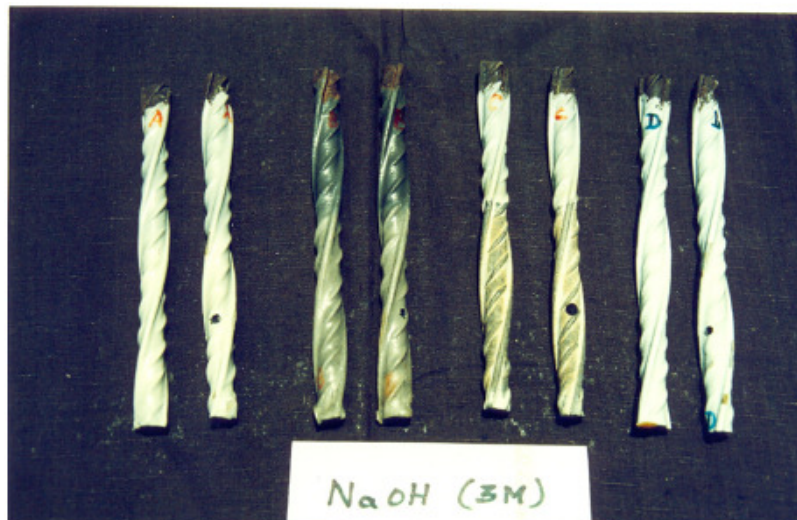
**Figure 3.** Photograph of coated rebars immersed in 3 M NaOH solution for a duration of 60 days.

Table 4 and Fig 3 show the results of chemical resistance test carried out on coated rebars immersed partially in 3.0 M NaOH solution, with and without damages on coatings, for 60 days.

Due to high alkalinity of the solution, there was no corrosion or rust spot on any of the rods (damaged and undamaged rods) until a period of 60 days. But the coating C (polyester polyol coating) dissolved in the solution upto about 90% during this period. This is due to alkali hydrolysis of polyester resin with NaOH [7]. The coating B started showing a change of colour from dark gray to dull gray from 45<sup>th</sup> day in the immersed zone. This may be due to the reaction of loosely

adhered zinc phosphate with the caustic soda to form zinc oxide at the initial stage. Therefore there is no possibility of the formation of this zinc oxide because zinc oxide plugs the micro pores on the surface. No blisters, rust, undercutting of coating were noticed. This shows that the coating is intact on the surface.

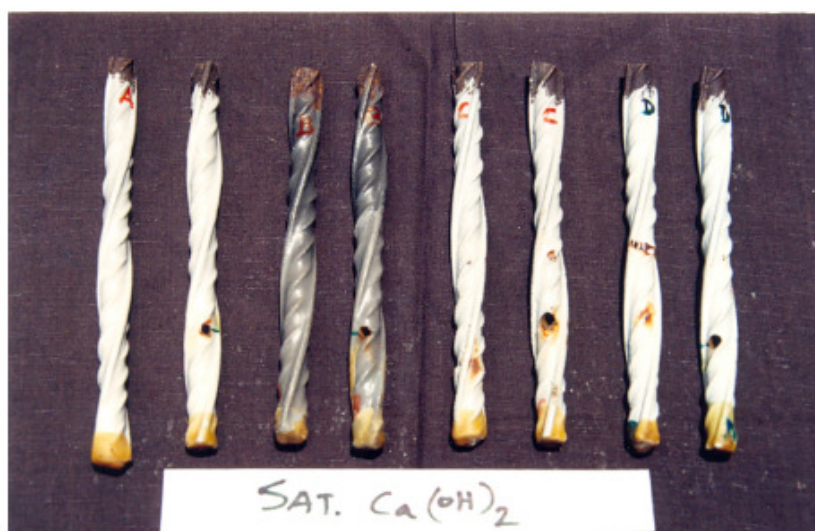
**Figure 4.** Photograph of coated rebars immersed in 3 M Ca(OH)<sub>2</sub> solution for a duration of 60 days.

Table 5 and Fig 4 show the results of coated steel rods with and without damages immersed partially in a saturated solution of Ca(OH)<sub>2</sub> for a period of 60 days.

Undamaged coatings such as A and B showed good results with no blisters, pinholes, rust spots and under cutting of coatings. However undamaged coatings such as C and D showed pinhole rust but no blisters and under cutting till 30<sup>th</sup> day of immersion. Damaged coatings such as C and D started showing blisters and rust after 30 days and were in progress further. This result indicates that the polyurethane coatings are affected by the Ca(OH)<sub>2</sub> electrolyte due to depolymerisation of resin component. Once the depolymerisation occurs, the passive layer formed by the zinc phosphate is also affected by the calcium hydroxide. This may be due to the formation of calcium phosphate which is a soluble salt. This is the mechanism for the formation of blisters and followed by rust spots on the coated rods after 45 days. On the other hand, the coating based on epoxy silicone performs well in the calcium hydroxide solution because of its resistance towards neutral and alkaline environments [1].

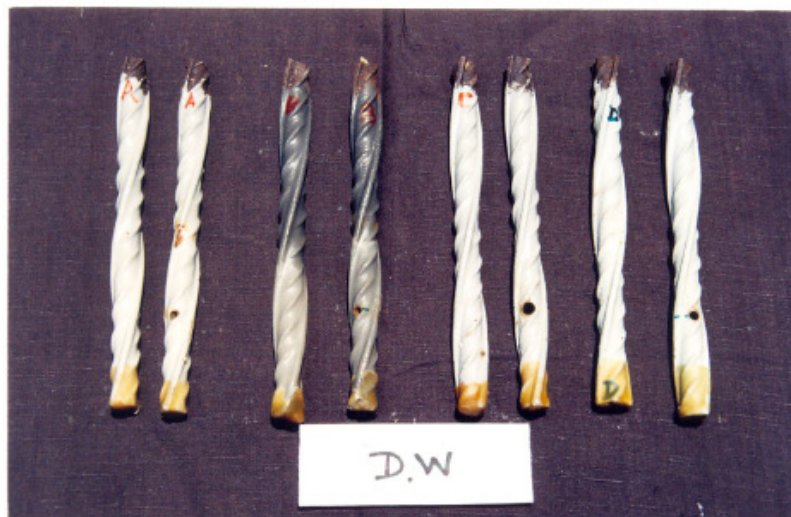
**Figure 5.** Photograph of coated rebars immersed in distilled water for a duration of 60 days.

Table 6 and Fig 5 show the results of coated steel rods with and without damages immersed partially in distilled water for a period of 60 days

Undamaged area of coating A should show the formation of blisters at the interface between the distilled water and vapour phase after 30 days of partial immersion in distilled water. This blisters formation continued till 60 days. The damaged coating A showing rust formation at damaged spots after 30 days and were in progress until 60 days. The undamaged coating B did not show any blister or pinhole formation until 45 days and at the end of 60 days few pinholes where formed. The damaged coating B started showing rust formation at damages after 30 days of immersion and was in progress thereafter. At the end of 60 days of immersion, a slight discoloration of coating was observed. The undamaged coating C (polyester polyol coating) started developing small blisters after 30 days in the submerged zone. The formation of blisters were in progress until 60 days and 6% of the immersed area showed blisters. However, no rust or corrosion spot was identified over the coated surface. The damaged coating C had started showing rust in the damaged spot and blisters at the immersed zone after a duration of 30 days. This was in progress until 60 days and at the end of 60 days exposure, 8% of the submerged area showed blisters. Undamaged coating D started showing blisters formation from 30 days of immersion along with few pinholes. At the end of 60 days of immersion, 10% of the submerged area was affected by the blisters and the formation of few more pinholes. The damaged coating D started showing rust in damages and a few pinholes after 30 days. Slight delamination of coating near the damage was observed along with the rust at the interface between distilled water and the vapour phase after 45 days. In the immersion zone, 10% of the area was affected by blisters after 60 days of immersion. It was agreed [8] that the coating in the deionized water will show more blisters in the immersed zone than in the fresh or salt water. This is because the coating normally absorbs 0.1 to 0.3% of water by weight of coating upon exposure to water or electrolyte [9-11] and dissolves some quantity of inhibitive pigment of the coating and became filled with water. Further the blisters will absorb water and swell. Blisters thus formed on coating are known as neutral blisters [12]. The number of blisters and the area covered by the

blisters are controlled by the ionic mobility of the electrolyte through the coating films [13]. The formation of blisters at the interface between water and vapour phase can be due to the fact that the vapour density at the interface is more. Therefore the formation of more blisters and thereby more corrosion occurs.
