Characterization of Grain-boundary Precipitates after Hot-ductility Tests of Microalloyed Steels

Maurizio VEDANI,¹⁾ David DELLASEGA²⁾ and Aldo MANNUCCI³⁾

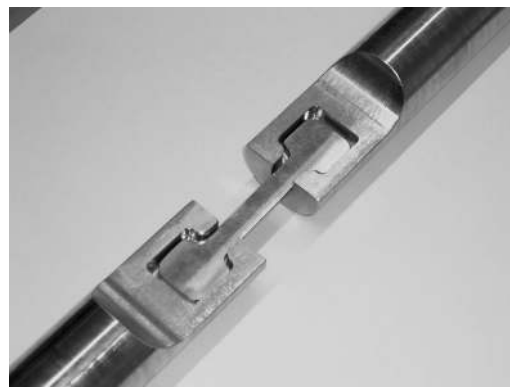
Fig. 1. View of a tensile specimen installed in the fixturing device.

Analysis of possible microstructural damage that had occurred during plastic straining was then investigated by using an experimental setup that allowed rapidly quenching the specimens after straining so as to “freeze” the steel structure for further microstructural analyses. For this purpose, the fixturing device and load train depicted in **Fig. 1** was designed to pull in tension flat specimens having a gauge length of 50 mm and a rectangular section of $3 \times 10 \text{ mm}^2$ in a tubular resistance furnace. After having reached the expected strain level, the specimens could be rapidly separated from the fixtures and quenched in a water tank positioned below the furnace within a couple of seconds. The described experimental device was installed in a universal testing frame. Owing to the required rapid separa-

tion of the specimens from the load train for their quenching, the use of a high-temperature strain gauge was avoided. Therefore, the engineering strain was evaluated as the displacement of the testing frame divided by the full gauge length of the specimens.

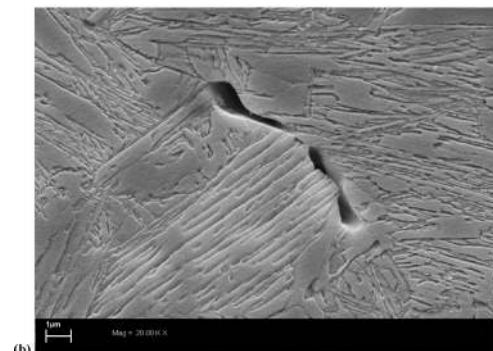
Fig. 5. SEM micrographs of steel B strained by 17% at 950°C.

In **Figs. 4(a) to 4(c)** the microstructure of steel B after straining by 17% and 30% at 850 and 950°C is depicted. The optical micrographs were taken from longitudinally sectioned specimens at mid length of their gauge length (the loading direction is always horizontal in the following micrographs). The micrograph in **Fig. 4(a)** shows the duplex ferritic–martensitic structure of the steel that was generated as a consequence of the relatively low holding temperature (850°C) before straining and quenching. On the contrary, **Figs. 4(b) and 4(c)** highlight the fully martensitic structure of the steel obtained after hot straining at 950°C and water quenching, together with the prior-austenite grain boundaries. Intergranular cracks are clearly visible. These are preferentially oriented perpendicularly to the loading direction. A further example of the damage, taken at higher magnification by SEM is given for the same steel B in **Fig. 5**, showing in more details the intergranular character of the hot cracks.
