# Comprehensive Testing of Sulfate Erosion Damage of Concrete Structures and Analysis of Silane Coating Protection Effect

**Abstract:** In order to study the protection performance of silane coating on in-service concrete structures in a sulfate environment, we collect concrete samples in the field to simulate the concrete erosion process by accelerated erosion with wetting–drying cycles. We place the samples into protected, exposed and control groups corresponding to a corrosive environment with silane protection, corrosive environment without protection and general environment for three different service conditions. A combination of ultrasonic velocimetry, CT (Computed Tomography) scan imaging, NMR (Nuclear Magnetic Resonance) pore structure analysis, strength testing and other methods are used to analyze the strength, ultrasonic wave velocity, pore structure and other characteristics of the specimens during sulfate erosion. Based on the test results, the protective effect of silane coating on concrete structures under sulfate attack is quantitatively analyzed, and an index for judging the damage rate of specimens is proposed to quantitatively analyze the protective effect of si

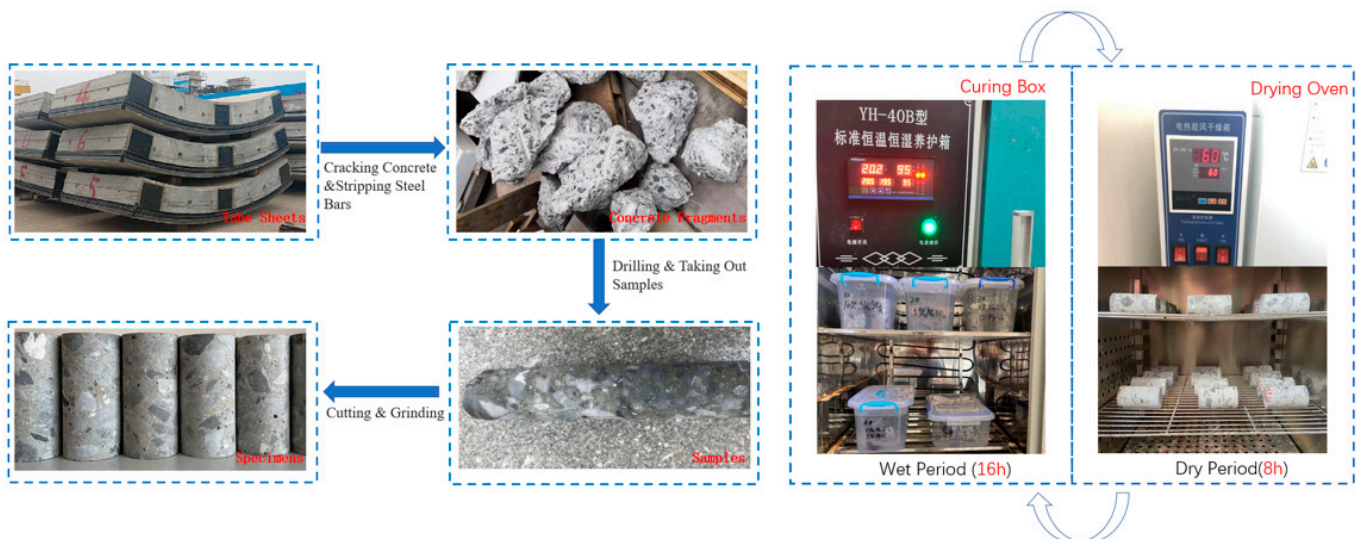
The wetting–drying experimental maintenance cycle consists of an immersion phase (wet phase) and a drying phase (dry phase). The experimental immersion phase simulates the erosion process of the tunnel-tube sheets by immersing the test blocks in the erosion solution of the corresponding composition. During the immersion period, the test blocks of the protected and exposed groups were placed upright in a PVC box with a lid containing a 10% mass fraction of sodium sulfate solution. The controlled group was placed in the same style of PVC box with water. The top of the specimen was placed in the PVC box with the same water, the distance between the top of the specimen and the liquid level in the box was not less than  $3 \text{ cm}$  and the solution in the box was changed once every 30 days. The set maintenance temperature was  $20 \pm 0.5 \text{ }^\circ\text{C}$ , and the relative humidity was  $95 \pm 0.5\%$ . The specimens entered the drying stage after the specified soaking time. The specimens were taken out from the erosion liquid box, the residual liquid on their surface wiped off and then placed in a blast-drying box. The specimens were dried at  $60 \text{ }^\circ\text{C}$  for  $6 \text{ h}$  and placed in a cool and ventilated place for  $2 \text{ h}$ , then put back into the original erosion solution box for the next wetting–drying cycle. Three groups of specimens started the cycle at the same time, and the number of cycles for each group of specimens was 180 times. Preparation and curing of specimens are shown in Figure 1.

**Figure 1.** Sample preparation and test.

To prepare the specimens, the poured pipe pieces were first broken using a crushing hammer to extract the reinforcement inside the pipe pieces. A concrete core sample with a diameter of 50 mm was extracted using core-drilling equipment. Then, the core sample was processed into a 50 mm × 100 mm cylindrical specimen. The specimens were prepared for testing, with an age of 1150 d and an original compressive strength of 75 MPa.

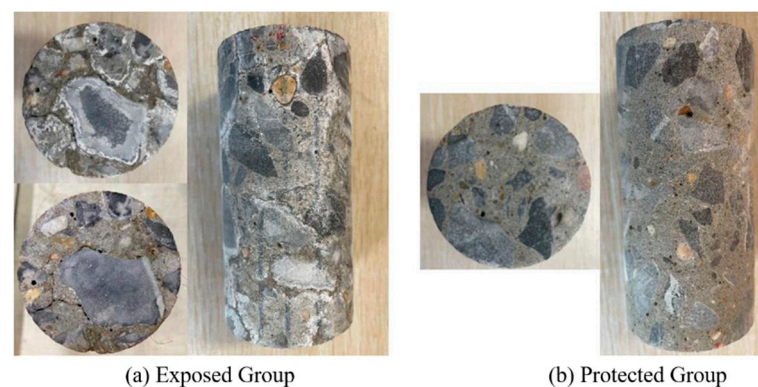
Figure 4 shows the appearance of the specimens in the exposed group compared with the specimens in the protected group after 180 days. The specimens in the exposed group showed significant cracks on the surface, while the specimens in the protected group showed a more complete surface.

**Figure 4.** Changes in specimen appearance.

The surface of the exposed group specimens showed a white powdery substance at some locations on the surface before cleaning. Its composition was tested by XRD (X-ray Diffraction) and found to be mainly sodium sulfate, mostly distributed at the joints between the aggregate and the cement paste. After cleaning the surface, it was found that significant cracks were produced in the area where the white powder appeared. This indicates that these cracks are mainly due to the physical salt erosion caused by the heating of the sodium sulfate erosion solution inside the specimen during the drying process.

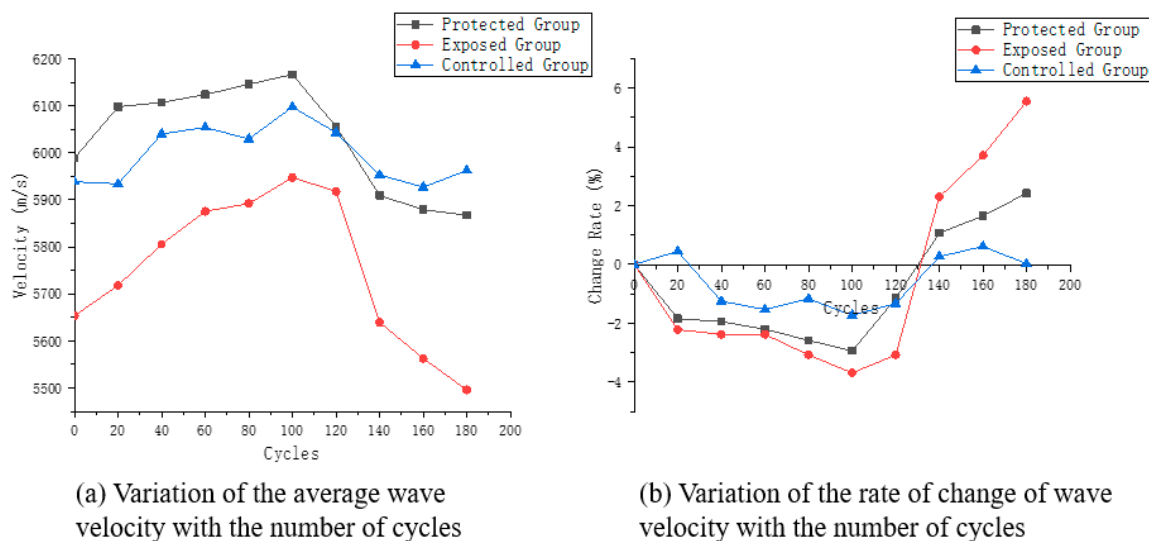
Figure 5a reflects the average wave velocity of the measurement points of the three groups of specimens, which show different trends. The wave velocity of the exposed group specimens showed a more obvious trend of increasing and then decreasing. The mean wave velocity of specimens in the protected group also showed a similar trend, but the change was not significant. The average wave velocity of the controlled group showed a back-and-forth fluctuation, but the change was small.

Figure 5. Wave velocity characteristic curve.

Figure 5b reflects the variation of the mean wave velocity at the measurement points for the three groups of specimens. The most significant variation is found in the exposed group, where the variation of velocity in a period fluctuates within the range of 10%. The wave velocity variation for specimens in the protected group was about half of that in the exposed group. In contrast, the controlled group showed essentially no change, with its maximum velocity change not exceeding 2%.

The specimens in this paper were made directly from in-service structural concrete, which has a large structural variability. This is also reflected in the variation of the wave velocity during the test period. Figure 6 shows the variation of single-point wave velocity at some measurement points of the three groups of specimens, and Figure 7 shows the variation of wave velocity variation rate at the corresponding measurement points.

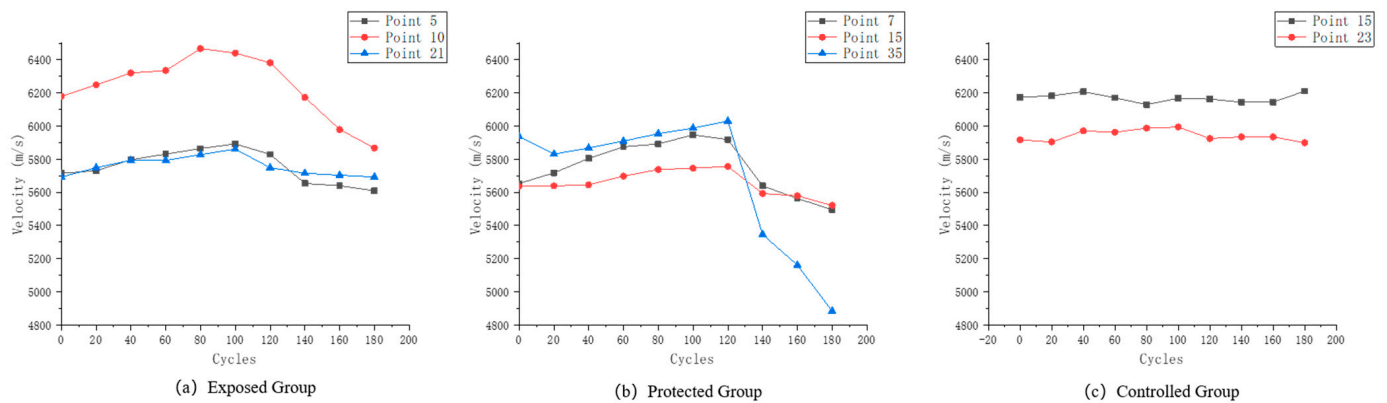
Three typical patterns of variation at different measurement points of the exposed group specimens are shown in Figure 6a. Measurement point No. 7 is mainly composed of cement paste on both sides, and its deterioration form is typical of the combined action of PSA (physical salt attack) and SA (sulfate attack). The wave velocity variation also shows a clear trend of increasing and then decreasing. Measurement point No. 15's contact location is mainly the aggregate cut surface. Since sulfate does not chemically interact with the aggregate, the PSA erosion of the aggregate is also relatively weak. Therefore, this point is the most stable point of wave velocity among the three types of points. However, the wave velocity still varies to some extent due to the internal expansion of the fracture in locations adjacent to it. Measurement point No. 35 increases in the early stage of erosion,

and the velocity decreases significantly after reaching the peak. This type of measurement point is mostly at the junction position of aggregate and cement paste. After a period of wetting–drying cycles, the crystalline precipitation of sulfate crystals took the lead in destroying the joint surface of the aggregate and cement paste, resulting in cracks and a significant decrease in wave velocity.

**Figure 6.** (a) Wave velocity variation of the characteristic measurement points of the exposed group; (b) Wave velocity variation of the characteristic measurement points of the protected group; (c) Wave velocity variation of the characteristic measurement points of the controlled group.

Figures 6c and 7c selected two types of measurement points in the controlled group, one with a single aggregate or mortar surface at point 15, and one at the material interface at point 23. The original wave velocity variation during the experiment for these two types of measurement points was lower than that of the exposed and protected groups, indicating that the wetting–drying cycle experiments in the clear water environment caused basically no damage to the specimens.

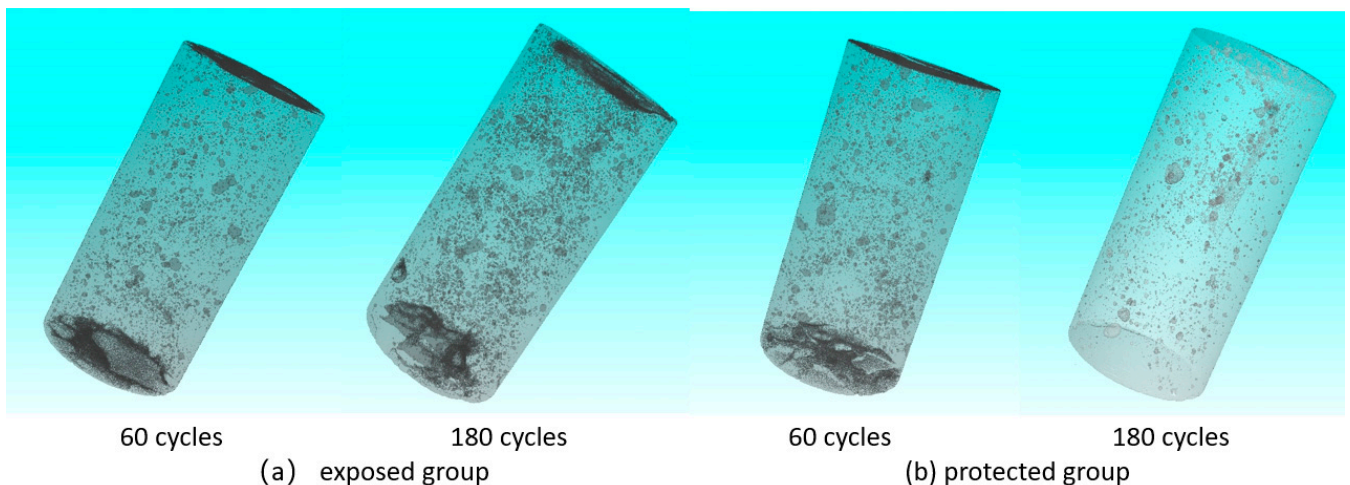
It can be seen in Figure 8 that the development of pores in the exposed group specimens is more significant during the erosion process, and there is a certain degree of increase in the number of small pores on the outside of the specimens. The number of small pores on the outside of the specimens in the protected group, on the other hand, showed a significant decrease during the erosion process. The difference between the two is that the sulfate component in the erosion solution filled some of the native pores during the subsequent erosion process after the application of the silane protective coating. However, due to the protective layer, the specimen surface was maintained in a relatively good condition, which inhibited the generation of subsequent pores and fissures.

**Figure 8.** (a) Three-dimensional pore-structure reconstruction of specimens in the exposed group; (b) Three-dimensional pore-structure reconstruction of specimens in the protected group.
