# CONDITION ASSESSMENT OF RC BRIDGES. INTEGRATING MACHINE LEARNING, PHOTOGRAMMETRY AND BIM

P. Borin <sup>1\*</sup>, F. Cavazzini <sup>2</sup>

**KEY WORDS:** Cultural Heritage, HBIM, Photogrammetry, Machine Learning, Infrastructure

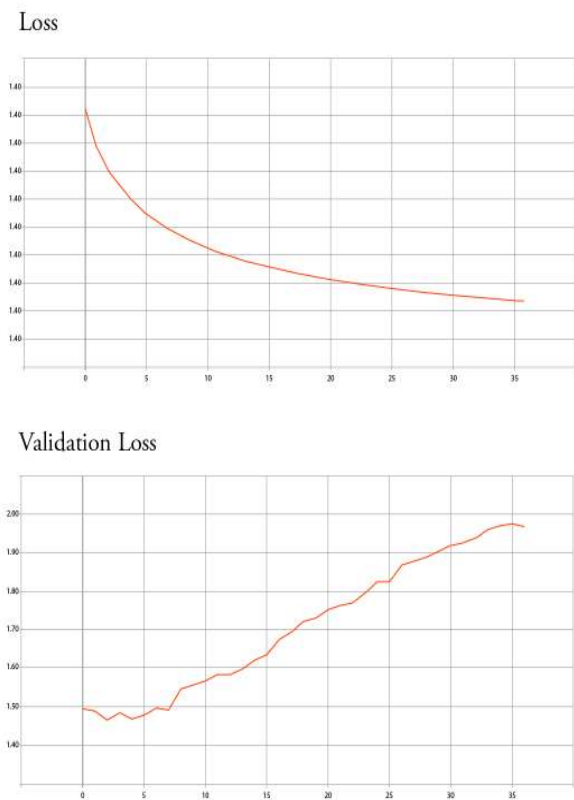
The training phase was executed for 16 hours and a total of 80 epochs, each one with 575 steps and a batch size of 1 image per step. The tenth epoch model was used to perform the recognition of the degradation, in addition to which overfitting was beginning to occur (Figure 2).

Figure 2. Loss and Validation Loss graphs from Tensorboard

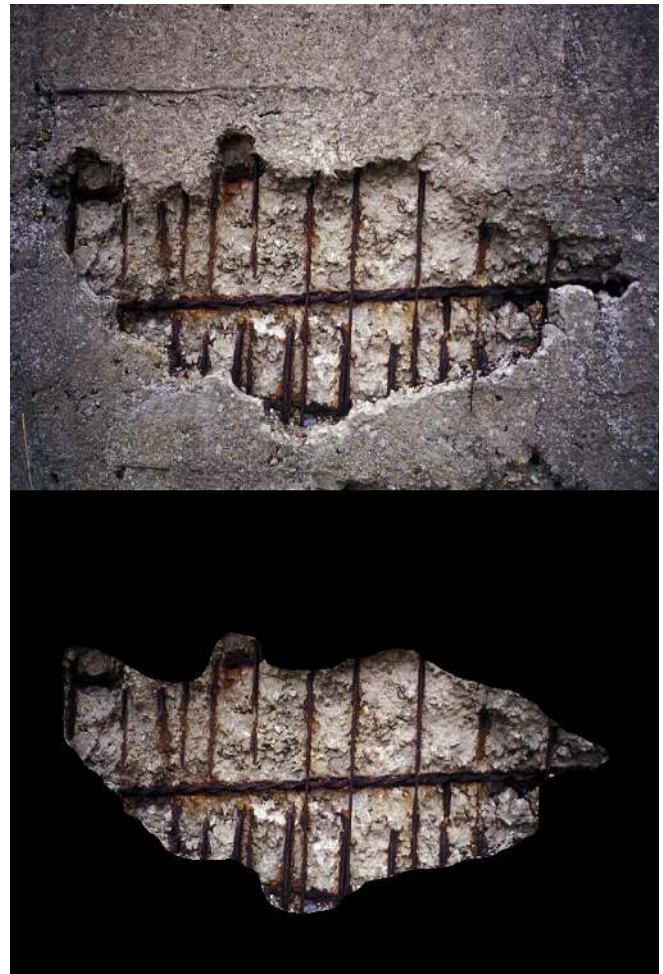
detection, the algorithm extracts the images containing only the detected spalling (Figure 3).

Figure 3. Example of spalling detection

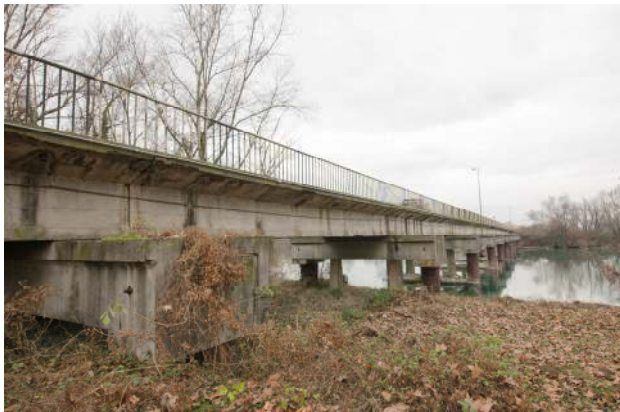
Figure 4. Current state of the bridge

The structure of the bridge is in reinforced concrete, composed of three longitudinal beams, supported by girder spans each supported by four pillars.

There is an evident state of degradation, with widespread concrete spalling, an ideal condition to test the validity of the proposed method.

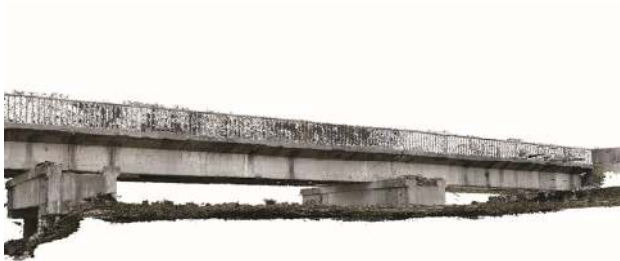
Figure 5. Photogrammetric point cloud

The dense point cloud obtained, once the superfluous data have been manually eliminated, counts 155 million points. Although there are several studies on automated modeling (Martarelli et al., 2014; Quagliarini et al., 2017; Sánchez-Aparicio et al., 2018), the BIM model was reconstructed manually. The lack of standard makes necessary to align the objects typically defined for buildings in a bridge model. Beam objects have been used for beams, columns for bridge piles, a slab for the road slab, etc. Each element was modeled individually, using parametric elements that have been adapted to reflect as close as possible the current situation, in order to guarantee the best precision during the following degradation projection phase.

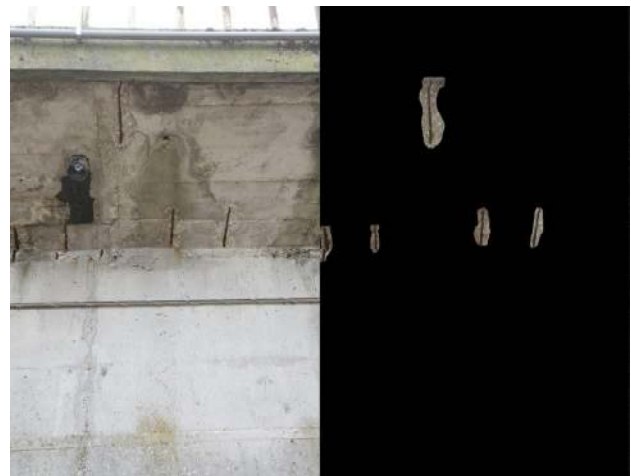
Figure 6. Detailed image of the slab intrados, at right recognized damages

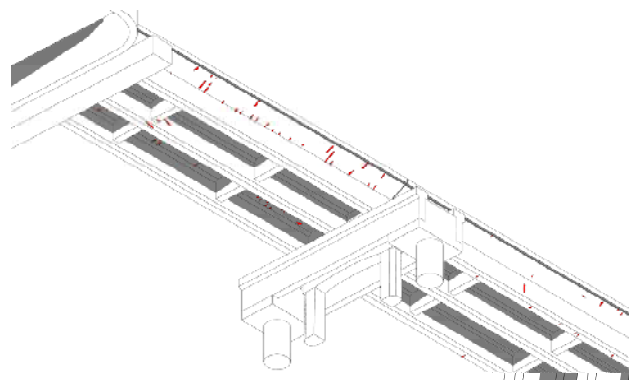
To perform the projection of the masks as recognized by the neural network, an ad-hoc script was created using Dynamo. The data extracted from the neural network (EXIF data and contours of the degradations) and from the camera alignment phase (position and orientation), allow reconstructing each selected picture in the 3D model. As described above, each photo was projected inversely towards the 3D objects, identifying the vertices of the degraded surfaces, then converted into classified elements of degradation.

Figure 7. BIM model with the detected damages

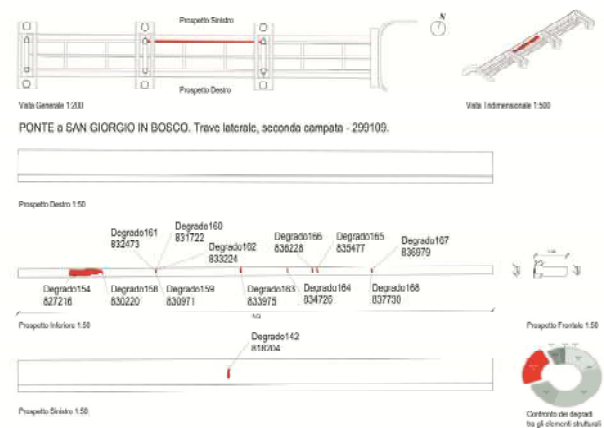
Figure 8. Representation of the current condition of bridge parts

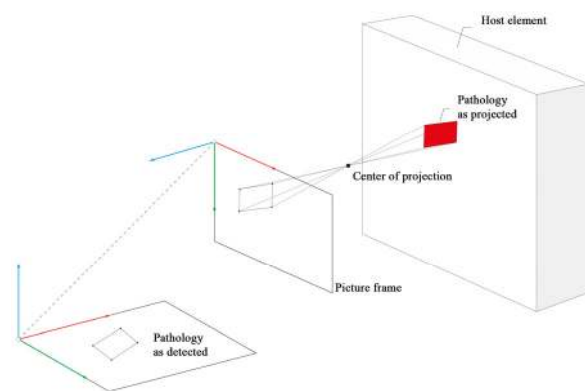
Figure 9. Projection of curves from analyzed images to BIM elements.
