Corrosion of Barrier Materials in Seawater Environments

**John H. Heiser
Peter Soo**

July 1995

**Environmental and Waste Technology Center
Department of Advanced Technology
Brookhaven National Laboratory
Associated Universities, Inc.
Upton, Long Island, New York 11973**

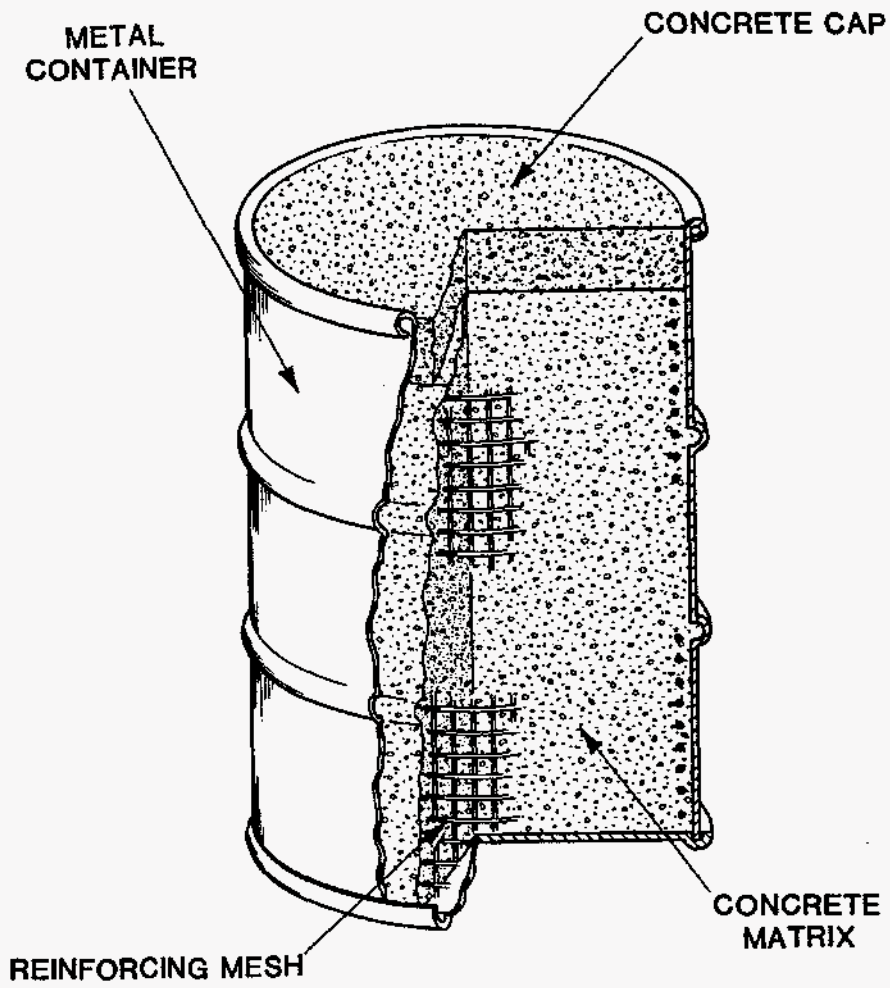
Figure 1.1 Waste package used in early ocean disposal.

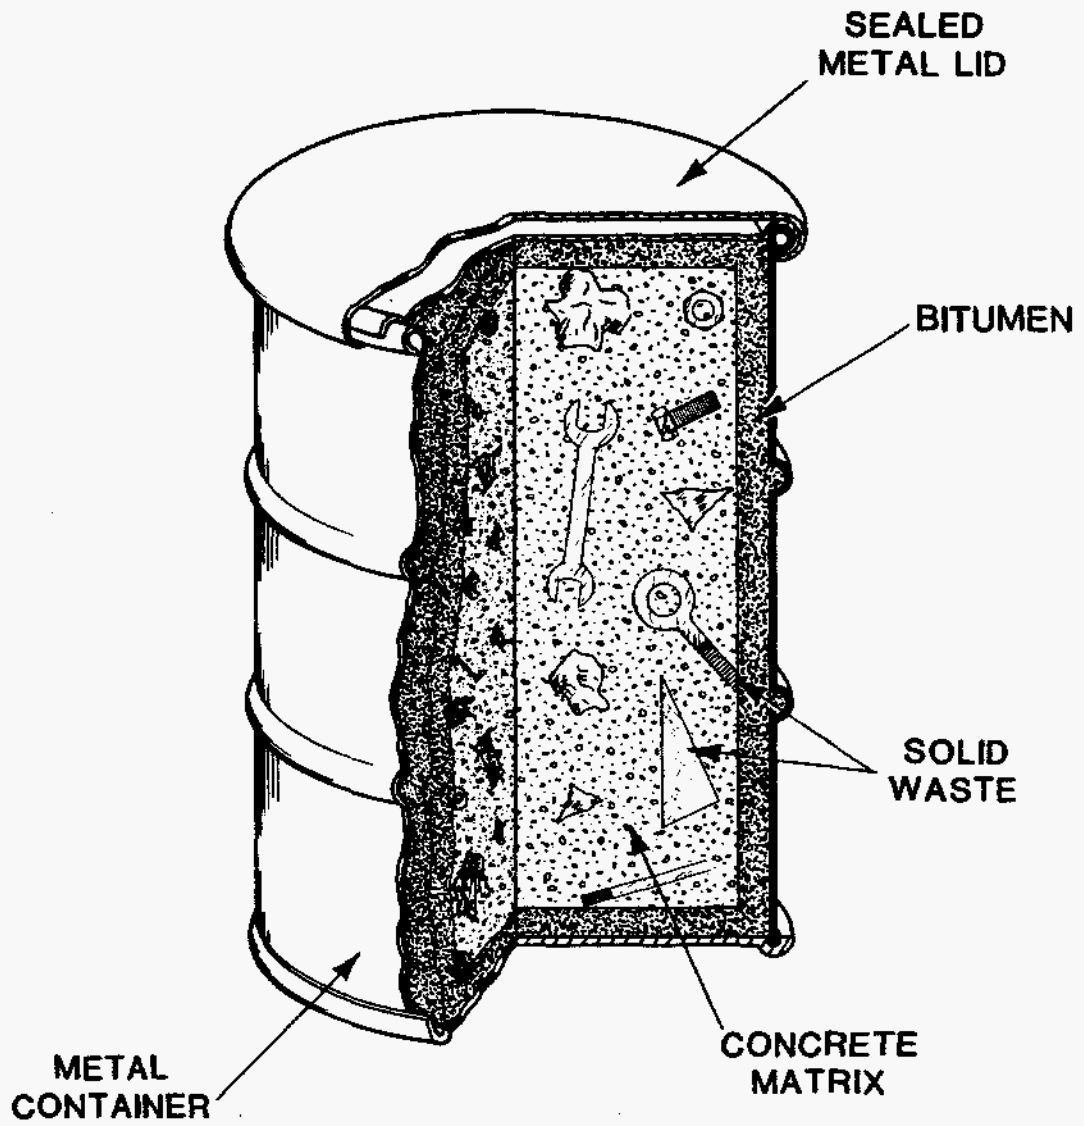
Figure 1.2 Alternate type of waste package used for early ocean disposal.

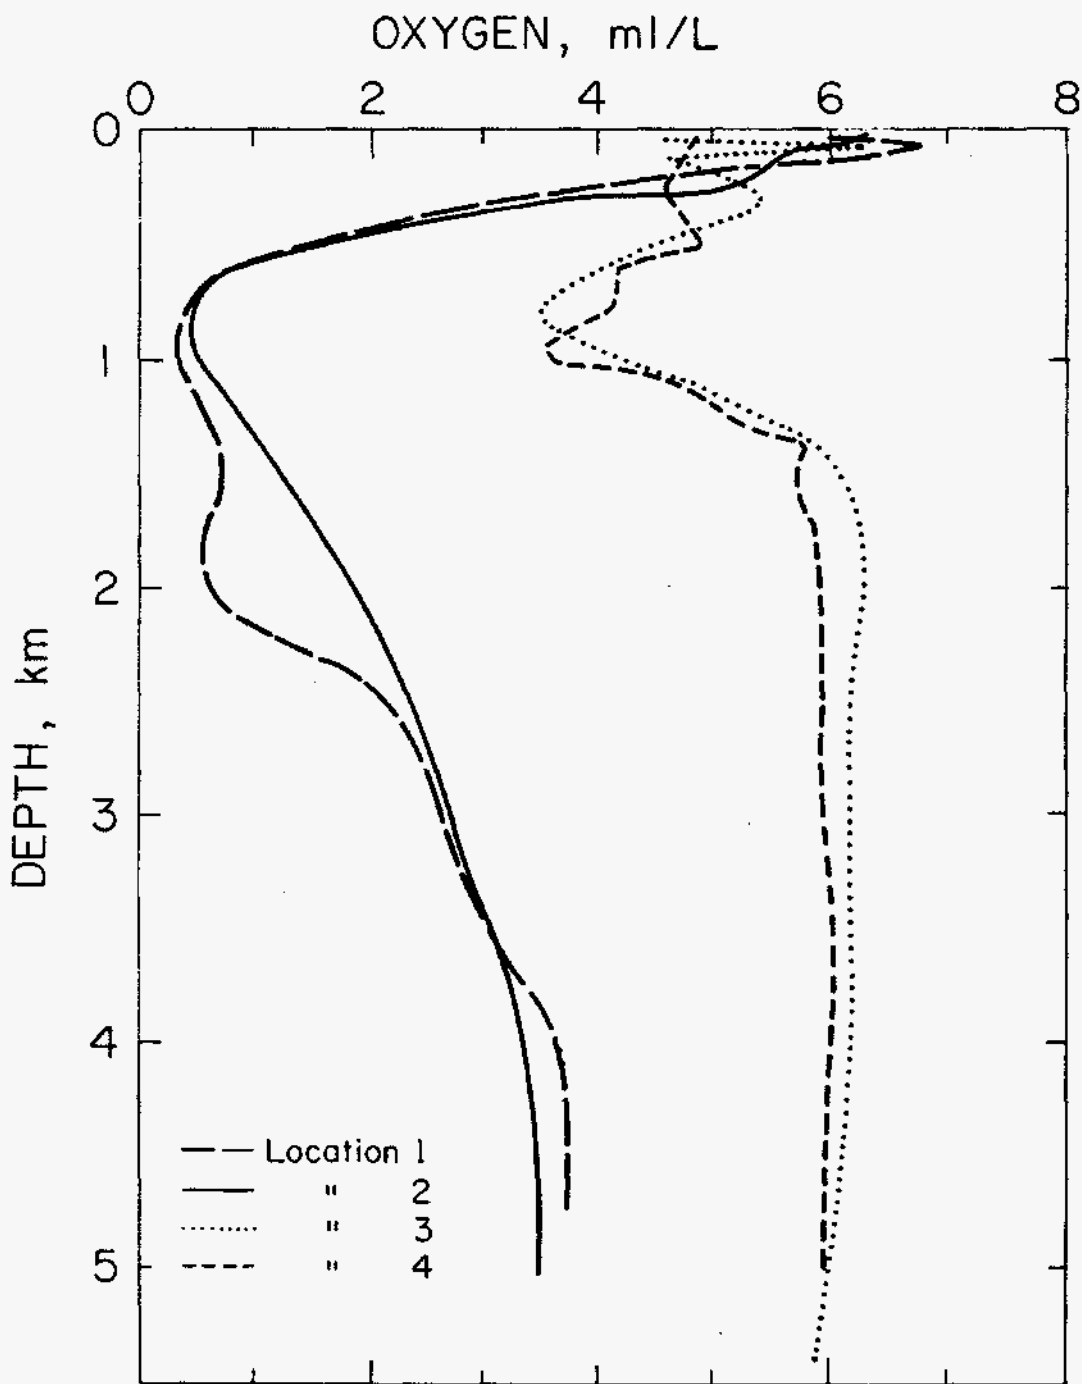
Figure 1.4 Variability of oxygen with depth in the North Atlantic and North Pacific [5,8]. Location defined in Figure 1.3.

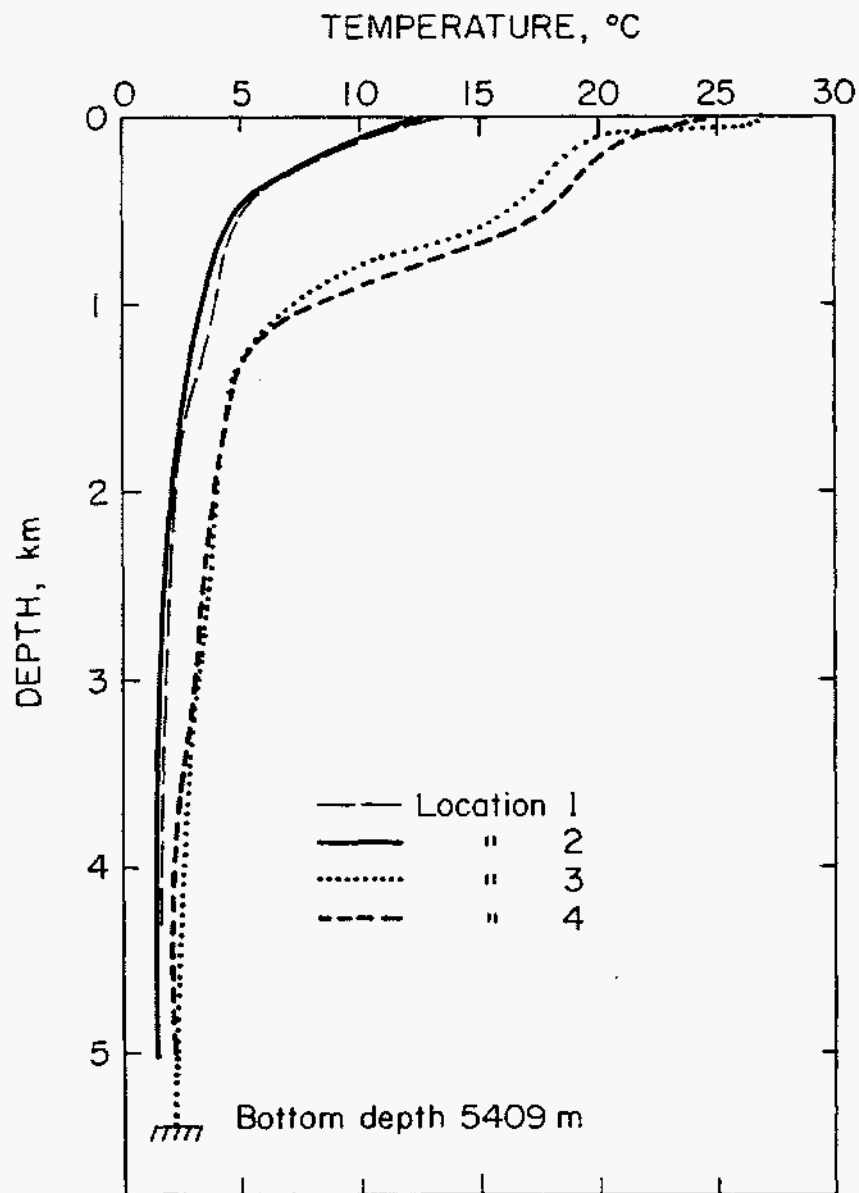
Figure 1.5 Variation of temperature with depth [5,8].
Locations defined in Figure 1.3.

Temperature in surface waters is variable and shows pronounced seasonal changes in temperate regions. In deeper waters the temperature shows less variability. At ocean depths below 4000 m the temperatures in both the Atlantic and Pacific remain in the range of 3-6°C throughout the year. These low temperatures tend to retard most failure modes (i.e. corrosion) but may cause materials to become more brittle (e.g., plastics). Figure 1.5 shows the temperature profile with depth at the locations shown in Figure 1.3.

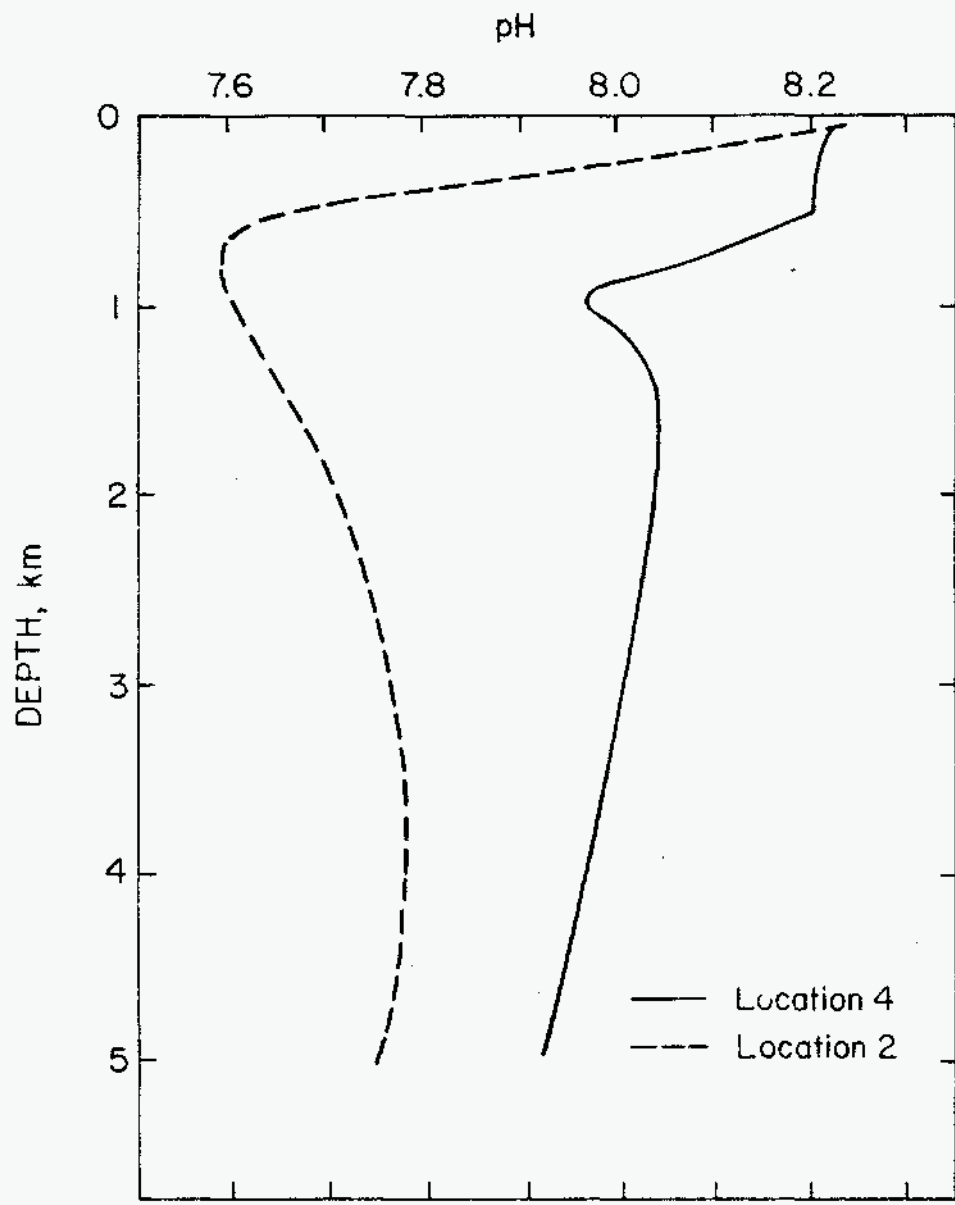
Figure 1.6 Variation in pH with depth [5].
Locations defined in Figure 1.3.

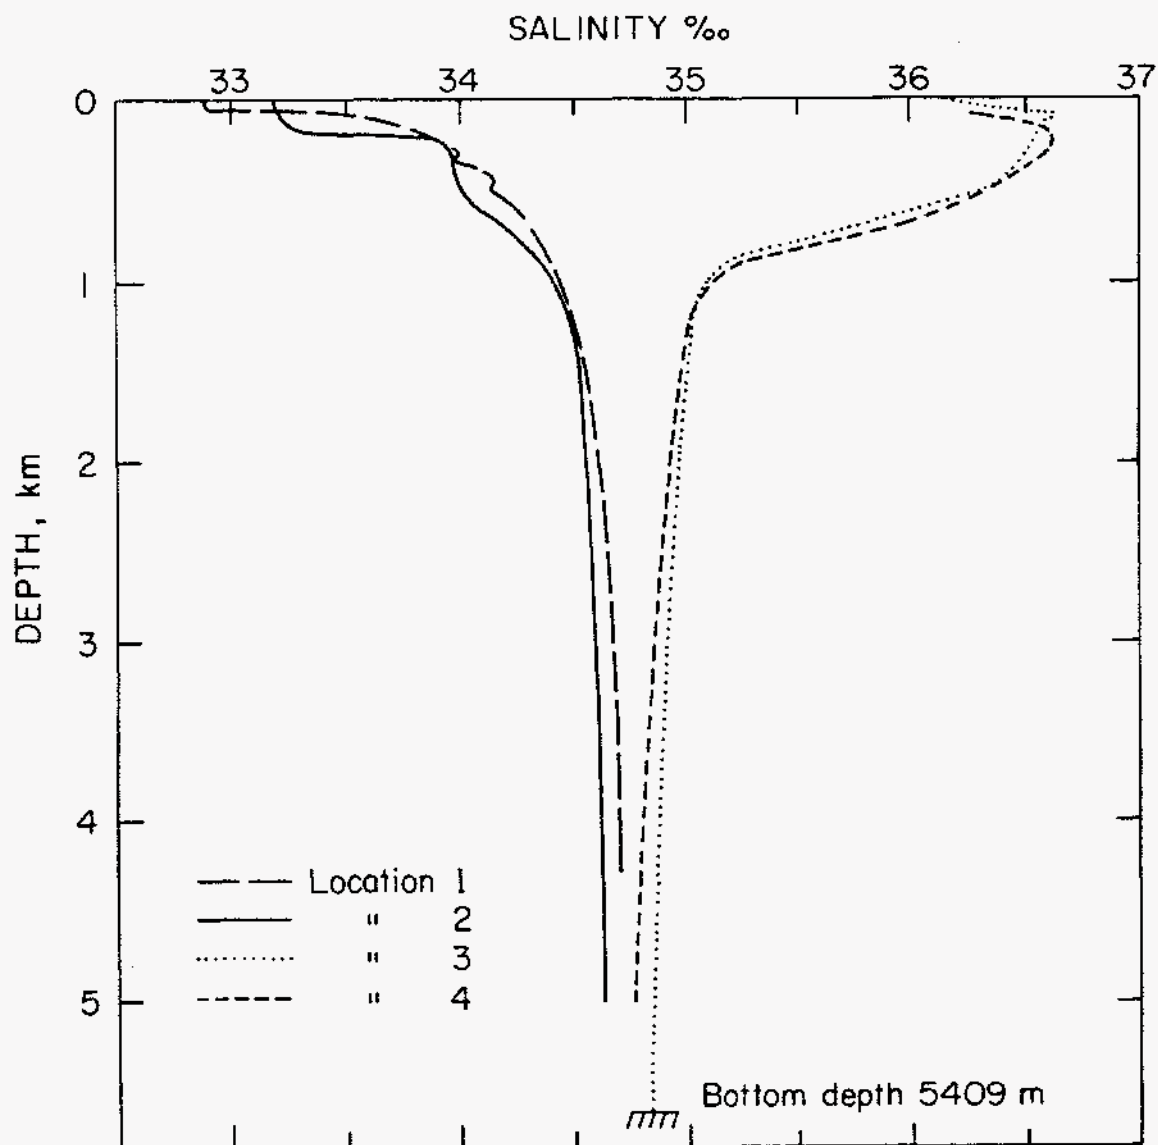
Figure 1.7 Variation in salinity with depth [5,8].
Locations defined in Figure 1.3.

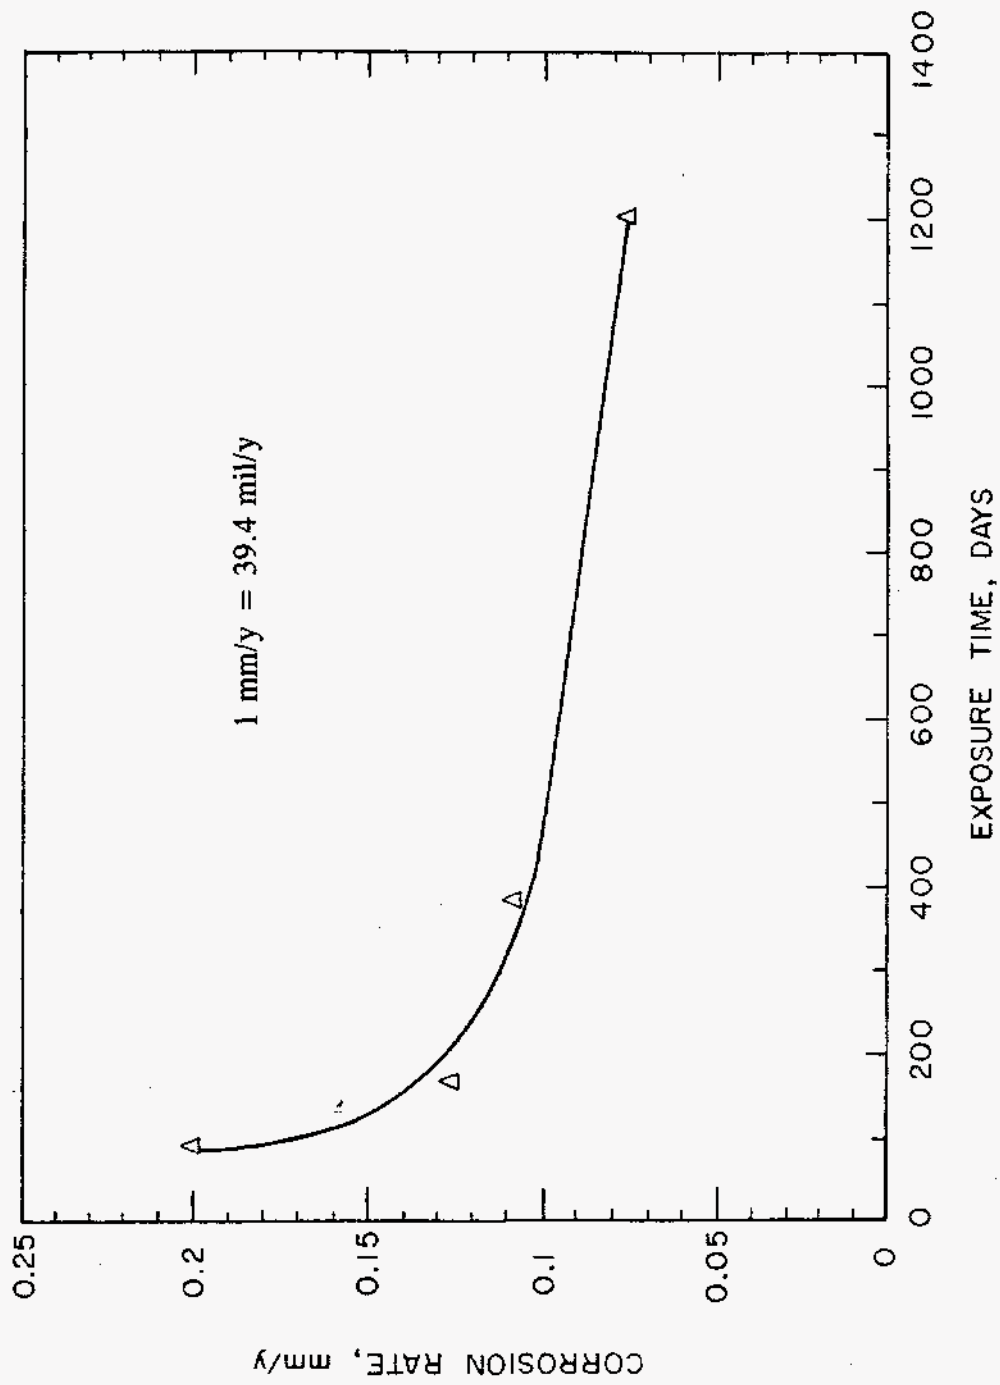
Figure 2.1 Effect of exposure time on corrosion of low alloy steels in seawater [34]

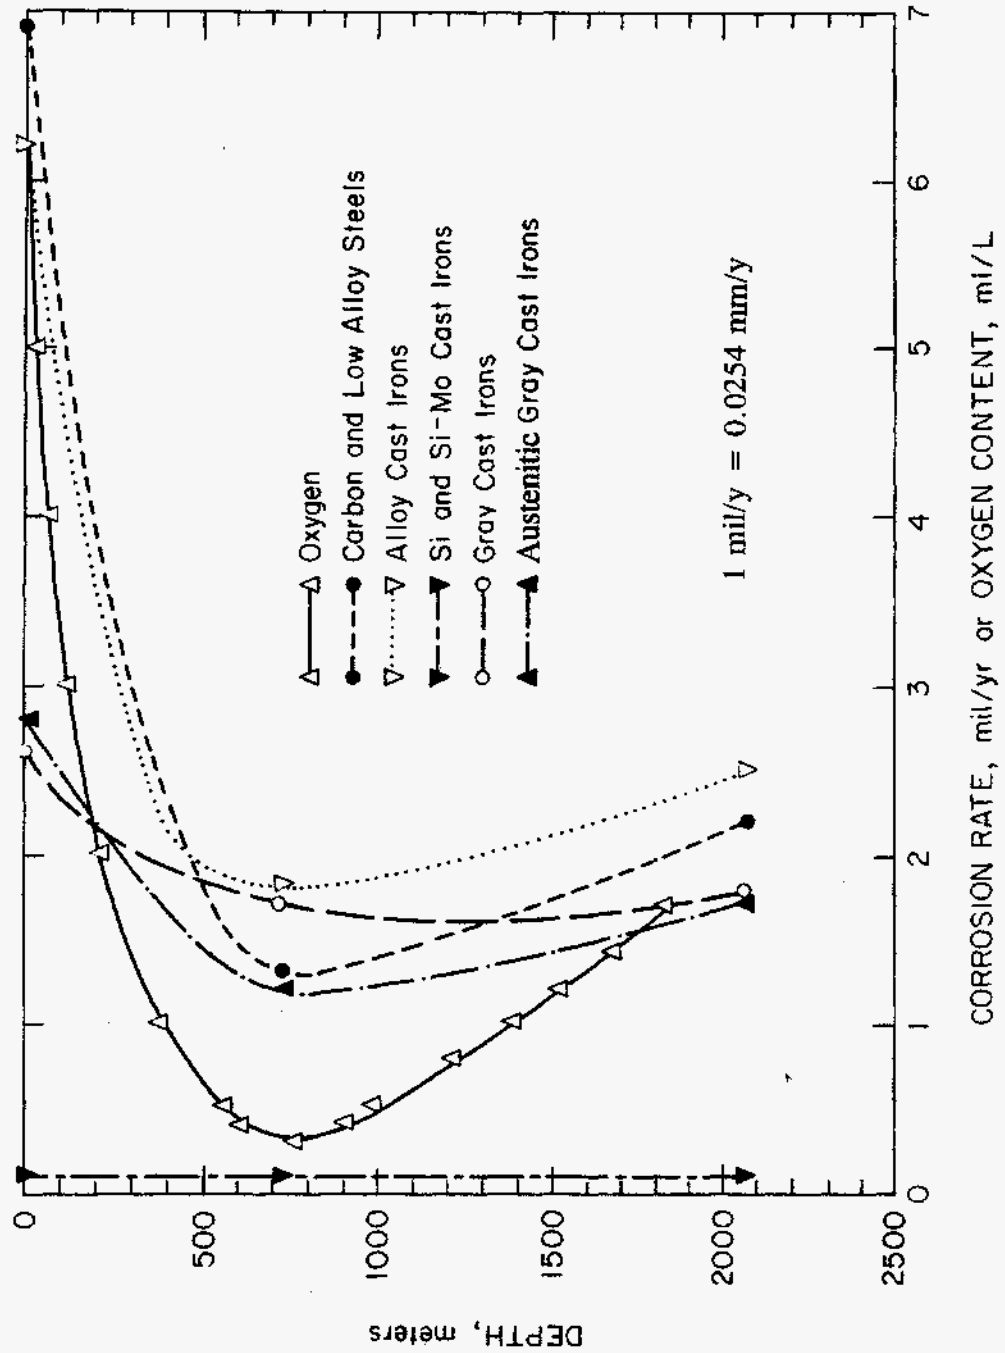
Figure 2.2 Change in corrosion rate and oxygen content with seawater depth for iron and low alloy steels [31].

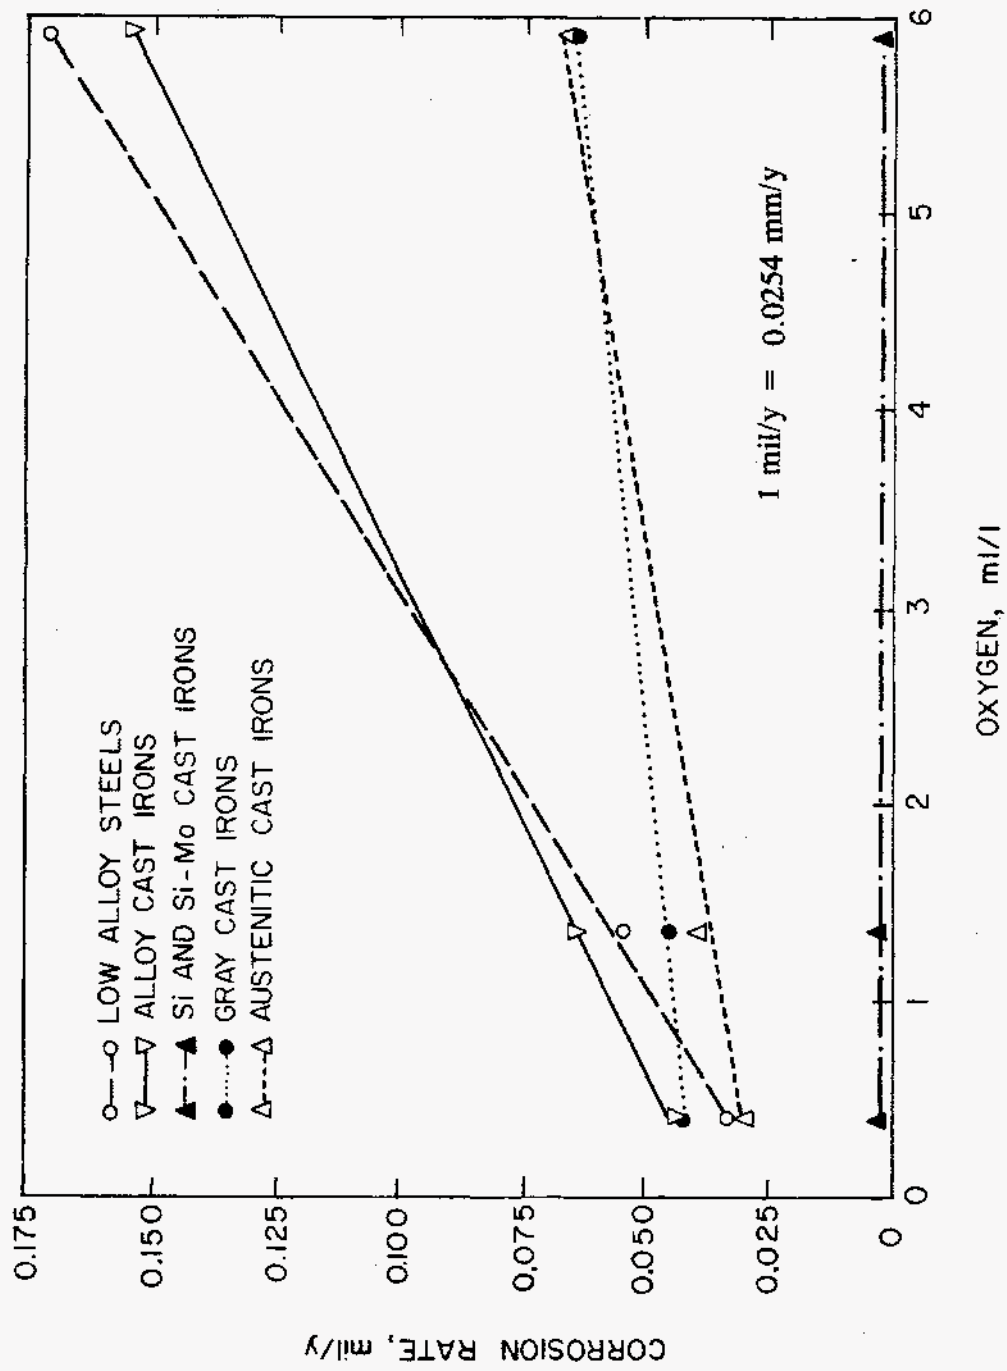
Figure 2.3 Effect of oxygen on corrosion of cast irons and low alloy steel in seawater [31].

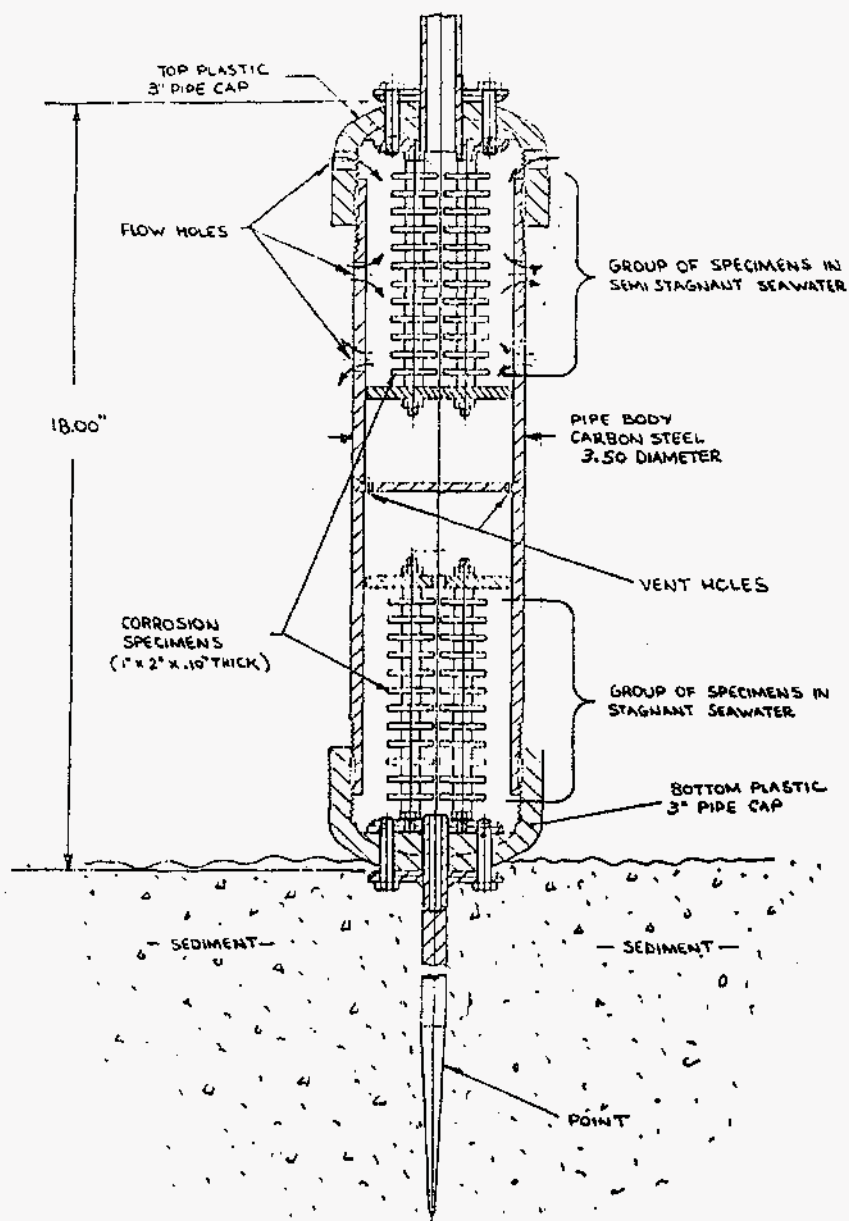
Figure 2.4 Type 3 corrosion specimen assembly [35].

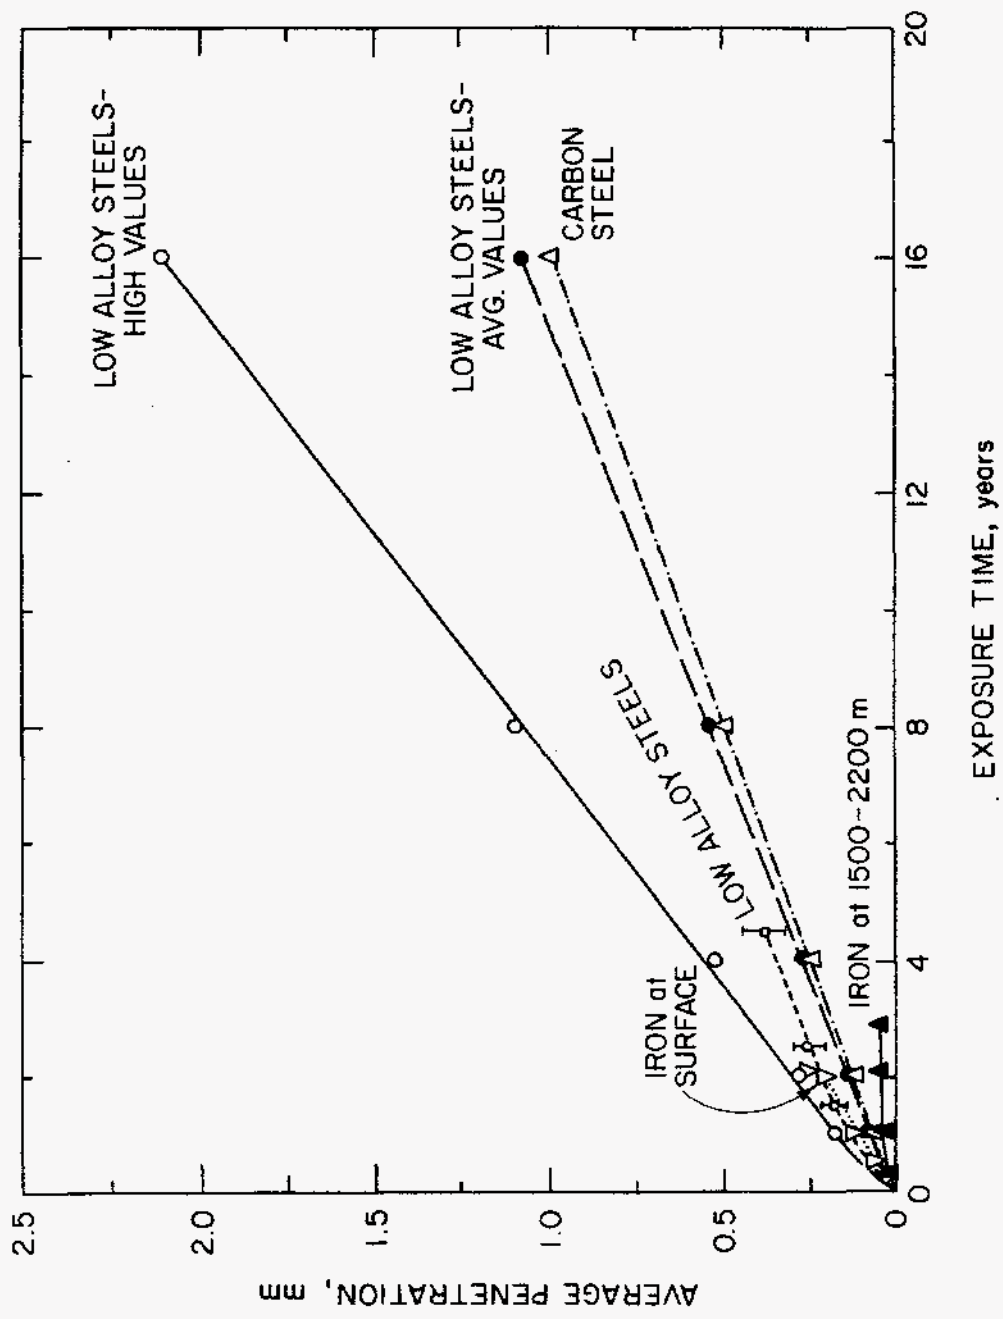
Figure 2.6 Penetration versus exposure time for irons and low alloys steels in seawater [31,37,38].

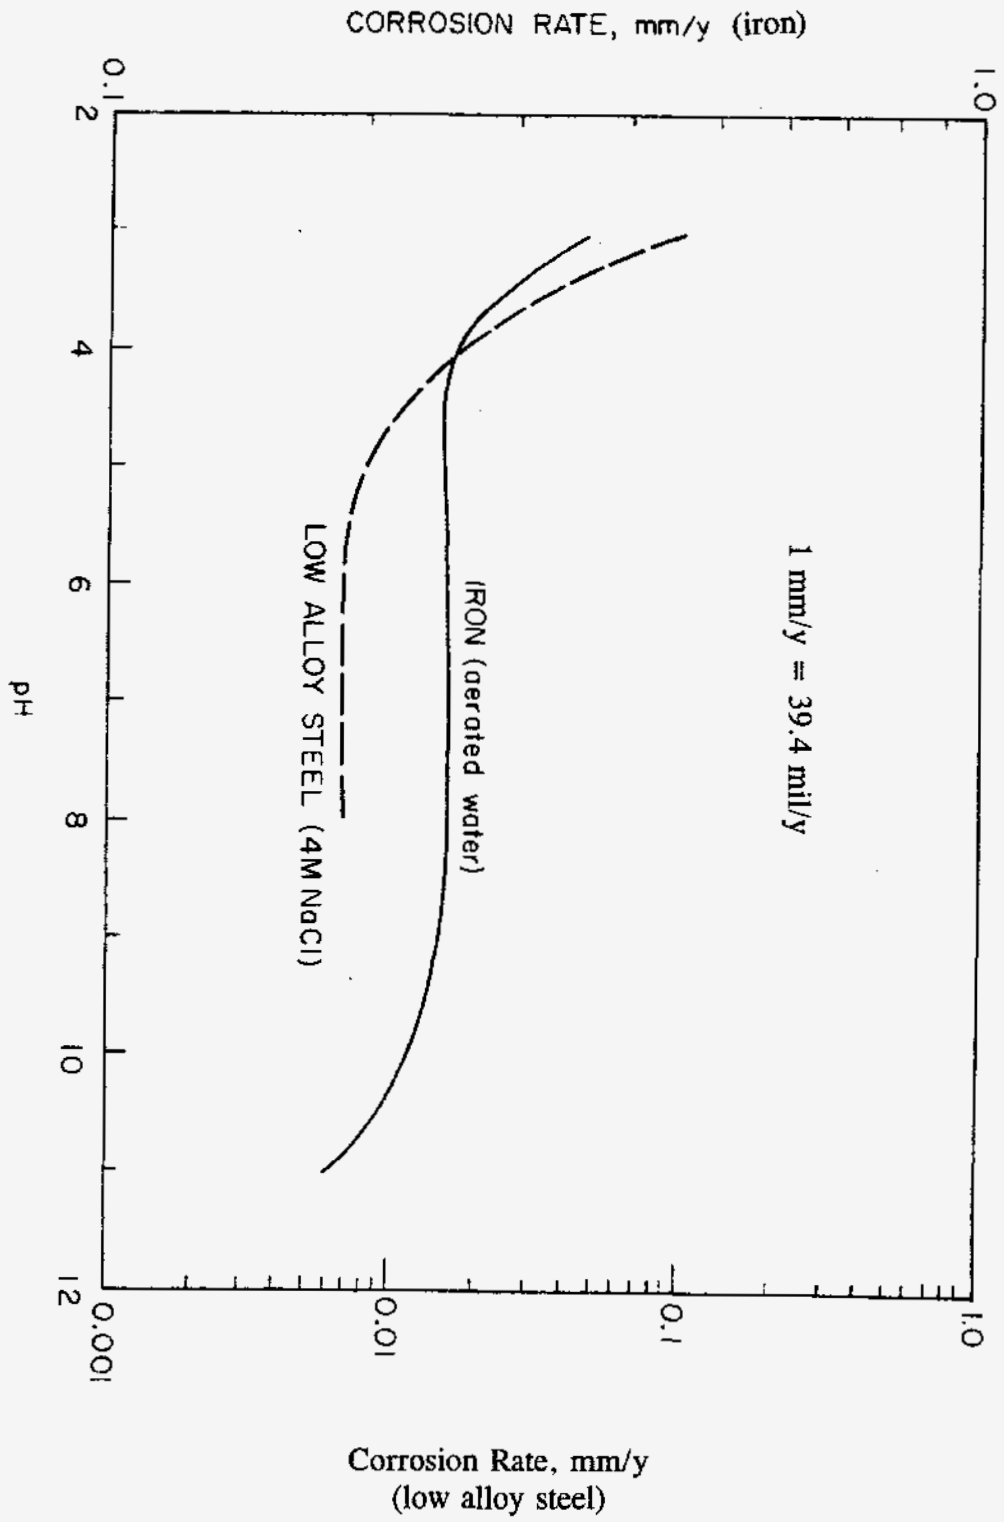
Figure 2.7 Effect of pH on corrosion of iron and low alloy steel in seawater and NaCl solution [39,40].

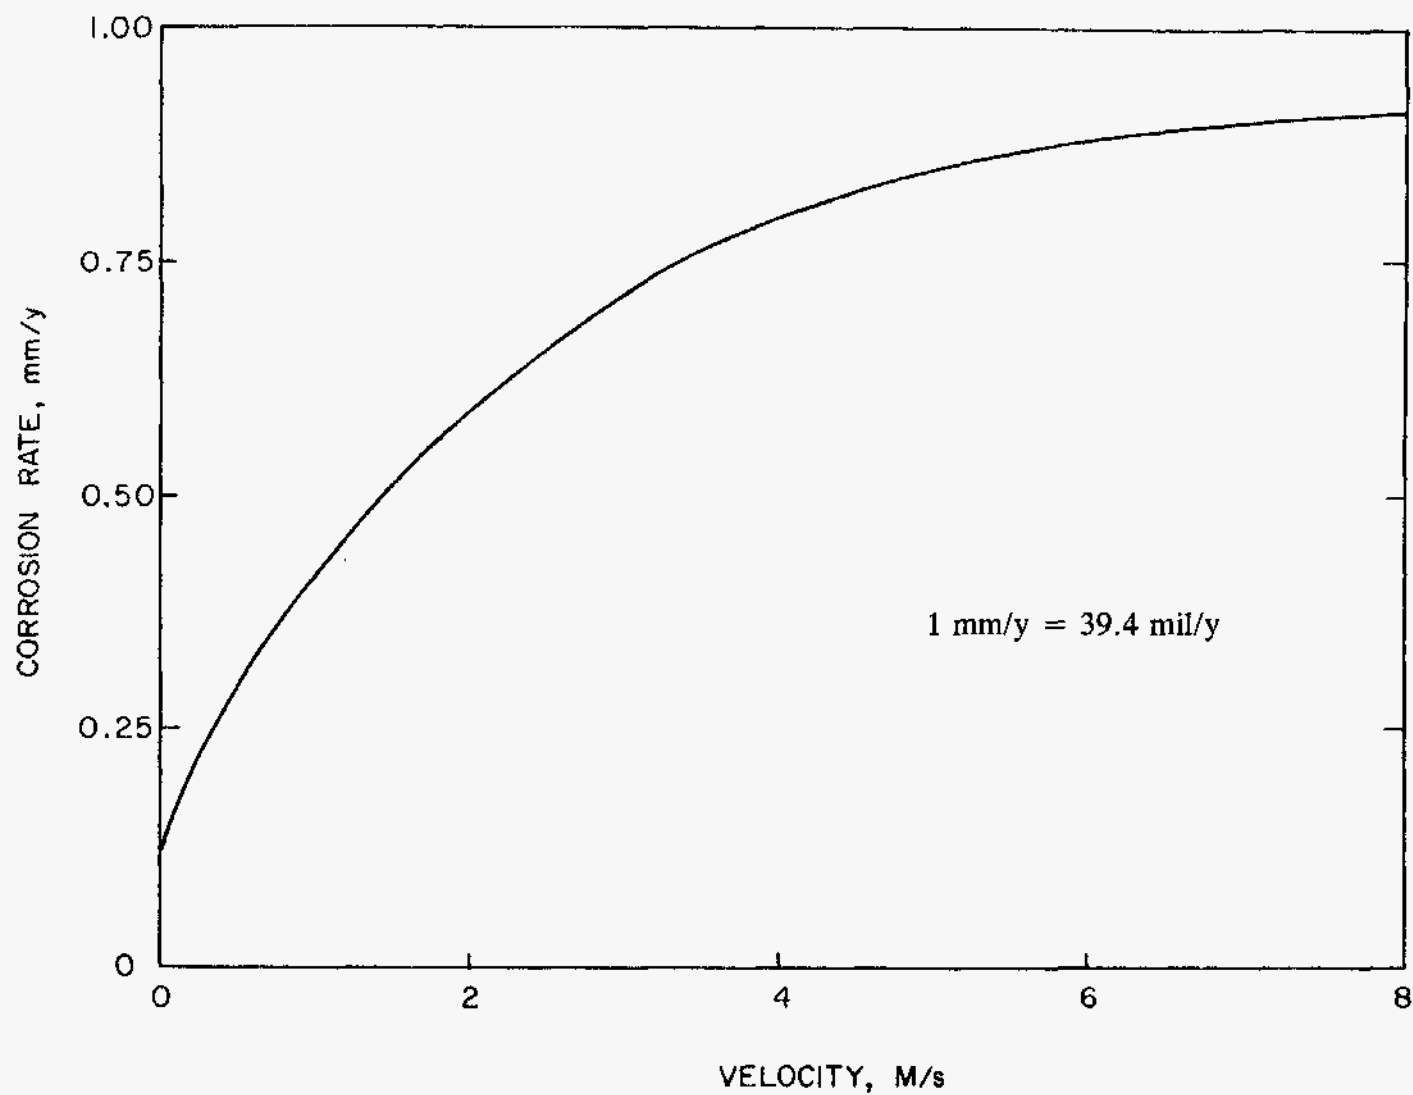
Figure 2.8 Effect of seawater velocity on corrosion of low alloy steels [41].

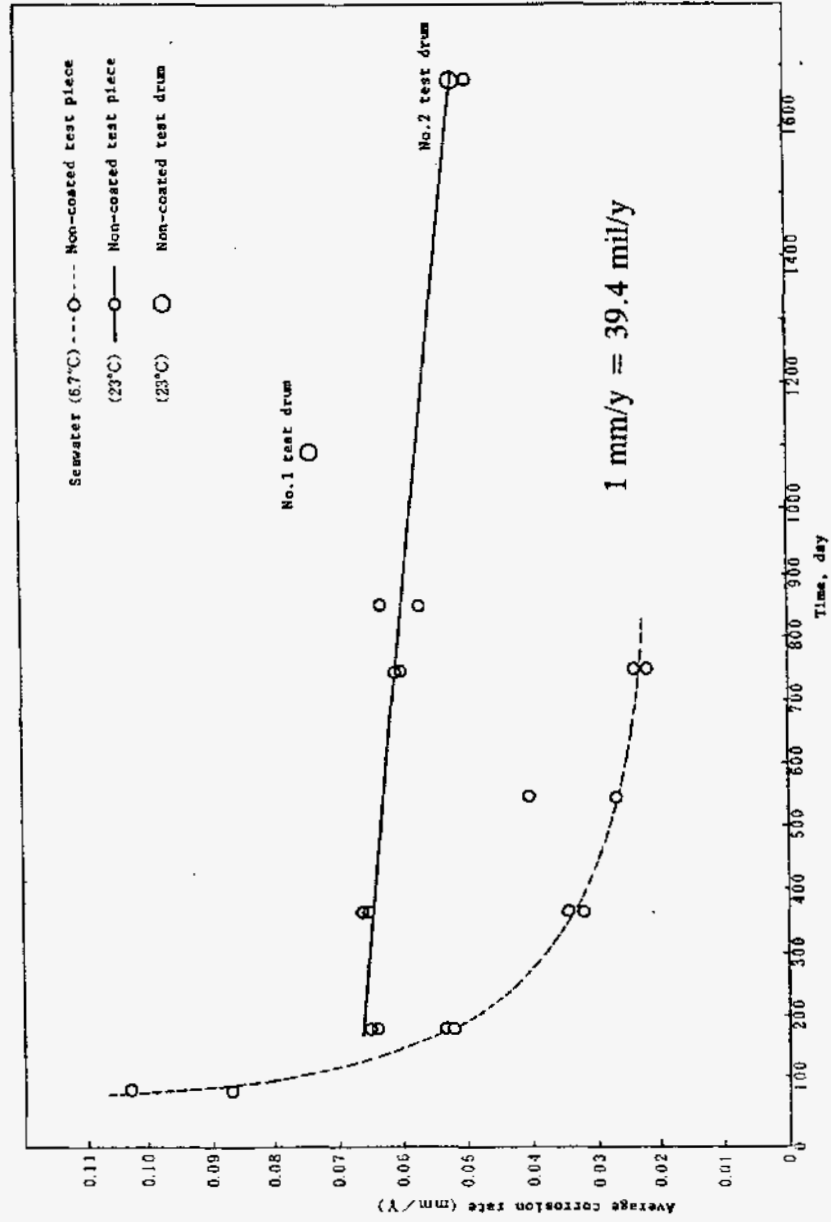
Figure 2.9 Average carbon steel corrosion rates in seawater calculated from weight changes on non-coated test pieces [43].

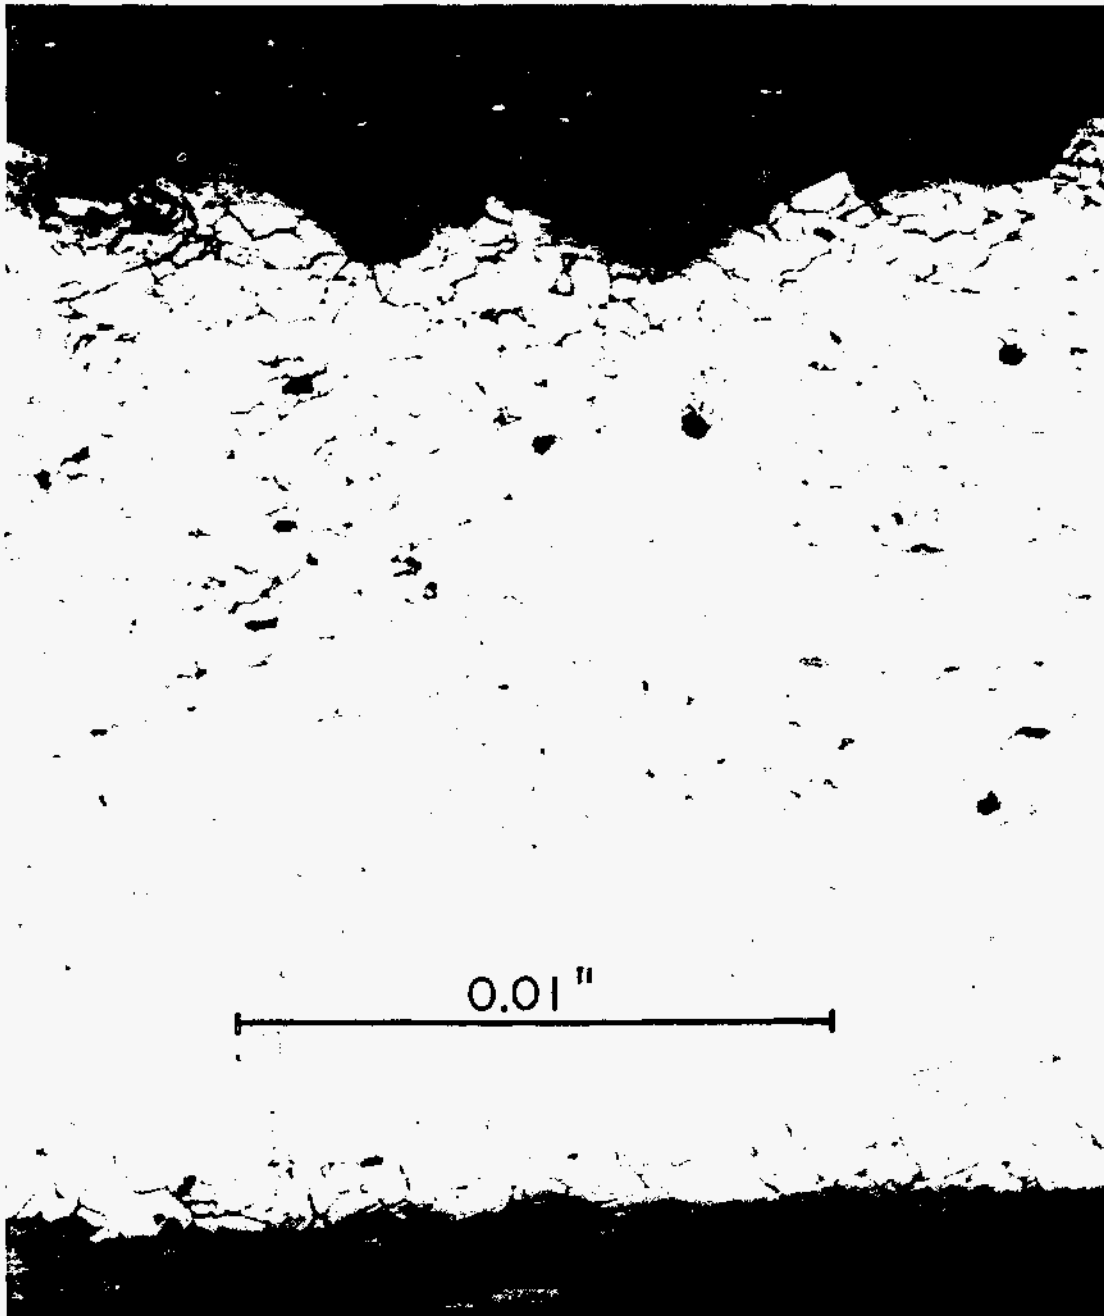
Figure 2.14 A typical metallographic cross section of the upper portion of the container retrieved from the 2800 m Atlantic site [2].

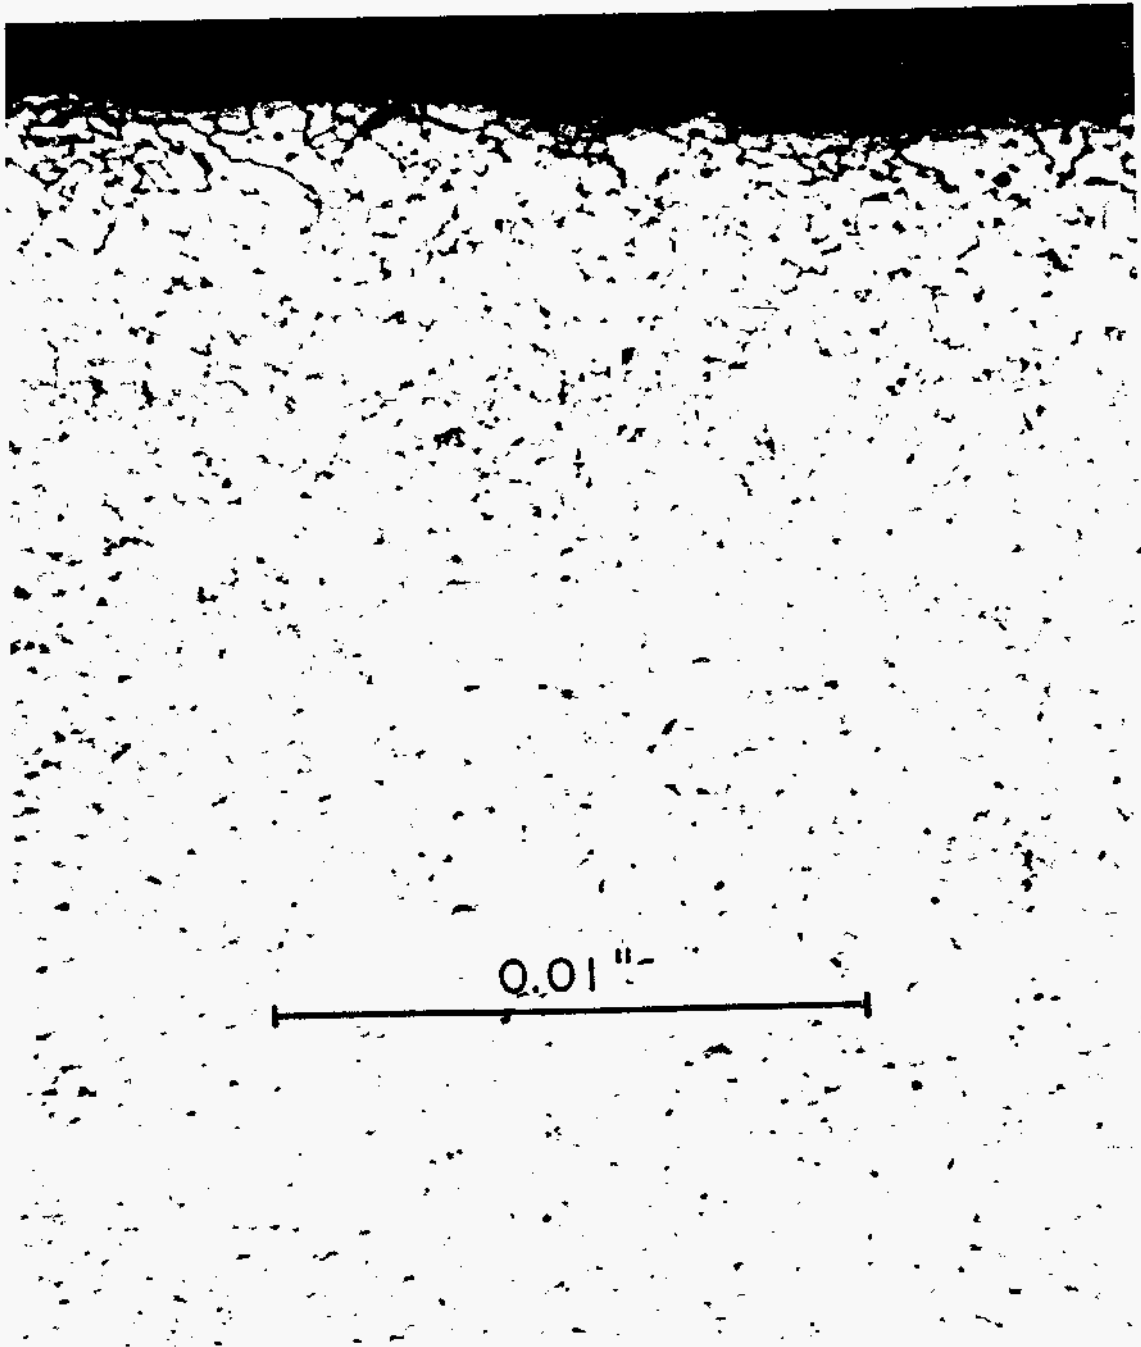
Figure 2.15 A typical metallographic cross section of the lower portion of the container retrieved from the 2800 m Atlantic site [2].

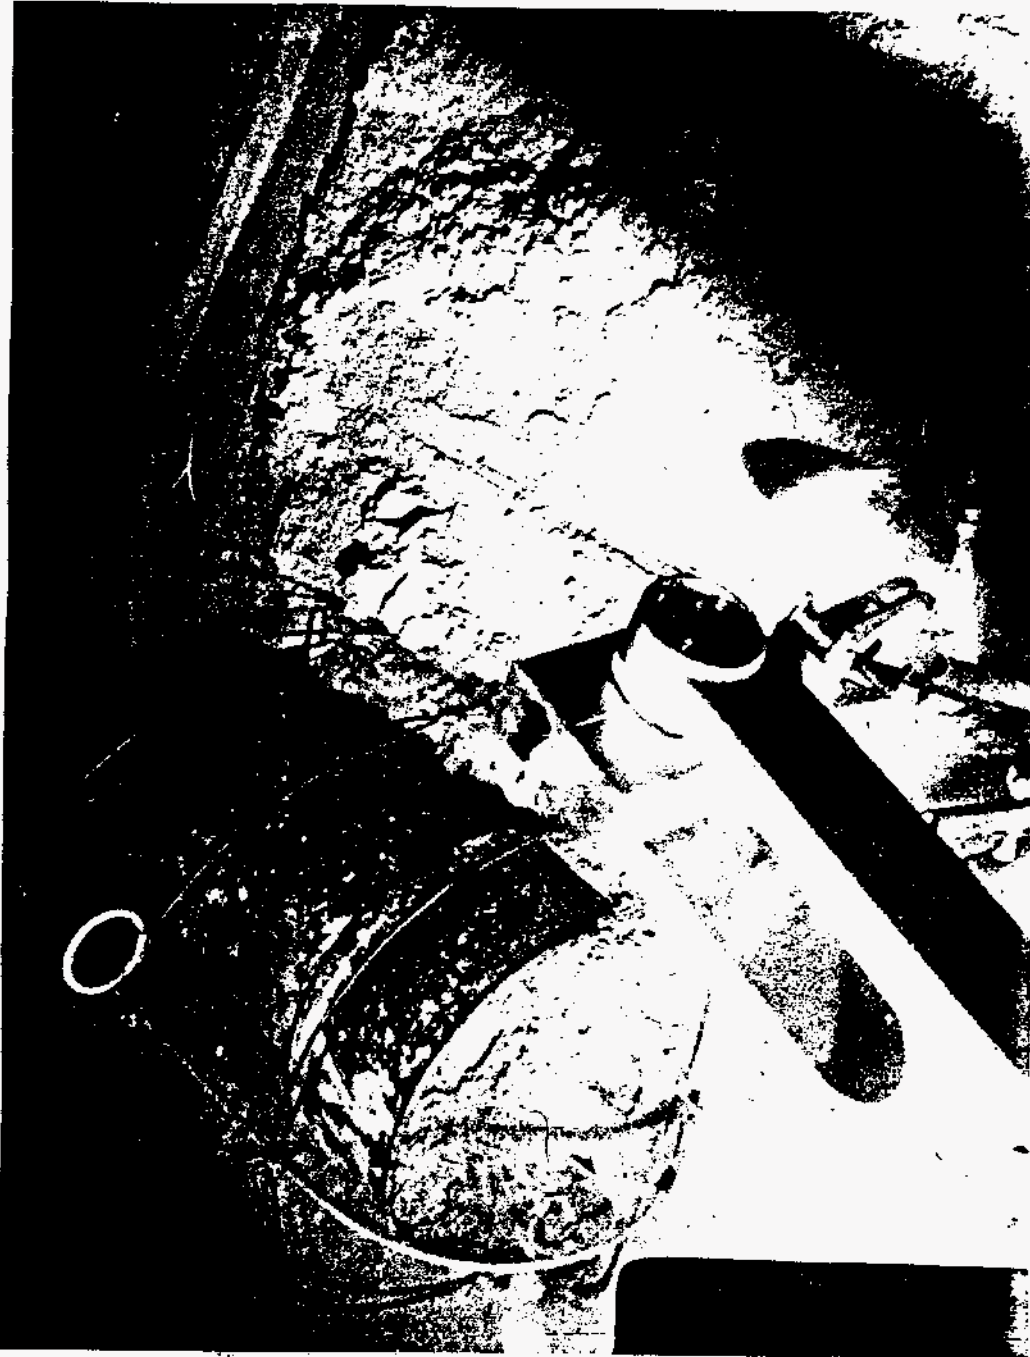
Figure 2.18 Retrieval operations using Alvin's mechanical arm to place a metal harness around the waste package at the 3800 m Atlantic site [4].
