Corrosion of Barrier Materials in Seawater Environments

**John H. Heiser
Peter Soo**

July 1995

**Environmental and Waste Technology Center
Department of Advanced Technology
Brookhaven National Laboratory
Associated Universities, Inc.
Upton, Long Island, New York 11973**

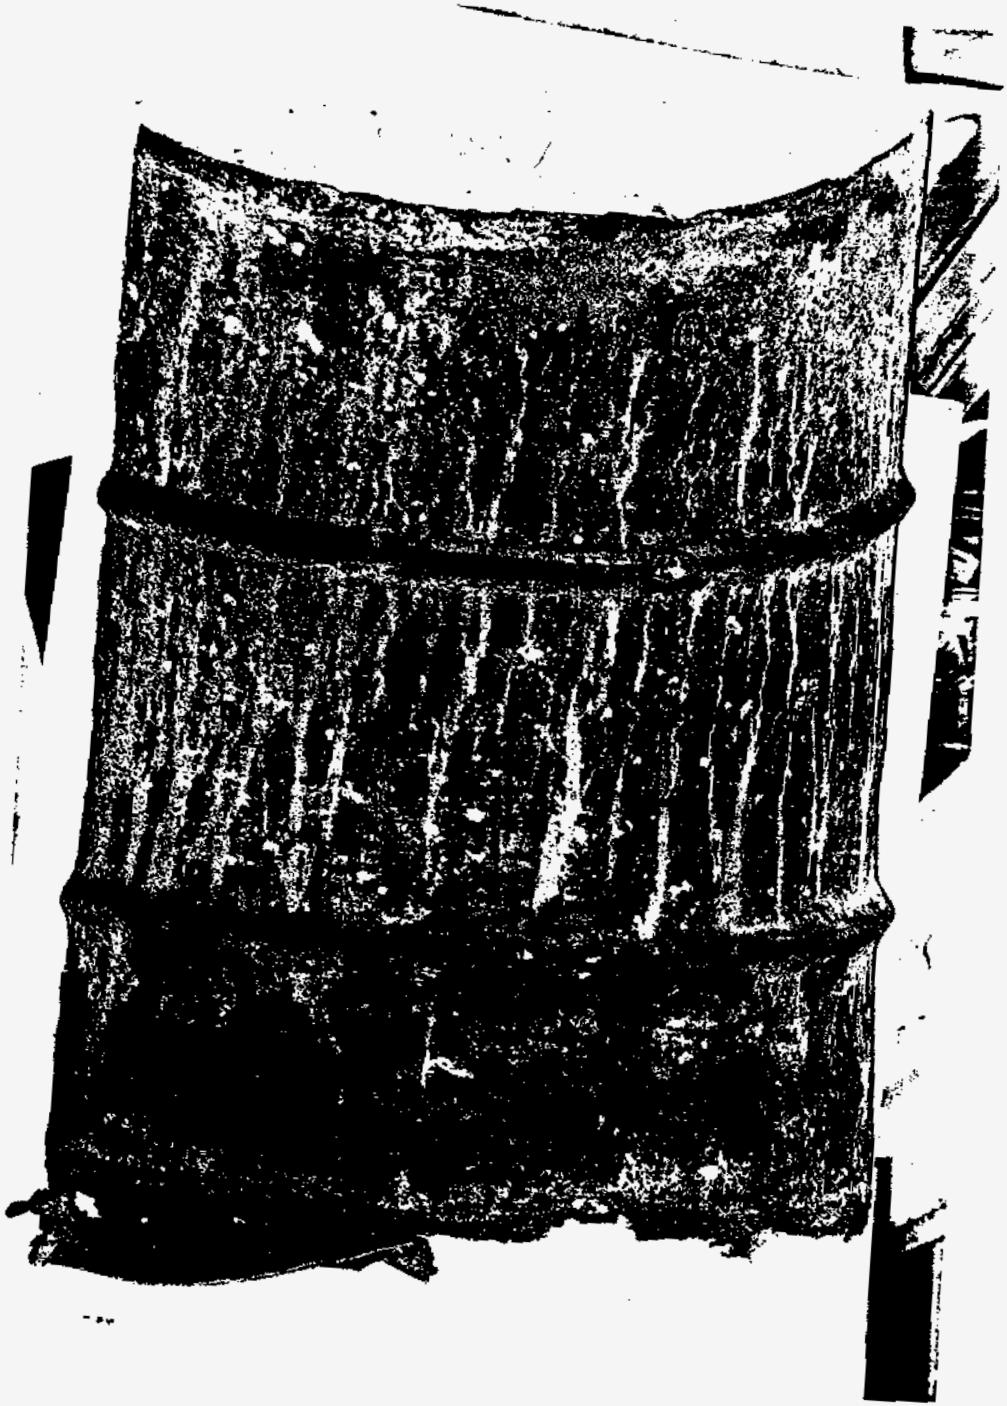
Figure 2.22 Photograph of inner side of container from the 3800 m Atlantic site after removal from concrete. Perforations appear near rim of the chimnes and at the mudline [4].

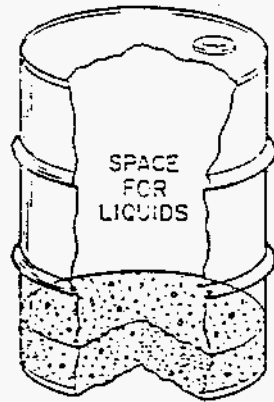
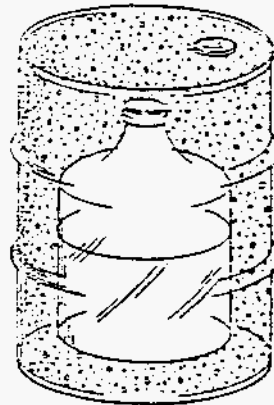
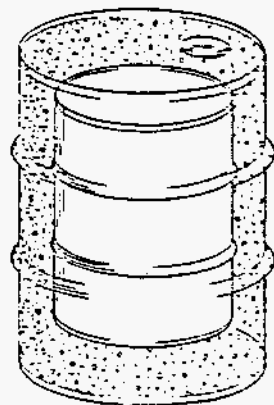
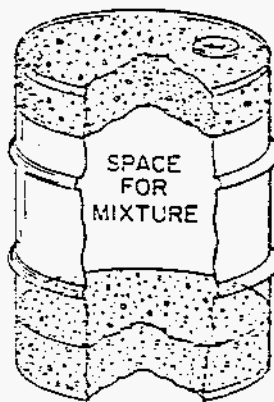
(a)
Weighted drum for
low level liquids

(b)
Carboy of low level
liquids

(c)
30 gallon drum of
solidified liquids

(d)
Mixture of solid waste
materials and concrete

Figure 2.23 Cut away isometric views showing modifications of 55-gallon drums for packaging radioactive wastes which were disposed of in the Farallon Islands 900 m disposal site.

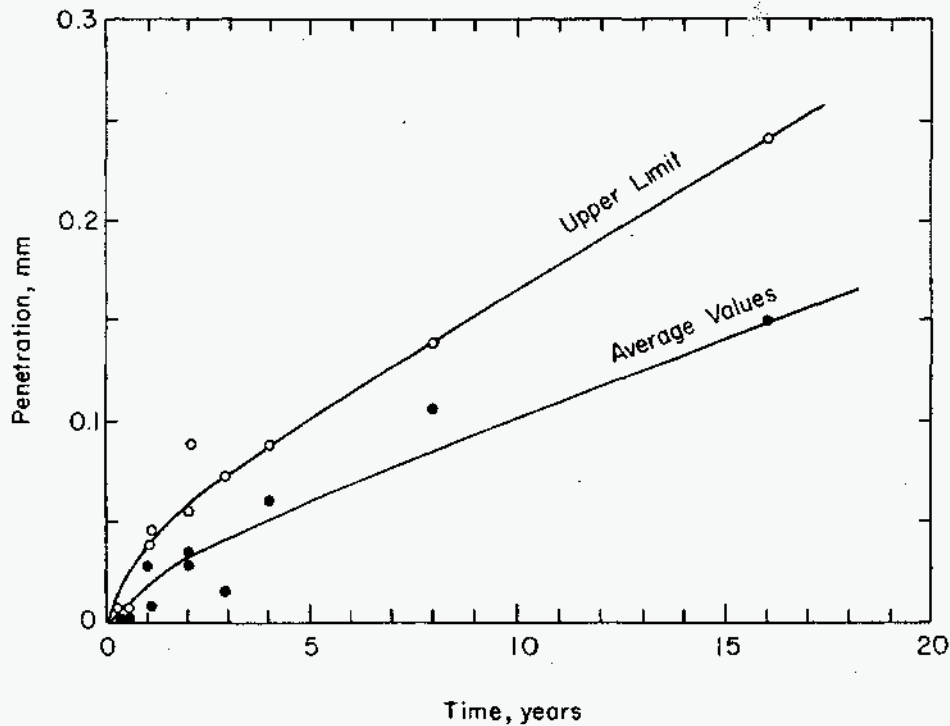
Figure 2.24 Effect of exposure time on the penetration of stainless steels as determined from weight-loss measurements [8].

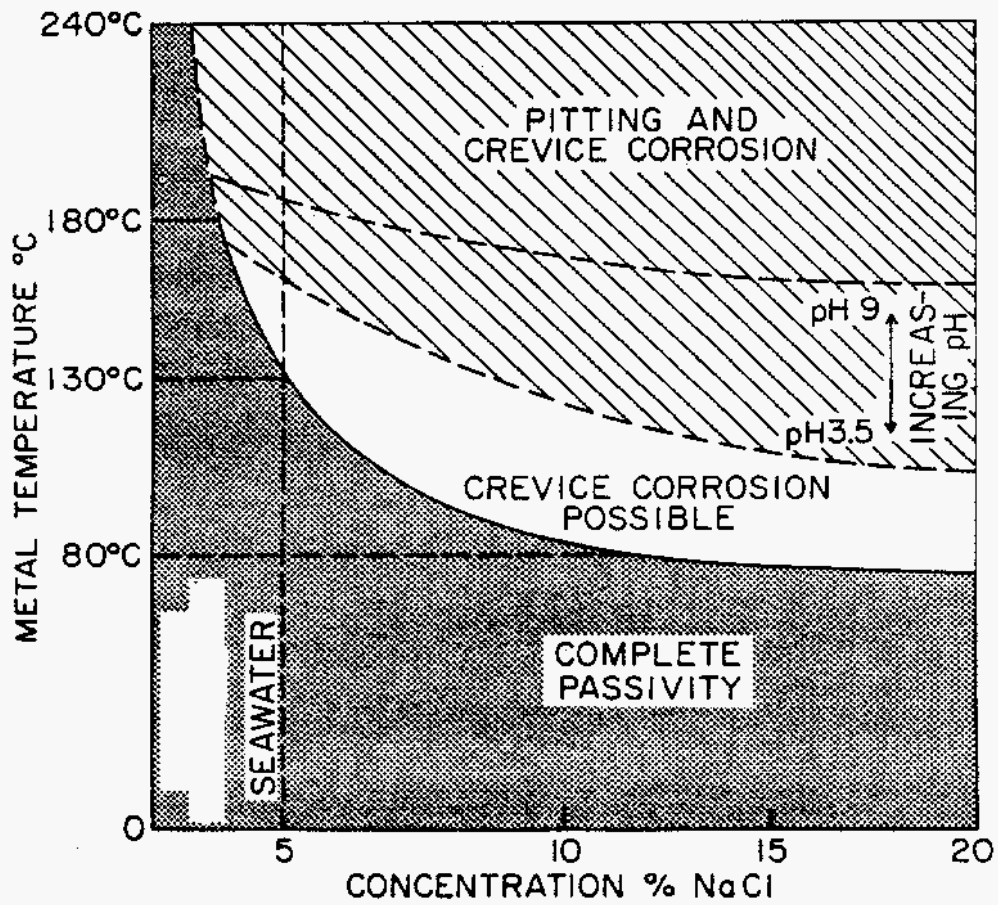
Figure 2.25 Influence of temperature, chloride content and pH value on crevice corrosion and pitting of unalloyed titanium [52].

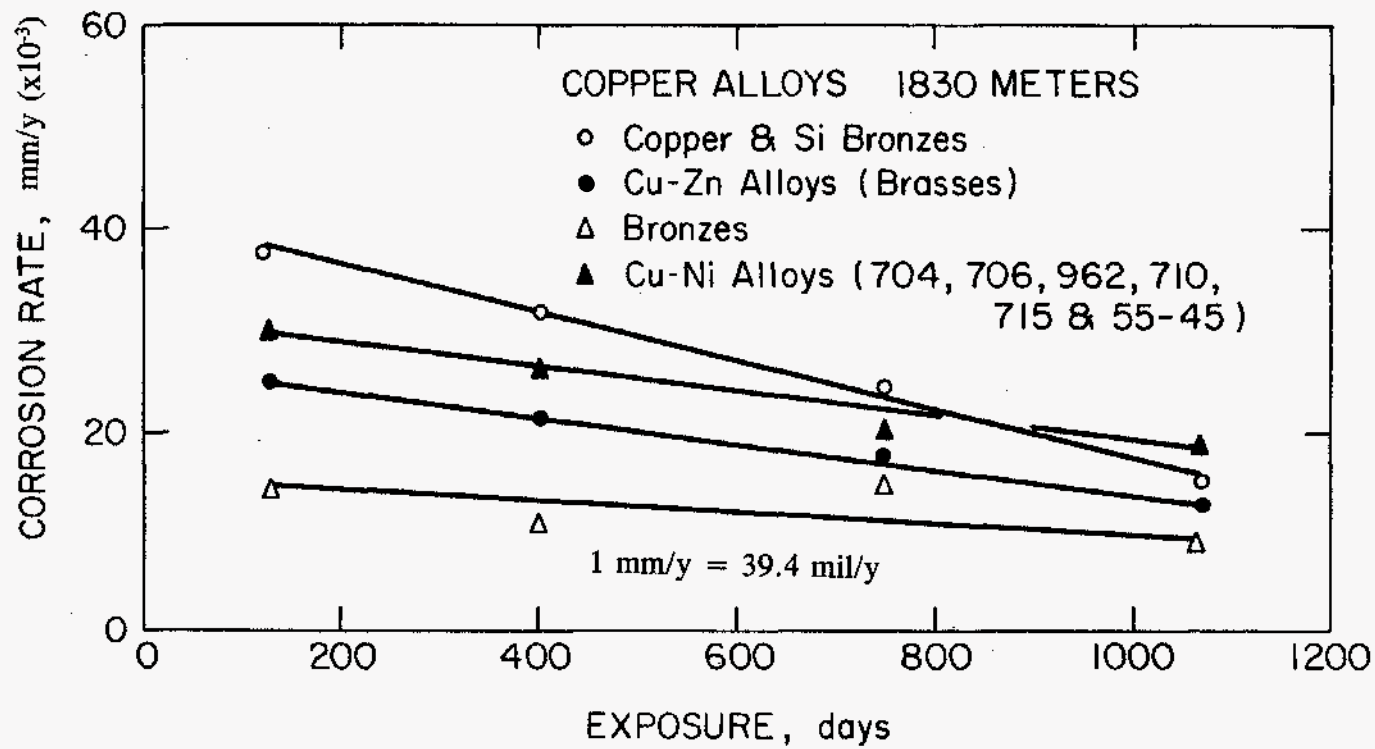
Figure 2.26 Effect of exposure time on corrosion of copper metals in an ocean environment [58].

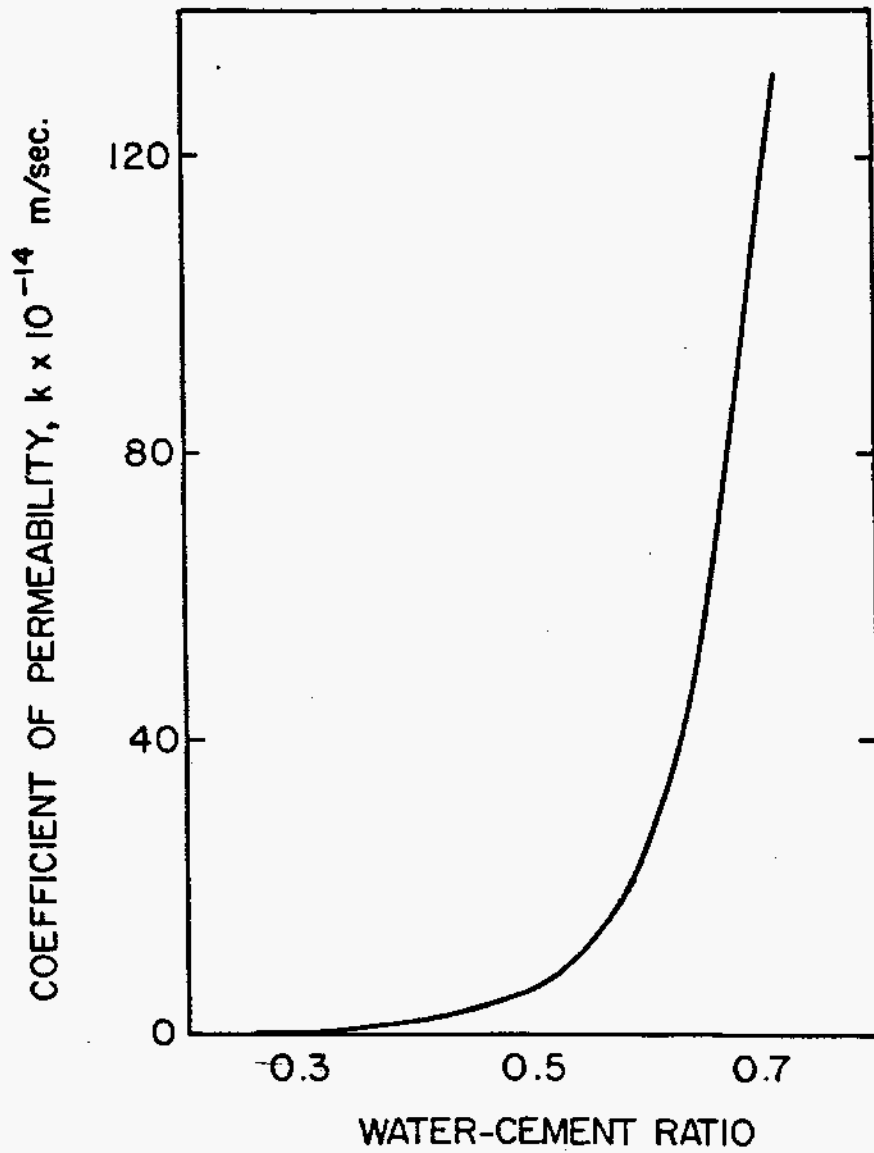
Figure 3.1 Effect of water/cement ratio on permeability [80].

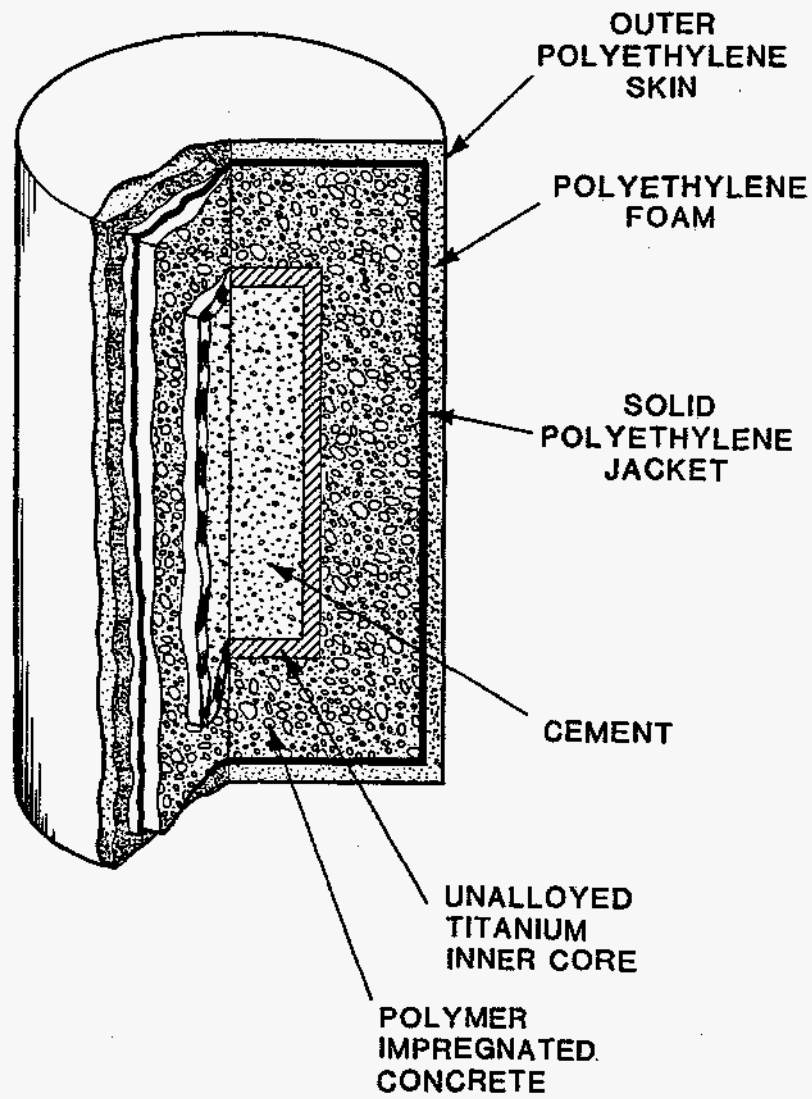
Figure 6.1 Proposed multibarrier waste package [101].

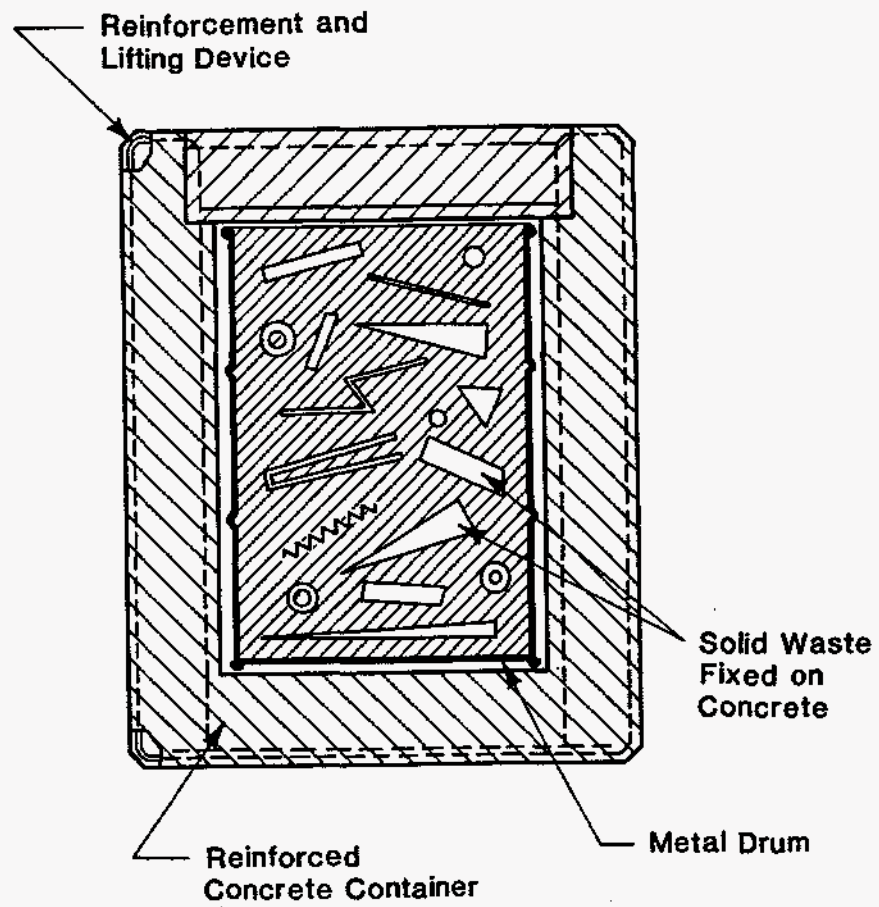
Figure 6.2 Steel waste container set in concrete container [102].
