Published in:
E C S Transactions

CORROSION RELIABILITY OF ELECTRONIC SYSTEMS

Rajan Ambat, Stine Garder Jensen, and Per Møller

Abstract

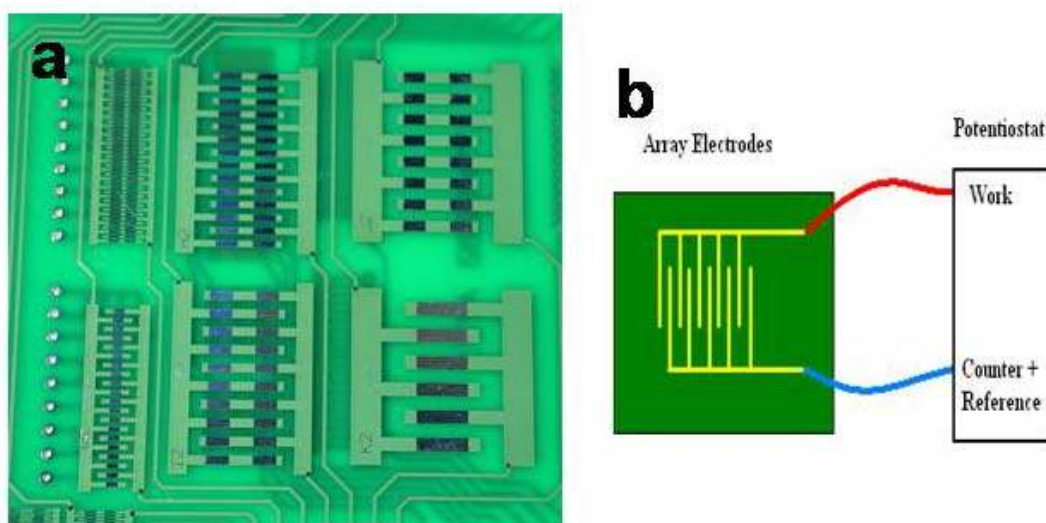
A model PCB with arrays of Sn-Pb alloy conduction lines as shown Figure 2a was made by re-flow soldering process. Each set of array electrodes on the PCB (Figure 2a) has different separation distance between alternative lines. For the experiment, a suitable array electrode set was cut from the PCB. Figure 2b shows a schematic of the cell set up arrangement for the electrolytic migration experiments. The array electrodes with cell connections as shown in Figure 2b is placed inside a humidity chamber under saturated conditions. The electrodes were cleaned thoroughly prior to each experiment with alcohol followed by water to remove any unwanted organic or inorganic contaminants on the surface. The variables related to array electrodes for investigation was only the separation distance between electrodes, which was varied between 0.3 mm – 3 mm. Exposure condition variables are temperature and applied voltage. The applied voltage shown in this paper is the potential difference between the adjacent electrodes in the array, which means that each electrode is polarized to a value that is half of the applied potential to negative and positive side. The current resulting from the migration is recorded as a function of time until a permanent surge in current was observed due to dendrites (due to electrolytic migration as explained before) filling the gap, which leads to a permanent electrical short.

Figure 2. Electrodes and cell arrangement: (a) Model PCB with different electrode arrays and (b) cell arrangement used for the investigation with one set of arrays.

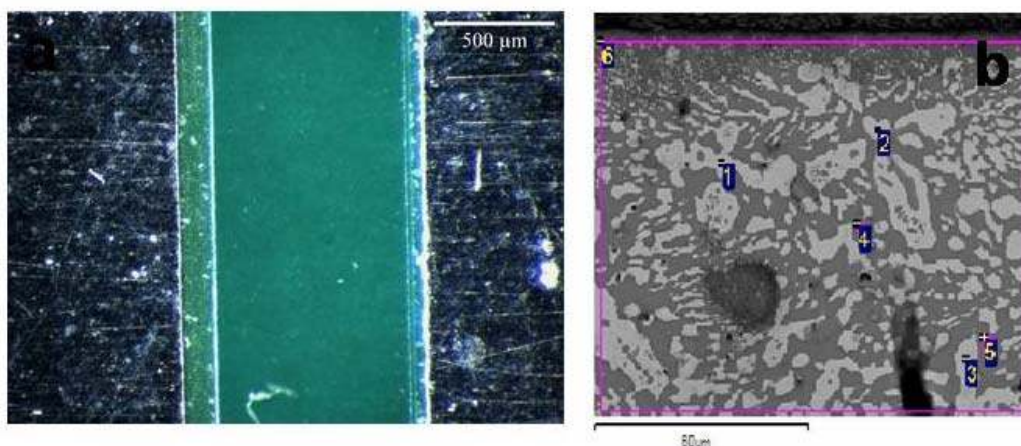
Figure 3a shows an optical micrograph of a pair of electrode from the model PCB (Figure 2a). The electrodes are compact without any visual defects. A number of such layers were analyzed with different separation distance using optical microscope. No significant variation in separation distance was observed between different arrays. The surface topography of the re-flow solder layer was also found to be uniform with a smooth surface appearance. Figure 3b shows the typical microstructure of the solder lines using SEM. At high magnification the solder arrays showed a dendrite structure with Pb dendrites in Sn matrix. This is attributed to the solidification process of the solder alloy with eutectic composition. The phase with bright contrast is lead rich and the other has more Tin. Table 1 shows composition of the overall alloy and various phases marked in Figure 3b. Overall composition of the solder material is shown in spectrum 6, which consists of 59 wt. % Zn, 32 wt. % Pb, and 9 wt. % Cu. The presence of copper is because of the higher interaction volume of the electron beam that will penetrate down to the base copper layer on the PCB over which the solder lines are formed by re-flow process.

Figure 3. (a) Surface morphology of array electrodes, and (b) Microstructure of the array electrode at high magnification.

Table I: EDS analysis of array electrodes (Analysis areas are numbered in Figure 3b)

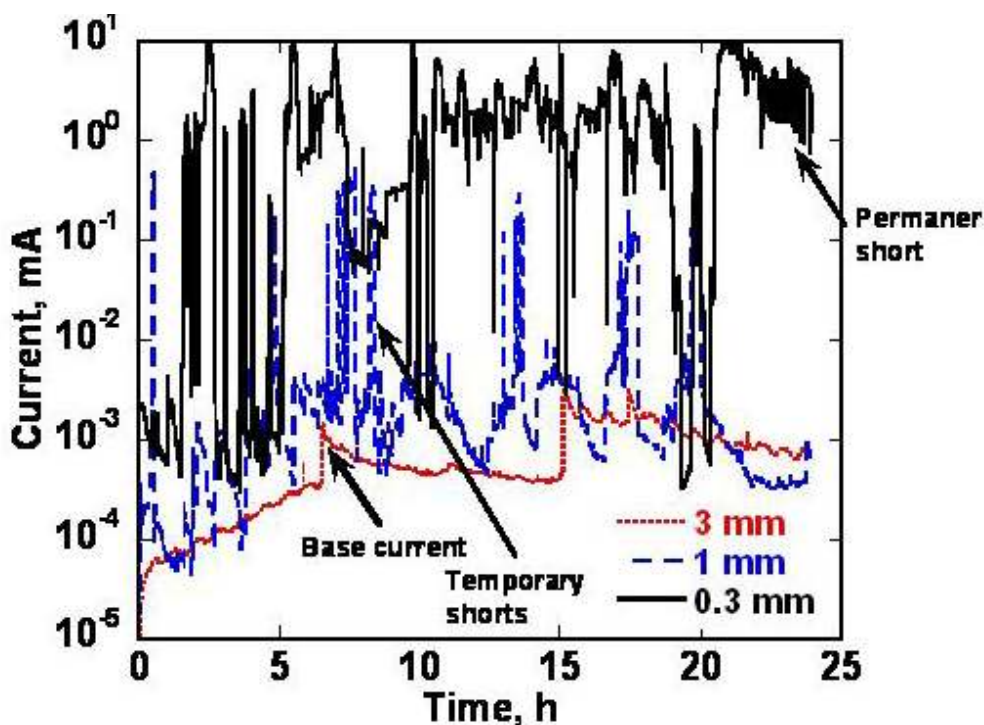
Figure 4 shows the current spectra resulting from the exposure of electrode arrays with varying separation distance (the distance between two oppositely charged lines on the array in Figure 2) under exposure to saturated humidity with an applied potential of 1V at 50°C. The resulting base current (marked in the figure) level for each curve is a function of the electric field acting between lines. The magnitude of electric field is controlled by the distance of separation, IR drop within the solution layer, and the rate of faradic reactions occurring at the anode and cathode. The intermittent peaks (marked as temporary shorts) are due to dendrite formation and burning off, and a gradual increase in current to higher values (for example for the curve 0.3 mm distance after 20h) is due to a permanent short by dendrites filling the electrode gap.

Figure 4. Migration current spectra as a function of separation distance.

The base current levels in Figure 4 (in electronic reliability terms, it is usually called as leakage current as it represents the level of current leaking through the solution layer between two points on a PCB surface) increases slightly with decrease in distance. This might be attributed to the increased electric field with decrease in separation distance. The difference in leakage current was high initially between various separation distances (by an order of magnitude), however, the difference decreases with exposure time. This is because with time as the ions build up in the solution due to dissolution of electrodes, naturally the current increases due to increased conductivity of the media reducing the difference between different separation distances. Table 2 gives the calculated electric field between the conduction lines at various potential differences.

The curves in Figure 4 also shows intermittent peaks (temporary shorts) corresponding to instantaneous surge in current. The temporary electric shorts produced by a growing dendrite, which eventually burn off due to current surge during the shorting, produce these peaks. This process will continue until a significant volume of the dendrite is formed, which cannot be burned by the surge in current. The curve shows that the distance between electrodes has a significant effect on the temporary shorts as it can be observed that the number of peaks increases with decrease in distance between electrodes. The time elapsed until the formation of the first temporary short is also decreased with

decrease in distance of separation. Also for 0.3 mm distance, a permanent short has been established after 20h of exposure that is absent for other distances. Takemoto (13) also reported a decrease in the time required for the formation of first short with reduction in distance between conductors, as the metal ions in this case have to migrate only shorter distances under higher electric field. From the perspective of the miniaturization of the electronic devices, the present results clearly show how a decrease in distance on PCB could influence electrolytic migration and therefore cumulative damage and malfunction of the components due to temporary shorts and current surge.

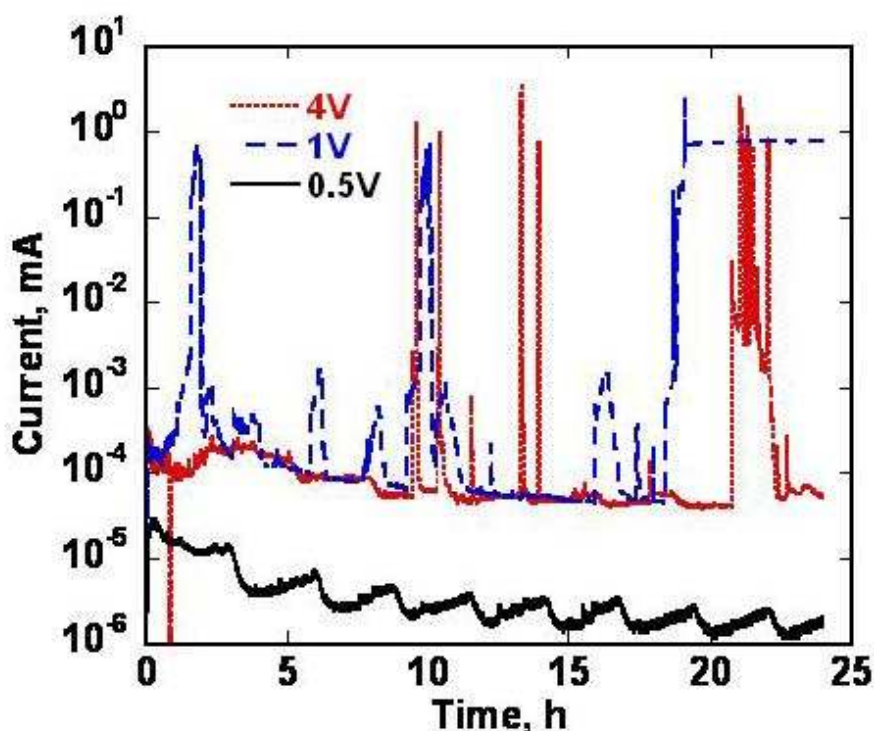
Figure 5 shows the current spectrum from a similar experiment using 0.3 mm wide electrode array at 30°C with different potential values between them. The base leakage current increases by an order of magnitude with increase in potential from 0.5 V to 1 V, while further increase in potential did not show any increase. At 0.5 V, no temporary shorts were observed showing that the potential is not enough for electrolytic migration under these conditions. However, increasing the voltage to higher values showed temporary peaks (~1.5 h for 1 V and ~9 h for 4 V) and incidentally for 1 V, a permanent short was observed after 18 h of exposure. The number of temporary shorts were slightly more for the 4 V, however, the width of the peaks are higher for 1 V. At 1 volt, the peaks (dendrites) typically have duration of 1h, where as at 4V they burn off immediately. This is understandable as more migration is expected at higher potential and therefore growth of dendrites. Formation of more dendrites gives rise to more temporary shorts, while width of the peak decreases with increase in voltage due to fast burning of the formed dendrites due to higher current levels. Takemoto (13) has observed similar behaviour for Sn-Pb electrode with increasing potential gradient between them. The increased potential gradient enhances the driving force of migration of the metal ions, as well as it enhances the dissolution of metal ions, until the limiting corrosion current density is reached.

Figure 5. Migration current spectra as a function of applied potential.

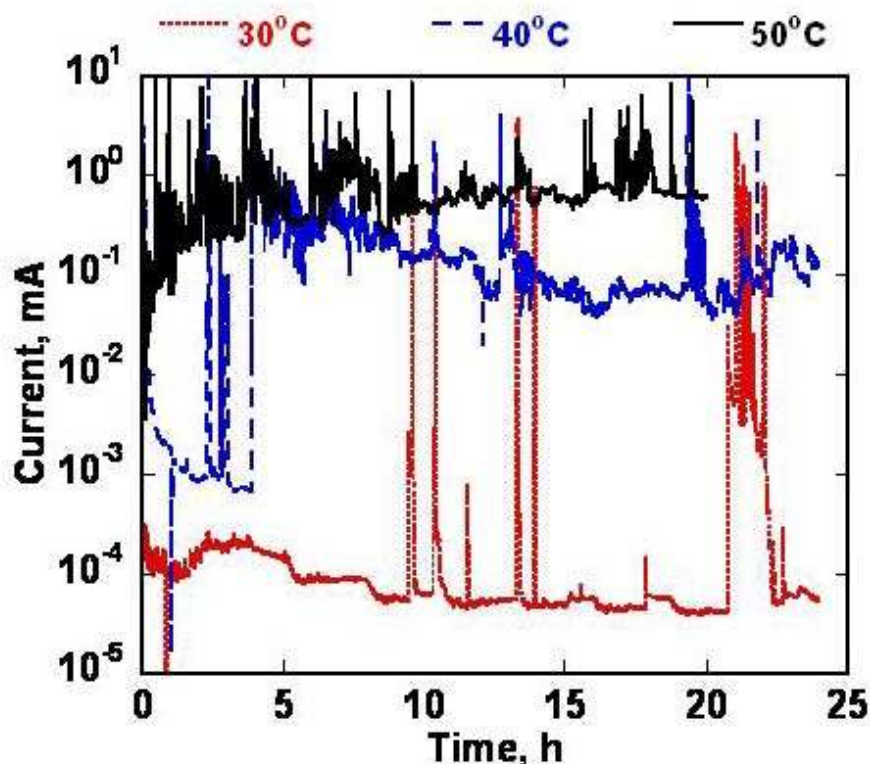
Figure 6 shows the migration current spectrum as a function of temperature from an electrode array with 0.3 mm width with 4V potential difference. The effect of temperature is clear as the base current level at 30°C is low and only few temporary shorts are observed starting after 9 h. On the other hand at 40°C after 4h and 50°C within few minutes, current increases to a value of 1 mA corresponding to permanent short due to electrolytic migration. The observed effects are assumed to be due to increased rate of the overall processes including transport through the solution as the temperature increases. The results are very relevant as in practice PCBs undergo temperature cycling to the tune of 20-30°C or more depending on the application. A localized variation in temperature is also possible between different locations on a PCB surface.

Figure 6. Migration current spectra as a function of exposure temperature.

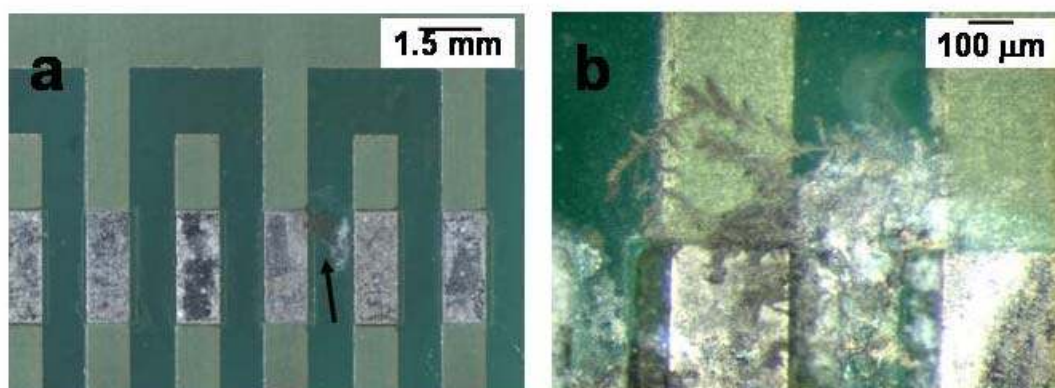
Figure 7 shows the optical micrographs of the electrodes after migration experiments. Localized growth of dendrite could be seen (see arrows in Figure 7a) and white patches representative of the heat damage on the epoxy polymer. This is more visible in Figure 7b where the heat damage to the polymer is clearly seen as white patches together with dendrites covering one of the electrode surfaces. The heat damage indicates that when two conductors are short-circuited, some amount of heat is generated depending on the level of current. The amount of dendrites as well as the extent of damage to the polymer due to heat was found to be largest on the PCBs exposed to highest potential difference. Also, the electrode systems separated by the smallest distance were more affected by this heat damage than the electrode systems with larger distances.

Figure 7. Optical micrographs showing morphology of electrode arrays (1 mm width, 40°C, 4V) after migration experiments.

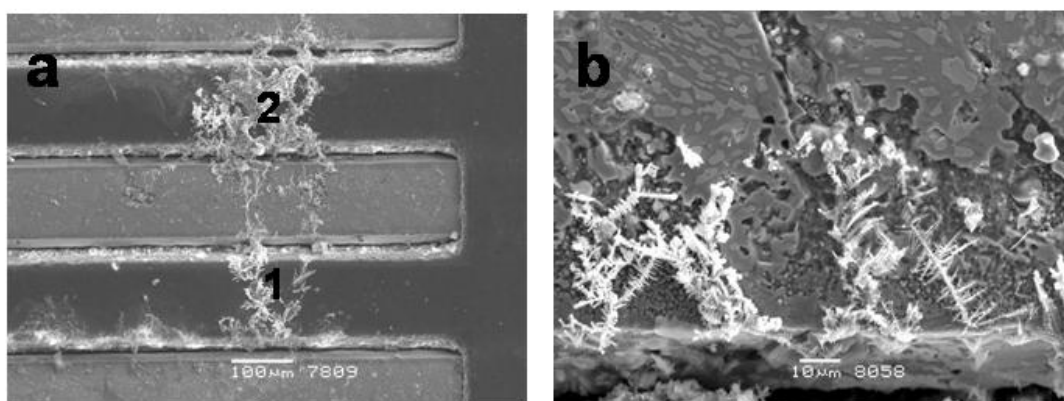
Figure 8 shows the SEM image of the array electrodes exposed at 50°C at 4V after migration experiments. The morphology of the migrated species between electrodes showed two types of morphology: (i) slim fine branched dendrites consisting mainly Sn (~80-90%, marked 1) and (ii) bulky dendrites consisting mainly Pb (~50-80%, marked 2) with some Sn. Formation of Sn rich dendrites with similar appearance for Sn-Pb alloy was reported by Yu et al (14, 15). Formation of Sn rich dendrites was more dependent on the applied potential difference. The amount of Sn rich dendrites increased with increase in applied potential.

Figure 8. SEM pictures of migration tested electrode array at 50°C, 4V: (a) dendrite morphology, and (b) selective dissolution of microstructural features.

At higher magnification, the effect of microstructure on dissolution is observed as shown in Figure 8b. The bright areas corresponding to Pb rich phase is preferentially dissolved compared to the Sn rich phase. This is understandable as Sn is more passive and less active than Pb.

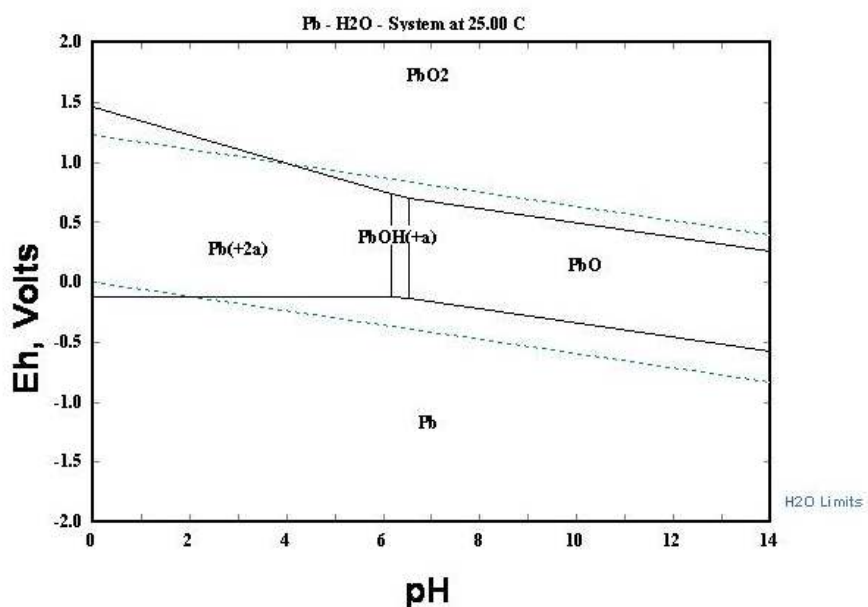
Figure 9. Pourbaix diagram for Pb in pure water with Molarity of Pb ions 1×10^{-6} Mols/l constructed using standard Outokumpu HSC Chemistry 4.0 software.

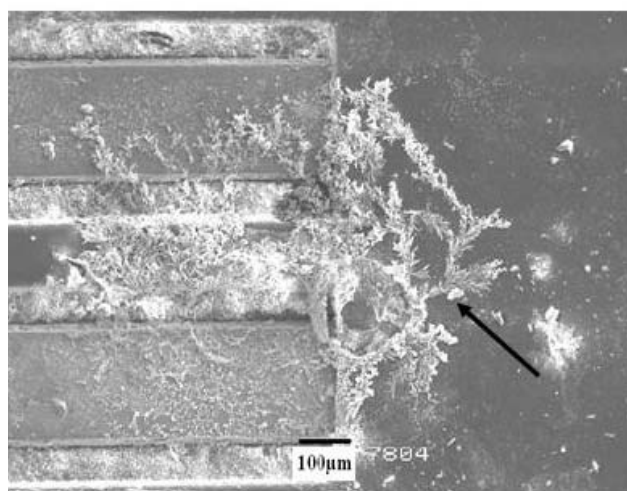
Figure 10 clearly shows the edge effect on the electrolytic migration. As the current lines concentrate

Figure 10. Edge effect on electrolytic migration.

preferentially at the sharp edges, preferential growth of dendrites in the form of an arc could be seen at the edge of the electrodes (see arrow in Figure 10).

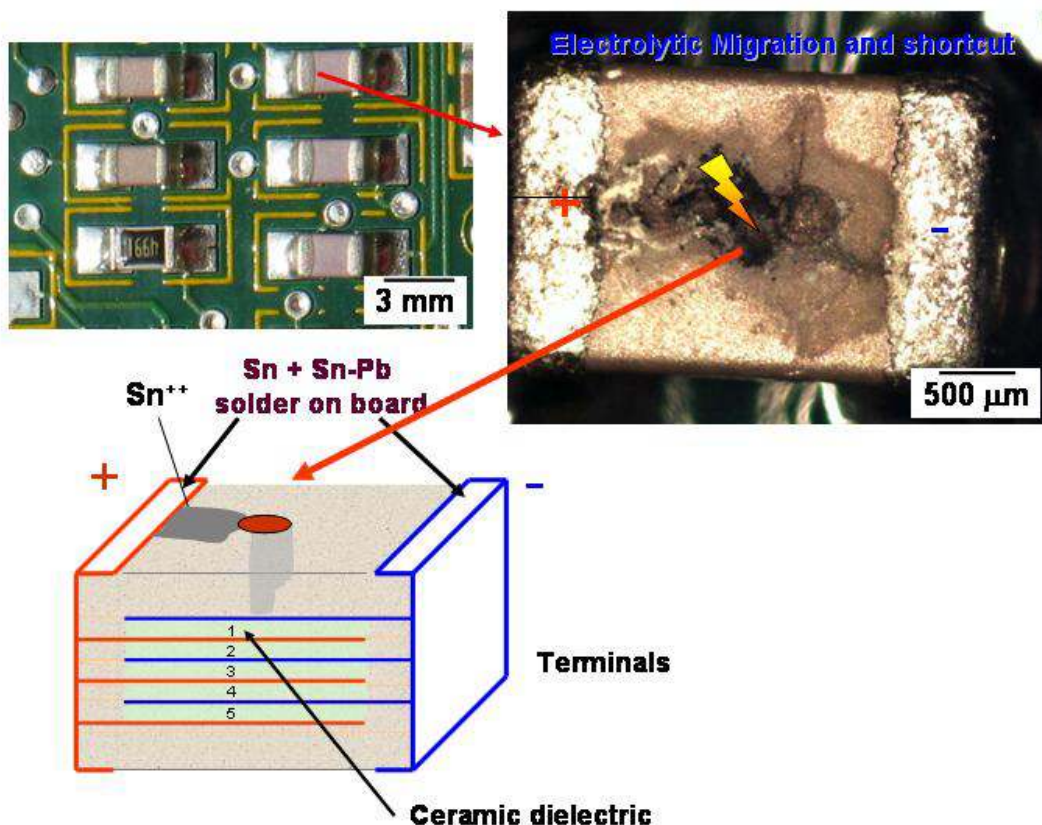
Figure 11 shows a typical example of such in-service failure of a ceramic capacitor on a PCB under humid conditions. This ceramic capacitor had a Sn termination electrode that wave soldered on to the PCB using Sn-Pb alloy. The ceramic was dielectric Barium Titanate. A number of ceramic capacitors on this PCB have failed due to electrolytic migration in-service. The capacitor shown in Figure 11 shows migration tracks from cathode to anode produced by electrolytic migration. The capacitor has also been broken up at the centre possibly due to penetration of humidity inside and downward migration as shown in the schematic in Figure 11.

Figure 11. An in-service electrolytic migration failure of a ceramic capacitor.

The ingress of water into the capacitor leads to evolution of gases at the negatively biased metal foils of the capacitor as well as downward migration causing shorting and current surge. Microscopic flaws in the ceramic layer lead to ingress of water for facilitating a conducting path between the inner electrode layers of the capacitor to the outer electrodes

(as shown in the schematic). This results in electrochemical reactions at the inner foils depending on the bias. A possible scenario is the coupling of the cathode foil layers with positive electrode of the capacitor giving rise to cathodic reactions on the inside foils evolving gases making the capacitor to break.
