Nuclear Science and Technology Division

**Corrosion Test Results for Inconel 600 vs
Inconel–Stainless UG Bellows**

Date Published: August 2002

Prepared by the
OAK RIDGE NATIONAL LABORATORY
Oak Ridge, Tennessee 37831-6285
managed by
UT-BATTELLE, LLC
for the
U.S. DEPARTMENT OF ENERGY
under contract DE-AC05-00OR22725

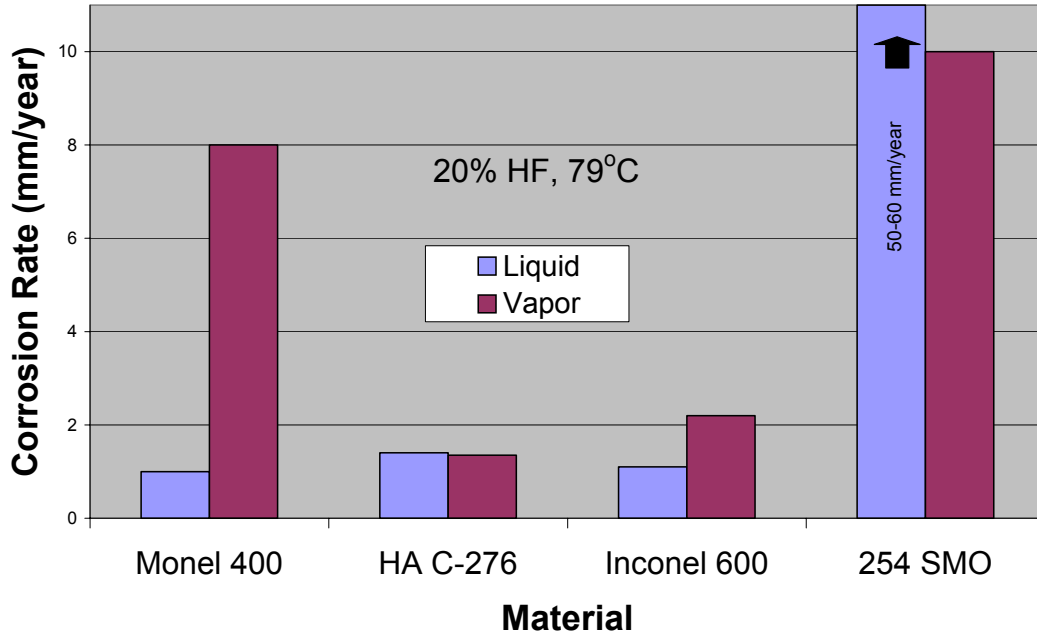
Fig. 2. Comparison of the corrosion rate of alloys in HF vapor and liquid.
 Adapted from R. B. Rebak, J. R. Dillman, P. Crook, and C. V. V. Shawber, "Corrosion Behavior of Nickel Alloys in Wet Hydrofluoric Acid," *Mater. Corros.* **52**, 289–297 (2001).

The final alloy, and the one of particular concern in this study, is Inconel or Alloy 600. Rebak et al.¹ reported that Alloy 600 underwent intergranular attack when immersed in aqueous HF, with a corrosion rate of about 39 mpy.¹ The Nickel Development Institute reported that Alloy 600 was resistant to dilute aqueous solutions at ambient temperatures but may experience significant corrosion in hot aqueous solutions.⁵ Another study confirmed this result and reported a 9-mpy corrosion rate for an Alloy 600 sample in impure 12% HF at 83°C. This same study reported a 12-mpy corrosion rate for Alloy 400 and a 700-mpy corrosion rate for stainless steel 316 (ref. 5). Schillmoller recommended Alloy 600 in place of Alloy 400 in applications where temperatures exceed 150°C (ref. 3). Alloy 600 performs slightly worse in moist aerated HF vapor than when immersed. Studies show a corrosion rate of 80–120 mpy and intergranular attacks and voids forming in a vapor environment.¹ Figure 2 summarizes the performance of Alloy 600 in comparison with those of other alloys at 79°C.

Both parts of the bellows assembly were returned to the vendor for analysis, and it was determined that a stainless steel bellows had been inadvertently welded to an Inconel flange. Figure 2 shows the effect of aqueous HF on stainless steel (i. e., on the chemically similar 254 SMO). The vendor is currently investigating how this stainless steel bellows could have been shipped as an Inconel bellows.

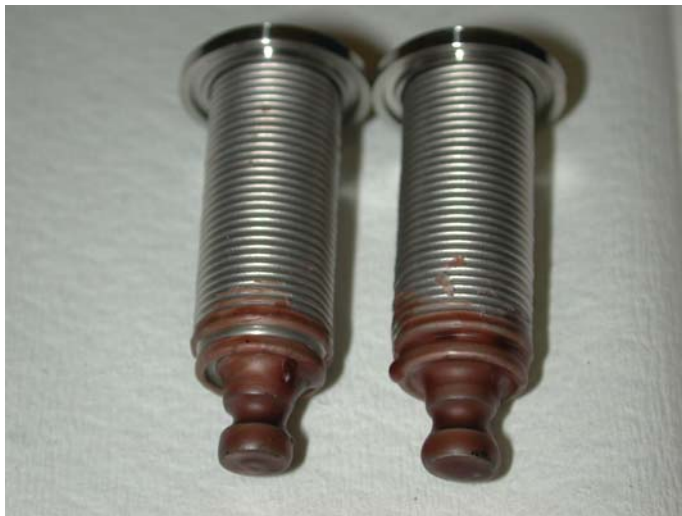
Fig. 3. New bellows assemblies, showing wax-coated tips.

In the past, many experiments were performed in support of the CP to determine the corrosion performance of a variety of metals and polymers that might be used in the system. Because of time constraints, it was decided to run a very simple corrosion test involving immersion of the samples in concentrated (33 wt %) HF at ambient temperatures and pressures. The bellows assemblies received from the vendor had been cleaned and triple packaged and were carefully handled to avoid contamination. It was decided that four bellows assemblies would be tested in a side-by-side test. Because of the extremely high corrosion rate of stainless steel in HF, the stainless steel tips (which are not a normally wetted surface) were dipped in molten wax (Fig. 3) to protect this area from the HF vapors.

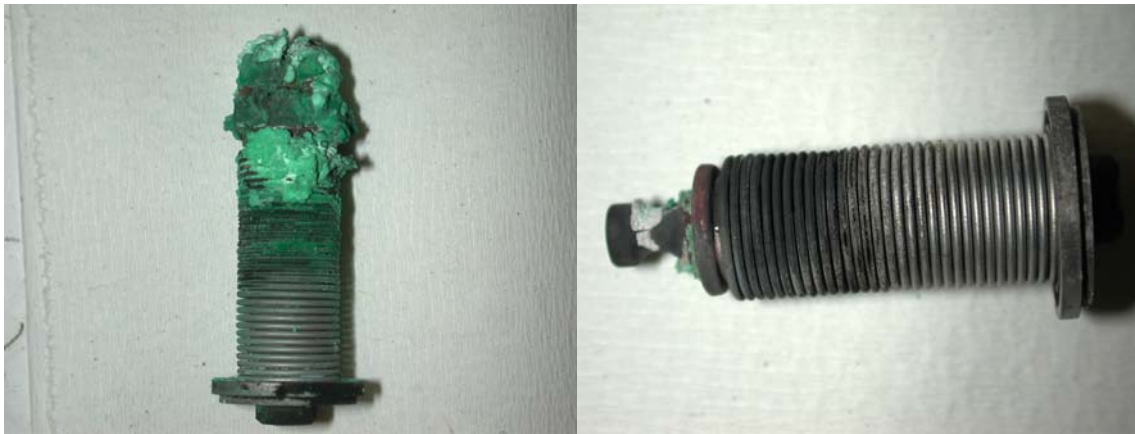
Fig. 4. Bellows C (left) and D (right) at the end of testing (28 days).

appearance of some pitting on the flanges and severe corrosion on the stainless steel tip. At the end of the test, on both bellows A and C large corrosion deposits had built up on the area that was above the liquid and especially around the stainless tip (see Fig. 4). Both were cleaned ultrasonically in warm water, but the deposits were unaffected. Bellows A was manually scraped, and 1.34 g of corrosion deposits was removed. This resulted in a final bellows weight of 26.92 g and a total loss of 4.16 wt %. The corrosion on bellows C was left intact but was estimated to approximate the corrosion deposit on bellows A. Bellows C was estimated to have a final weight of 26.54 g and a loss of 5.99 wt %. It is apparent that most of the weight loss for both bellows A and C can be attributed to the normally non-wetted stainless steel tip.

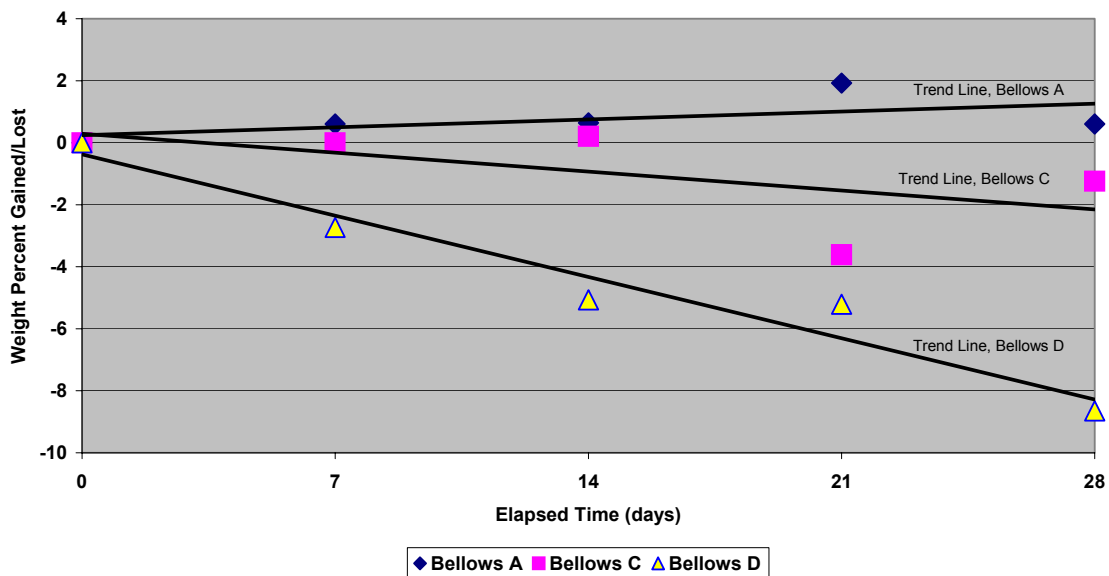
Fig 5. Corrosion test results for Inconel bellows.

Bellows D had a slight weight gain during the first 3 days of the test, but its weight gradually began to decline on days 6 and 7. By the end of the short-term test, bellows D had lost almost 3 wt %. Again, part of this decrease can be attributed to the loss of wax protecting its stainless steel tip during this time. At the end of day 14, the bellows had lost just over 5 wt %. It continued to lose another 0.2 wt % by day 21, before experiencing a large loss of 3.4 wt % the final week. Overall, with the exception of B, it was the most severely attacked and lost a total of 8.65 wt %. Because it was ultrasonically cleaned and rinsed at the end of each cycle, very little corrosion remained on bellows D at the end of the test. Figure 5 illustrates the weight losses and gains for bellows A, C, and D throughout the test.

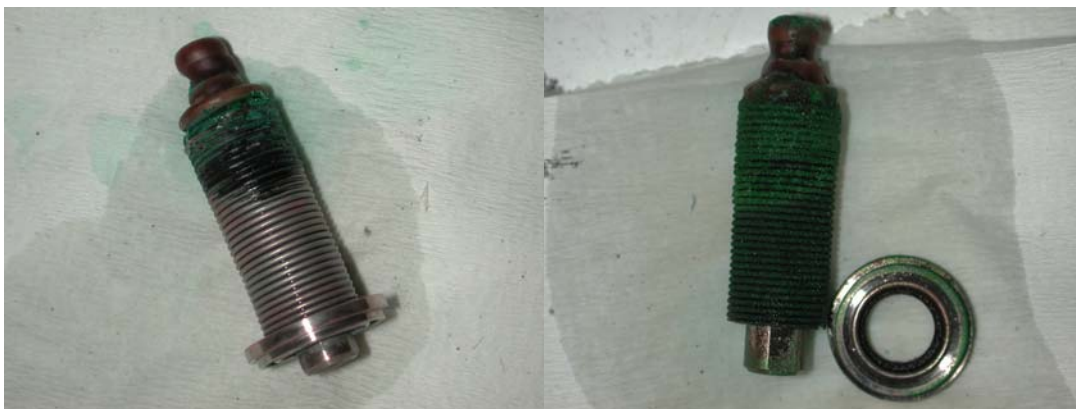
Fig. 6. Comparison of bellows A (left) and B (right) after 32 h of HF exposure.

Except for one of the bellows, the results from the short-term (1-week) test were good. The bellows in question, bellows B, experienced catastrophic failure after only two cycles. The bellows came apart between the convolutions just above the flange (see Fig. 6).
