Coupling infrared thermography and acoustic emission for damage study in CFRP composites

by V. Munoz *, B. Vales*, M. Perrin**, M.L. Pastor**, H. Weleman*, A. Cantarel** and M. Karama*

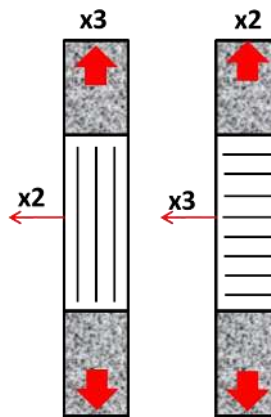
A carbon fibre reinforced laminate is considered for this study. The composite is made of 14 unidirectional plies of prepreg Hexply M10R/38%/UD150/CHS leading to a 2 mm thickness composite with fibre volume f_v of 62%. The reference of the fibre is TORAY T700S. Sample fabrication is carried out using the manual lay up technique. Then the sample is cured at 125°C during 90 minutes at a pressure of 2 bars. This sample is representative of a transversely isotropic composite. To obtain the tensile samples, the cured plate is cut according to the standard ISO 527-5 [12]. Two composite directions are obtained after cutting the plate (0° and 90°). Figure 1 shows the axis fibre direction (direction x3) for each category of specimen.

Fig. 1. Fibre direction for each kind of specimen

The tensile tests are made at ambient temperature. These tests are performed with an electromechanical testing machine INSTRON 5500. 2 tests are carried out according to the fibre direction, 0° (axial load along the direction x3) and 90° (axial load along direction x2) (figure1). To check the reproducibility of the response, three specimens are considered for each loading direction.

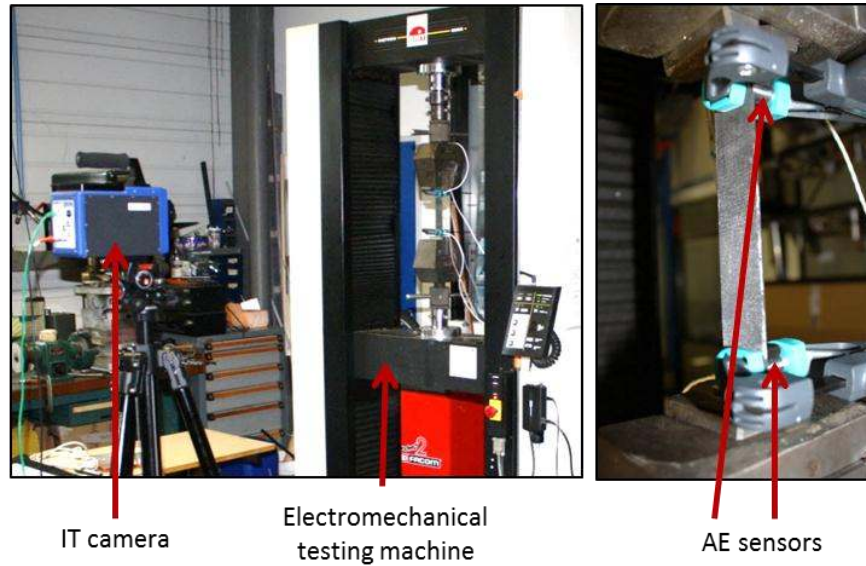
dB. The acquired signals are amplified by 40 dB. Two sensors have been positioned at the top and bottom of the specimen in order to derive the location of the AE events. The full experimental setup is shown in figure 2.

Fig. 2. Experimental setup

The thermal acquisition is done with a FLIR Titanium SC7000 retrofitted camera. Automatic calibration, control of the camera and data recording are done by Altair software. Acquisition frequency is 150 Hz. So as to limit surrounding influences, a data processing after the acquisition phase has provided the temperature variations fields $\Delta T = T - T_0$ over the sample, with T the temperature field at time t and T_0 the temperature field in the initial state $t = 0$. Such relative analysis avoids the most disturbing effects, including environmental ones, and highlights the thermal events induced in the material.

The acoustic emission activity is recorded during the tensile test using AEwin for SAMOS software. The data acquisition system is composed by a PCI8 board in which two channels are used. The AE monitoring is conducted using two piezoelectric sensors mounted on one side of the specimen. The sensors are attached using mechanical support while supplying the necessary acoustic coupling agent. The WD sensors are wideband with frequency band-width between 100 kHz and 1 MHz. In view of environmental noise in the laboratory, the acquisition threshold is set to 32-35

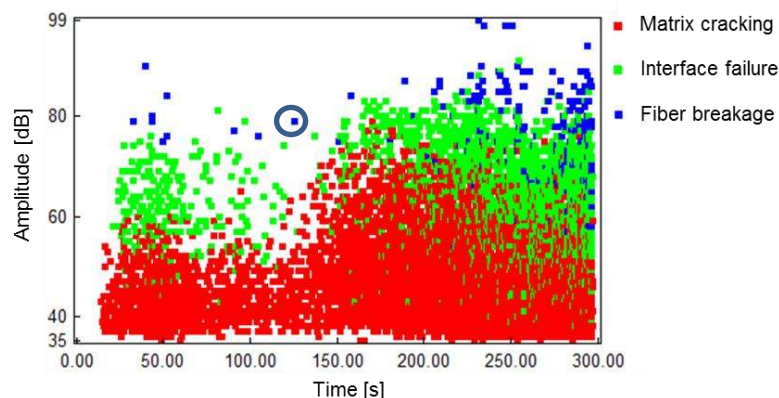
Figure 3 shows on the amplitude versus time graph the classes of AE data obtained after the application of the pattern recognition method. Three groups are clearly distinguished. The red group with the lowers amplitudes corresponds to the matrix cracking, the green group refers to the debonding and interphase failure and the last blue group corresponds to the fibre breaking. We can see that the fibre breaking generates AE at high amplitudes in regards to the others damage mechanisms.

Fig. 3. Cluster results of acoustic emission for 0° tensile test

Correlations between AE and TI measurements have been done between several heat sources and acoustic events of high amplitude and high energy. As an illustration of the analysis, the procedure and results are explained here on the case of the one specific AE event selected on figure 3. Figure 4 shows the thermogram (figure 4a), the heat source (figure 4b) and the located amplitude (figure 4c) for this damage that appeared at 128.428 seconds after the beginning of the tensile test. According to the figure 3, this damage (at this specific time) corresponds to a fibre breaking. We can see that the amplitude of the analyzed acoustic event is around 79 dB (figure 4c). To correlate that specific AE to

Regarding the specific event highlighted in figures 3 and 4b, we can see that the location of the heat source and acoustic event stand in the same zone of the specimen (lower part) near the sensor number 2 (indicated by the green number 2 in figure 4c). The error of the AE location in regards to the heat source is 25%. However, it is important to note here that the location in AE is done by measuring the velocity of the wave for each specimen in the initial state. The slight difference in location may thus be explained by velocity change induced by the damage and load applied.

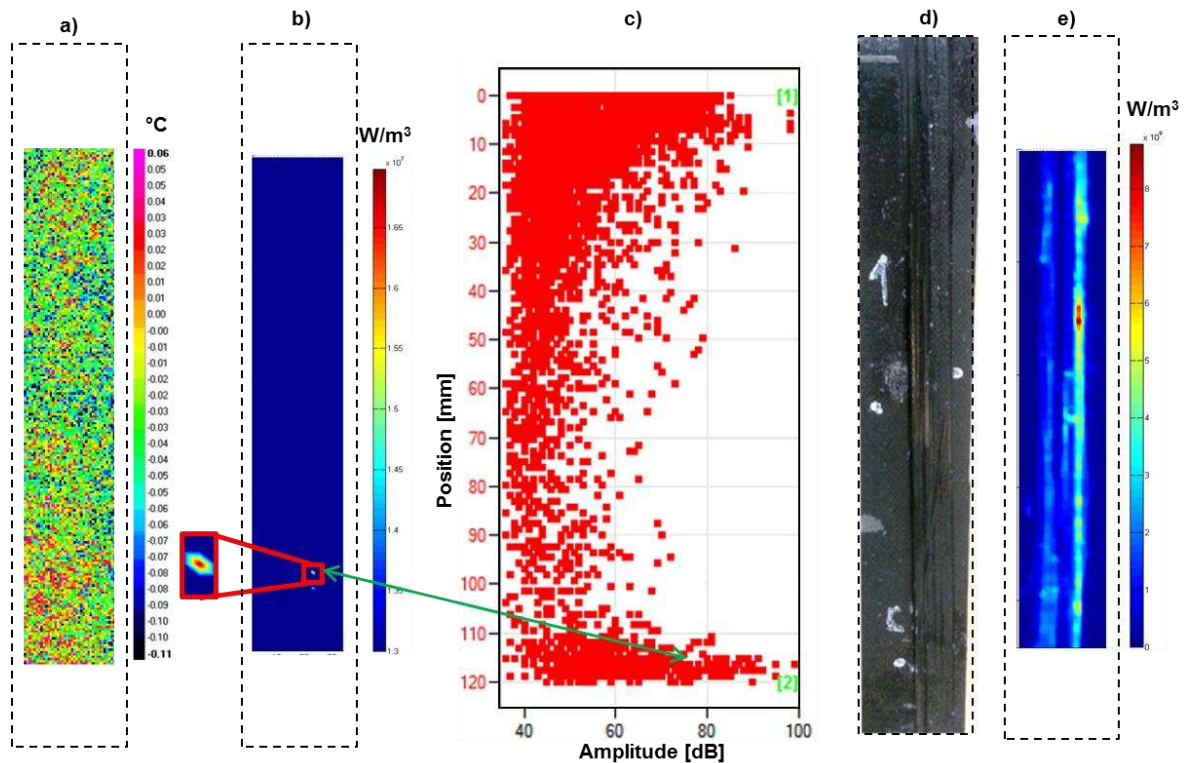
the heat source, it is needed to analyse the maximum of heat source at a specific timespan. We have considered an interval of 1 s around the AE event (128.428 ± 0.5 s) which includes 150 thermal frames. During this timespan the maximal heat source is obtained at 128.407 s. (error of 0.02%) for the pixel highlighted in figure 4b. Figure 5 shows that for such analyzed pixel, the heat source gets indeed its maximal value at the AE event time.

Fig. 4. Correlation between heat source and acoustic emission amplitude for the 0° specimen

Figure 4c provides the location of AE events during the test. Events take place all along the specimen length, which stands in agreement with the post-mortem observation shown in figure 4d and its heat source (breaking time) (figure 4e). We can clearly see that the final breaking of 0° specimens results from macroscopic debonding in the fibre direction.

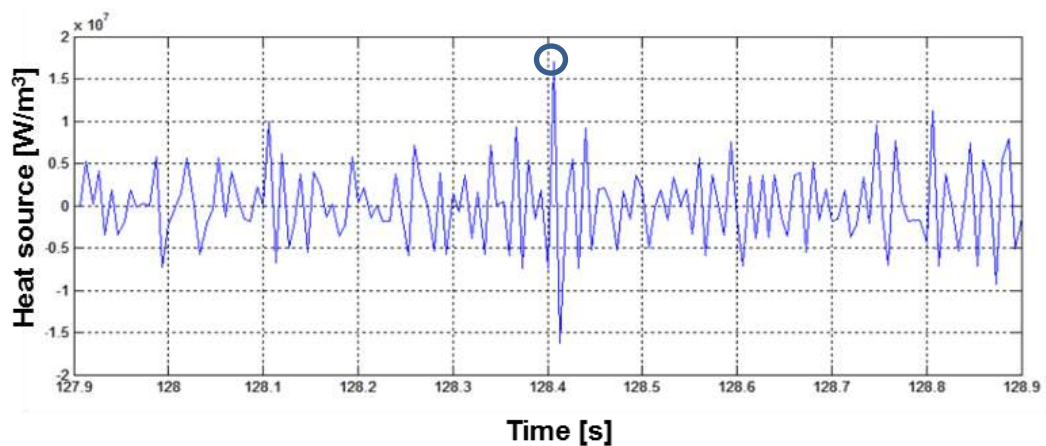
Fig. 5. Heat source variation ± 0.5 s before and after the studied instant for the analyzed pixel (0° specimen)

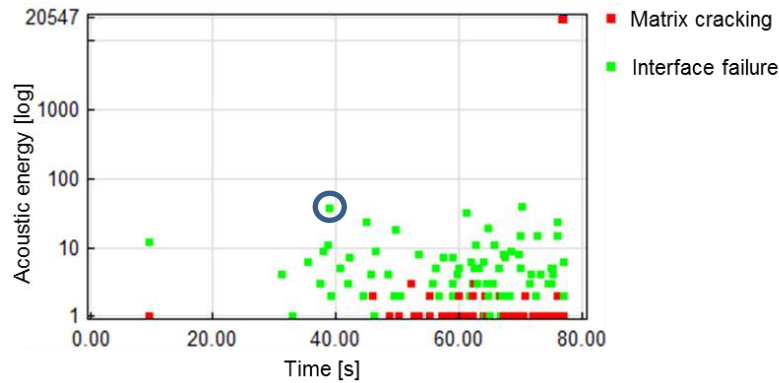
Figure 6 shows the classes of AE for the 90° specimen. As explained before, only two groups are needed according to the damage mechanisms for this fibre direction: the red group represents the matrix cracking and the green group refers to debonding. The AE corresponding to the matrix cracking have the lowest energy and amplitude. In this case the analyzed AE corresponds to a debonding (selected AE event in figure 6). This allows observing that debonding or delamination also create heat sources as important as the fibre breaking.

Fig. 6. Cluster results of acoustic emission for 90° tensile test

In the same way, a specific timespan is selected for the analysis. Figure 7 shows the thermogram (figure 7a), the heat source (figure 7b) and the located acoustic energy (figure 7c) for the selected damage at 42.220 seconds after beginning the tensile test. As explained above and according to figure 6, this damage (at this specific time) corresponds to an internal debonding. The acoustic energy for this specific damage is 38 aJ (figure 7c) which is high in regards to the others AE. For the analysis we have considered an interval of 1 s (42.220 ± 0.5 s) which leads to 148 thermal frames to be analyzed. During this timespan the maximal heat source is founded at 42.216 s. (error of 0.01%) (Figure 7b). Again, figure 8 shows the correspondence between AE event and maximal value of the heat source for the analyzed pixel. Some high heat sources can be seen some milliseconds before and after the analyzed instant but should be considered as parasite events generated by some thermal noise since they do not correspond to any AE.

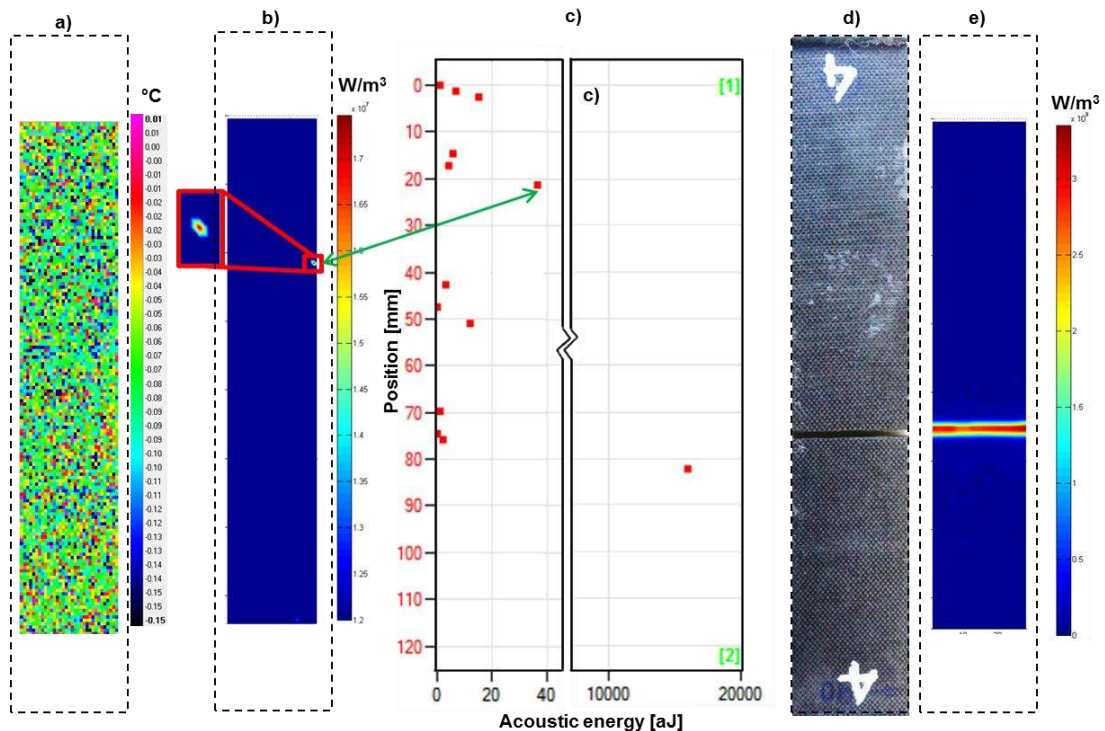
Fig. 7. Correlation between heat source and acoustic emission energy for the 90° specimen

In this case, the location of the heat source and the acoustic event are also in the same zone of the sample (near sensor number 1) with an error of 21%. In addition to the changes in velocity, such difference may be related to much more brittle character, and therefore instable of the failure in that case. Indeed, it is shown in figures 7d and 7e the final failure breakdown occurs in the fibre axis, induced by the failure of the weakest point of the epoxy matrix (the breakdown is transversal to the load axis). The full load of the tensile test is supported by the matrix (epoxy) and so the break takes place transversally to the load axis.

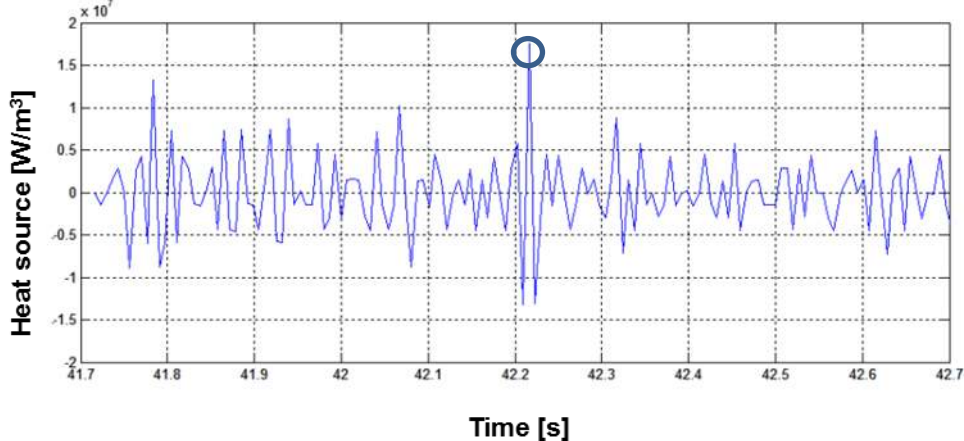
Fig. 8. Heat source variation ± 0.5 s before and after the studied instant for the analyzed pixel (90° specimen)
