# CUTTING TOOL LIFE TESTS OF CERAMIC INSERTS FOR CAR ENGINE SLEEVES

Original scientific paper

This article is focused on the experimental determination of tool life tests for indexable ceramic cutting inserts. The set criterion of tool wear was  $V/B_{\text{Bmax}} = 0,6$  mm (in accordance with ISO 3685) or 30 pieces of machined sleeves. After at least one of the mentioned parameters was achieved, the tests were stopped and evaluated. Two types of cutting material by Saint Gobain Advanced Ceramics s.r.o. Company – ZTA 7 NI and D 250 were tested. We monitored their tool life at the same cutting parameters. The experiments were performed on machine tool – CHEMNITZ NILES N22. The machined material was the cast iron 25P mainly used for car engines. Tool wear was monitored on every fifth machined sleeve. Microgeometry was measured after tool wear test on each fifth sleeve. The aim was to determine the arithmetic tolerance of  $Ra$  profile, the greatest height of  $Rz$  profile and the external diameter  $D$ . The measurement was carried out four times; arithmetic average was performed subsequently as it is shown in the tables.

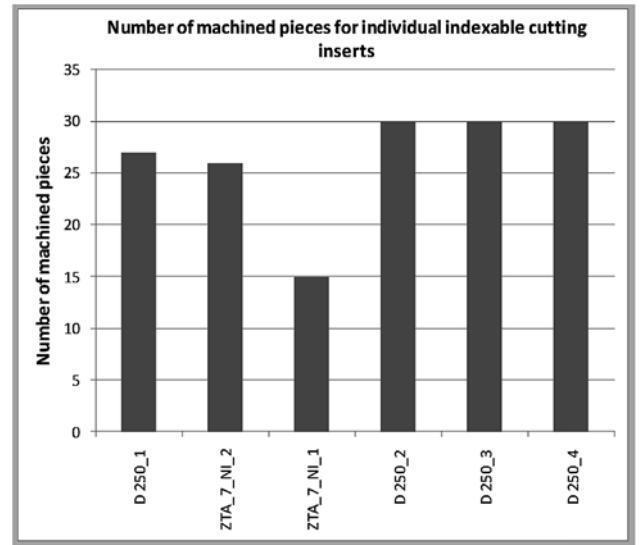
Figure 7 The number of machined pieces for individual indexable cutting inserts

The number of machined pieces by individual ceramic cutting inserts is shown in the following graph (Fig. 7). D 250 series of cutting inserts machined the maximum number of 30 pieces except for D 250\_1 insert. The D 250\_1 insert probably reached this maximum as well. There was a crack of sleeve (at machining the 27<sup>th</sup> sleeve) and it resulted in cutting edge destruction. ZTA\_7\_NI inserts reached the criteria of tool wear at 26<sup>th</sup>, respectively at 15<sup>th</sup> machined sleeves. Fig. 8 shows the tool life of plates calculated according to formula (1) and (2) in minutes.

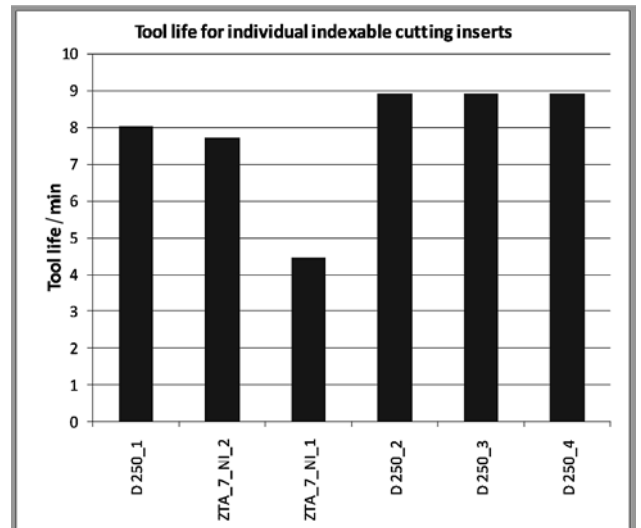
Figure 8 Tool life for individual indexable cutting inserts  
Slika 8. Vijek alata za indeksirane rezne uloške

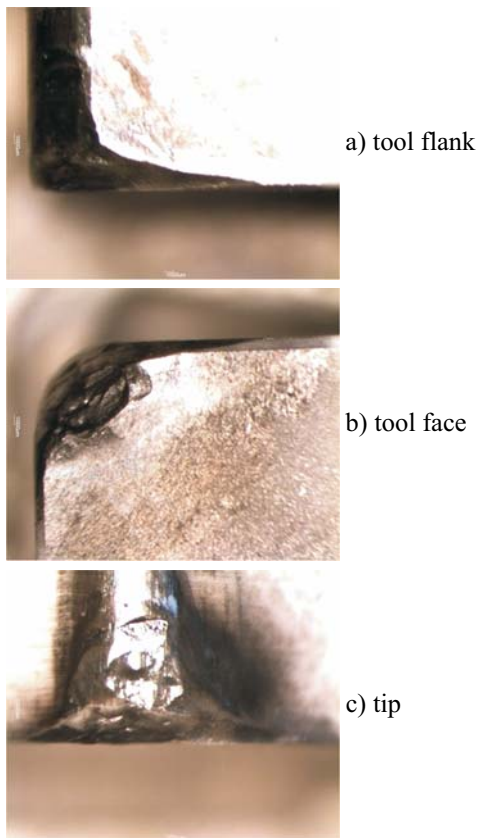
**Figure 9** Tool wear – indexable cutting insert type D 250\_1  
**Slika 9.** Trošenje alata – rezna pločica tipa D 250\_1

- Tool face chipped from 17<sup>th</sup> piece;
- 28<sup>th</sup> piece – workpiece snapped and destroyed insert.
