CUTTING WEDGE WEAR EXAMINATION DURING TURNING OF DUPLEX STAINLESS STEEL

Grzegorz Królczyk, Stanisław Legutko, Pero Raos

Original scientific paper

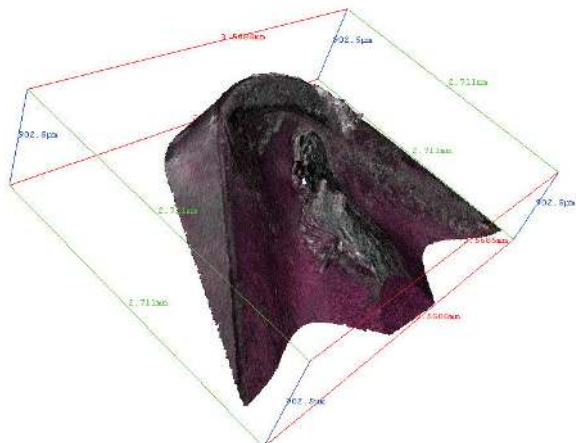
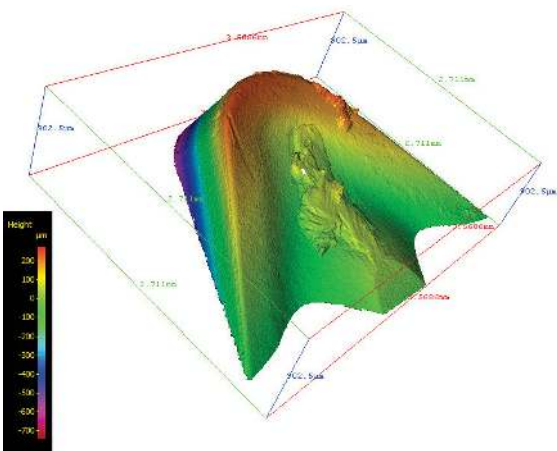
a) Rake face of the tool point W1 in real colour ($v_c = 150$ m/min, $f = 0,3$ mm/rev, $a_p = 2$ mm, dry)

b) Rake face of the tool point W1 in pseudo colour ($v_c = 150$ m/min, $f = 0,3$ mm/rev, $a_p = 2$ mm, dry)

Figure 1 Topography of W1 tool wear during turning of DSS steel for $v_c = 150$ m/min

The results of stereometry visualization of a cutting wedge working at cutting speed of 150 m/min are shown in Fig. 1. In the photographs, one can see a built-up edge on the rake face located next to the main cutting edge and between the main cutting edge and the chip breaker.

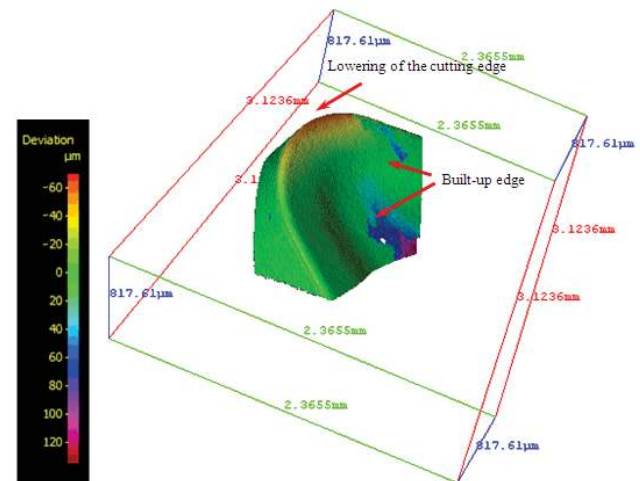
Figure 2 Overlaid models of selection (region under investigation), deviations displayed in pseudo colours

As can be seen in Fig. 2 showing the differences between unworn wedge working at the cutting speed of 150 m/min and that of an idle wedge, cutting edge lowering by $30 \div 50 \mu\text{m}$, as well as the previously described built-up edge, are visible. The measurement results were as follows:

- mean deviation $-2,865 \mu\text{m}$,
- max. deviation $70,432 \mu\text{m}$,
- min. deviation $-135,26 \mu\text{m}$.

Those results allow for the statement that machining duplex steel at the speed of 150 m/min in the time of 30 % tool life causes significant lowering of the cutting edge, locally in excess of $70 \mu\text{m}$, as well as a large built-up edge of maximum $135 \mu\text{m}$. The mean deviation was $2,865 \mu\text{m}$, which indicates significant wear of the cutting wedge and the prevalence of built-up edge over abrasion. Figure 3 shows a histogram of the distribution of vertices and upgrades located on the cutting wedge. It can be seen that the distribution is even. This proves that the 30 % tool life period is within the so called second stage of the cutting edge wear.

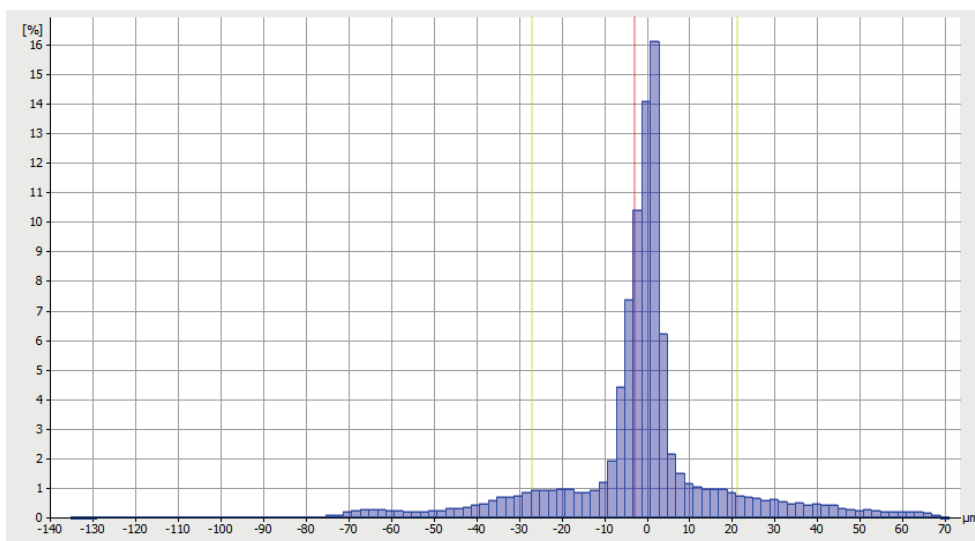
Figure 3 Deviation values tool wear histogram during turning of DSS for $v_c = 150$ m/min

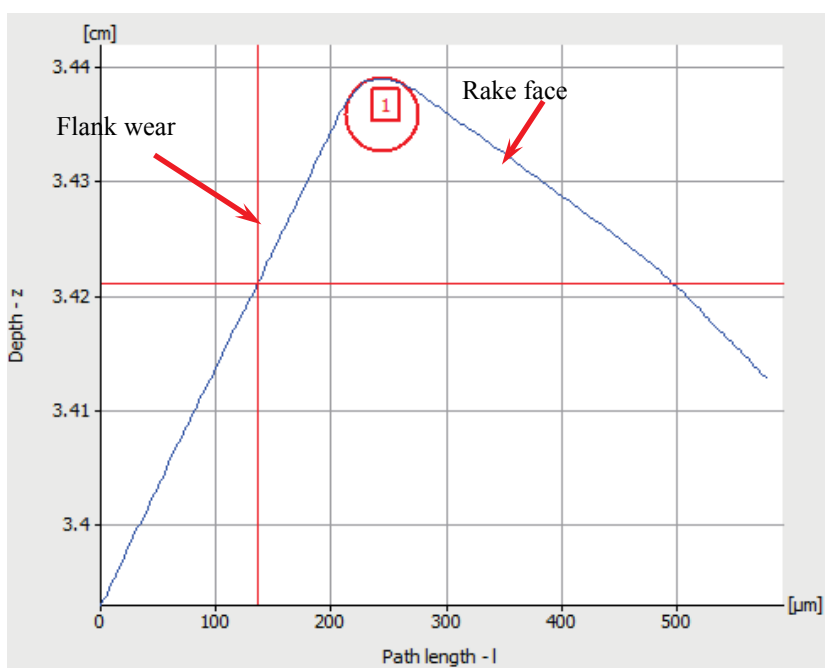
Figure 4 Extracted profile of cutting wedge during turning of DSS for $v_c = 150$ m/min

Fig. 4 shows an extracted cutting wedge profile together with matched geometry. The cutting plate acc. to PN-ISO 1832:1998 [8] is designated E (E – rounded shape). Therefore it has the cutting edge radius r_n .

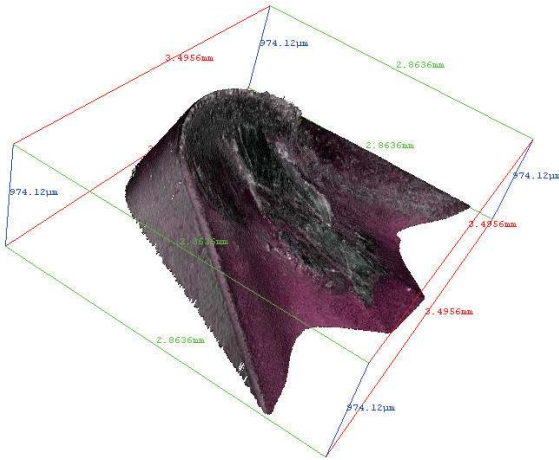
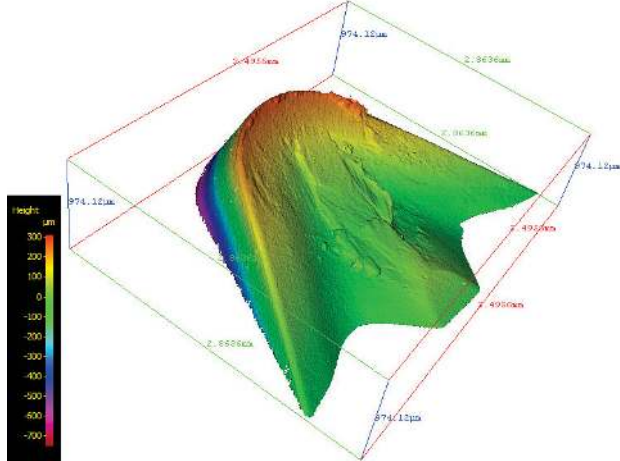
a) Rake face of the tool point W1 in real colour
($v_c = 50$ m/min, $f = 0,3$ mm/rev, $a_p = 2$ mm, dry)

b) Rake face of the tool point W1 in pseudo colour
($v_c = 50$ m/min, $f = 0,3$ mm/rev, $a_p = 2$ mm, dry)

Figure 5 Topography of W1 wedge wear during turning of DSS steel for $v_c = 50$ m/min

The cutting wedge surface topography after turning duplex steel at the cutting speed of 50 m/min is shown in Fig. 5. The built-up edge on the rake face is located as in the case of the wedge working at the cutting speed of 150 m/min, next to the main cutting edge, but with significantly smaller dimensions. One can also see the place of chip friction between the main cutting edge and the chip breaker together with a small built-up edge.

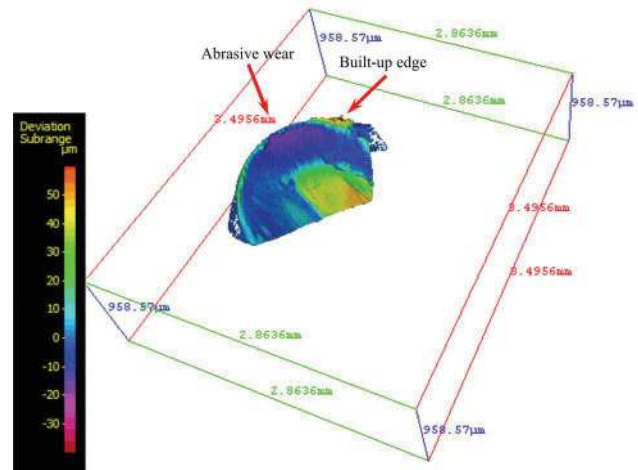
Figure 6 Overlaid models of selection (region under investigation), deviations displayed in pseudo colours

In order to find the dimensional differences between a wedge working at the cutting speed of 50 m/min and an unworn one, two digital images of the wear form of the cutting edges were compared. The result of the comparison of the cutting wedges is the built-up edge, dimensions shown in Fig. 6. One can see less intensive

formation of built-up edge next to the main cutting edge than in the case of the wedge working at the cutting speed of 150 m/min. During the operation of the wedge at the reduced speed, lowering of the cutting edge did not occur, but an abrasion wear land was found on the rake face at the location of chip friction.

- mean deviation $-5,1034 \mu\text{m}$
- max. deviation $88,492 \mu\text{m}$
- min. deviation $-117,71 \mu\text{m}$.

Those results allow for the statement that the reduction of the cutting speed within the examined range of parameters of machining duplex steel results in a decrease of built-up edge on the rake face and eliminates lowering of the cutting edge. The mean deviation on the rake face of wedge no. 4 was $-5,1034 \mu\text{m}$ while, at the same time, in the case of a wedge working at the cutting speed of 150 m/min, the value was $-2,865 \mu\text{m}$. Fig. 7 shows a histogram of the distribution of vertices and upgrades on the cutting wedge. In the figure one can see even distribution in the part from -20 to about $15 \mu\text{m}$. Surface irregularities with the height of $40 \div 50 \mu\text{m}$ are about 2 % of the total number of irregularities. It can be seen that the cutting edge differs from the edge of the wedge working at the cutting speed of 150 m/min. Lowering of the cutting edge, on the other hand, has not been observed. Fig. 8 shows an extracted profile of a cutting wedge working at the speed of 50 m/min.

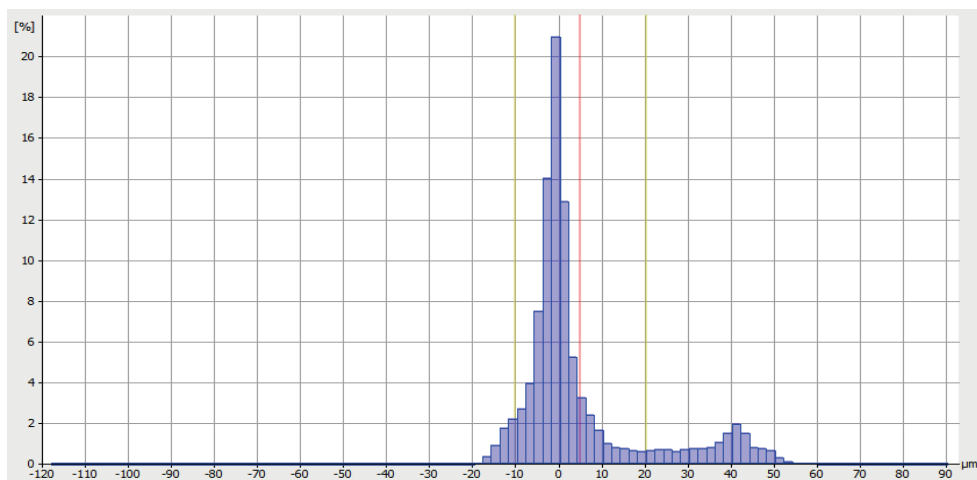
Figure 7 Deviation values tool wear histogram during turning of DSS for $v_c = 50$ m/min

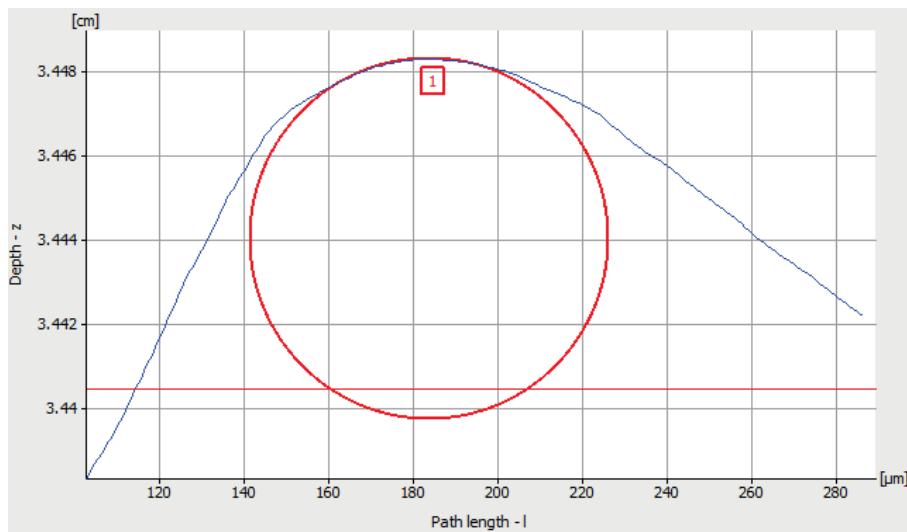
Figure 8 Extracted profile of cutting tool during turning of DSS for $v_c = 50$ m/min – zoomed in

Based on the measurement of the geometry presented in Fig. 8, it was determined that the radius of the cutting

edge rounding r_n was $42,418 \mu\text{m}$. This confirms that machining of duplex stainless steel at higher speeds of the

order of 150 m/min causes lowering of the cutting edge, which is probably due to higher temperatures in the process of turning.

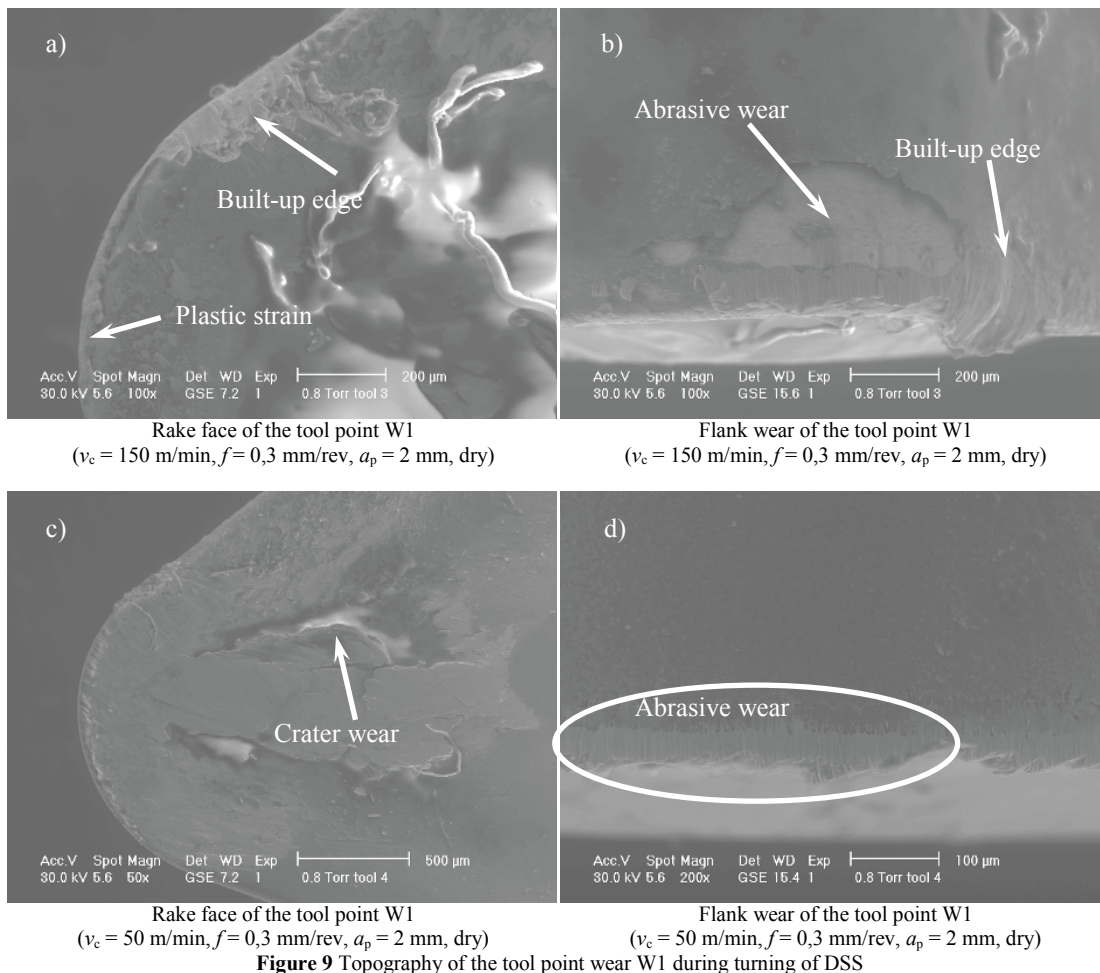
Figure 9 Topography of the tool point wear W1 during turning of DSS

In this chapter, the condition of used tool point surfaces was assessed using the corresponding SEM images shown in Fig. 9. It should be noted that Figs. 9a and 9c represent SEM surface images of the rake face, while the Figs. 9b and 9d show the flank wear. It can be

concluded that in the process of sliding friction between surfaces some DSS particles were transferred to rake face near the tool point - chip contact zone. This phenomenon was documented in Fig. 9a. These particles in the form of a built-up edge are particularly visible on the rake face of the tool point with a cutting speed of 150 m/min. For this cutting speed a small plastic deformation on the rake face

and the built-up edge with the clash of the major flank can be observed (Fig. 9b). Reducing the cutting speed to 50 m/min resulted in crater wear appearing on the rake face (Fig. 9c) and the abrasive wear of the major flank (Fig. 9d).
