Cyclic Loading of a SiC-fiber Reinforced Ceramic Matrix Composite Reveals Damage Mechanisms and Thermal Residual Stress State

Konstantinos G. Dassios, Dimitris G. Aggelis, Evangelos Z. Kordatos,
Theodoros E. Matikas

To appear in: *Composites: Part A*

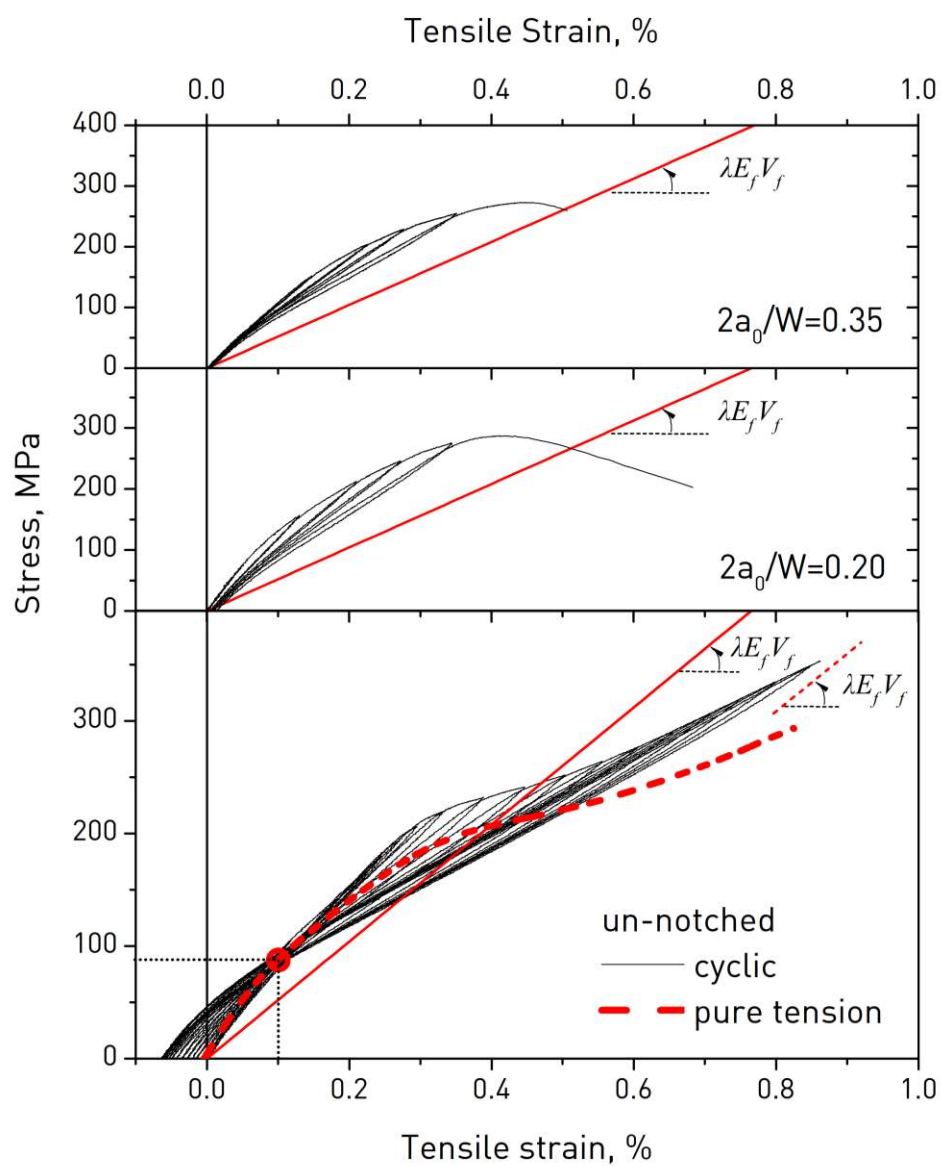
Fig. 2

Fig. 2. Examples of tensile curves of the SiC/BMAS composite for varying notch-to-width ratios

Typical cyclic tension curves for three DEN specimens of different notch-to-width ratios of the SiC/BMAS composite are shown in Fig. 2. The response of the material in static tension is also included in the bottom graph of Fig. 2, represented by a dashed line. The tensile curves of the composites exhibited an initial linear part, followed by a regime of gradually decreasing tangent modulus to the curve. The observed softening is attributed to interfacial debonding and slipping between matrix and fiber in the area confined between neighboring matrix blocks. These blocks, interconnected through fiber bundles, are formed as a result of matrix cracks developing in planes perpendicular to the fibers' axis, initially within the 90° plies and subsequently also in the 0° plies. The decreasing average slope of unloading-reloading cycles, compatible with decreasing material stiffness, is also indicative of progressive matrix and interface damage.

Based on the above argumentation, the slope of the final unloading cycle before failure (Fig. 2) must correspond to the purely elastic behavior of load-bearing fibers in the composite. This behavior can be approximated by a line of slope $\lambda E_f V_f$, where E_f is the Young's modulus of the fibers, V_f is the fiber volume fraction and λ is the non-unidirectional reinforcement correction factor, accounting only for fibers oriented in the direction of load application. The slope of the last unloading cycle, calculated as 52 GPa, is then equal to $\lambda E_f V_f$. Using $E_f=190\text{GPa}$ and $\lambda=0.5$ for biaxial reinforcement, the effective fiber volume fraction in the composite is calculated as 55%. The experimentally-established $\lambda E_f V_f$ line is included in all graphs of Fig. 2, as solid straight lines through the origin, to facilitate an analysis to follow.

By comparison of the un-notched material response under static and cyclic tension (curves in the bottom graph of Fig. 2), an unambiguous overall strengthening is observed as a result of cyclic loading. Most interestingly, the pure tension curve perfectly intersects the CIP of unloading-reloading cycles of un-notched specimens at 0.3% strain. The overall shapes of the two curves were qualitatively comparable, with the previously explained "triple regime" behavior being apparent in both testing conditions. Quantitatively, at strains lower than the CIP, the material's response under pure tension appeared of comparable magnitude to that of cyclic loading. After the CIP, the tangent modulus to the pure tension curve decreased more rapidly than that of cyclic loading. This resulted in the

It should be recalled that the tensile curves of double-edge notched specimens did not exhibit a CIP, as seen in Fig. 2. This finding signifies that the TRS may be relieved in notched specimens due to (positive) stress concentration gradients acting in the neighborhood of the notch root, that cancel the negative TRS state of the matrix. For a machined notch radius of 125 μm , (Fig. 3), the stress around the notch can theoretically magnify up to 6-8 times of the macroscopically applied value, for specimens with 0.2 and 0.35 notch-to-width ratios. If, at the conventional yield strength of the material, this stress concentration spans a region that is equal to the notch length -as the classical Irwin plastic zone approach predicts- then the remaining unaffected ligament may be of insufficient dimensions for its TRS to affect the overall mechanical behavior.

The elastic behavior of fibers in the composite (line of slope $\lambda E_f V_f = 52 \text{ GPa}$) is included in the tensile curves of Fig. 2. The point of intersection of the $\lambda E_f V_f$ line with a tensile curve defines a fully-saturated matrix cracking state where fibers in the loading direction are completely bridged by the transverse saturated matrix cracks [3]. In this context, tensile data located above the $\lambda E_f V_f$ line are associated with large nonlinear phenomena due to time-dependent matrix cracking. Below the $\lambda E_f V_f$ line, lies the regime of global load sharing by intact fibers and fiber bundles in a completely cracked matrix that results in the macroscopic “stiffening” phenomenon and the linear stress–strain relationship toward the end of the curve. As shown in Fig. 2, the curves of notched specimens, including all cycle loading data, are located *above* the $\lambda E_f V_f$ line and the line intersects the tensile

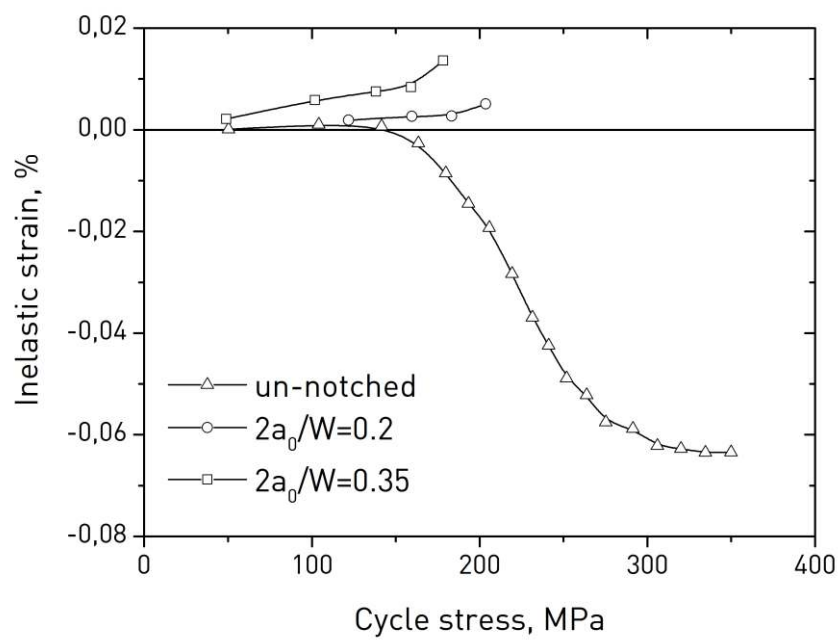
Fig. 5. Cumulative inelastic strain as a function of cycle stress for varying notch-to-width ratios of the SiC/BMAS composite. Solid lines connecting experimental points are spline regressions to the data.

Inelastic strain, calculated as the strain offset at zero load at the onset of reloading, is plotted as a function of cycle stress (stress at the onset of unloading) for different notch-to-width ratios in Fig. 5.

Notched specimens exhibited a small degree of positive inelastic strain accumulation with values increasing with increasing notch length. The scenario changed dramatically in the un-notched specimens where inelastic strain was of negative sign and reached a maximum value that was more than 4 times greater than of notched specimens. For un-notched specimens, it was also observed that inelastic strain increased with cycle count and attained a plateau value in the final cycles where matrix cracking was saturated. This finding implies that inelastic strain is related to matrix cracks, most possibly through the mechanical impediment of complete crack closure due to fiber roughness and/or contact between opposing faces micro-crack slightly moved from their original positions during unloading-reloading. This explanation is further supported by analysis of the hysteresis loops that showed an apparent increase in stiffness towards relaxation, i.e. an increase in the tangent modulus of the unloading curve at the lower ends of the loops.

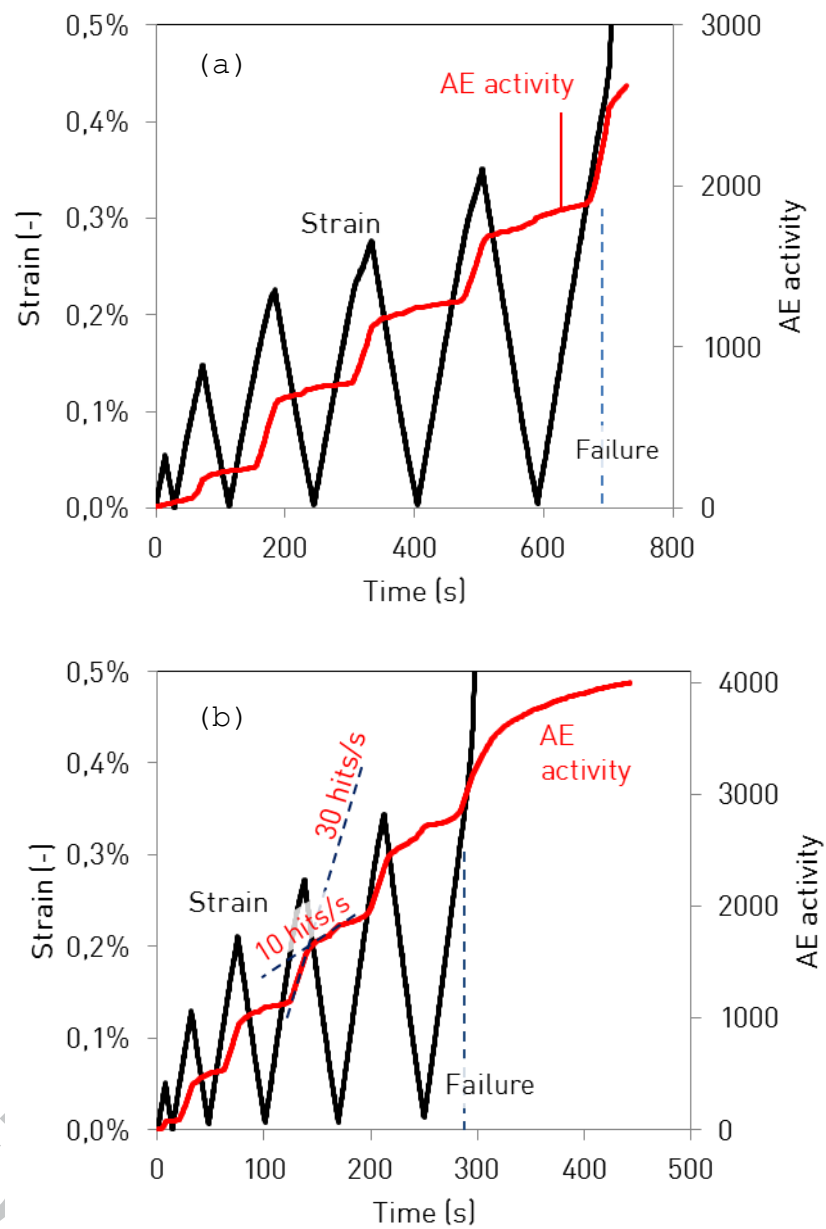
Fig. 6. Strain and time histories for specimens with notch-to-width ratios of (a) 0.2, and (b) 0.35

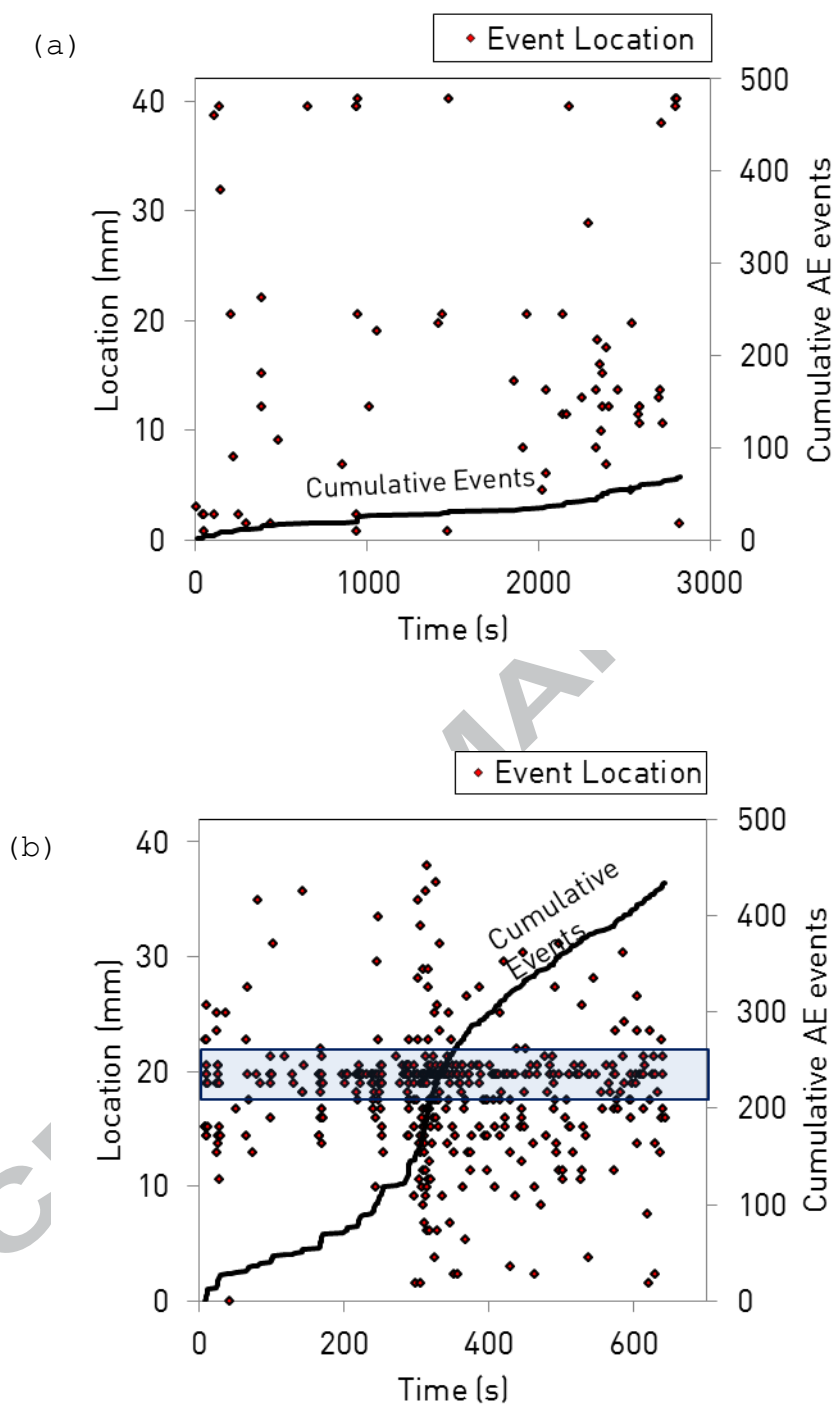
Fig. 7. Location and time histories of events for specimen with (a) $2a/w=0$, and (b) $2a/w=0.35$

If we were to concentrate on events only, (signals that were simultaneously recorded by both sensors and attributed to the same source incident), interesting trends arise as to their location. Figure 7a

shows the location of events and the associated time instances for an un-notched specimen. The total number of events is below 100 and their location exhibits a wide distribution in the whole measured length of the specimen. For the notched specimens, the events are reasonably located in the center zone of the specimen (see Fig. 7b, location 20 mm from the first sensor). A percentage of 56% of the total number of events was included in a zone of ± 2.5 mm from the center, a result clearly attributed to the presence of the notch that marks the fracture process zone. Due to the sensitivity that the notch brings into the specimen, the number of events is quite high (more than 400) compared to the case of un-notched specimen. This shows the ability of AE to distinguish and locate accurately events coming from certain discontinuities even at close separation distances of 40 mm.

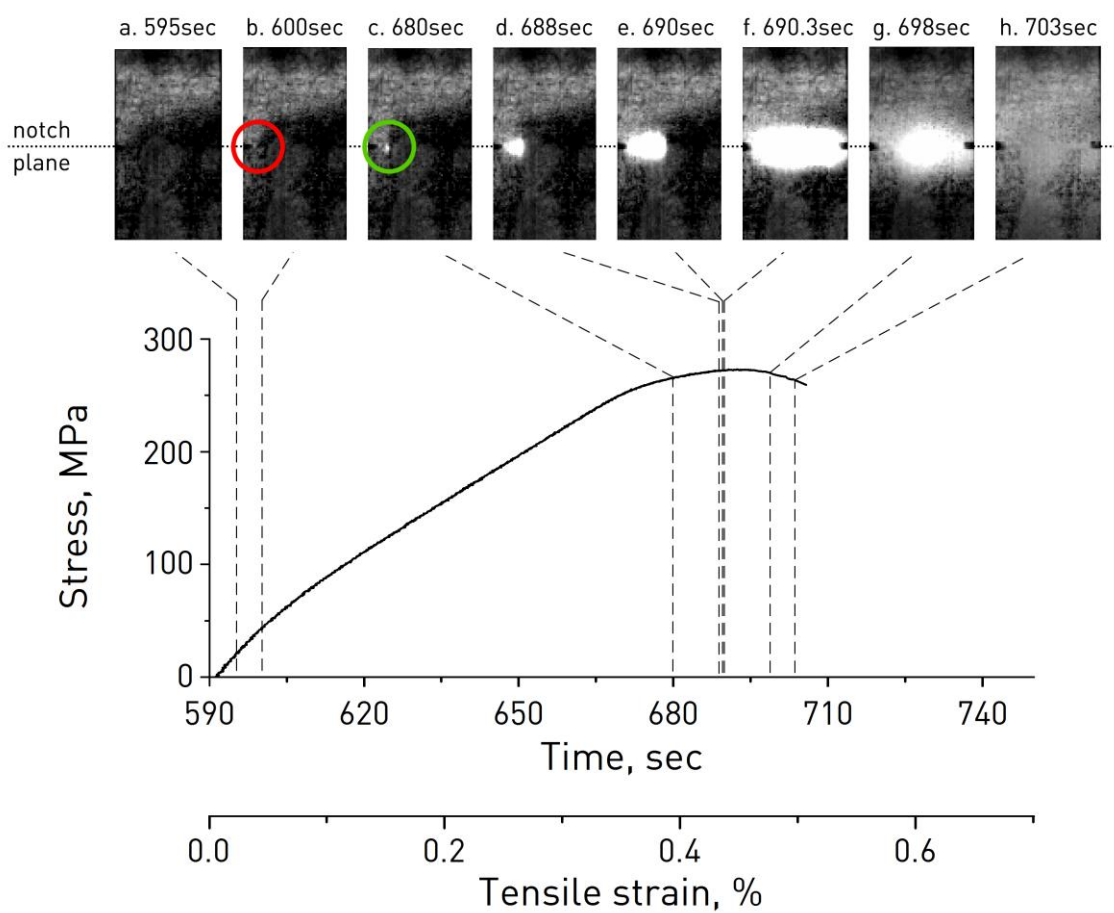
Fig. 9.

Fig. 9: Thermographic imprinting of damage evolution during the ultimate reloading stage of a notched SiC/BMAS composite

IRT was used to capture valuable information concerning the location and evolution of damage in the CMC under investigation. Fig. 9 focuses on the damage sequence captured via IRT within the last reloading cycle of the specimen with notch-to-width ratio of 0.2, up to failure. Thermographs a-h in Fig. 10 show the magnitude of damage occurring within the material at select critical instances within this cycle. Time and strain associated with each thermography instance are correlated to the thermographs by dashed lines; time in sec is also indicated in the thermographs' label.

Fig. 9a demonstrates the baseline thermal fingerprint of the composite specimen prior to the commencement of catastrophic fracture, with no obvious temperature variations evident on the specimen's surface. Damage commenced 5 seconds within the last reloading cycle, at 600 sec, and is indicated by a red circle in Fig. 9b. Notwithstanding the fact that this instance falls within an apparently "linear" regime, it should be reminded that, at this loading stage, the material had already undergone 4 unloading-reloading cycles and extensive interfacial damage had already occurred. Initiation of fiber failure appeared at 680 sec on the left side of the specimens, as clearly captured in Fig. 9c (green circle) and is directly associated with the macroscopically observed decrease in modulus, that is due to the decrease in V_f . Fiber failure progressed in a stable manner within the next 10 sec, with damage gradually accumulating over half of the notched ligament, under the global load sharing principle, as evident in Fig. 9d and 9e. It appears that, once *ca* 50% of fibers had failed, their remaining population was not sufficient to withstand the macroscopically applied load, and spontaneous fiber failure was triggered. Hence, within the next 300 msec (Fig. 9f) the remaining intact fibers failed massively at locations within the matrix environment. This observation validates our previous finding that notched specimens failed soon after the attainment of the maximum load and did not exhibit a final stiffening regime. Once fiber failure had spanned the whole bridged ligament, the magnitude of damage, as captured by IRT, appeared to gradually fade out symmetrically from both notch roots (Fig. 9g). This "fade-out" is believed to be associated with the contraction of failed fiber ends within the matrix environment, prior to the initiation of the pull-out. As shown in the thermograph of Fig. 9h, no significant new damage developed in the material prior to load relaxation.
