# Damage assessment in single-nave churches and analysis of the most recurring mechanisms after the 2016–2017 central Italy earthquakes

F. Ceroni<sup>1</sup> · C. Casapulla<sup>2</sup>

## Abstract

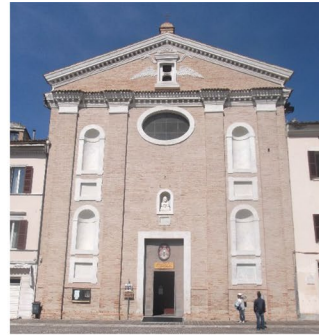
**Fig. 3** **a** Statistical distribution of the façade type for 146 brick masonry churches and 403 stone masonry churches; **b** example of a gabled façade

Within these 549 single-nave churches, Fig. 3a shows that the most common façade has a gabled shape (Fig. 3b), with an occurrence of about 70% for both clay brick and stone

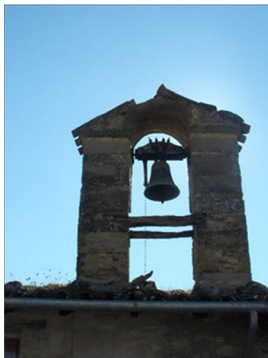
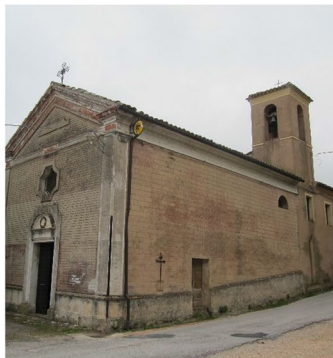
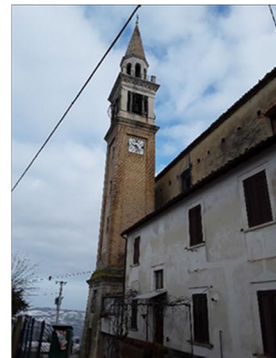
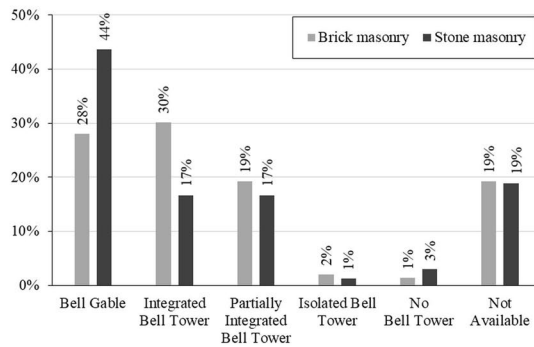
**Fig. 4** **a** Stone masonry bell gable in the Santa Maria Assunta Church (Funtoli, Ascoli Piceno); **b** integrated brick masonry bell tower in the San Paterniano Church (San Severino Marche, Macerata); **c** partially integrated brick masonry bell tower in the San Nicola Church (Casacanditella, Chieti); **d** isolated bell tower in the San Giovanni Church (Cascia, Perugia); **e** statistical distribution of bell tower typologies for 146 brick masonry churches and 403 stone masonry churches

Among the 633 single-nave churches of the investigated stock, three main typologies of bell towers are identified: the ‘bell gable’ (Fig. 4a), the ‘integrated’ bell tower, which can

be joined to different parts of the church (Fig. 4b-c), and the ‘isolated’ bell tower (Fig. 4d). It is worth noting that information about the bell tower typology is not available for a relevant number of churches of the whole database (20%, 129 churches).
