Dating the Romanesque Mural Paintings and the Ducal Rotunda of St. Catherine, in Znojmo: New Discoveries (2010)

Kateřina Dvořáková^{a*}

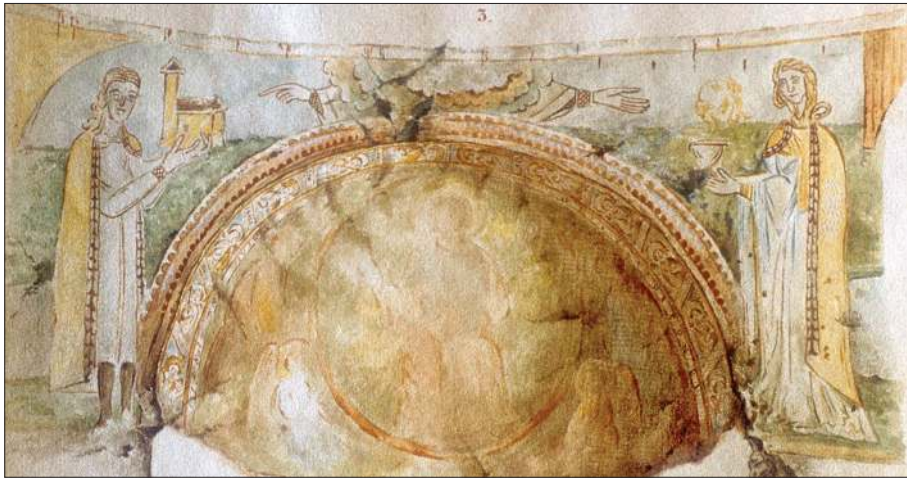
Figure 1. M. Trapp, 1861, coloured drawing (photo from author's archive).

Taking the murals in the dome of the apse, as an example, we can see on Trapp's coloured drawing the condition of the murals in 1861 (Figure 1) – which is limited to singular

After comparing cross sections of samples, images from non-destructive ultraviolet and infrared investigation (Figure 4), and historical documents, it is possible to state that the best documentation of the mural's appearance is Trapp's aquarelle. The postures and shapes of figures correspond to the original appearance and to the discovered Deesis composition. Both lateral figures of Virgin Mary and St. John the Baptist were created by Melicher (as we know he used zinc white during the restoration – documented by the analysis of samples taken from select parts of the painting).

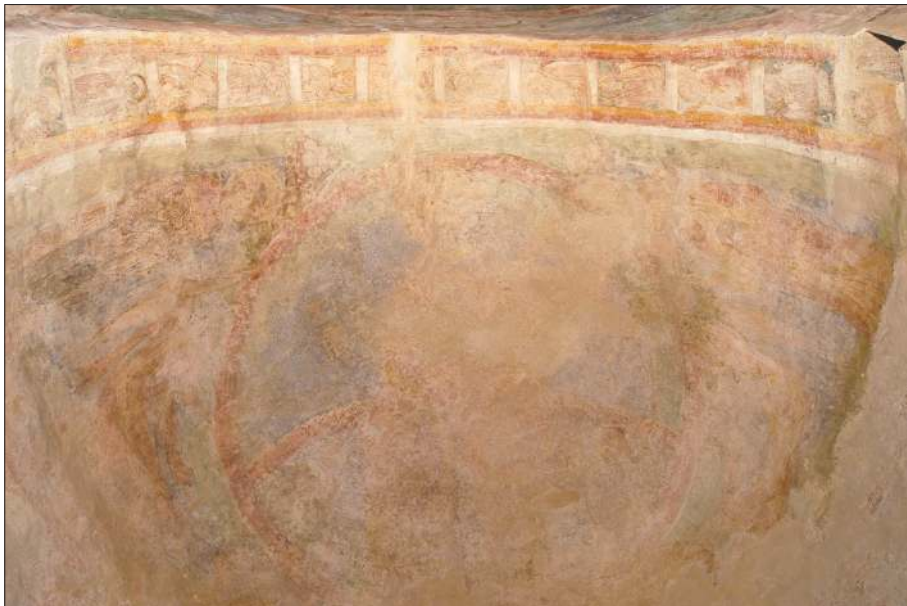
Figure 2. Conditions of the mural painting in the dome of the apse in 2006 (photo from author's archive).

On Figure 2 we can see the present condition of the murals.

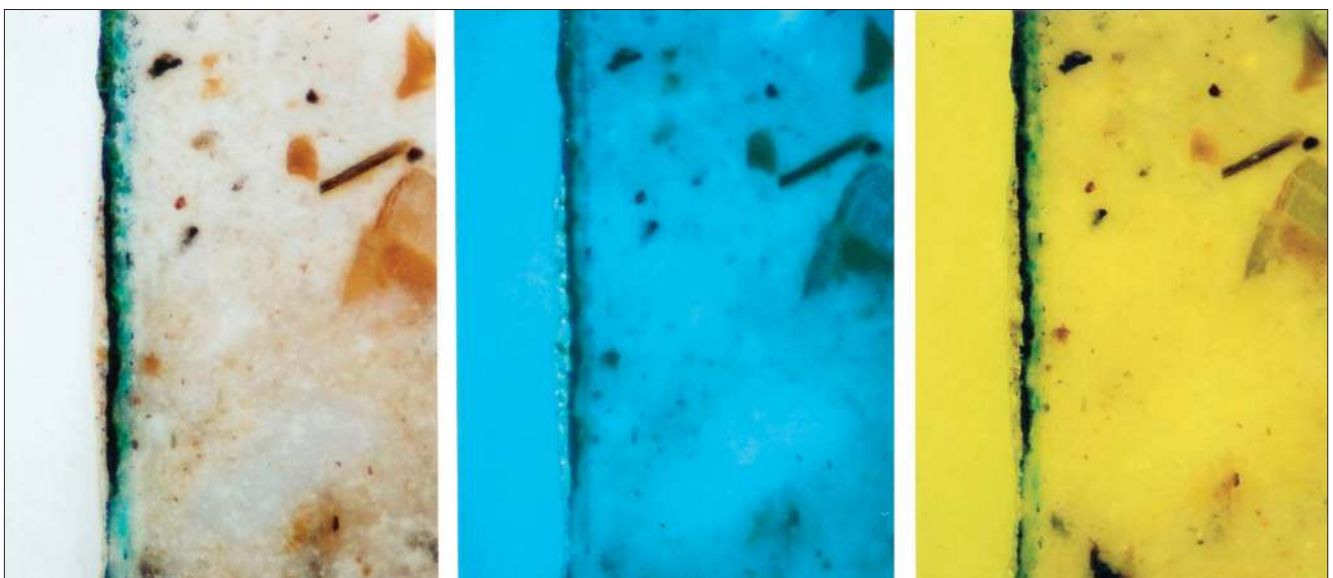
Figure 3. Stratigraphy of the paint layers (photo from author's archive).

us a continuous painting on plaster, which could, except for the outlines, have been done as a secondary painting, because nothing more is conserved than this painting. It is obvious that without the identification of colour layers of the mural it would not be possible to verify opinions about the credibility of the restorations (Figure 3).

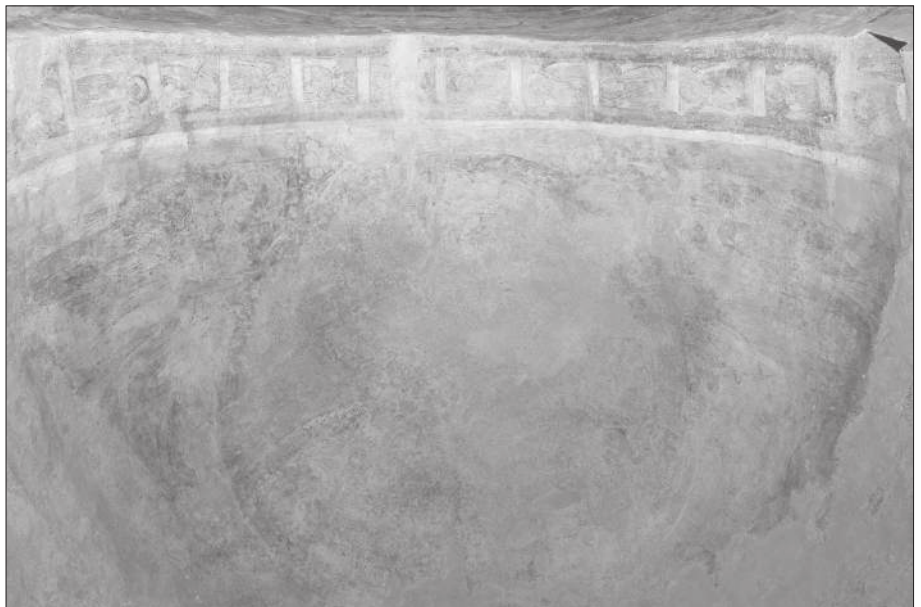
Figure 5. Dome of the apse, infrared image of the mural in 2006 (photo from author's archive).

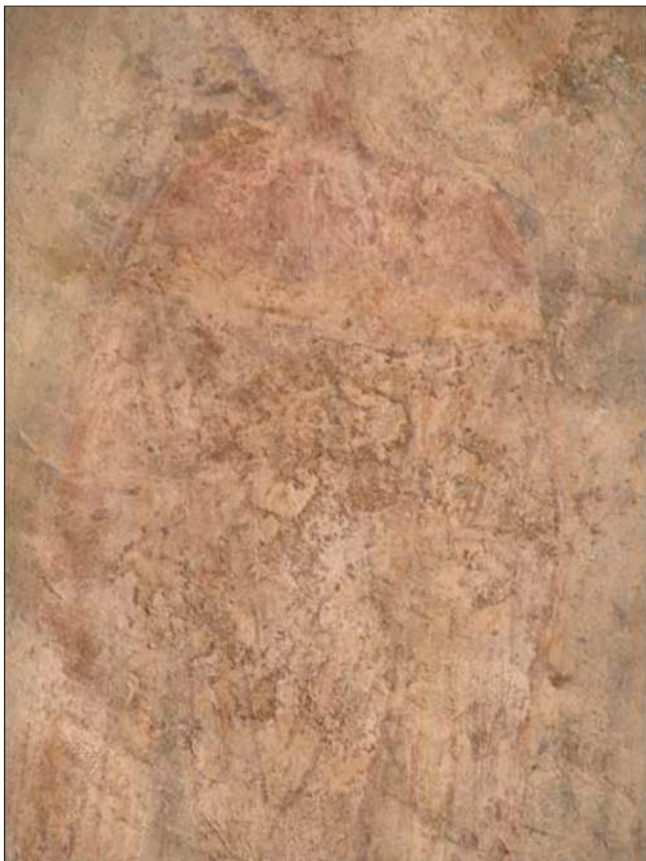
Figure 6. Hands of the Virgin Mary. Detail of parts of the mural which have fallen out, salt efflorescence and mold (photo from author's archive).

The hands of the Virgin Mary are not in their original state, in contrast to Konečný's comments, as shown on the coloured images of the Institute of Classical Studies of the Academy of Sciences of the Czech Republic. In this case there are parts of dropped plaster, salt efflorescence and mold that give the impression of a mural painting (Konečný 2005; Figure 6).

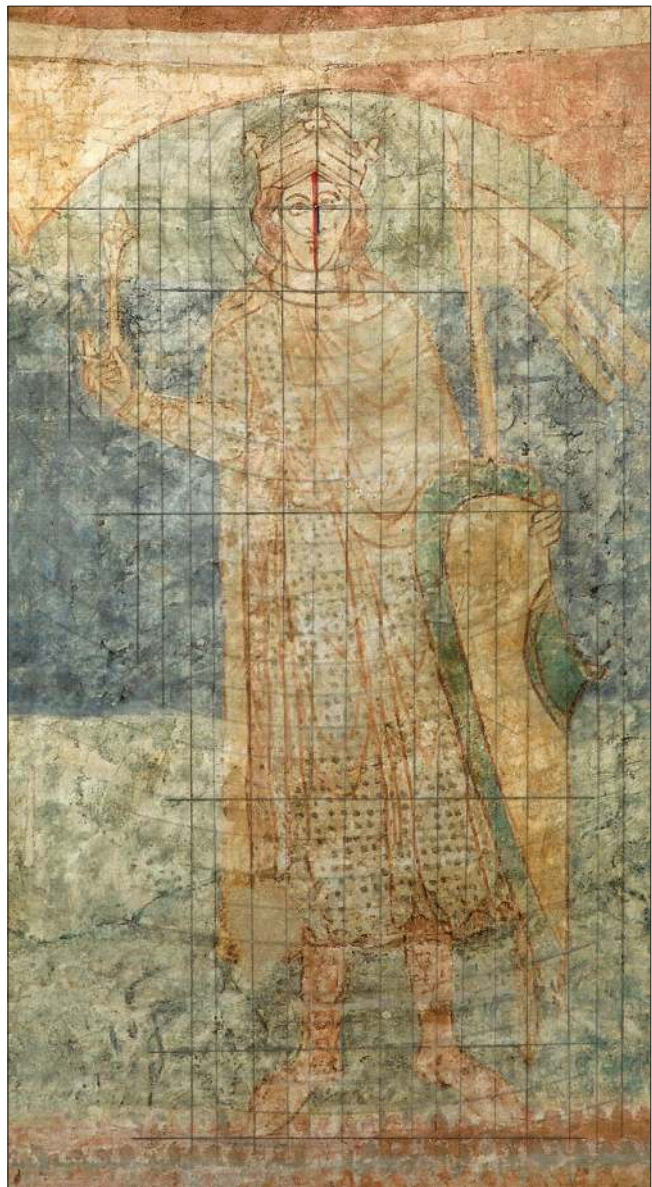
Figure 7. Rotunda of St. Catherine in Znojmo, figure of King Vratislaus II. Plan metric construction of the figure.

inside the ducal rotunda of Saint Catherine. The rotunda has an internal ground plan length of 33 feet (the age of Jesus Christ). Painters composed the figures in the same way, dividing the figures to 33 parts. The length of the nose served as basic size, a fact that had already been defined by the byzantine tradition and painting manual from Mount Athos (Painting manual from Mount Athos, Schäfer 1855). All images of rulers are created by the same construction principle (Figure 7).
