Degradation of Power Contacts in Industrial Atmosphere: Silver Corrosion and Whiskers

Bella H. Chudnovsky
Square D Company
West Chester, OH 45069, USA

Copyright © 2002 IEEE. Reprinted from Proceedings of the Forty-Eighth IEEE Holm Conference on Electrical Contacts, 2002, p. 140-150.

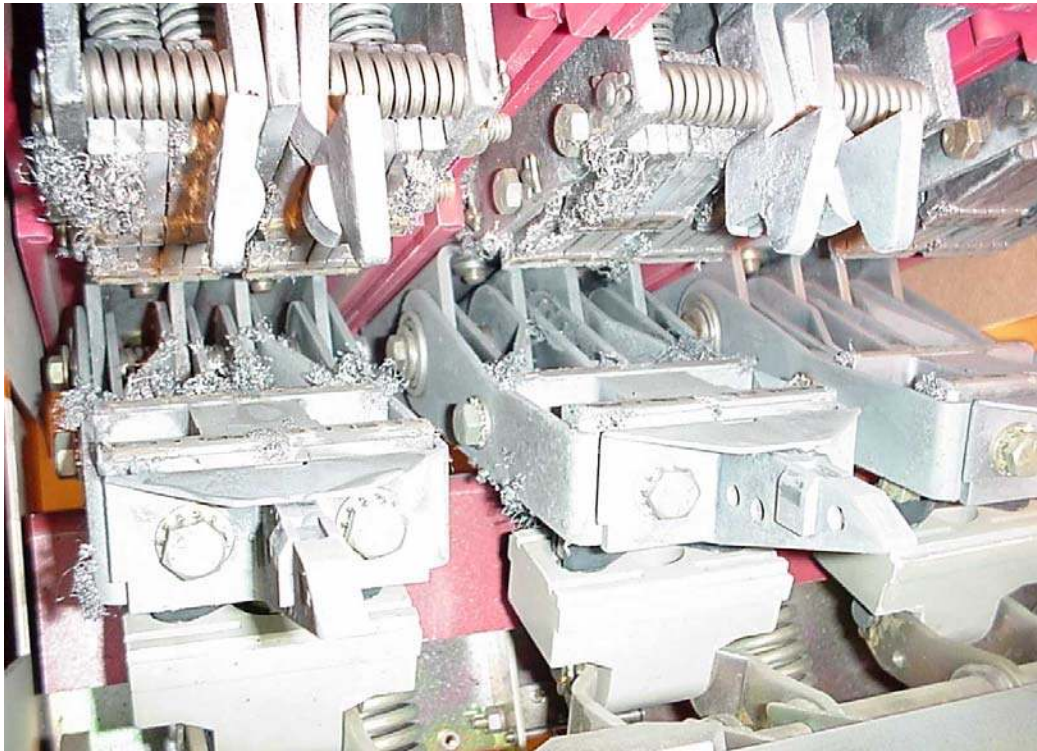
Fig.1. Silver whiskers inside circuit breaker in May 2000 (before cleaning)

Since then every 2-3 months the electric service group at the plant performed cleaning of the units subjected to extensive corrosion and whiskers' growth (Fig. 1). Two units, which have been thoroughly cleaned in May 2000, failed in July 2000 just two month after previous maintenance (Fig. 2).

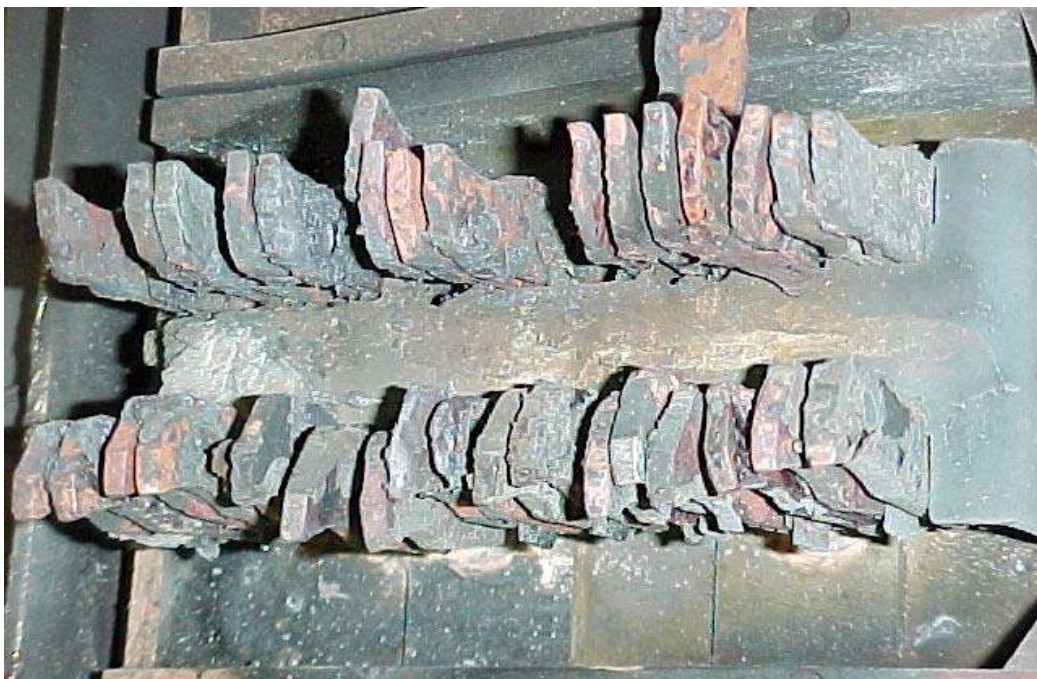
Fig.2. Finger Cluster after failure in July 2000

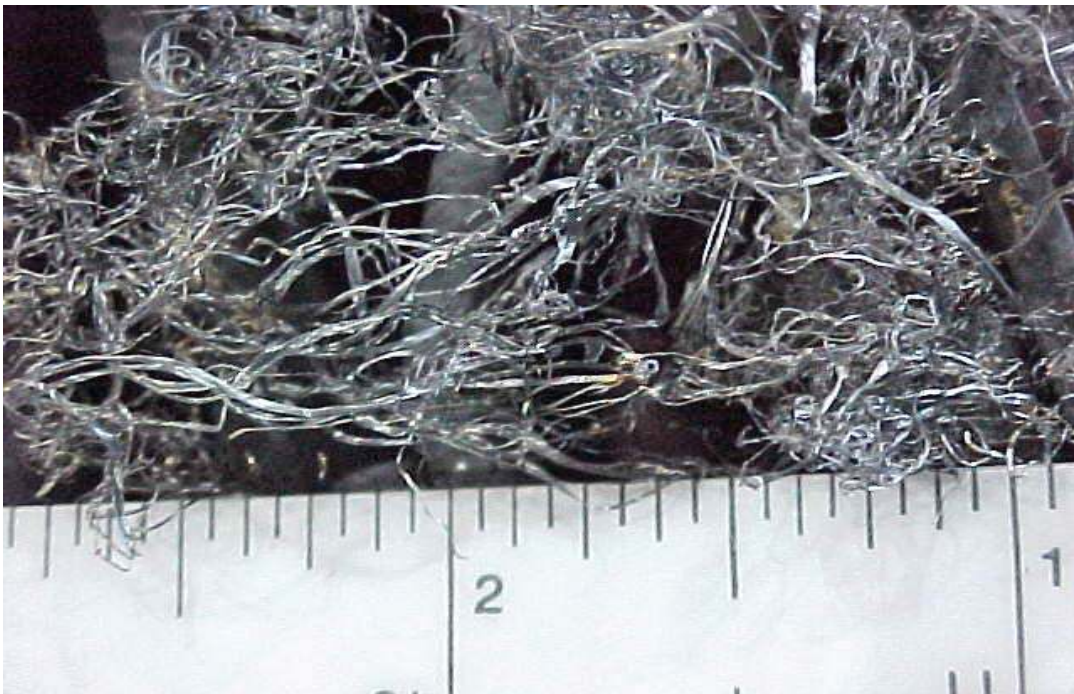
Fig. 4. Clump of two-month old silver whiskers

We collected the samples of silver whiskers from heavily corroded circuit breakers during scheduled overhauls or after thermal failures in May-August 2000. The clumps of the whiskers found inside current carrying path of the breaker after failure in July 2000 are shown in Figs. 3-4. Almost 12 g (4 oz) of the whiskers has been collected from two low voltage breakers. The period during which they grew before failure was only two months.

ranging from tiny thin “dawn”-looking formations to thick and strong threads, which are bound together into large tufts and clumps (Figs. 3, 4).

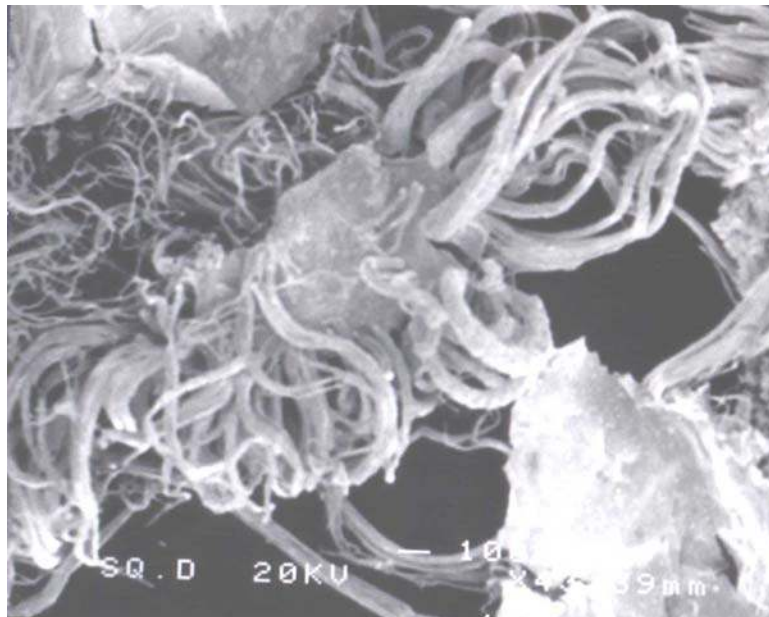
Fig. 12. Whiskers growing from the flakes, x43

The color of the whisker surface seems to correlate very well with the surface morphology. The surface of two whiskers, one with metallic luster (Fig. 9) and another one having dull dark color (Fig. 10) is significantly different. Various types of whisker growth from the corrosion flakes are shown in Fig. 11 and 12.
