# Deposit formation on cylinder liner surfaces in medium-speed engines

Øyvind Buhaug

Faculty of Engineering Science and Technology  
Norwegian University of Science and Technology

Trondheim, Sept 15, 2003

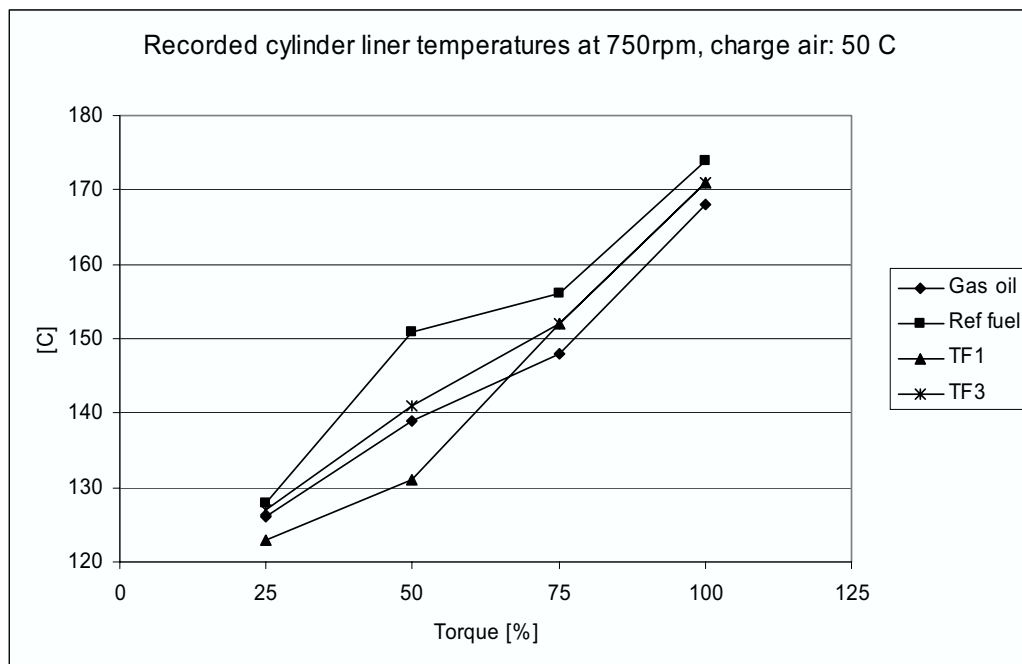
Figure 2-6 Load and fuel dependent maximum cylinder liner temperature  
Drawn from measurement data obtained in [46]

This work is done in a 6 cylinder long-stroke medium speed engine rated at 17 bar BMEP. Seven residual test fuels, one reference fuel and one gas oil were tested. Cylinder liner temperatures were recorded amongst other data. The liner temperature was measured with thermocouples positioned 2-3 mm below the liner surface. It was planned in this work to include a test fuel consisting of pure light cycle oil (LCO), however large cycle to cycle pressure variations, high exhaust valve temperature and knocking combustion caused this test to be abandoned.

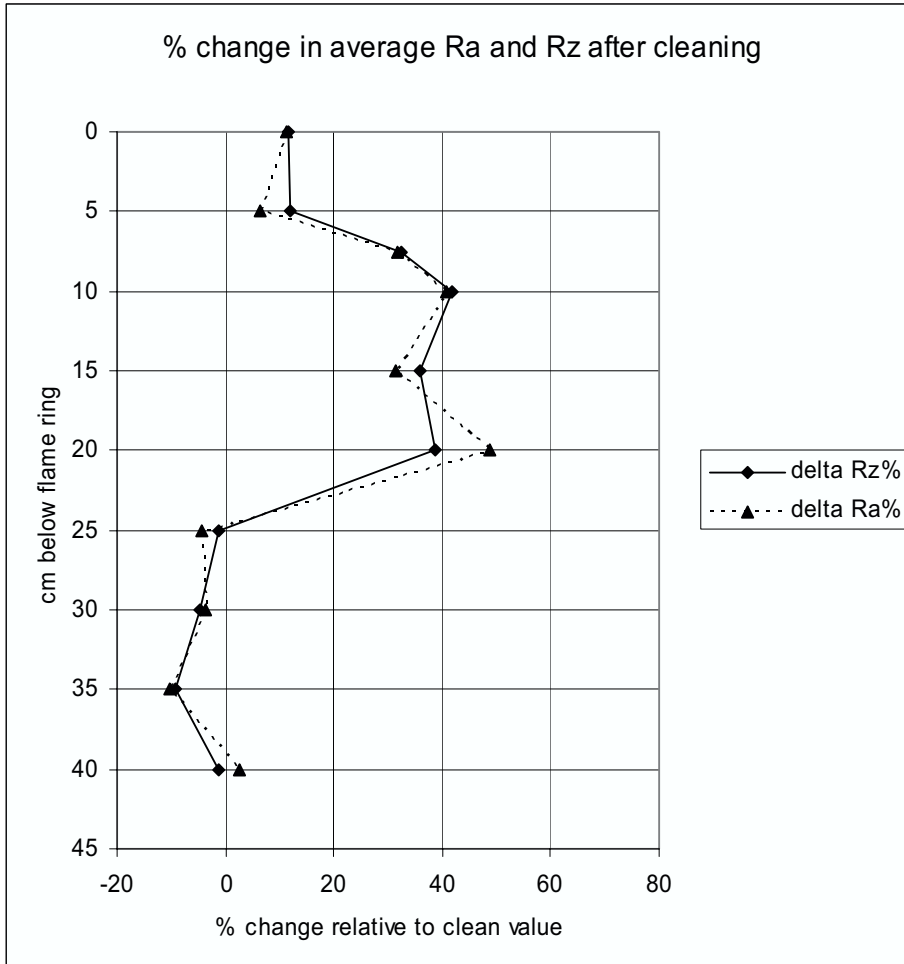
Figure 3-13 *Change in average surface roughness parameters after cleaning liner with acetic acid.*

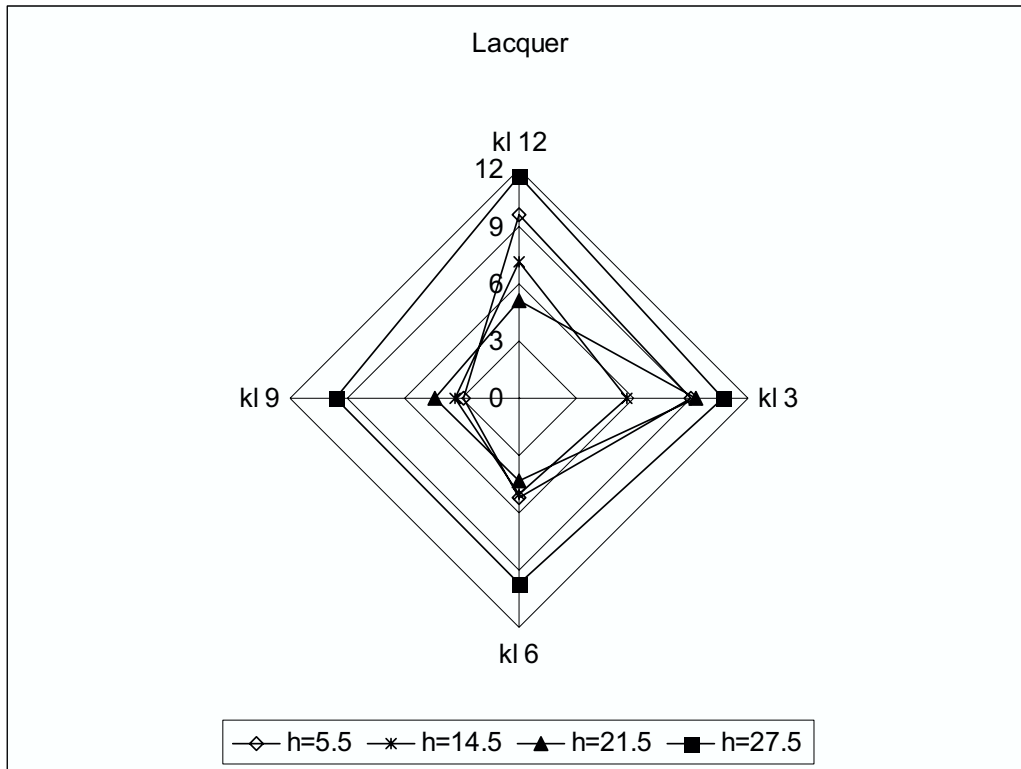
Figure 3-14 *Illustration of liner lacquer deposit pattern in engine A*

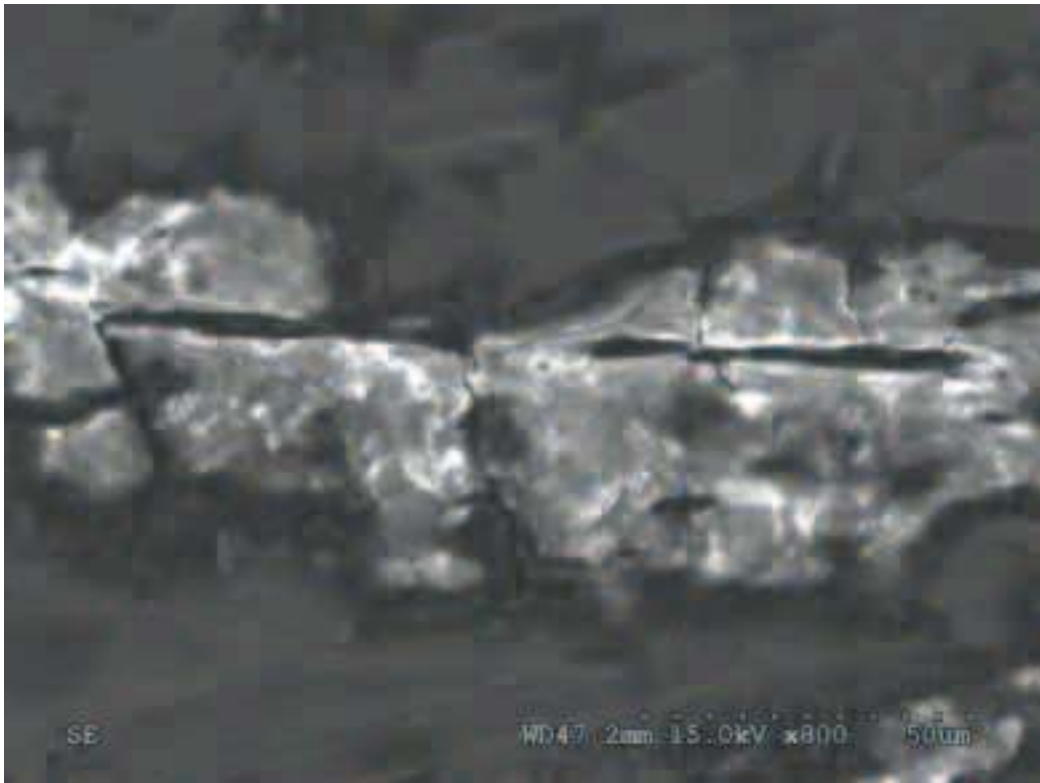
Figure 3-18 *Lacquer with crack parallel with groove (center region)*

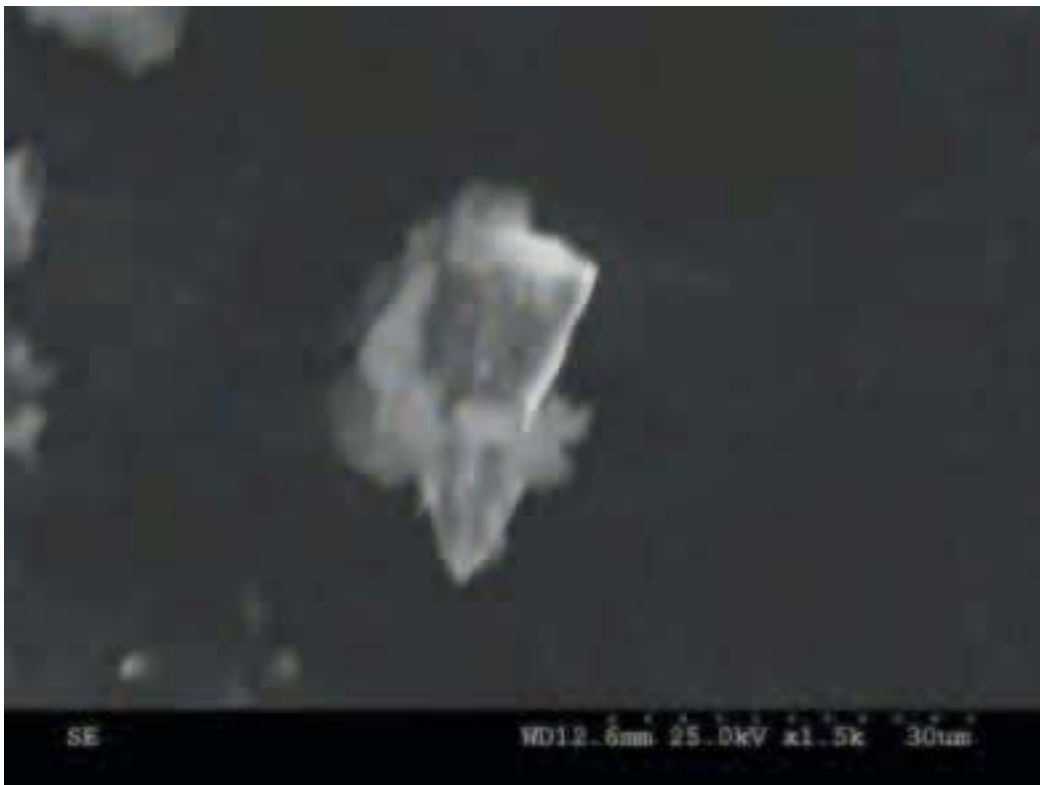
Figure 3-35 *Iron flake with deposit*

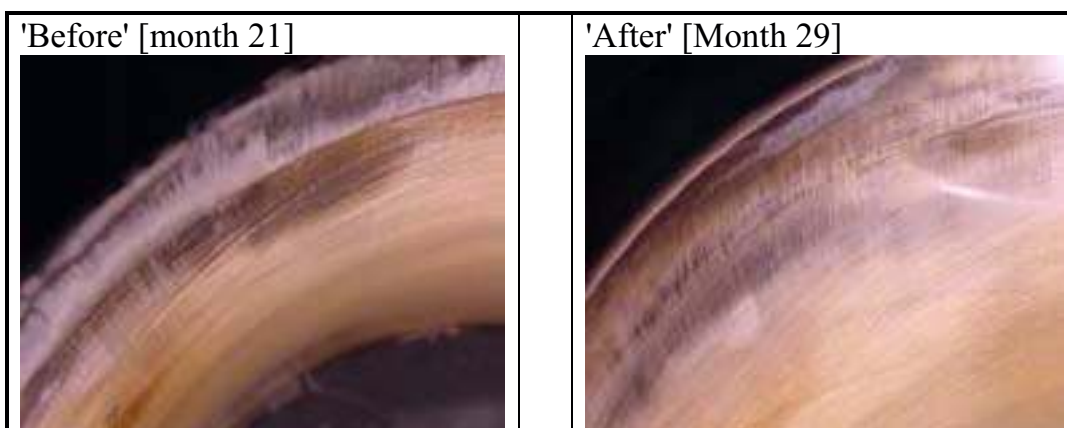
Figure 4-23 *Cylinder B5 before and after 8 months fuel additive treatment. Lacquerish deposits replace the soot above upper ring reversal.*

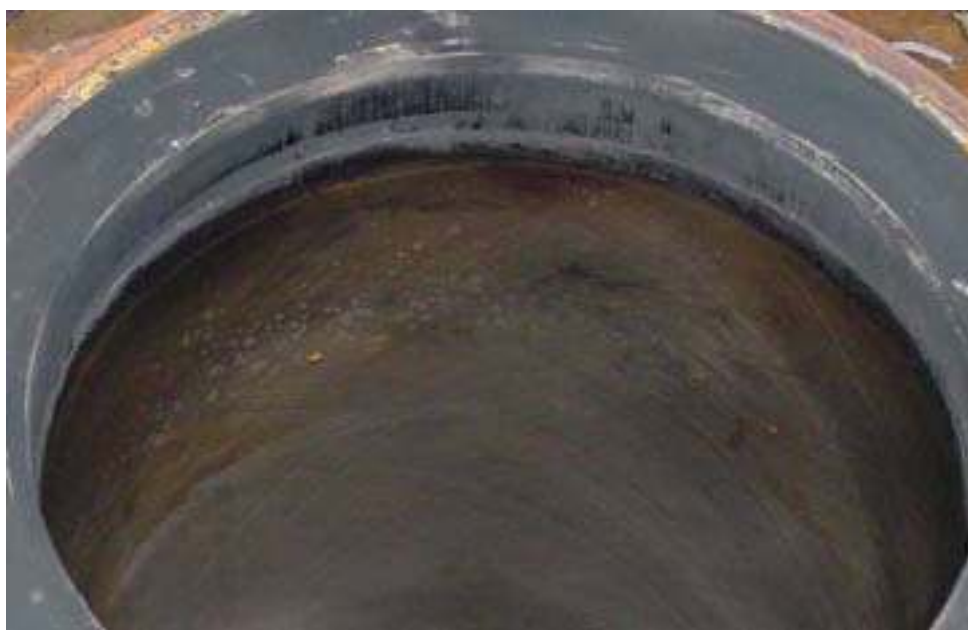
Figure 4-37 *Picture of the liner at inspection one*

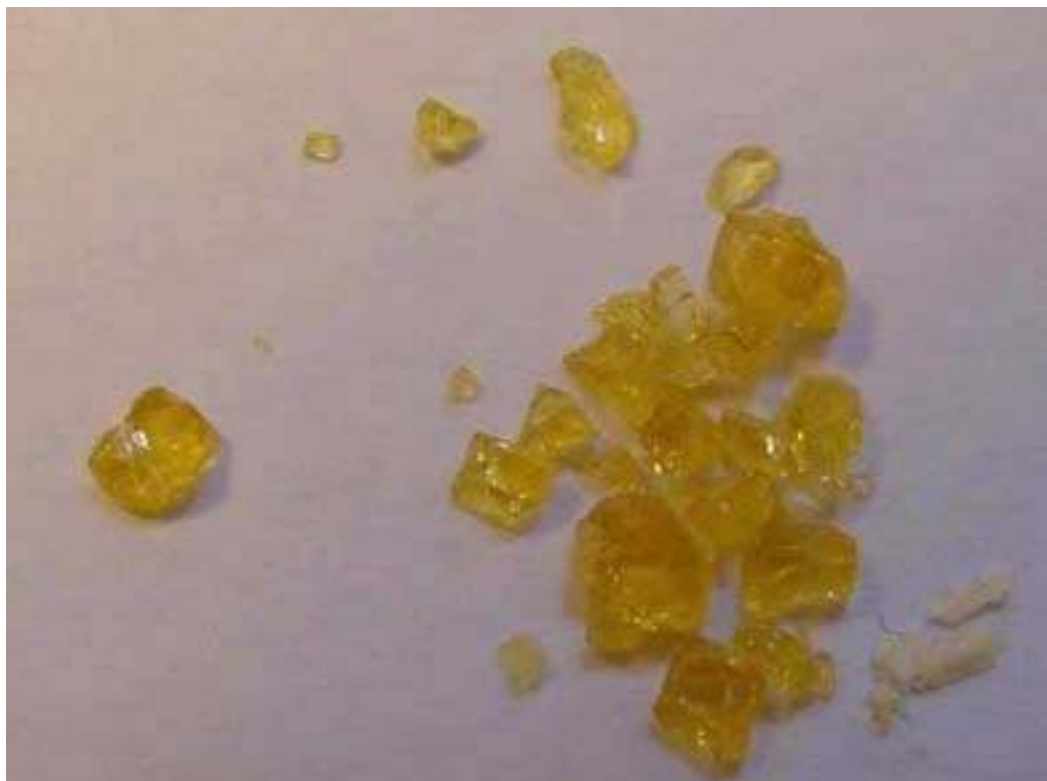
**Figure 1** Extracted calcium sulphonate
