DESIGN AND EXPERIENCE WITH REGENERATORS FOR INDUSTRIAL GAS TURBINES

ABSTRACT

This paper describes the present base load gas turbine regenerator. Covered herein are the basic design parameters, the actual physical configurations of these units along with considerable construction detail, and the service experience covering the eleven years of its existence. The evolution of the design is described.

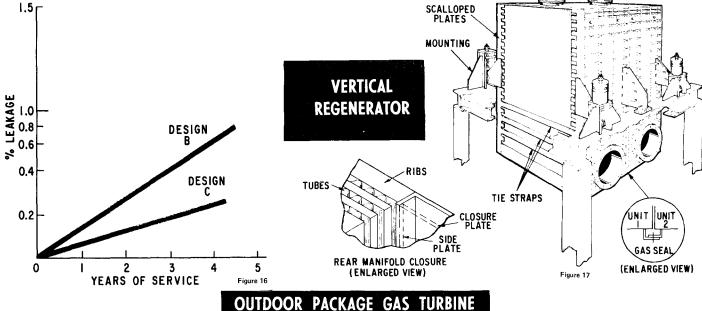
AIR LEAKAGE vs POWER OUTPUT & EFFICIENCY

If the units can be maintained at 100% capacity with the proper repair technics, then the leakage becomes the prime method of determining when unit service is necessary. The first warning of excessive leakage would be output. Slide 15 shows the effect of leakage on both output and thermal efficiency. If a machine is running properly, there is no reason to pressure test the regenerator. If, however, an unexplained loss of performance occurs, leakage is a prime suspect. Testing of the unit is done by breaking the combustion air piping at the regenerator flanges, capping the regenerator flanges and pressurizing the unit.

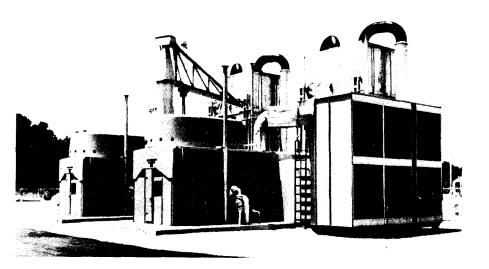
In 1957, Harrison Radiator Division constructed the first Model TR regenerator. This unit was installed at Alexandria, La. at a Tennessee Gas Transmission Company compressor station. In 1969 this unit will have 100,000 hours of operation. Since 1957, Harrison has manufactured over 75 regenerators which to date have accumulated over 1,000,000 hours of service.

NUMBER OF TUBES	PERCENT OF TUBES	4 –
YEAR	PLACED IN SERVICE	OPERATIONAL 1-1-69	1
1957	440	97.50	
58	2200	96.14	REDUCTION,%
61	1320	99.17	Z
62	1188	100	Ĕ 2
63	1700	100	<u>'</u>
64	1360	100	Ō
65	1020	99.41	i ⊒
66	6600	100	
67	3520	100	
68	2352	100	0
		AVG. = 99.22 % Figure 14	-
