Design Of A Laboratory Set-up For Evaluating Structural Strength Of Deteriorated Concrete Sewer Pipes

Nikola STANIĆ^{1*}, Theo SALET^{2,3}, Jeroen LANGEVELD^{1,4} and François CLEMENS^{1,5}

¹ Delft University of Technology, PO Box 5048, 2600 GA Delft, The Netherlands

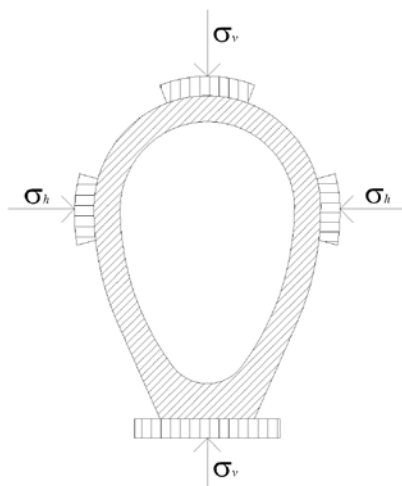
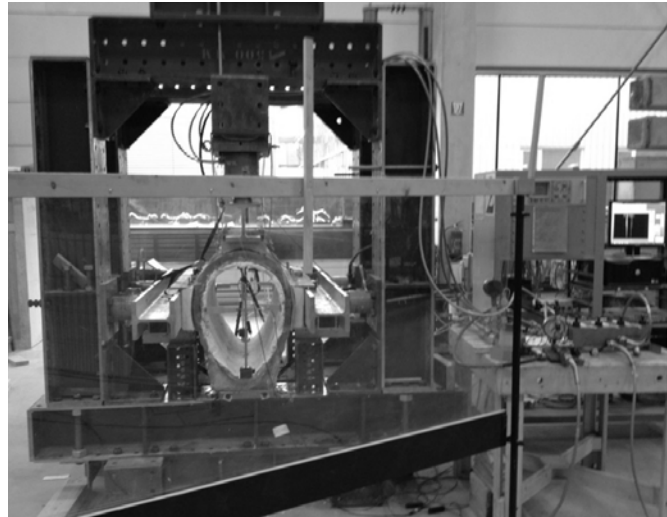
Figure 1. The schematic diagram of adopted experiment principle (left) and actual experimental setup (right).

In the setup design hypothetical soil properties were assumed (Young's modulus $E = 80$ MPa, Poisson's ratio $\nu = 0.25$, angle of internal friction $\phi = 40^\circ$, angle of dilatancy $\psi = \phi/4$, cohesion $c = 0$, and unit weight $\gamma = 18$ kN/m³) (Brachman *et al.* 2000). Further, horizontal stresses are expressed as $K\sigma_v$, where $K = \nu/(1 - \nu) = 0.33$ is the coefficient of lateral earth pressure. This is a laboratory idealization of field conditions. The applied experiment principle is shown in Figure 1 (left).

Design. The experimental setup (Figure 1, right) consists of a test cell (steel frame/beams) and a concrete, egg shaped sewer pipe. Applying a uniformly distributed pressure at the crown of the pipe may reasonably represent the vertical stress from the weight of the overburden material. As a reaction vertical stresses are present at the invert level of the pipe. Horizontal stresses could be simulated in a similar manner by applying lateral pressures equivalent to the horizontal stresses generated in the field. The pipe was stressed using a system of oil pressure jacks and steel beams. In order to achieve a uniform distribution of stresses plaster moulds of pipe and soft boards were attached to the steel beams. The size of the load bearing plates is 1.5 time of the pipe thickness. The tests were carried out at a loading rate of 10 kN/min. Sewer pipes were loaded in the set-up till the point of the pipe collapse. Vertical and horizontal load were measured together with their front and back vertical/horizontal displacements.

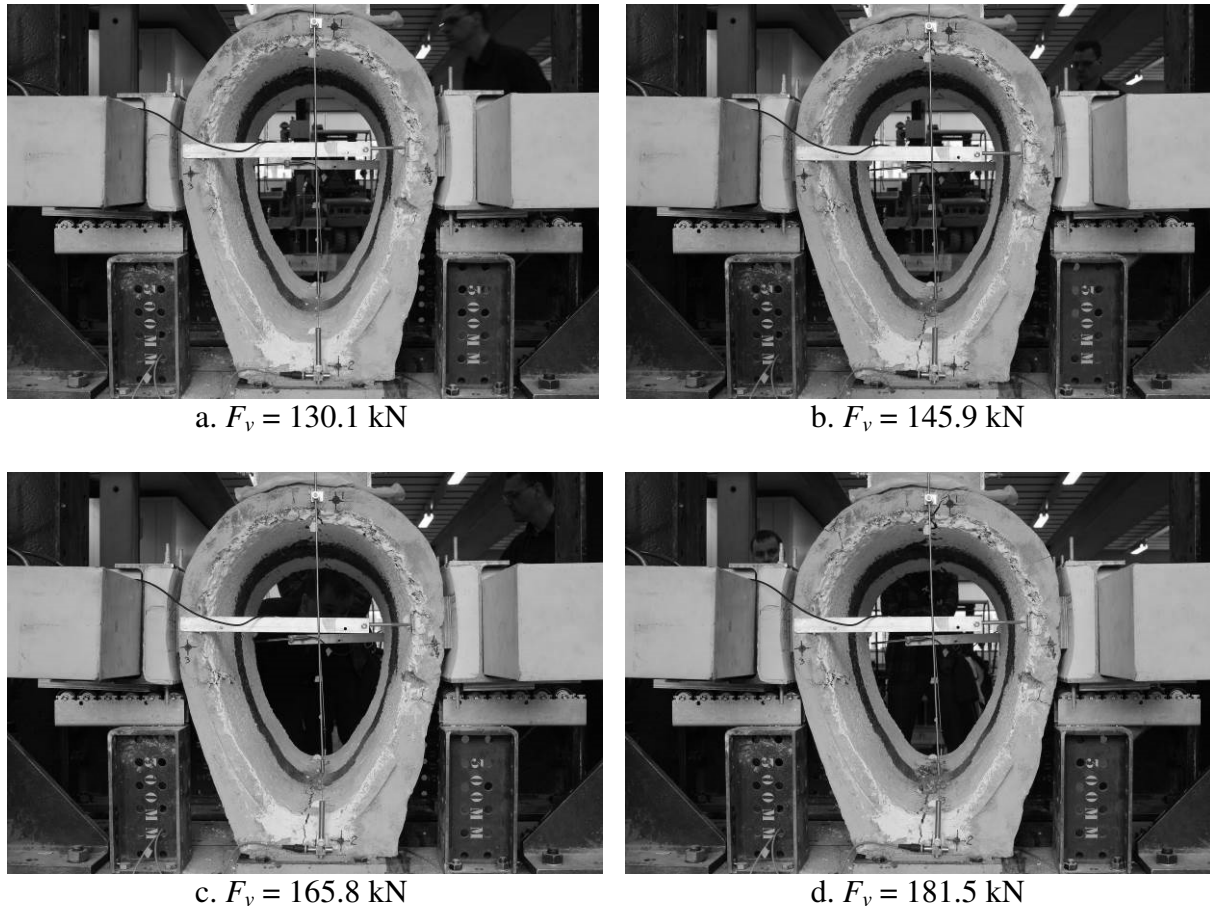
Figure 2. Successive stages in the test of a sewer pipe from Municipality of The Hague during the experiment.

For all pipes cracks appeared at the same location suggesting that the distribution of stresses through the pipes during the tests was the same. The first crack always appeared at the pipe invert level, followed by cracks at the pipe crown area and one on each side (Figure 2). It was followed by the crack at crown of the pipe and further by cracks on both sides of the pipe.

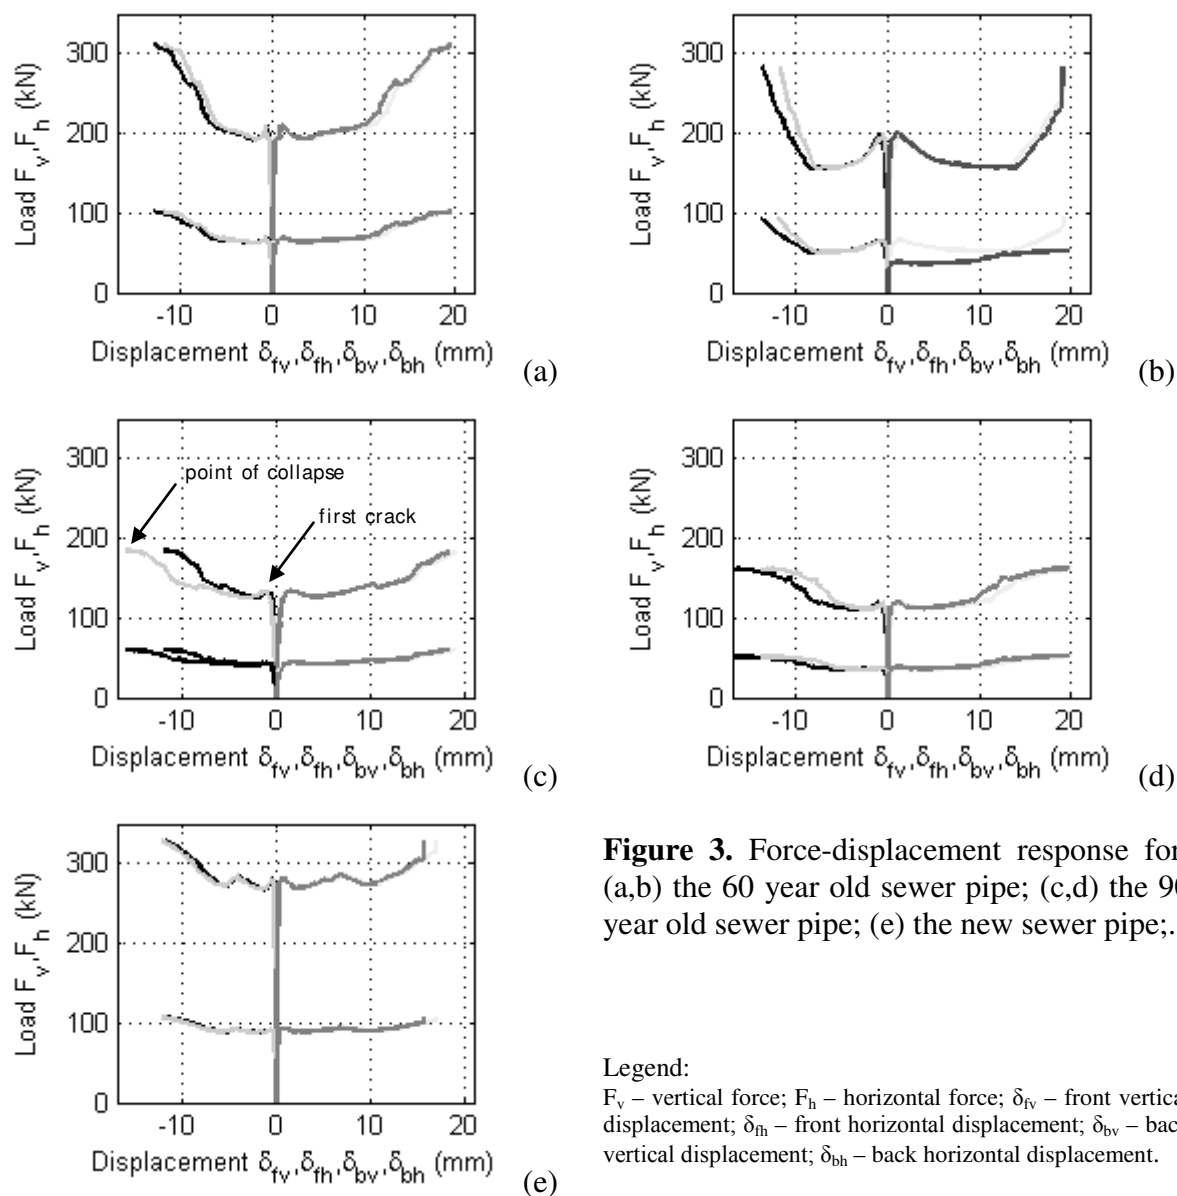
Figure 3. Force-displacement response for; (a,b) the 60 year old sewer pipe; (c,d) the 90 year old sewer pipe; (e) the new sewer pipe;.

Figure 3 shows load-displacement response for the studied pipes. The results show clearly the regions of crack formation and points of the pipe collapse. Major cracks on the new pipe appeared at the vertical load, $F_v = 280$ kN. The major cracks on the 60 and 90 year old pipes appeared at around 25% and around 55% smaller load. With an increase of the load, however, the pipes resisted collapse due to the combination of vertical and horizontal loads.

Test results showed that the new pipe was able to withstand a load up to 330 kN. Also, results showed that the 60 year old pipes could withstand almost the same amount of load, $F_v = 315$ kN and $F_v = 290$ kN. In contrast, the 90 year old pipes could withstand a load up to 185 kN and 162 kN (around 40% less stress). This implies that pipes, that are considered old (60 year old), can withstand similar loads as a new pipe. Consequently, when considering all these results, it could be regarded that pipe age, the main information source in deciding upon sewer system renewal (van Riel *et al.* 2014), is unreliable. Furthermore, from the results it can be seen that the first cracks occurred with displacement of about 0.6 mm, and that the pipes reach the point of collapse with displacements between 13 and 19 mm.

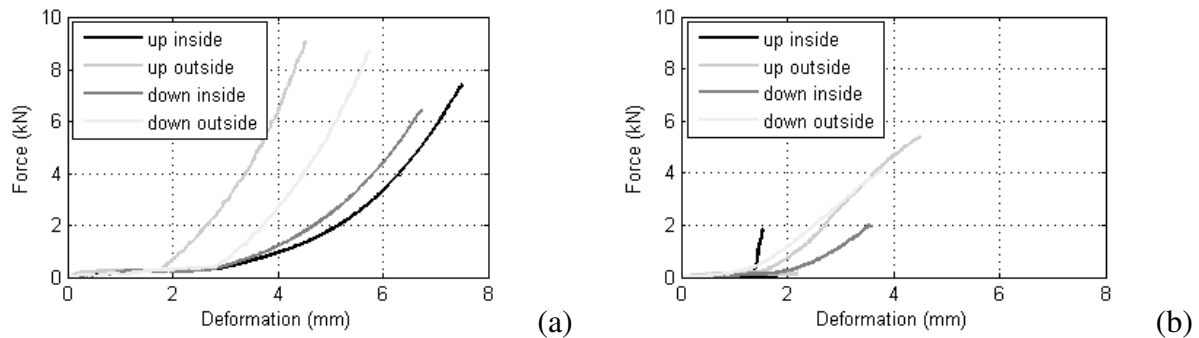
Figure 4. The four-pint flexural test force-deformation response for; (a) the new sewer pipe; (b) the 60 year old sewer pipe.

Figure 4 shows the four-point flexural tests results from the accompanying research by Stanić *et al.* (in preparation) that contributes to better understanding of structural status. The tests have been performed in order to get a first impression whether or not the structural properties of the concrete are still homogeneous over the thickness of a wall. The four-point flexural tests were carried out on rectangular samples (with dimension of 105 mm x 62-75 mm x 480 mm) taken from the upper and lower part of broken pieces of the pipes. Results showed that

there is no consistency between the experimental results for the new pipe and the 90 year old sewer pipe. This can be explained by the fact that the tested beams were not completely rectangular due to the shape of the pipes. In addition to the irregular shaped beams, the 90 old pipe did not deteriorate uniformly, thus making these results more inconsistent. Furthermore, the initial quality of the concrete is not the same for the studied sewer pipes. There is no recorded information on the quality of the studied old concrete sewer pipes.
