Research Report 348

DETECTING STRUCTURAL HEAT LOSSES
WITH MOBILE INFRARED THERMOGRAPHY
Part III—Survey of USA CRREL

R.H. Munis, R.H. Berger, S.J. Marshall, M.A. Bush

December 1975

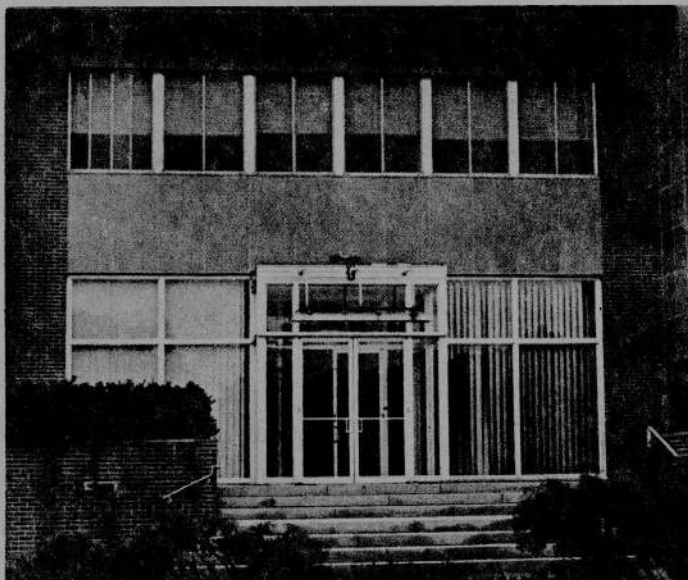
Daylight, Conventional Photograph

Nighttime, Thermogram

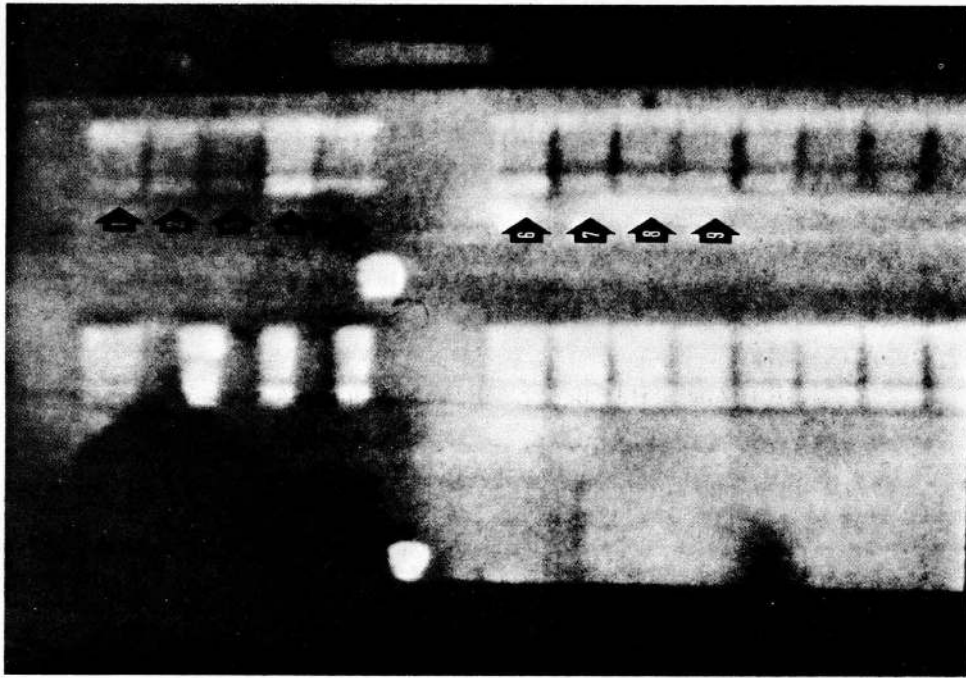
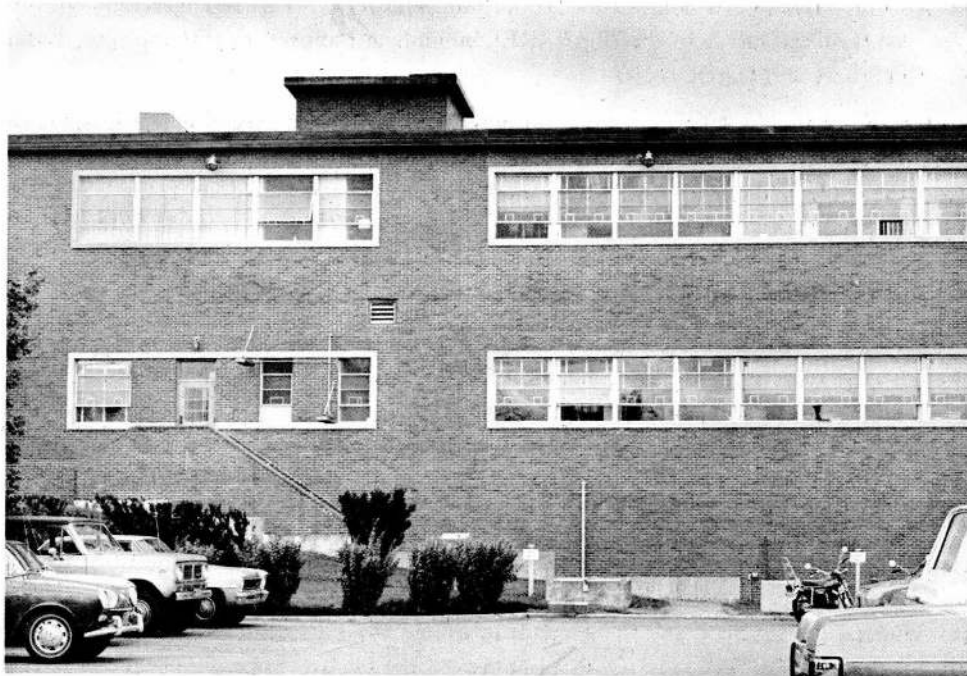
Figure 1 shows the thermogram and regular picture of the northeast side of the USACRREL building. The thermogram was taken on 13 February 1974 at approximately 2200 hours. The ambient temperature was 36°F and the wind (as measured at a station located at USACRREL) was from the south at 2 mph. The large white spot between the two rows of windows shows heat flowing out of an open vent. An interesting qualitative comparison of the relative heat flow (white to black contrast) from the five second floor windows located at the east corner of the building can be noted. Windows 1-3 are fitted with a pair of heavy drapes with a separate liner between the windows

Figure 1. Northeast side of USACRREL building. Windows are numbered to distinguish differences in heat loss. (See text.)

and the drapes, while window 6 has venetian blinds (pulled down), and windows 4 and 5 have neither blinds nor drapes. Notice that there is relatively more heat (whiter contrast) emanating from the top panes of windows 4-6 than there is from the top panes of windows 1-3. The remaining windows (all fitted with venetian blinds) on the second floor show this same pattern, indicating a rather uniform stratification of warm air near the ceiling in all the rooms in which these windows are situated. While this stratification is somewhat evident at the top panes of windows 1-3, it is obvious that the

drrape-liner combination does retard a noticeable amount of heat in comparison with the venetian blinds. However, in comparing windows 4 and 5 with those fitted with venetian blinds, it is obvious that the venetian blinds retard little if any of this layer of warm air near the ceiling from reaching the window surface.

Careful observation of window 6 shows heat escaping all along the left side of the window (top to bottom); this seems to indicate that there is a heat leak along the glass to metal casement joint or along the mortar to metal casement joint. Figure 2 shows a typical window at the USACRREL building. It is interesting to note that window 6 is the only one of the 24 windows shown in the Figure 1 thermogram that has a rather bad heat leak around the metal casement, indicating a direct flow of air from inside to outside. The top horizontal casement member on all the windows seems to be warmer than the lower casement member and the lower part of the vertical members, indicating that conductivity through these top horizontal members is being generated by the temperature gradient between this layer of warm air near the ceiling and the outside air.

The large bright area beneath window 6 is the heat from the radiator which has reached the outside surface of the building. The bright zone beneath windows 7, 8 and 9 indicates the presence of a radiator at that location. The bright spot beneath the window directly below window 6 likewise indicates the presence of a radiator. Also, the bright region below and to the left of this window indicates heat being transmitted through the wall at that location. At the edge of this bright region (arrows) is located (inside of the building) a wall separating the two rooms.

The relatively bright appearance of the lower row of windows (compared with the top row) would perhaps lead one to believe that abnormal heat leakage is occurring through these windows. However, the real reason for this high apparent heat loss is that during the survey of the USACRREL building the first floor room temperatures were consistently significantly higher than the second floor room temperatures. The Figure 1 thermogram illustrates one of several reasons that the

The heat loss survey of the USACRREL building showed a number of locations where heat was being lost that could be conserved if corrective actions were taken. Since almost all of the windows are single panes, corrective action needed to be taken to provide an additional insulating layer over the single panes. (As a result of this research it was decided that the most cost-effective approach in the interim was to put sheets of plastic over the inside window frames on the north side of the building.) The thermographic analysis also showed that in a number of places heat from the wall-mounted radiators was being lost by conduction through the masonry wall. This situation could be corrected by placing metal reflectors behind the radiators (but insulated from the wall).

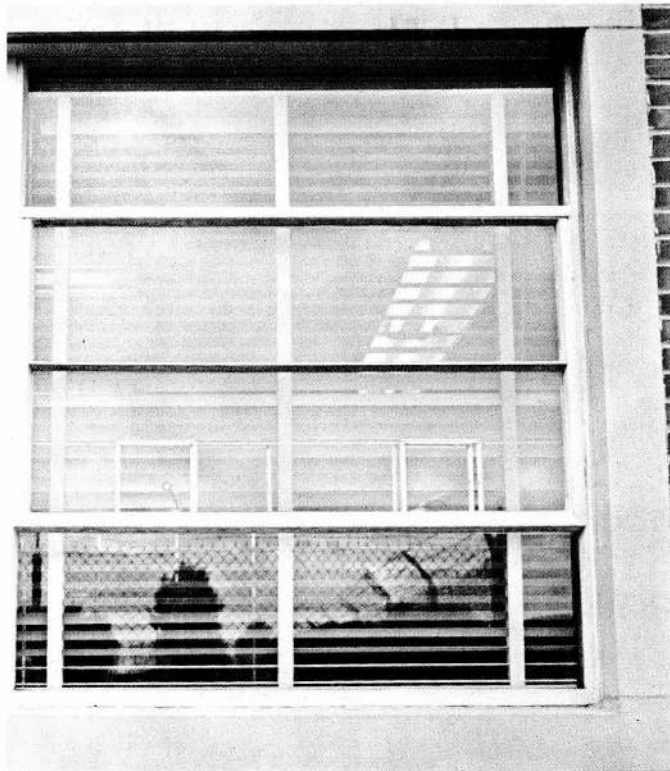
Figure 2. Typical window at USACRREL.

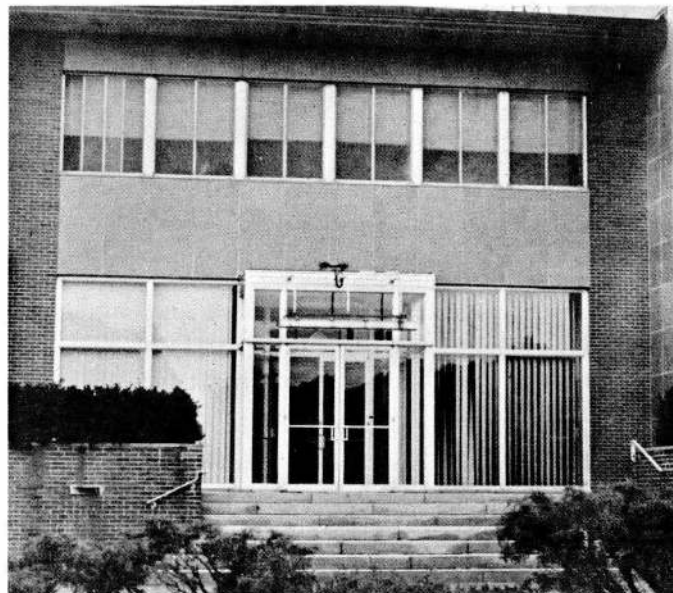
Figure 3. Main entrance of USACRREL building. Black horizontal arrows point to south-facing slate wall. White horizontal arrows point to east-facing slate wall. Each of six vertical arrows points to window with an installed storm sash.

Figure 3 shows the thermogram and regular picture of the front entrance of the USACRREL building. The most obvious heat loss (two bright rectangles) in this thermogram is through the single panes of glass in the two large windows of the lobby. Again it must be emphasized that a significant amount of this heat loss is due to the higher than normal lobby temperature which was recorded on the evening that the thermogram was taken. However, as can be seen from the dark zone between the two bright rectangles, there is a distinct advantage in having a foyer (which can act as an air lock) leading into a building. Because of the insulating value of the airspace in the foyer, the heat flow at this location is approximately only one-fourth of that occurring through each large window.

In the same manner, the added value of storm windows is illustrated in Figure 3 (six vertical arrows). Each arrow points approximately to the bottom of a window which has a storm sash installed. Comparison of the white-black contrast at this location with that observed at the foyer indicates that the insulation effectiveness of a storm window is comparable to that of the foyer.

The large bright area (horizontal black arrows) to the right and above the lobby windows illustrates another important point regarding thermographic analysis. The black arrows point to the relatively warm south-facing slate wall of the auditorium-library extension, while the vertical white arrows

point to the cool east-facing slate wall. One might immediately conclude that all of this heat is escaping through the wall from the inside. However, several factors must be taken into consideration before a final conclusion can be reached. When this thermogram was taken (2100 hours), the air temperature was 36°F. Although the sky had been overcast part of the day, there had been a few hours of sunshine during both morning and afternoon. The combination of solar heating of the slate, an abnormally warm air temperature, the protected exposure of the south-facing wall, and a low wind velocity (southerly at 2 mph) serves to explain why the south-facing wall of this extension is warmer than the east-facing wall.

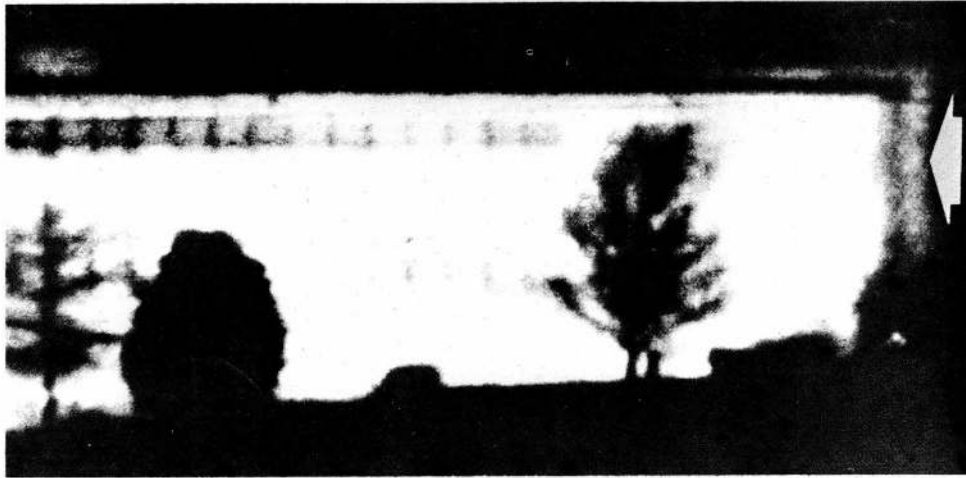
Figure 4. South side of USACRREL building. Thermogram taken at 2100 hours, 13 February 1974. Arrows point to south-facing slate wall.

Additional evidence of the effect of solar heating can be seen by comparing the white-black contrast of Figure 4 (south exposure of USACRREL) with that of Figure 1 (northeast exposure). Both thermograms were taken about an hour apart. As can be seen from Figure 4, the entire brick wall is white, indicating the rather uniform retention (and decay) of solar radiation. Some of the radiation from the south-facing slate wall of the library-auditorium extension can be seen in this thermogram (arrow). Figure 5 shows a thermogram of the south exposure taken at 1600 hours on 21 February 1974. The air temperature was 46°F and the wind velocity was northwesterly at 10 mph at the time that this thermogram was taken. A considerable amount of incoming solar radiation during

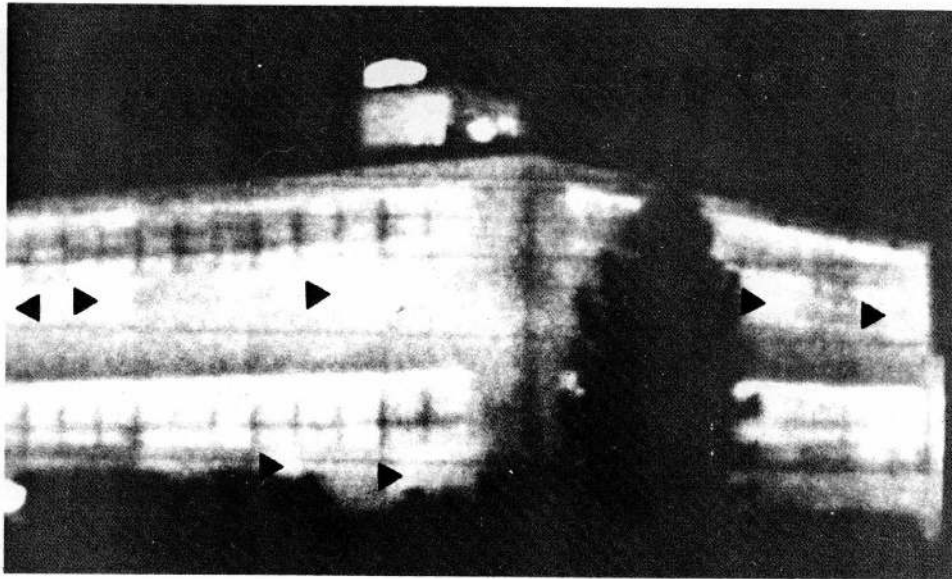
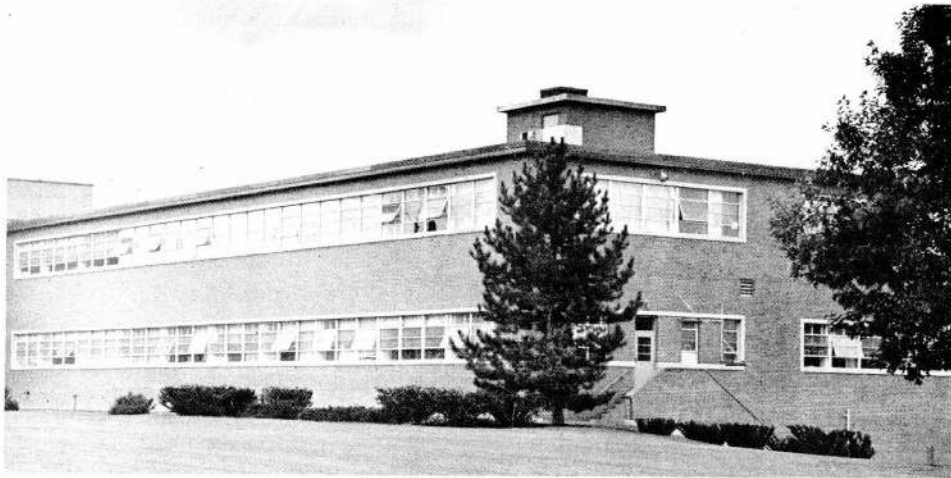
Figure 6. Northeast corner of USACRREL building. Arrows point to wall surface heated by radiators.

Figure 6 shows the thermogram and regular picture of the northeast corner of the building. Arrows point to locations of outside wall surface heated by radiators mounted on the wall directly behind these heated areas.

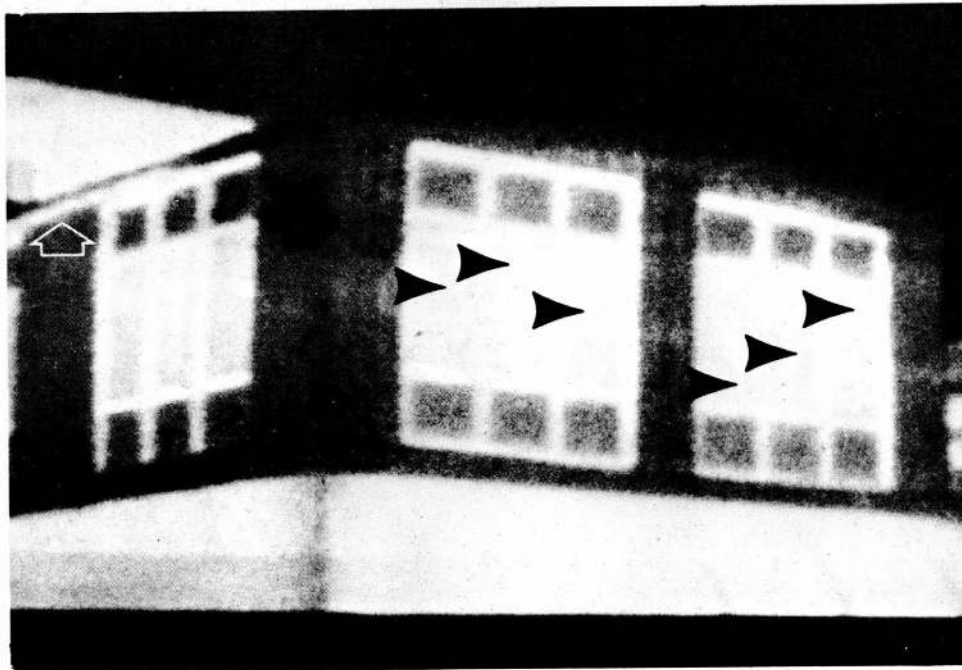
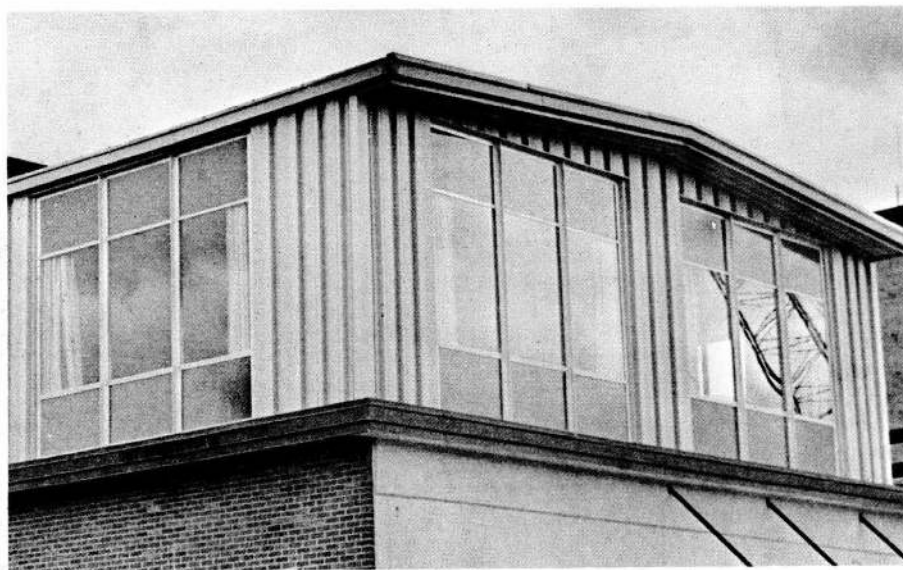
Figure 7 shows the thermogram and regular picture of the northwest corner of the cafeteria. One noticeable path of heat loss is through the metal window frames (vertical and horizontal white lines). Since metal has a relatively low emissivity, these frames should appear dark (cool) if there is no heat loss through them. However, since there is no insulation between the inside and outside frames, conductivity carries the heat directly to the outside surface where it is lost to the air through radiation and convection. The horizontal black arrows point to insulated porcelain-enamel panels

Figure 7. Northwest corner of cafeteria addition (metal building). Black arrows point to insulated porcelain-enamel panels. White arrow points to location of heat leak at roof-wall joint of metal building.

($1\frac{5}{8}$ in. thick) consisting of a sandwich fabrication. Notice that the surfaces of these panels are considerably cooler than the surfaces of the window glass (white rectangles) in spite of the fact that the drapes were drawn at the time this thermogram was taken. However, since these drapes are translucent and have no liners, their insulating effectiveness is considerably inferior to that of the drape-liner combination used in the windows shown in Figure 1.

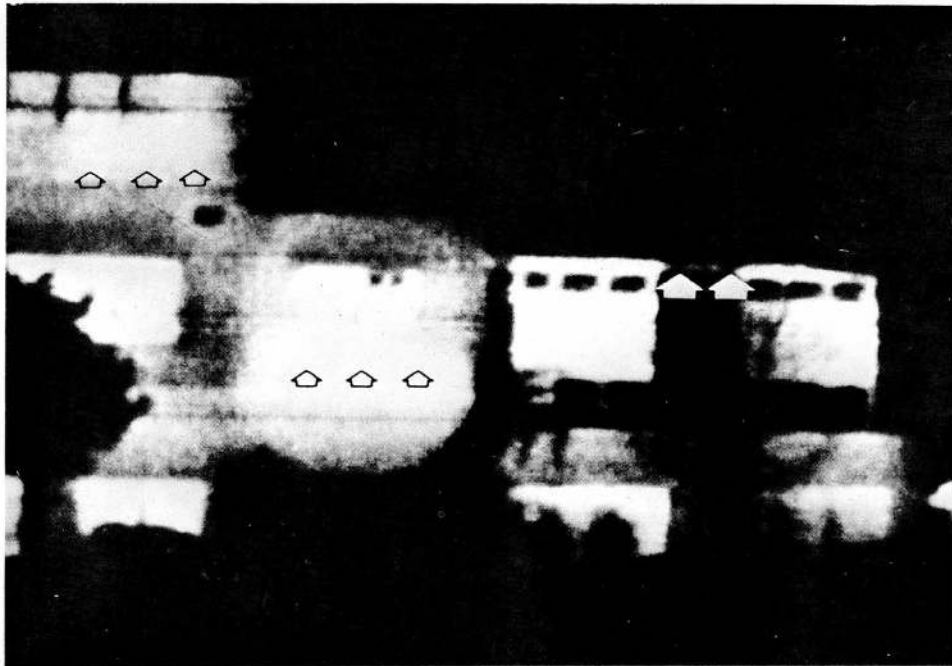
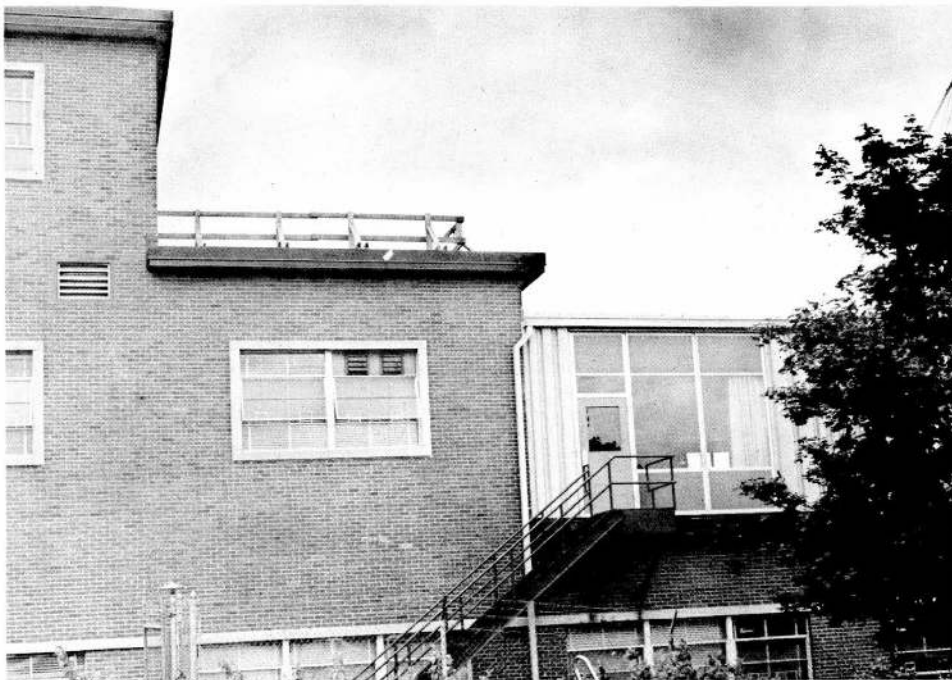
Figure 8 shows the thermogram and regular picture of the west side of the north-facing wall. The white zone (lower arrows) underneath two of the cafeteria kitchen windows indicates an excessive loss of heat at that location, attributed to a tank of hot water kept at 200°F and a section of the

Figure 8. West side of north-facing wall. Lower arrows point to heat escaping by conduction through wall of the cafeteria kitchen. Upper arrows point to heat escaping by conduction through wall of second floor office. White arrows point to location of heat leak (see Fig. 7).

room heating unit. The white zone to the upper left (upper arrows) indicates that this radiator is on and that a significant amount of the radiated heat is being conducted directly through the wall. The faint white line (white arrows) between the two large north dining area windows indicates a possible heat leak at the roof-wall joint of this metal building. Another view of this location can be seen in Figure 7 (arrow at extreme left side of thermogram).
