Detection of severe sliding and pitting fatigue wear regimes through the use of broadband acoustic emission

E D Price¹, A W Lees^{1*}, and M I Friswell²

¹School of Engineering, University of Wales Swansea, Swansea, UK

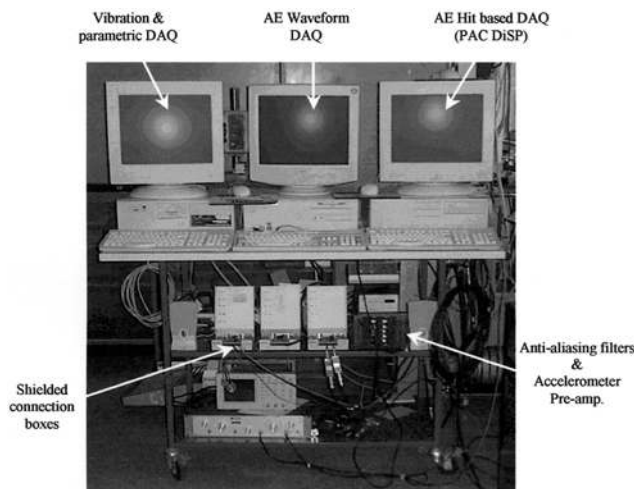
Fig. 5 Data acquisition system

The data acquisition (DAQ) system used to collect vibration and acoustic emission data consisted of three computer-based subsystems (Fig. 5). Each of the subsystems performed a dedicated task and all were externally connect together to enable synchronization. One computer was used to collect vibration and parametric data channels and two computers were used to collect AE data. A commercial system was used to collect AE hit-based data and a custom system was used to reliably store AE waveform data.

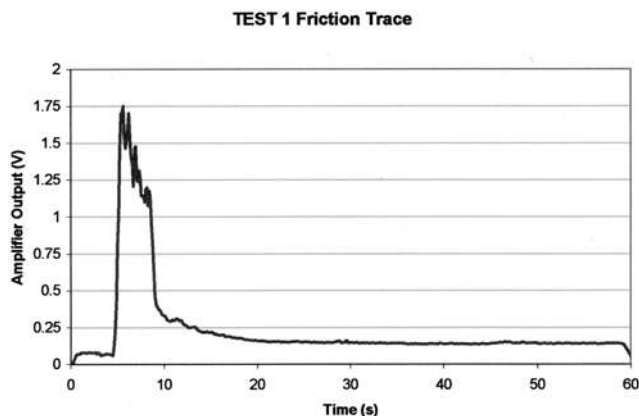
Fig. 6 Typical sliding test friction trace

At higher loads, shortly after starting the machine the lubricant film would fail, causing metal-to-metal contact. As the surfaces of the three lower balls abrade at their respective contact points, the contact area increases and thus the contact pressure decreases. Eventually the pressure falls to a level where lubricant can re-enter the contact and scuffing wear stops. Owing to the increased area of the lubricated contact, friction in the system after the seizure event is higher than before.

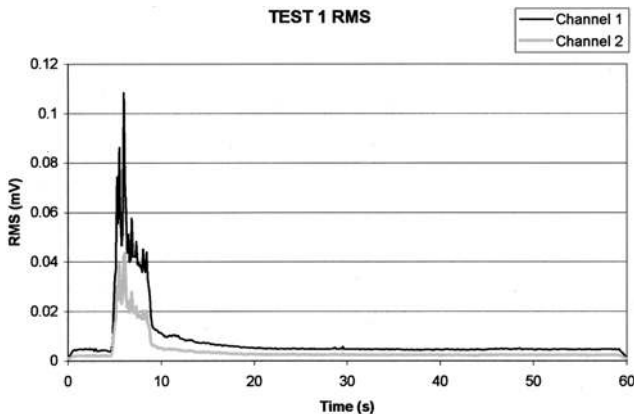
Fig. 7 Sliding test RMS results, Test 1

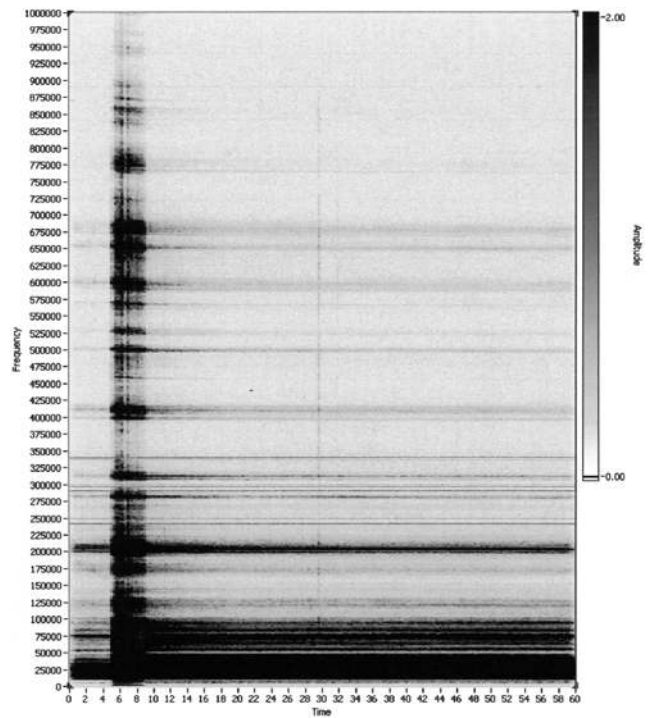
Fig. 8 Sliding test FFT results, Test 1, 0–1 MHz

Figure 8 displays the FFT results for the frequency range 0–1 MHz. Figures 9 through 11 display the same data with the axes adjusted to show zoomed views of the frequency bands 0–50 kHz, 50–150 kHz and 150–250 kHz, respectively.

Figure 8 shows the response on the sensor over its entire operating range. The seizure event, occurring between 5 s, and 9 s, is clearly visible from the

sharp increase in amplitude of all peaks. Signal amplitudes before seizure are also less than after seizure. The correlation between AE amplitude and friction is good at all peaks in the frequency plot.

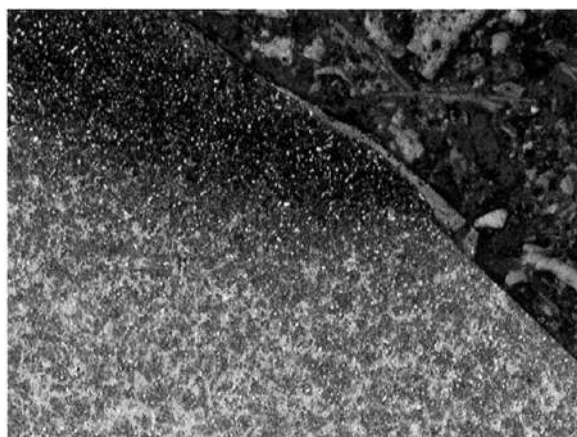
Fig. 15 Sliding test wear scar, $100\times$

through the wear scar, magnification $50\times$. Figure 15, magnification $100\times$, shows more closely the white transfer layer and deformation at the edge of the wear scar. The discolouration in the area of the wear scar could be indicative of work hardening or temperature effects, although no difference in hardness could be detected through microhardness testing.

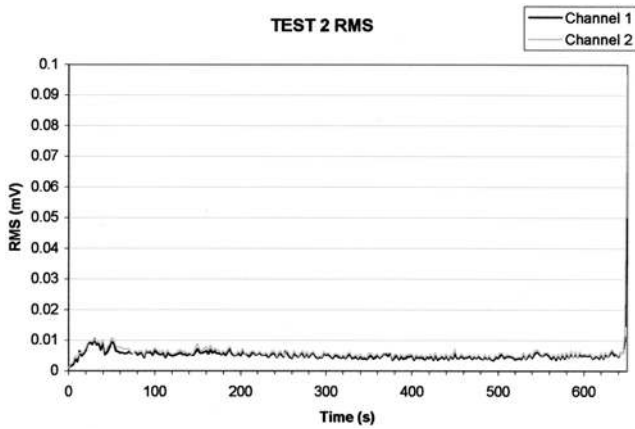
Fig. 16 Rolling test RMS results, Test 2

Figures 16 and 17 show the RMS history of the broadband AE signal. The raw waveform was digitally filtered with a pass-band between 100 and 400 kHz before further processing. RMS values for both tests steadily decrease until failure, where the values increase by an order of magnitude. The initial ramp up of values at the start of tests is consistent with machine spindle run-up and the slow addition of load, which occur at the start of each test. Although pitting can be detected using these methods, pitting cannot be predicted due to the lack of precursory events.

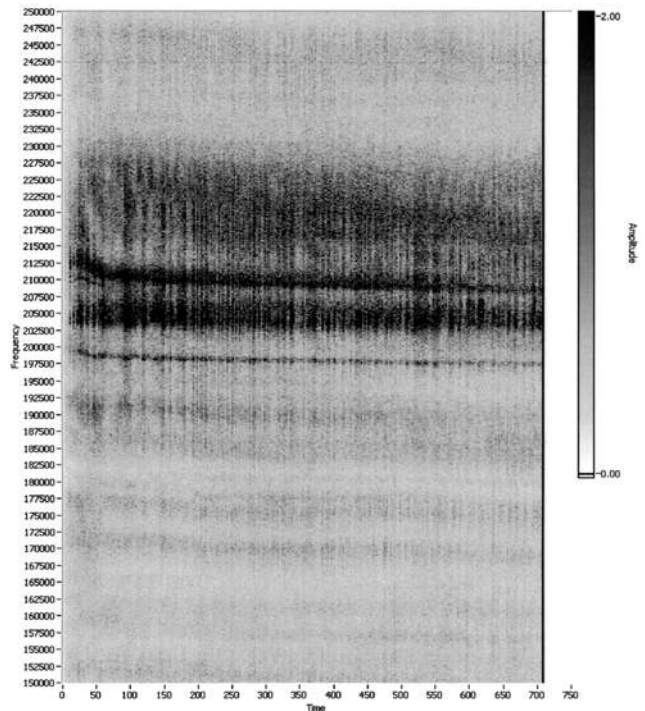
Fig. 23 Rolling test FFT results, Test 3, 150–250 kHz

The frequency content between 150 kHz and 250 kHz is similar to Test 2, except the pulsing energy is more evenly spread throughout the test.

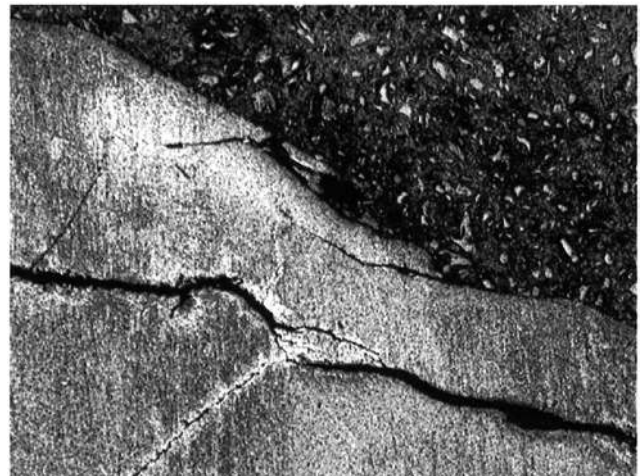
Fig. 26 Subsurface crack close to pit

After SEM analysis the sectioned balls were etched and examined optically. Figure 26 is a view of a pit taken at 50 \times magnification. With a higher magnification, two crack propagation modes are visible: intergranular and transgranular. Transgranular cracking, through grain boundaries, produces straight edges while intergranular cracking, along grain boundaries, produces jagged edges.
