DEVELOPMENT AND PRODUCTION OF SUPERCONDUCTING RESONATORS
FOR THE ARGONNE HEAVY ION LINAC

K. W. Shepard, C. H. Scheibelhut, P. Markovich,
R. Benaroya and L. M. Bollinger

Applied Superconductivity Conference
Pittsburgh, PA
September 25-27, 1978

ARGONNE NATIONAL LABORATORY, ARGONNE, ILLINOIS

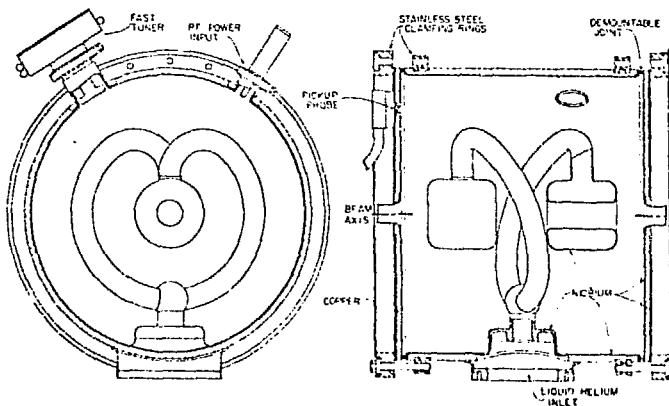
Fig. 1. The split-ring resonator. The overall length is 17 inches. The drift tube and inductive loop assembly is made of niobium, the outer housing of niobium explosively bonded to copper.

Shown in Fig. 1, the 97 MHz resonator is as previously described, and consists of an all niobium drift-tube and inductive loop assembly inside a cylindrical housing formed of niobium explosively bonded to a copper backing.^{2,3} At this writing, seven such resonators have been completed; a prototype unit currently used for beam bunching, and the first six of twelve resonators presently under construction for the linac proper.

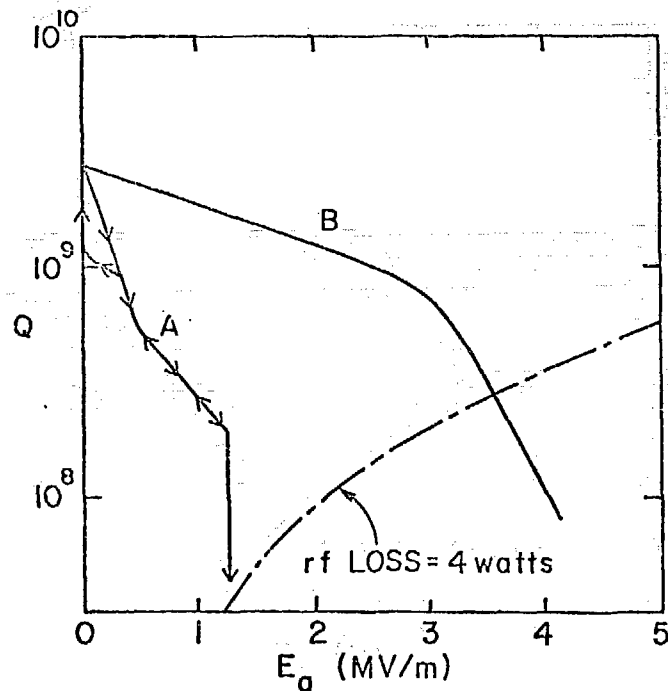
Fig. 3. Performance of the second linac resonator at 4.2K. Curve A is the result of the initial test. Curve B, the second test, performed after removing a small defect on the inductive loop.

Figure 3A shows the initial performance of the second linac resonator. The sharp decrease in Q at low field levels exhibits hysteresis, and the resonator is thermally unstable at a field level $E_a = 1.2$ MV/m. The second sound data showed a defect midway along one arm of the inductive loop. Visual examination revealed a .015 inch diameter bead of niobium within the region indicated by the second sound data. The behavior shown in Fig. 3A seems explainable in the following way. The hysteresis at low field levels is caused by the switching of the bead itself between the superconducting and normal states and indicates poor thermal contact between the bead and the resonator. The decrease in Q with increasing field level is caused by heating of the bead which increases the normal state surface resistance. At $E_a = 1.2$ MV/m the heat load into the surrounding niobium is sufficient to drive it normal and the resonator becomes unstable. Removal of the bead resulted in the performance shown in Fig. 3B.

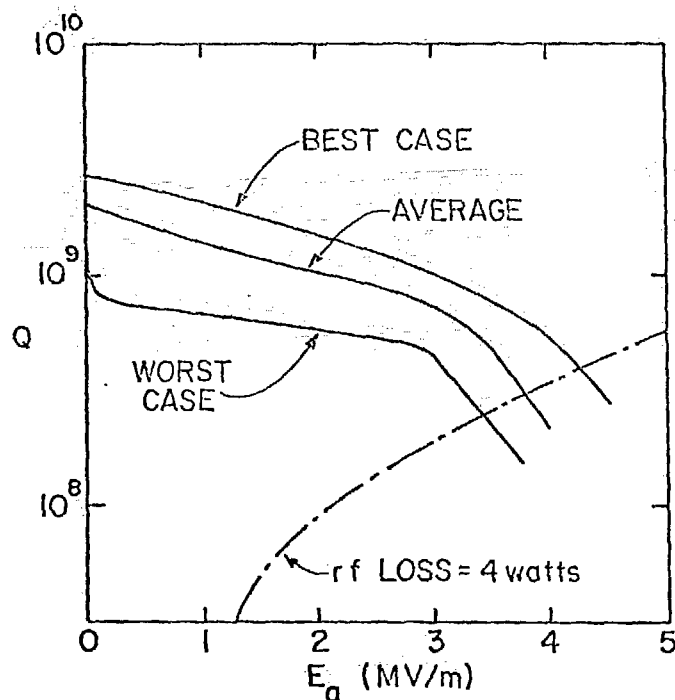
Fig. 4. Performance of the first six linac resonators at 4.2K. The accelerating field E_a is defined as the energy gain per unit charge for a synchronous particle divided by the interior length of the resonator (14 inches).

Figure 4 shows the performance at 4.2K of the six linac resonators so far completed. The average accelerating field obtained is $E_a = 3.7$ MV/m at the design rf loss of 4 W/resonator which provides an effective accelerating potential of 1.3 MV/resonator.

The fall-off in Q at high field levels is accompanied by x-ray emission indicating electron loading. The performance shown in Fig. 4 was obtained after conditioning the resonators for one hour by operating at as high a field level as possible, typically 10 to 30 W rf input, in He gas at a pressure of 2×10^{-5} torr.⁵
