DIGITAL TECHNOLOGY IN THE PROTECTION OF CULTURAL HERITAGE BAO FAN TEMPLE MURAL DIGITAL MAPPING SURVEY

KEY WORDS: Three-dimensional Laser Scanning, Mural Digital Mapping Survey, Degradation Investigation

BAO FAN TEMPLE MURAL DIGITIZATION SURVEY MAPPING PROJECT

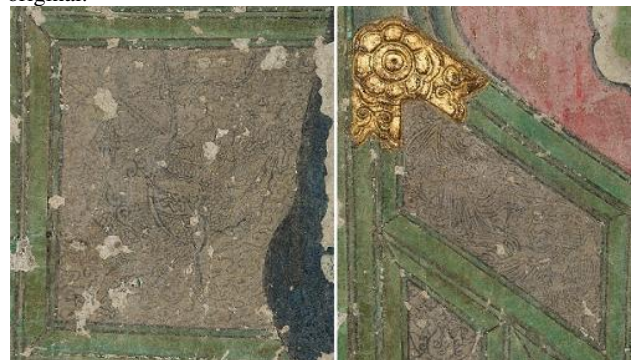
Figure 3 A10 mural image

Period one, created when the Bao Fan temple main building was constructed in Chinghua years (1465-1487), Ming dynasty. The mural is based on the Chinese couplet "*ran su zhu Luo han, tu hua xi fang jing*" describing a bodhi wonderland. Nine pre-existing mural were the product of the Ming dynasty, although the nine paintings were reconstructed, retraced, and even regilded, the mural still shows the original skills of the Ming. The survey and mapping digitized by means of high definition image recording, multi-spectral, hyper-spectral and other tech detection to show the detail of the original mural of Ming dynasty. For example as image A10, retain fine Ming style including a detailed portrayal of the Dragon and Phoenix and the Passion Flower (*passiflora caerulea*) border. Image A03 the tiger in the center bottom of the mural is drawn using the technique of a silky method to provide the illusion of a realistic coat of fur, resulting in difficulty for the artists to recreate the same affect, the differential in color is because the tiger is the original.

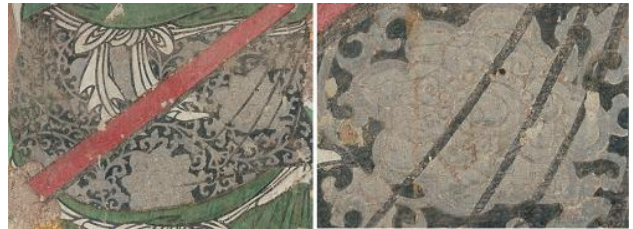
Figure 6 A03 mural image, the constructors painted the base black with white patterns

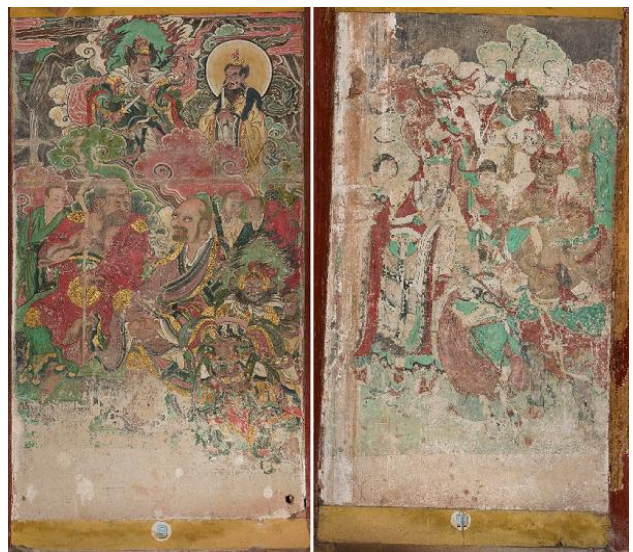
Figure 8 Image A12 (right) is part of the third period, the picture's composition and color compared to other murals (left) are quite different presenting the mural as late Qing.

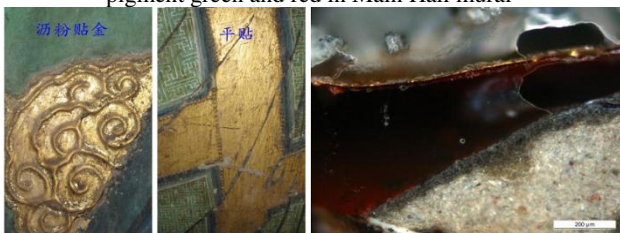
Figure 10 the microscopic cross-sectional structure of the gilding in Main Hall mural

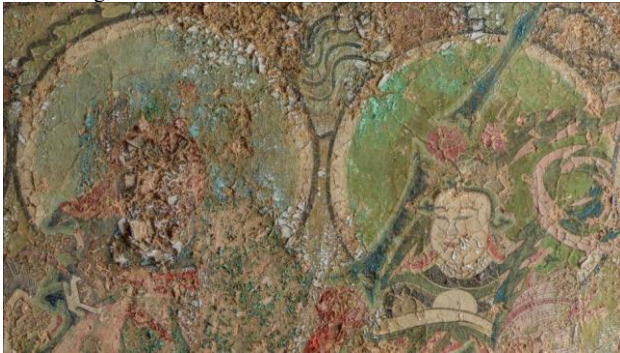
Figure 15 The degradation of mural

The digitization work we did is all for the needs of heritage protection and data collection. The collected data can be used for further monitoring and reconstruction. Using the digitization skills to recognize and provide statistics to help determine the level of degradation and the characteristics there of. Despite the focus on degradation of the murals themselves, much degradation are coming for the mural carrier. In the Main Hall mural long cracks generally appear at the same height. The root cause of these cracks is how the wall carries the mural and also the building structure related to the wall. We used a middle-distance scanner for a scan analysis of the overall wall carrying the mural. Figure 16 shows the Main Hall east wall shape changes for the four section mural. In the vertical direction as the standard plane color changing form red to blue represents a wall concavity and blue to red represents convexity changes. From the rightmost two sections, we can see that the upper part has an inward tilt of about 10 centimeter. The bottom corner of the rightmost section has a backward depression and not on the same plane with the other parts of the mural.

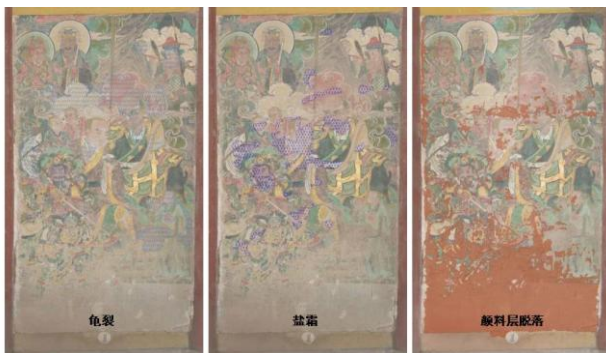
Figure 2125 degradation map of mural *yi fu fo hui*

Silhouette optical imaging is a kind of digitized tool: by emitting light from the side we can observe more subtle effects such as cracking, peeling, pigment shedding, salt formation etc. This mural depicts *yi fu fo hui* (a meeting of the gods). Its total area is 7.58 m². Cracking occupies 0.74 m² this is 9.76% of the total; salt formation occupies 0.39 m² (5.15%); pigment peeling occupies 1.83 m² (24.14%).

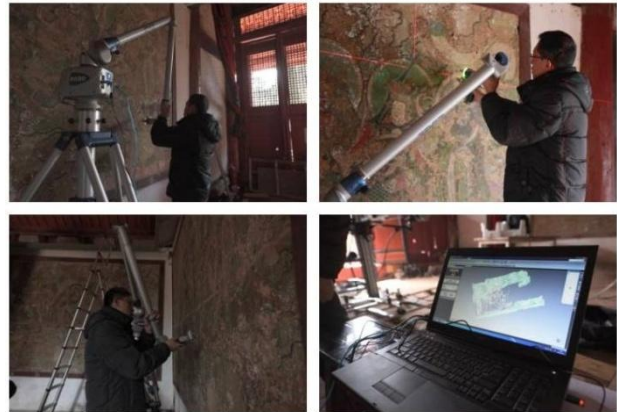
Figure 22 use arm of a laser scanner to develop a good 3D model of the mural surface

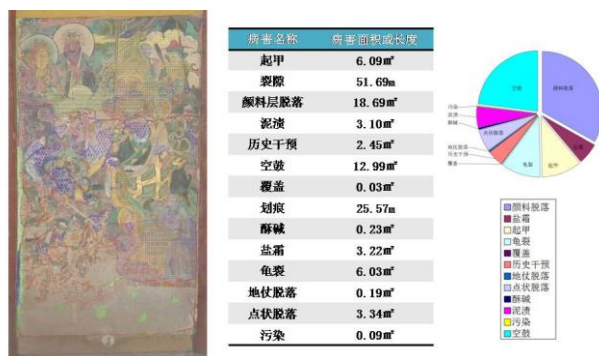
After all of this work, we now have a very detailed survey of the Bao Fan mural degradation. The Main Hall has ten sections of murals with fourteen forms of degradation and deformation. Including one-time damage such as animal damage, pigment separation, vandalism, human contact damage, nicks, water-logging, etc. Continuing degradation including changes in alkalinity, fissuring, hollowing, cracking, peeling, salt crystal formation, mud logging, etc. constitute a big threat to the murals. The most urgent threats is the structural degradation including

wall shape changes, large transverse crack formation as well as insect damage. The degradation and deformation statistics are shown in the table above.

Figure 2427 detailed survey of the Bao Fan mural degradation

We can see that continuing degradation related to the environmental humidity, and which is difficult to control, affects 16.8% of the Main Hall mural. In conclusion the next step, based on the result of the past survey mapping, is to develop a plan to prevent the mural from being destroyed any further and begin the reconstruction of the mural.
