Dissimilar underwater wet welding of HSLA steels

Abstract

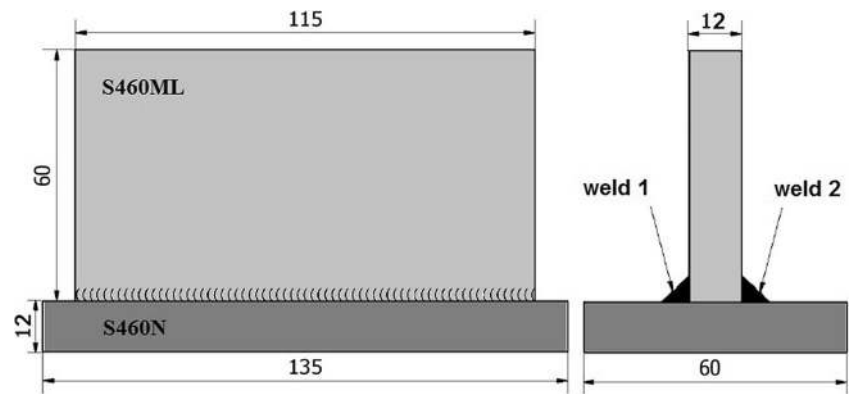
Fig. 1 Schematic view of T-joints with fillet welds

water surface to the upper surface of S460N steel) at a temperature of 20 °C. Plates from S460ML steel had a dimension of 115 × 60 mm; dimension and plates from the S460N steel had a dimension of 135 × 60 mm. The schema of T-joint is presented in Fig. 1.

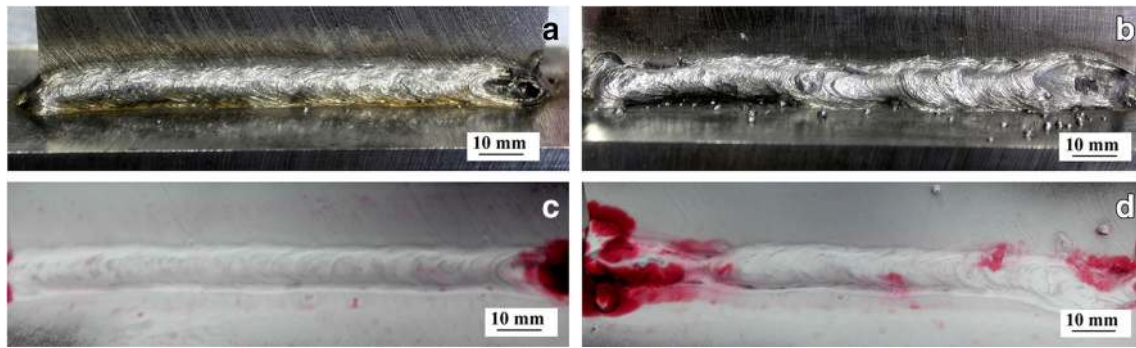
Fig. 2 Exemplanary results of the non-destructive tests. **a** VT, weld 1 from specimen 1; **b** VT, weld 1 from specimen 3; **c** PT, weld 2 from specimen 1; and **d** PT, weld 2 from specimen 2

At first, all six welds were visually tested in accordance with the EN ISO 17637:2011 standard [44]. Then, all of them were subjected to PT in accordance with EN ISO 3452-1:2013-08 standard [45]. Non-destructive tests were performed which showed some imperfections in welds prepared using the TBW technique. The most common imperfections were lack of fusion and undercut (Fig. 2b and d). These imperfections resulted from temper beads which were laid only for tempering the previous beads. Because the undercuts are classified as imperfect shape and dimension of weld, and do not affect the changes in the structure and properties of joints, all specimens were subjected to further tests. During testing, spatters was found on the surface of the specimens. In all welds, there were areas without any surface imperfection, which allowed the specimens and preparing cross-sections for further examinations. The exemplary results of the non-destructive tests are presented in Fig. 2.

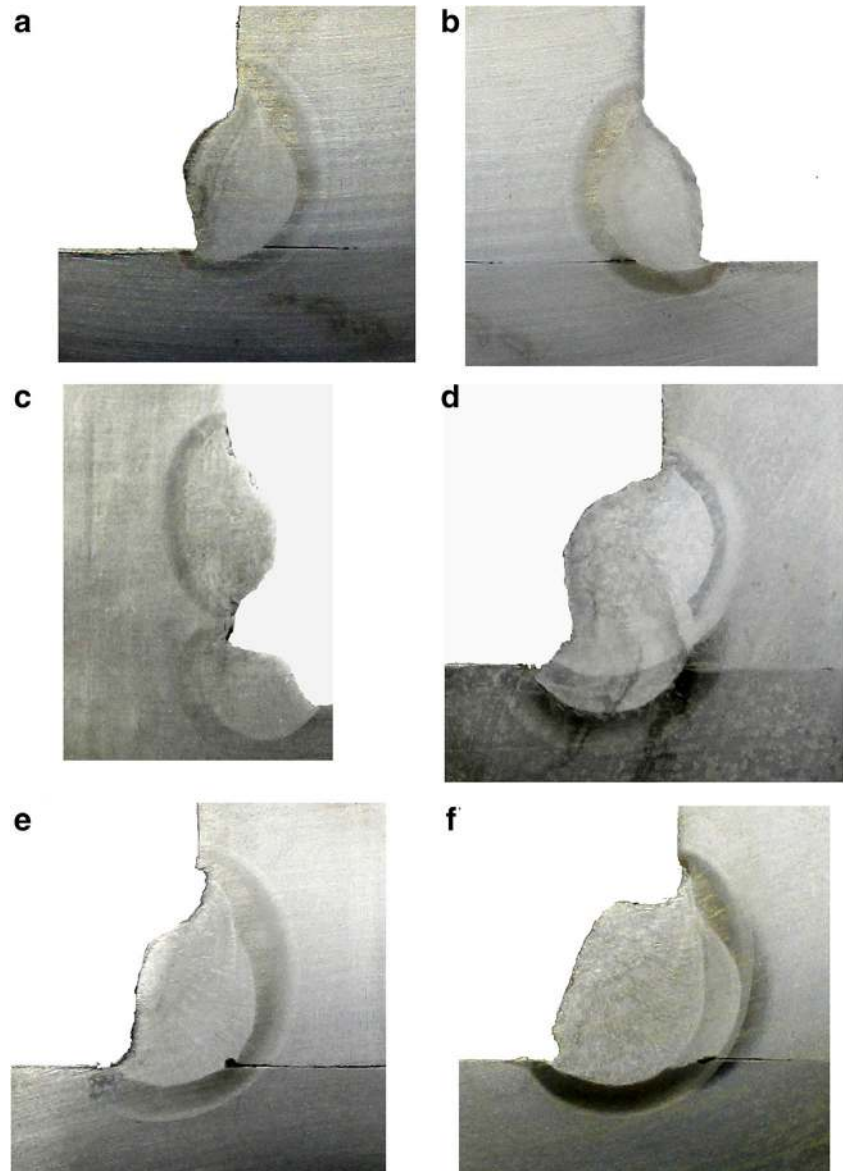
Fig. 3 Results of the macroscopic testing. **a** Weld 1 specimen 1—without TBW, **b** weld 2 specimen 1—without TBW, **c** weld 1 specimen 2—pitch 0%, **d** weld 2 specimen 2—pitch 79%, **e** weld 2 specimen 3—pitch 91%, and **f** weld 1 specimen 3—pitch 100%

Macro- and microscopic investigations were performed in accordance with EN ISO 17639:2013 standard [46]. After cutting, all the cross-sections were ground, polished, and etched with Nital (4%). The main aim of the macroscopic testing was to calculate the pitch in specimens 2 and 3. During macroscopic observations, the imperfection was seen as gas pores in both welds from specimen 1, weld 1 from specimen 2, and weld 2 from specimen 3. All these imperfections were located near the point of contact between the BMs. The used TBW technique did not affect their formation—the second weld did not cover these places. The results of the macroscopic testing are presented in Fig. 3.

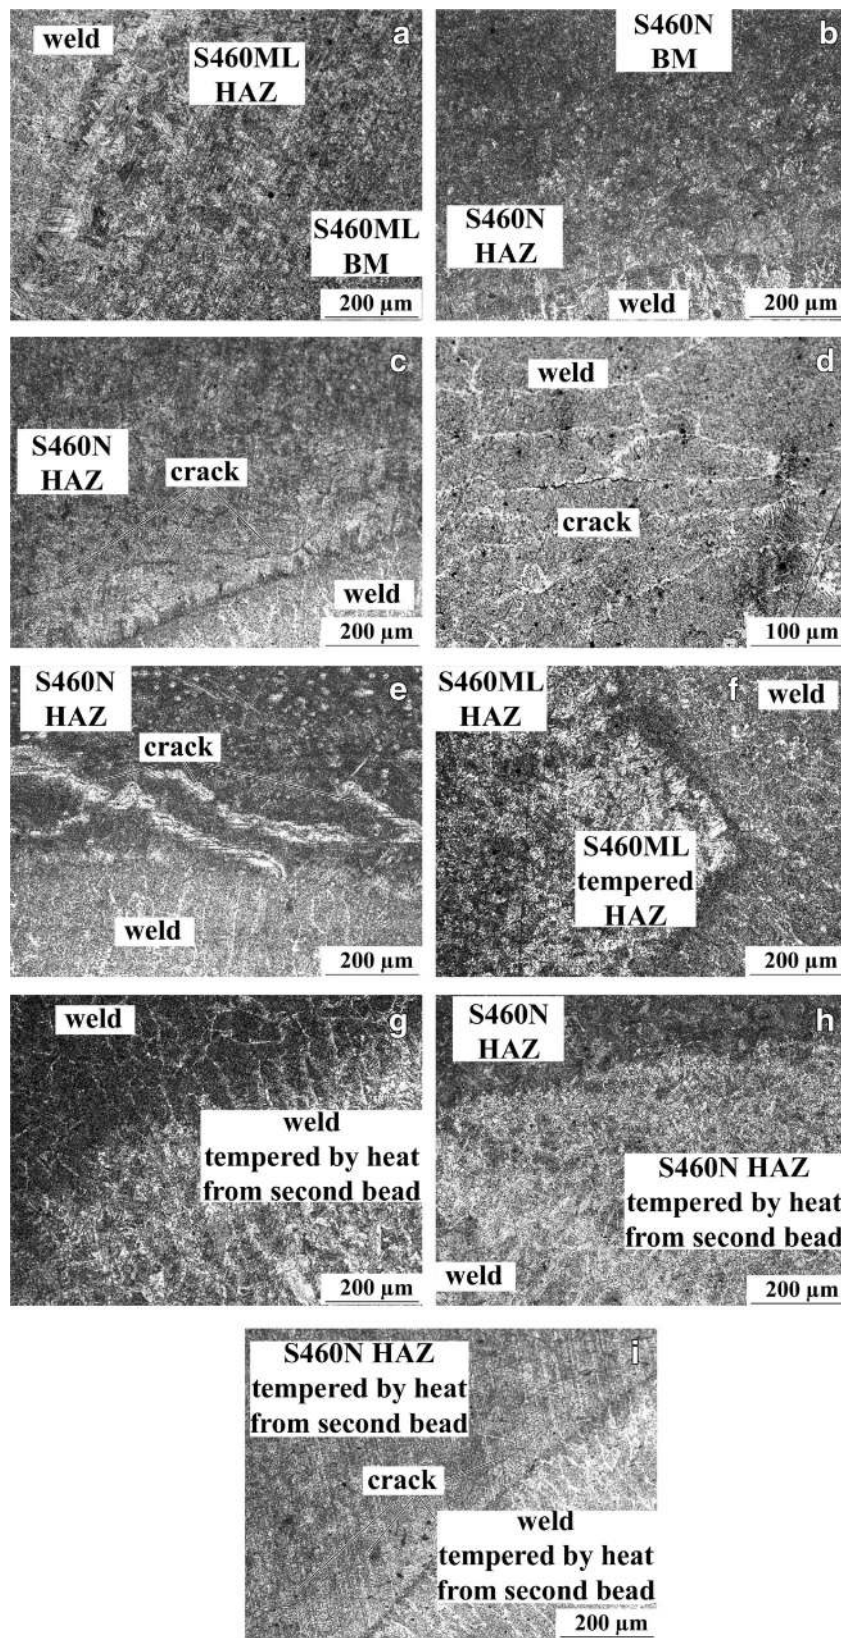
Fig. 4 Results of the microscopic tests. **a** Structure of S460ML HAZ—without TBW, **b** structure of S460N HAZ—without TBW, **c** cracks in S460N HAZ—without TBW, **d** cracks in weld material—without TBW, **e** cracks in S460N HAZ—pitch 0%, **f** tempered S460N HAZ—pitch 0%, **g** S460ML weld material tempered by heat from second bead, **h** tempered S460N HAZ that was affected by heat from second bead, and **i** cracks in S460N HAZ—pitch 91%

After macroscopic tests, the microscopic investigations were performed. The weld metal structures in specimen 1 were built of dendrites. In the specimen 1—welded without TBW technique, brittle structure such as low-carbon martensite was found in the HAZ of both steels in each welded joint. Near the fusion line the Widmannstätten structure was observed (Fig. 4a and b). In addition, in the HAZ of the S460N steel, cracks were found in weld 2, which was welded with a lower heat input (Fig. 4c). These cracks started in HAZ and propagated along approximately 80% of the length of the fusion line in the S460N steel. Cracks were also found in the weld material of the specimens in

which the TBW technique was not applied (Fig. 4d). In the case of specimens made using TBW, there was no crack in the weld materials. In weld 1 specimen 2, where the pitch was 0%, the HAZ in S460N was not changed and still presented brittle structures with cracks (Fig. 4e). The pitch was 0%; however, the HAZ from tempering bead refined and tempered the coarse-grained zone of the first bead in the S460ML steel (Fig. 4f). In the specimens with the pitch in the range of 79–100%, the tempering effect was observed in the HAZ of both the investigated materials. With an increase in the pitch, there was a decrease of grain size, which was expected in accordance with previous works [30, 31]. In the places where the HAZ of the second bead tempering the weld from the first bead, there was a partial disappearance of the structure of the dendritic base bead and the formation of a ferritic fine-grained structure (Fig. 4g). The structures in the area where the HAZ from tempering bead overlapped the HAZ of the first bead in both steels were characterized by the refined and tempered coarse-grained zone (Fig. 4h). The cracks in the HAZ of the BMs were found only in weld 2 in specimen 3 in the S460N steel (Fig. 4i). In the previous investigations [27, 30], it was found that TBW could not repair the microcracks that formed during the welding of the first bead. However, TBW could help to avoid cold cracking that might occur after welding [47, 49].

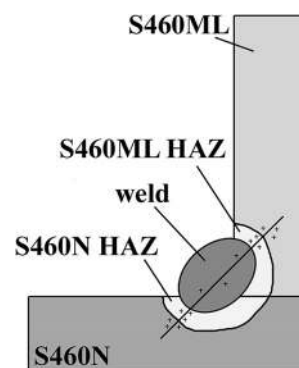
Fig. 5 Hardness point distribution for specimen welded without and with TBW technique

The hardness was measured in BM, in each HAZ, and in the weld material for each investigated weld of a specimen. The schema of distribution of hardness points is presented in Fig. 5.

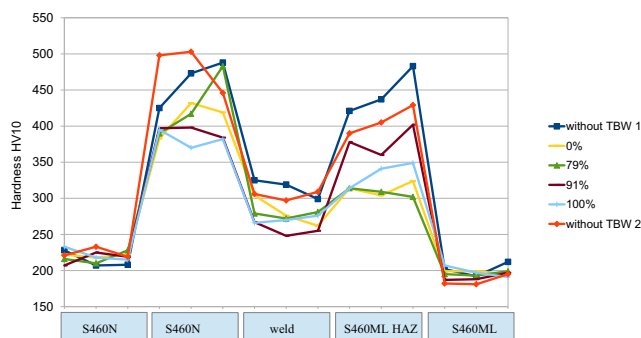
**Fig. 6** Hardness HV10 distribution for each specimen

EN ISO 15614-1:2017 standard for used steels. It was also observed that the hardness of S460N HAZ was higher than that of S460ML HAZ. In the specimen with the 0% pitch, the heat from the second bead, which was laid in S460N BM, affected the hardness of both steels. Second, HAZ was overlapping first in S460ML, and the hardness in this area decreased by 80–100 HV10 in comparison with the specimens welded without the TBW technique. In S460N HAZ, the hardness decreased by 40–80 HV10. In the next specimens, it was observed that if the pitch between two beads increased, the hardness in HAZ and weld material decreased. The best results for the investigated BMs were observed in the specimens with 100% pitch. The hardness measurements showed that the TBW technique allowed to reduce the hardness HV10 values of joints made in the water to the values lower than in specimens welded in the air [27]. Similar results were observed for welding of HSLA steel butt joints [49]. The reduction of hardness limits one of the factors adding to the initiation of cold cracks, which contributes to a reduction of cracking susceptibility.

The values of hardness in each point are presented in Table 4. The phrase “without TBW” means specimen welded without additional (tempering) bead. The specimen with “0%” pitch was welded with tempering bead. However, in the area of cutting specimen for metallographic testing, the second bead did not lay on the first one (Fig. 3c), but the heat from the second bead affects the previous laid stitch. The hardness distributions for each specimens are presented in Fig. 6.
