DIURON FROM MAUI SUGARCANE FIELD RUNOFF IS
POTENTIALLY HARMFUL TO LOCAL CORAL REEFS

Thomas C. Royer, Patricia A. Tester, and Thomas N. Stewart

Atoll Research Bulletin No. 605 ♦ 8 October 2014

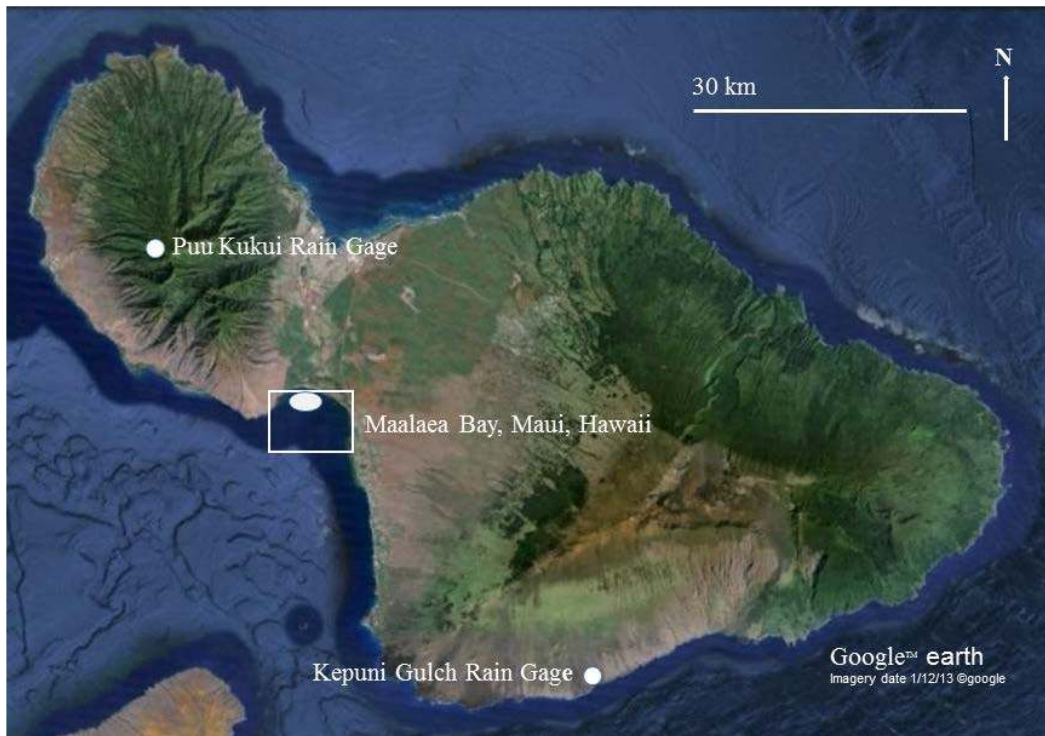
Figure 1. Maalaea Bay (square) and sampling site (oval), Maui, Hawaii, in relation to the local topography. The two rain gauges on Maui, Hawaii, are at Puu Kukui, Maui, Hawaii, in the north at 1,759 meters elevation and at Kepuni Gulch along the southwestern coast at 77.7 meters elevation (<http://hi.water.usgs.gov/recent/hawaii>). Data: LDEO-Columbia, NSF, NOAA, U.S. Navy, NGA, GEBCO. Image: Landsat. © 2014 Google.

Maalaea Bay is on the south central shore of a valley-like isthmus formed by erosional deposits from two overlapping volcanoes on Maui, Hawaii (20°44'36" N, 156°30'22" W) (Kyselka and Lanterman, 1980). The older, northwestern volcano is Puu Kukui (1,759 m). Haleakala is to the southeast, rising to 2,000 m (Figure 1). Maui's climate is characterized by annual wet and dry seasons, dominant trade winds from the north-northeast and marked geographic differences in rainfall related to topography. Maalaea Bay is on the leeward side of Maui and somewhat shielded from the trade winds. It is in the rain shadow of the mountains and experiences dry conditions except for sporadic showers associated with ephemeral frontal systems. Maalaea Harbor is at the northwestern-most part of the bay and separated from the coastal water flow from the south by a breakwater.

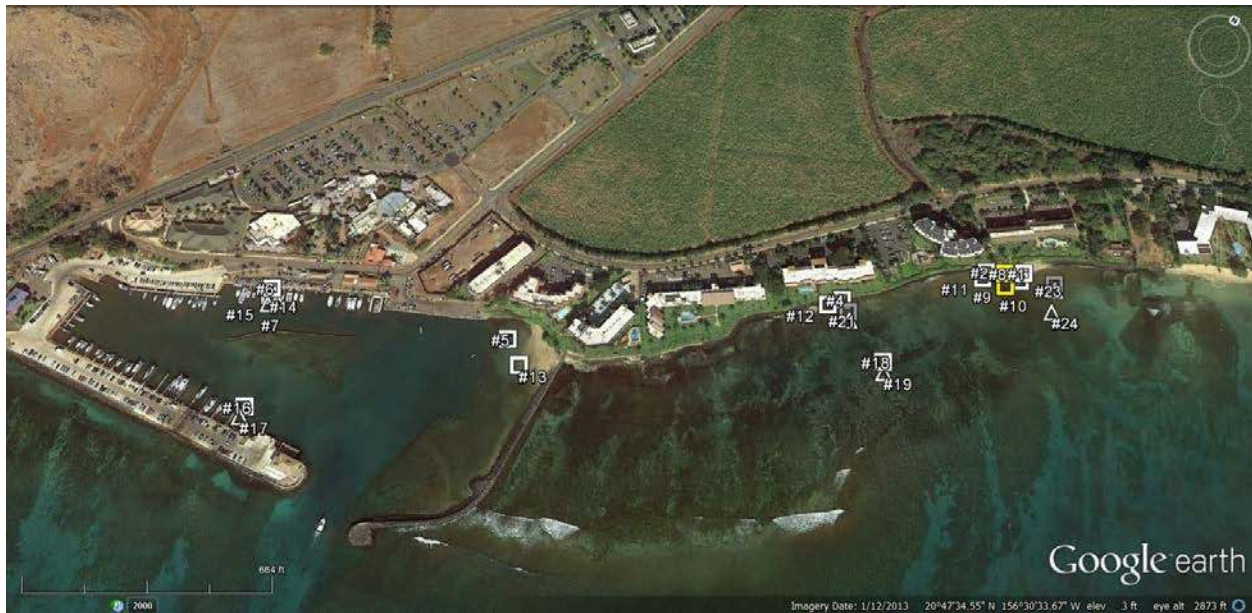
Figure 2. Sampling locations along Maalaea Bay, Maui, Hawaii. White squares indicate surface samples, white triangles indicate subsurface samples, and yellow squares mark stations that tested positive for Diuron in concentrations greater than 3 ppb (#8 and #9). © 2014 Google.

Water sampling took place before, during, and after the passage of Tropical Storm (TS) Flossie on July 29, 2013. It began on July 28 and ended six days later on August 3, 2013. Samples 1–2 and 4–7 were taken near the shore, from Island Sands Resort Condominium complex to Maalaea Harbor (Figure 2; Table 1) prior to TS Flossie. Sampling was repeated after TS Flossie (Samples 10–15). Samples 6, 7, 14 and 15 were taken on the northern side of the harbor. Samples 8 and 9 were drawn during TS Flossie from the runoff stream immediately east of Island Sands Resort Condominiums. Additional post-TS Flossie samples (16–17) were obtained on July 31 at Maalaea Harbor. Using a kayak on August 3, 2013, seven additional samples were gathered over the reef (Samples 18–24). One blank sample (Sample 3, distilled water) was added to the group as a control, making 24 samples in all.

Twenty-two of the 24 samples (Table 1) had no detectable Diuron concentrations (< 0.03 ppb). Twenty-one samples were obtained adjacent to and over the reef. One sample (Sample 3) was a distilled water blank. Two of the 24 samples had concentrations of >3 ppb (3.4 ppb, Sample 8; 3.3 ppb, Sample 9) (Table 1). Those samples were obtained from the stream on the eastern side of the Island Sands Resort Condominium complex on 29 July 2013 (Figure 2). The stream, which contained runoff from TS Flossie, was sampled approximately 2 hours (1855 Hawaiian Standard Time [HST]) after the rains began while the stream was flowing. Three hours later (2200 HST) the stream was no longer flowing. No elevated Diuron concentrations were recorded for the samples taken in the Maalaea Harbor boat basin before or after the passage of TS Flossie.
