**NASA TM X-3410**

**DURABILITY OF ZIRCONIA  
THERMAL-BARRIER CERAMIC COATINGS  
ON AIR-COOLED TURBINE BLADES  
IN CYCLIC JET ENGINE OPERATION**

*Curt H. Liebert, Richard E. Jacobs,  
Stephan Stecura, and C. Robert Morse*

*Lewis Research Center  
Cleveland, Ohio 44135*

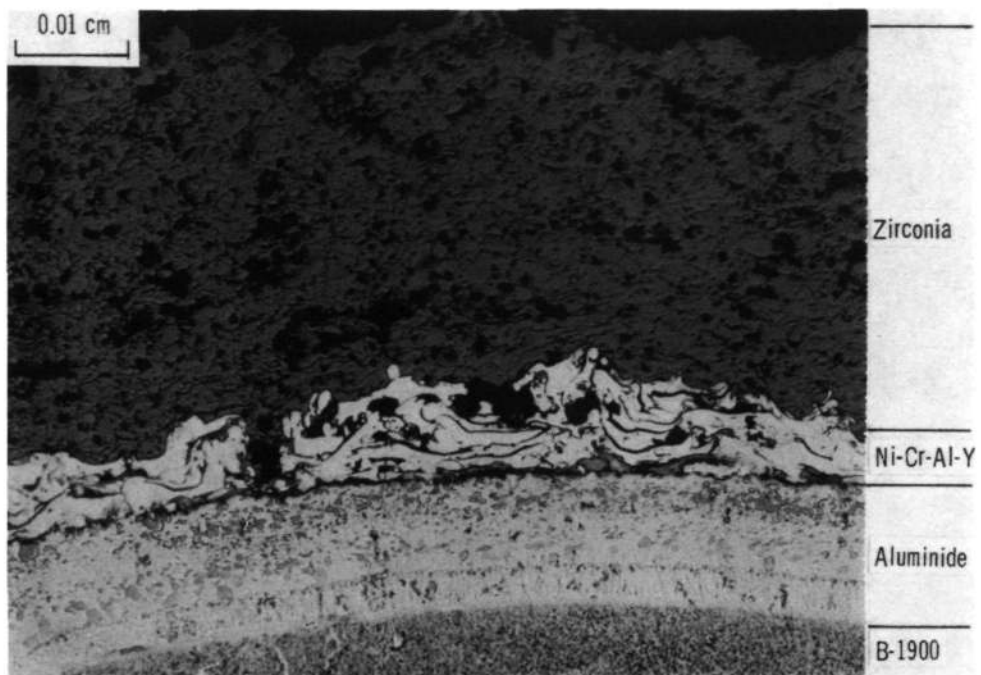
(a) Uncracked.

Figure 9. - Microstructure of calcia stabilized zirconia on turbine blade leading-edge at midspan.

Figure 9(a) shows a typical photomicrograph of a calcia stabilized zirconia composite after 500 cycles of testing. The microstructure is very similar to that of the yttria stabilized zirconia. Cracks in the calcia stabilized zirconia coating were observed on some of the micrographs (fig. 9(b)). These cracks generally were located parallel and adjacent to the bond coat. In some cases these cracks penetrated to the outer surface of the coating. The formation of such cracks shown in figure 9(b) can weaken the coating adherence. These cracks, however, did not cause spalling of the coating during testing. Although not shown, the microstructure of the magnesia stabilized zirconia composite was similar to the other composites, and the Ni-Cr-Al-Y bond coat adhered well to the aluminide coat.

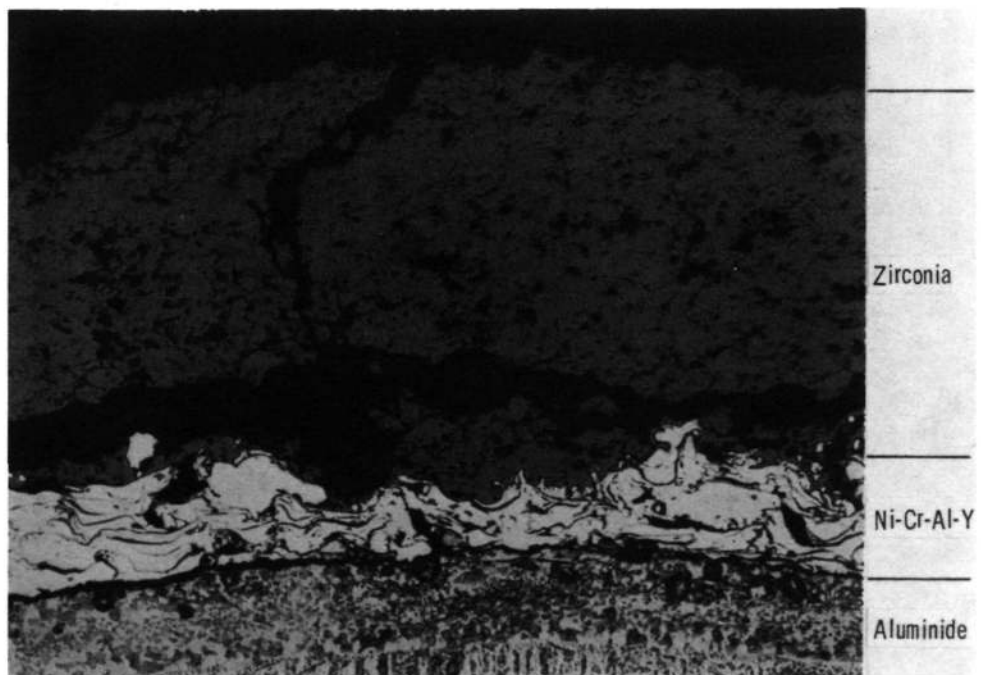
(b) Cracked.
