Dynamic Observation with Scanning Electron Microscope (SEM) of Hydrogen-Induced Cracking in High Strength Steel Weldments†

Fukuhisa MATSUDA*, Hiroji NAKAGAWA** and Takeshi MATSUMOTO***

KEY WORDS: (Hydrogen Embrittlement) (Cold Cracking) (High Strength) (Electron Microscope) (Plastic Deformation)

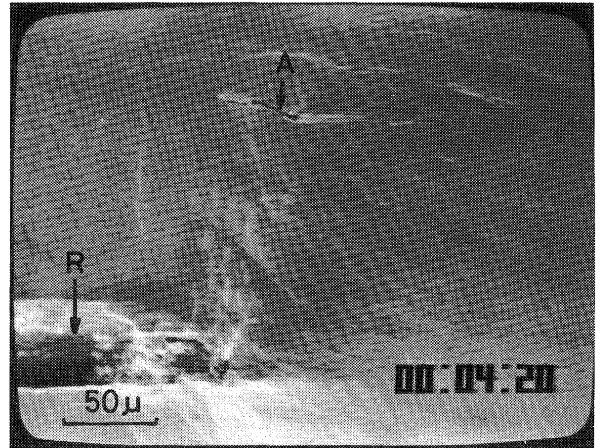
An example of sequence of video pictures during the testing is shown in Fig. 3. The six letters at lower right

Fig. 3 Change in plastic deformation and cracking vs. time

site in each picture show the time after the straining in a manner as XX(hr) XX(min) XX(sec). At 3 min 56sec, Fig. 3 (a), two regions deformed plastically are observed in two directions from the edge of root (R) which were formed at the same time of the straining, and a micro

crack (A) was formed in one of the regions deformed plastically. This micro crack hardly grew thereafter. Then the region deformed plastically which lay on opposite side of the micro crack grew a little in Fig. 3 (c), and then a micro crack (B) was formed in Fig. 3 (d). After a

while, other micro cracks were formed in front of B along the deformed zone in Fig. 3 (e). In Fig. 3 (f), (g) and (h), a micro crack (C) was growing at a place in far front of the micro crack (B). Figure 3 (i) and (j) show other micro cracks (D) and (E) growing, which are considered to occur along martensite laths. The growth of these cracks stopped by about 30 min, when they had grown to macro-cracks as seen in Fig. 3 (k). Figure 3 (l) shows the upper right area of Fig. 3 (K).

It is noticeable that a micro crack in Fig. 3 (b), (d), (e), (f), (g), (h) and (i) always occurred along very large slip bands which were seen brightly. Consequently SEM observation is suitable to reveal the relation between large

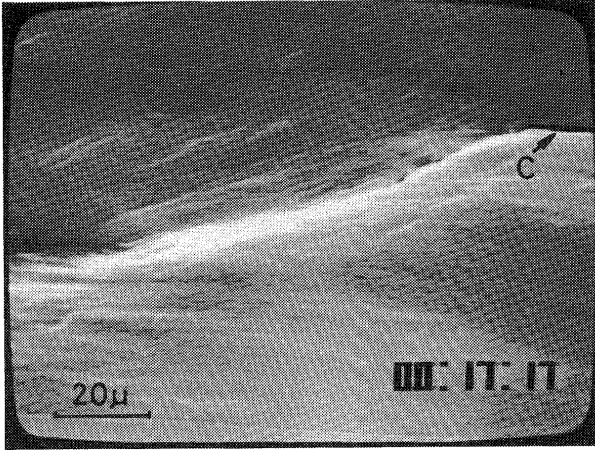
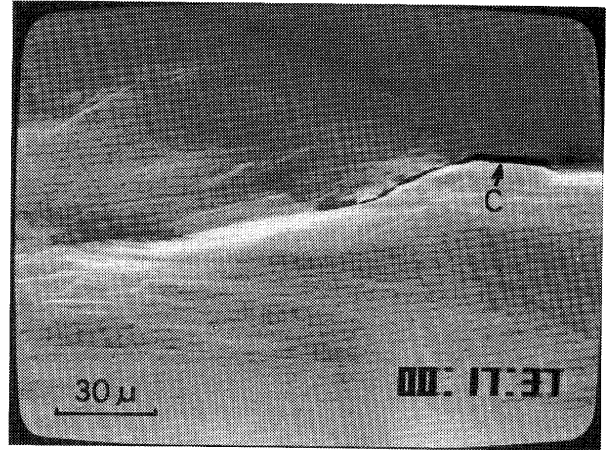
Fig. 3 (continued)
