## EFFECT OF GRAIN SIZE VARIATIONS ON THE LONG-TIME STABILITY OF ALLOY 718

J. P. Stroup  
and  
R. A. Heacox

### Abstract

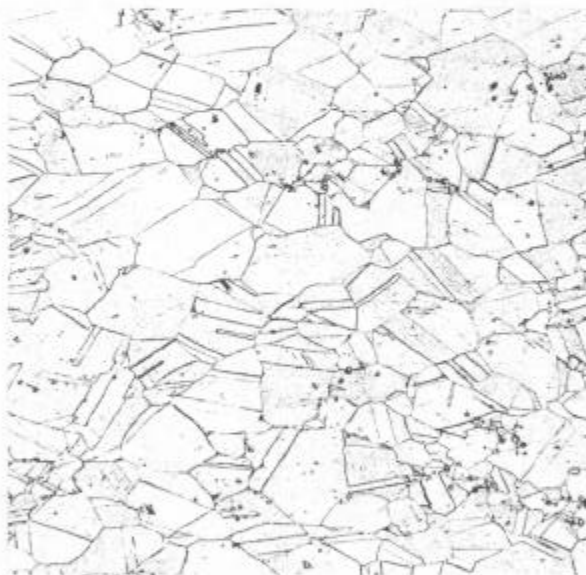
Fig. 2. Microstructures Typical of Those Exhibited by the As-Forged Pancakes  
Etchant:  $\text{HCl} + \text{H}_2\text{O}_2$  100X

Microstructures typical of the as-forged samples are shown in Fig. 2. In general, Pancakes C, E, H, I, and M, all of which had duplexed grain structures, exhibited microstructures similar to that of Pancake D, except for varying amounts of fine and coarse grains. Pancakes A, F and G had fully recrystallized (equiaxed) structures similar to that of B, except that the actual grain size varied, whereas Pancakes J, K and L had grain structures that exhibited little or no recrystallization.

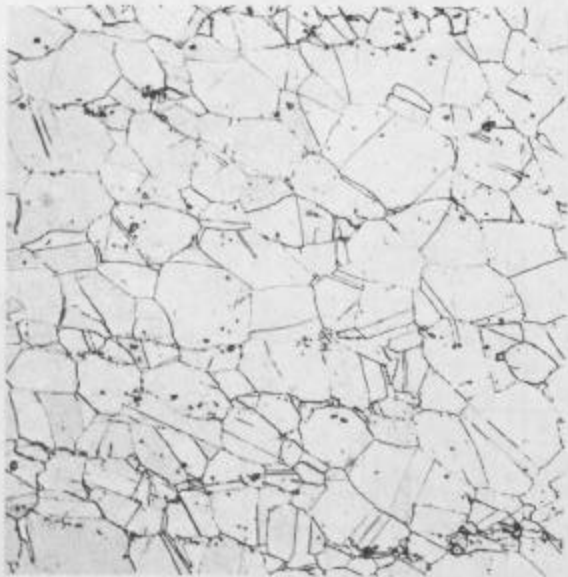
Fig. 6. Microstructures Typical of those Exhibited by Heat-Treated Specimens  
Etchant:  $\text{HCl} + \text{H}_2\text{O}_2$  100X

Microstructures typical of the heat-treated specimens are shown in Fig. 6. Additional metallography work was conducted on heat-treated specimens prior to exposure as a portion of Phase II of this study.

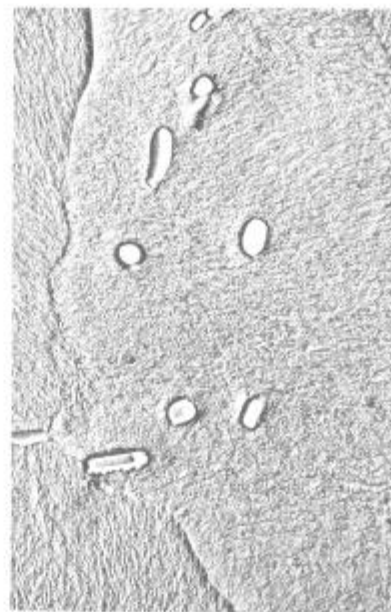
Plate 6533-4

Fig. 10. Electron Micrograph of Pancake B in the Forged Condition

Fig. 9 is an electron micrograph showing the clean grain-boundaries of Pancake B in the as-forged condition. This was also typical of Forgings D, G, H and J. Fig. 10 illustrates the structure of L in the as-forged condition. Based on the X-ray data, many of the visible particles in the micrograph of L are identified as  $Ni_3Cb$ .

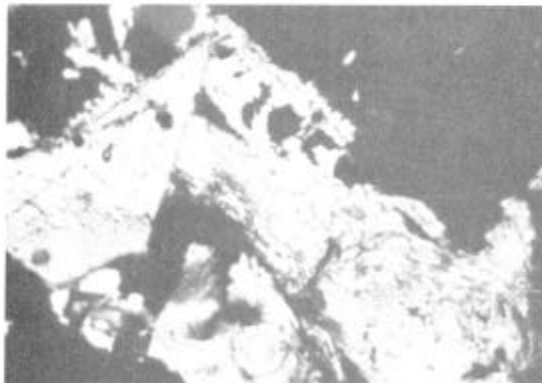
Fig. 11. Micrographs of Residues Extracted in 10% HCl - Methanol Solution

In addition, micrographs (Fig. 11) of the extracted residues used in the X-ray diffraction analysis revealed two significant facts:

- 1) The  $Ni_3Cb$  plate size becomes larger as grain size increases.
- 2) In the duplex grain size specimens, the  $Ni_3Cb$  was found as a mixture of large and small plates.

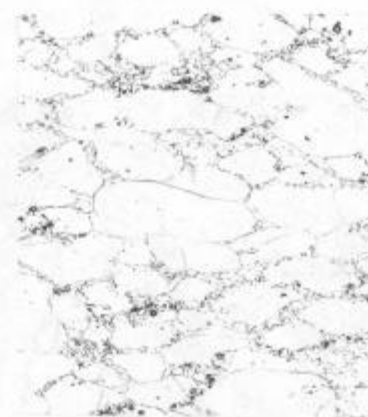
Fig. 13. Micrographs of Pancake D in the Heat-Treated Condition

The micrographs for D (Fig. 13) show the very severe duplexing in this sample. A mixture of large and small  $\text{Ni}_3\text{Cb}$  plates is apparent in the electron micrograph.

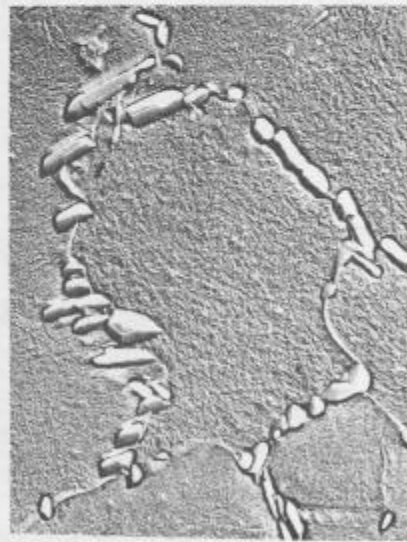
Fig. 17. Micrographs of Pancake L in Condition

Fig. 17 shows the very fine uniform grain size in L. A large volume of small  $\text{Ni}_3\text{Cb}$  plates is evident.
