Effect of Soil Grain Size Distribution on the Mechanical Damage of Nonwoven Geotextiles Under Repeated Loading

Abstract Installation processes (which induce mechanical damage) may cause undesirable changes on the properties of geosynthetics, affecting their performance. This work evaluates the effect of mechanical damage on the short-term tensile behaviour of two nonwoven geotextiles (with different masses per unit area). The geotextiles were damaged in laboratory using a standardised procedure and an artificial aggregate (*corundum*) and eight other soils. The damage induced was characterized using wide-width tensile tests. Results showed reductions of the tensile strength of both geotextiles, which depended on the grain size distribution and uniformity of the soils and on the mass per unit area of the geotextiles. The reduction in tensile strength provoked by *corundum* was higher than the decreases caused by most of the other soils. The mechanical damage tests also led to a reduction of elongation at maximum load and an increase of stiffness.

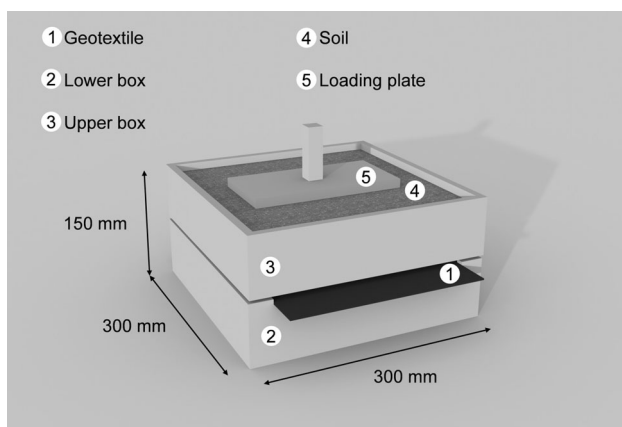
Fig. 1 Schematic representation of the equipment used in the mechanical damage tests

The mechanical damage tests were performed in a laboratory prototype equipment following the specifications of EN ISO 10722 [11]. The equipment was formed by a container (Fig. 1) divided into a lower and an upper box (rigid metal boxes where the geotextile and the soil were placed), a loading plate and a compression machine (full description of the equipment can be found in Lopes and Lopes [17]).

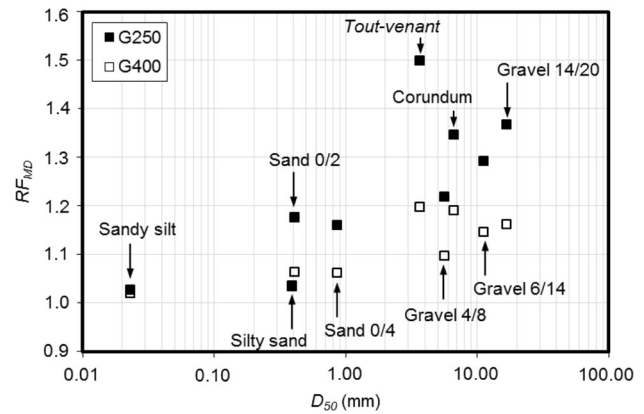
Fig. 6 Variation of RF_{MD} with the D_{50} of the soils for geotextiles G250 and G400

The reduction factors presented in this paper were determined from mechanical damage laboratory tests and thus should not be used for design. Nevertheless, they can be useful to compare the influence of the type of soil and the mass per unit area on the damage suffered by the geotextiles. Figure 6 illustrates the variation of RF_{MD} with the D_{50} of the soils used in the mechanical damage tests for geotextiles G250 and G400.

Geotextiles of the same product family with different values of mass per unit area have different robustness. Higher robustness resulted in lower values for the reduction factor, RF_{MD} . Generally, the soils with higher values of D_{50} led to larger reduction factors. However, as the soils used

were quite different, there are other factors to be considered. The uniformity of the soils also played an important role on the changes observed after the mechanical damage tests. Soils with wider range of particle sizes seemed to be less aggressive.
