ANNUAL REPORT EFFECT OF TEMPERATURE ON COMPOSITE SANDWICH STRUCTURES SUBJECTED TO LOW VELOCITY IMPACT

A. VISHNU SHARMA.

AUGUST, 1977

Langley Research Center

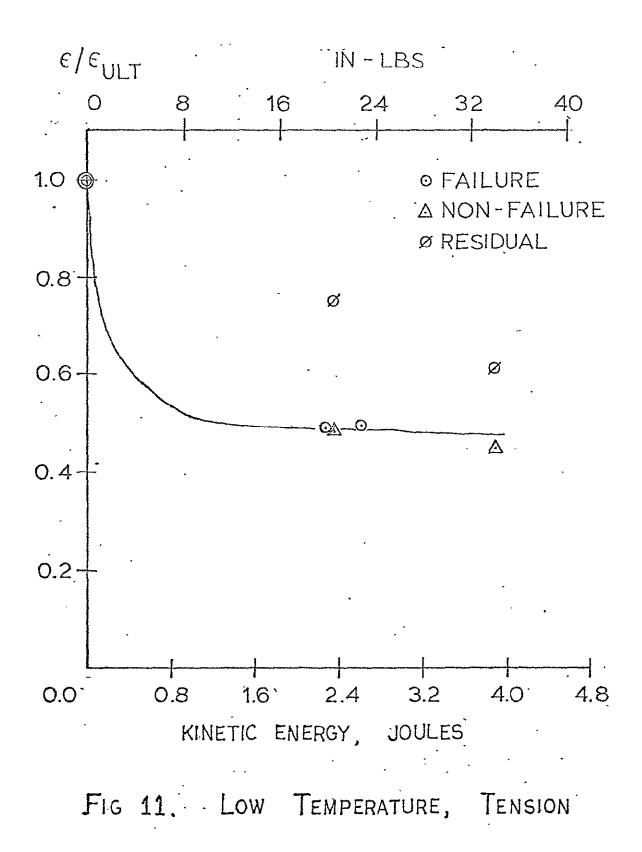
<u>Cooling/Tension</u>: Six hybrid specimens were tested in this series. The ultimate stress (σ_u) level was found to be 820 MPa (119 ksi) with a corresponding strain (ε_u) of 1%. The variation of stresses and strains with respect to energy of impact is shown in Figures 10 and 11. The residual strength of two specimens that survived the pre-load (43% of σ_u) impact was about 56% of σ_u . However, the corresponding values of strains were not proportional but higher (Figure 11). The failure threshold in this case was slightly less than 50% of σ_u .

$(O_{K}, 90_{\circ}, O_{G})_{\circ}$ Kevlar-Graphite/Hybrid Average surface temperature 223 ± 1 K

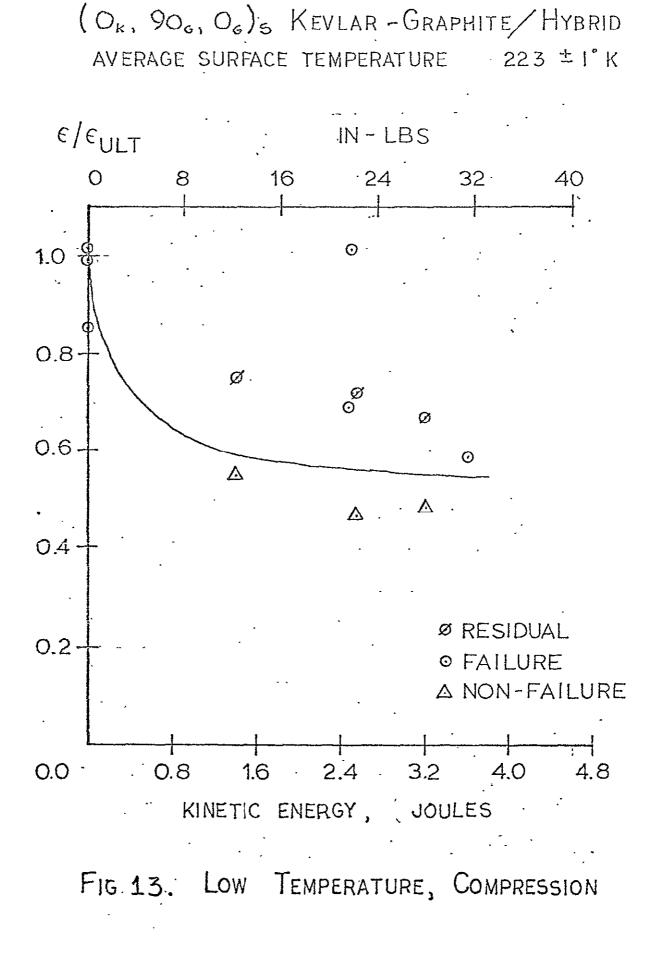
<u>Cooling/Compression</u>: Nine specimens were tested in this series. The average value of σ_u was found to be 352 MPa (51 ksi) with a corresponding value of ε_u at 0.5%. As shown in Figures 12 and 13, the impact energy range is wide for this series. The width of failure threshold is also wide.
