Effects of blast loading on prestressed girder bridges

William F. Cofer*, Debra S. Matthews and David I. McLean

Department of Civil and Environmental Engineering, Washington State Transportation Center, Washington State University, Pullman, WA, USA

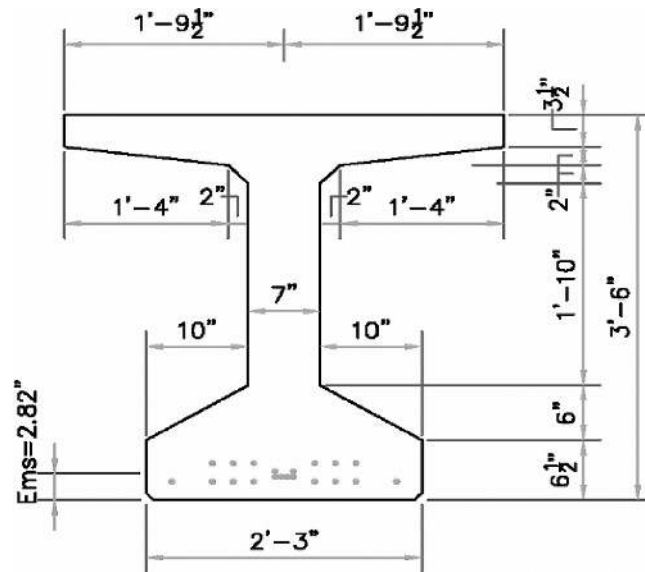
Fig. 1. Girder cross section at midspan.

The girder section for the test specimens was a Colorado Department of Transportation section. The bulb-tee section measured 3 feet-6 inches high with a 3 feet-7 inches wide top flange. Twenty 0.6-inch, grade 270 strands provided the prestressing for the girder, while other reinforcing steel was Grade 60. The concrete was designated as Class “S”. Figure 1 shows a cross-section of the girder at midspan. A span of 68 feet-4 inches was used for the model and experiments.

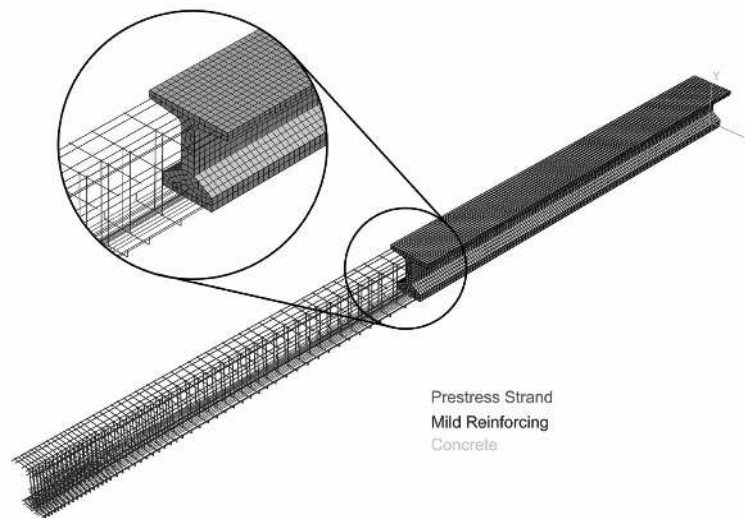
Fig. 2. Girder model.

A cut-away view of the girder model is shown in Fig. 2, displaying the concrete, the reinforcing steel, and the prestressing tendons. A typical concrete element at the location of the blast was approximately a 3-inch cube. ABAQUS/Standard was used to determine the initial state of equilibrium due to prestressing and self-weight. ABAQUS/Explicit was then used for all of the dynamic analyses. The model utilized 8-node continuum elements with reduced integration for the modeling of all concrete. Since hourglassing is a problem with this element, the built-in hourglass control was used. The reinforcing and the tendons were modeled with 2-node, 3-D stress and displacement truss elements. These were embedded within the concrete elements.

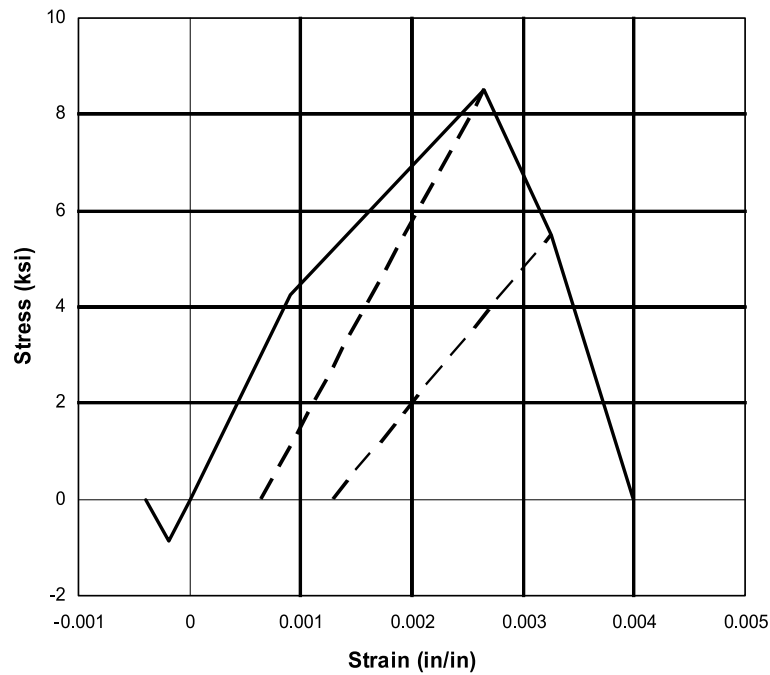
Fig. 3. High-strength concrete material properties.

under low confining pressures” [12]. Since the section is essentially completely unconfined, this material model is applicable. The plasticity model allows concrete’s nonlinear properties to be described, while the damage model describes irreversible damage caused by crushing and cracking. The material properties are defined in terms of initial elastic properties, followed by stress/plastic strain data and information for tensile and compressive damage. Figure 3 shows the concrete properties used for the high-strength concrete of the girder. The dashed lines show the effect of the damaged modulus of elasticity.

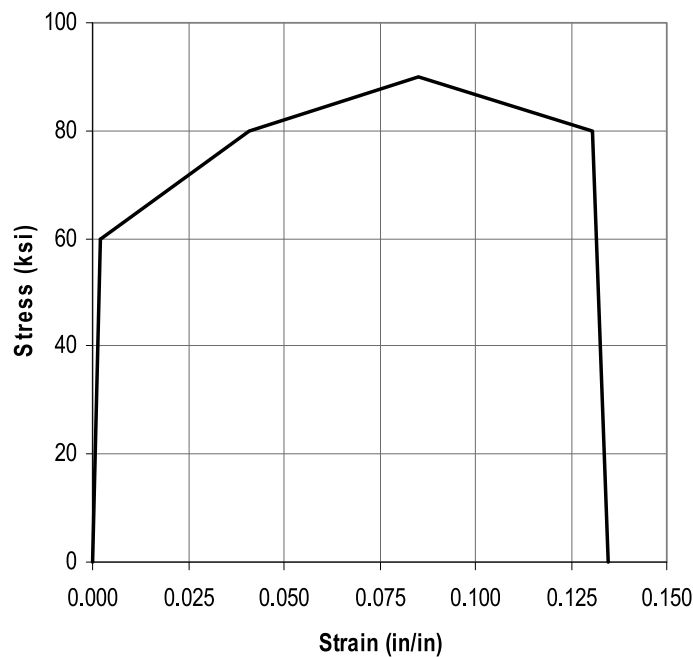
Fig. 4. Mild Reinforcing Steel Material Properties.

The prestressing and mild reinforcement were modeled with simple elastic-plastic models. A damage parameter was also introduced to account for breaking of the strands or bars. Figures 4 and 5 show the material properties used for the mild reinforcing and prestressing steel, respectively.

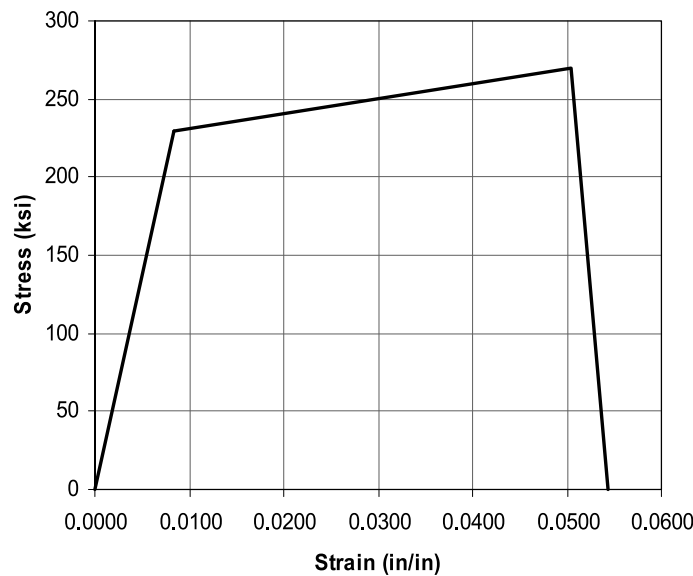
Fig. 5. Prestressing Steel Material Properties.

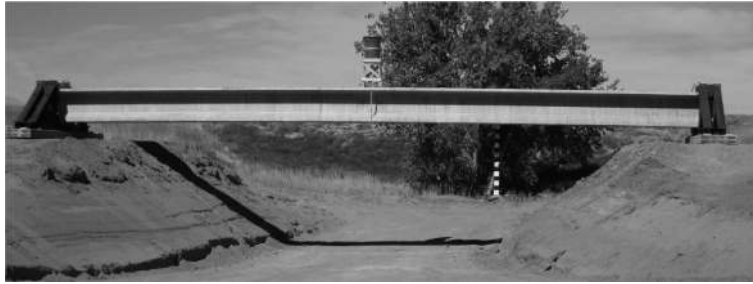
Fig. 6. Test setup (adopted from [13]).

Two identical specimens were used for explosive tests. Under the direction of personnel from the Engineer Research and Development Center of the U. S. Army Corps of Engineers [13], two loading scenarios were executed: an explosion above the girder and an explosion below the girder. Explosive charges and standoff distances were selected based on preliminary analysis results. The goal was to damage the girders enough to cause total failure, but not to destroy them to the point that little would remain for observation.

For the scenario of loading from above, a spherical blast wave was assumed for pressure simulation. Figure 6 shows the test setup for the girder.

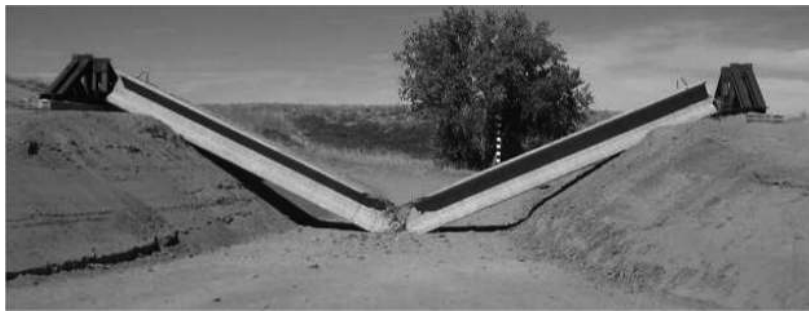
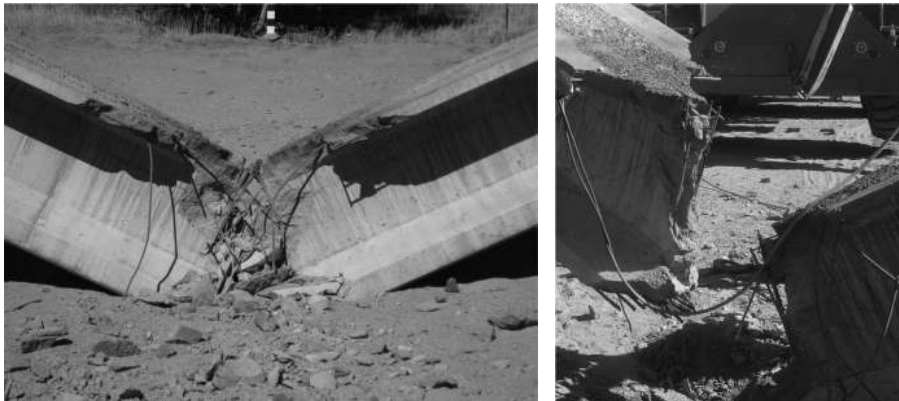
Fig. 7. Damaged girder from blast above midspan (adopted from [13]).

Examination of the girder after the test indicated that a little over 3.5 feet of the top flange and web had been blasted into small pieces. Additionally, heavy cracking could be seen for about four or five feet on either side of the destroyed web. Figure 7 shows the damaged girder. Note that, adjacent to the region of destruction at midspan, the edge of the remaining web is nearly vertical and that the top flange is sheared off at an angle for a short distance further. Also, while the bulb was damaged, the prestressing tendons were intact after the blast.

Near the location of the blast, large 45° cracks were observed. There was also longitudinal cracking on the underside of the flange where it intersected with the web. This cracking pattern is consistent with shear failure at the location of the blast. Due to the high pressures and rapid application, the pressure wave essentially punched through the girder. The longitudinal cracking also indicates localized flexure of the flange.

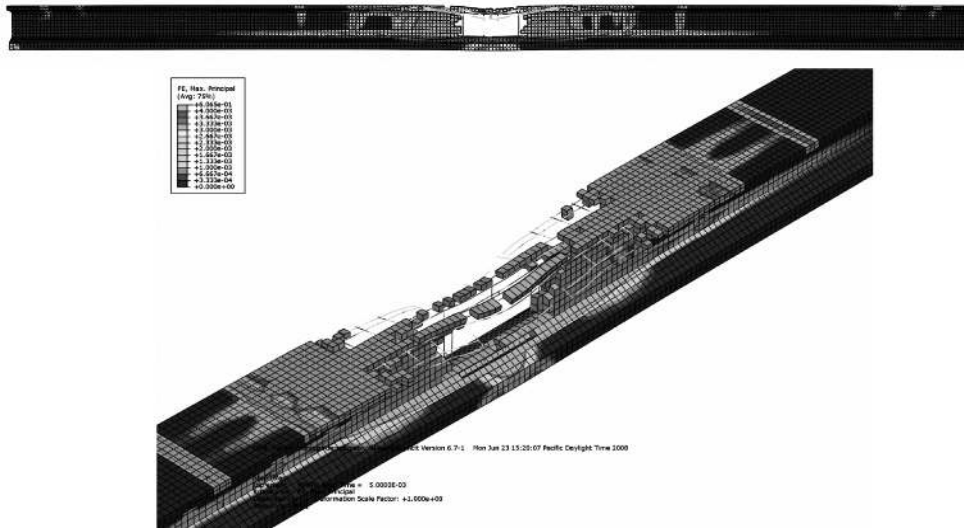
Fig. 8. Maximum principal plastic strain for the blast above the girder.

The results for the finite element analysis of this blast are shown in Fig. 8. As previously mentioned, pressure values were obtained from the BEL software and applied directly to the top surface of the model. Small time steps of 5.0×10^{-8} seconds were used, and the total time period of the analysis was 5 milliseconds, which is approximately the length of time for the blast pressure wave to traverse the structure. To determine areas of significant cracking, the maximum principal plastic strain parameter was examined. Strains exceeding 0.004 are associated with heavy cracking. This limit is equivalent to ten times the tensile cracking strain and thus represents large, highly visible cracks. The model shows about ten feet of heavily cracked concrete. Localized bending of the flange is also observed in the model.

Figure 8 shows the model at the end of the pressure wave application (5 milliseconds). All material shown in gray indicates heavily cracked concrete (maximum principal plastic strain greater than 0.004). The removed elements

are associated with rubbelized concrete (equivalent plastic strain greater than 0.02). This limit was derived from observations of the actual blast tests.

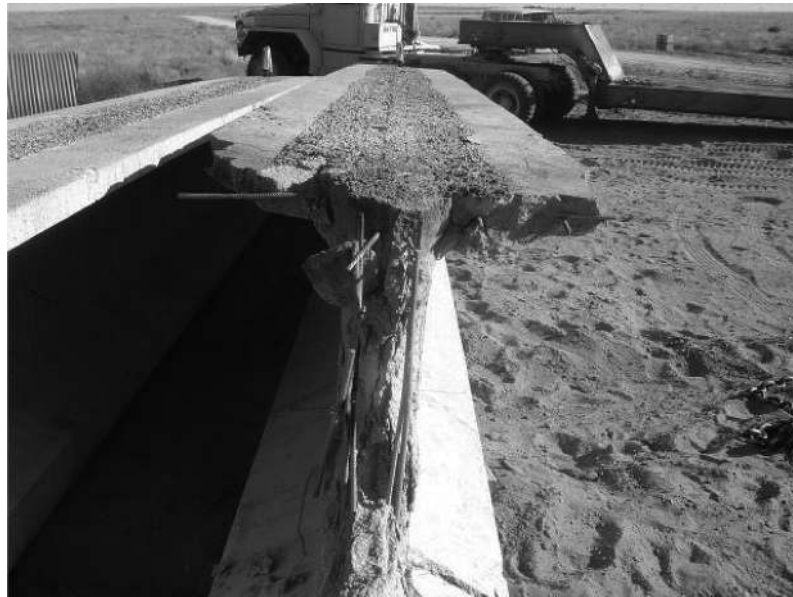
Fig. 9. Web cracking from blast above the girder.

Examination of the damaged cross section reveals vertical cracks within the web, as shown in Fig. 9. A plot of the direction of principal plastic strain within the model reveals the same type of cracking, as shown in Fig. 10. Clearly, the nature and extent of damage are well predicted by the finite element model.

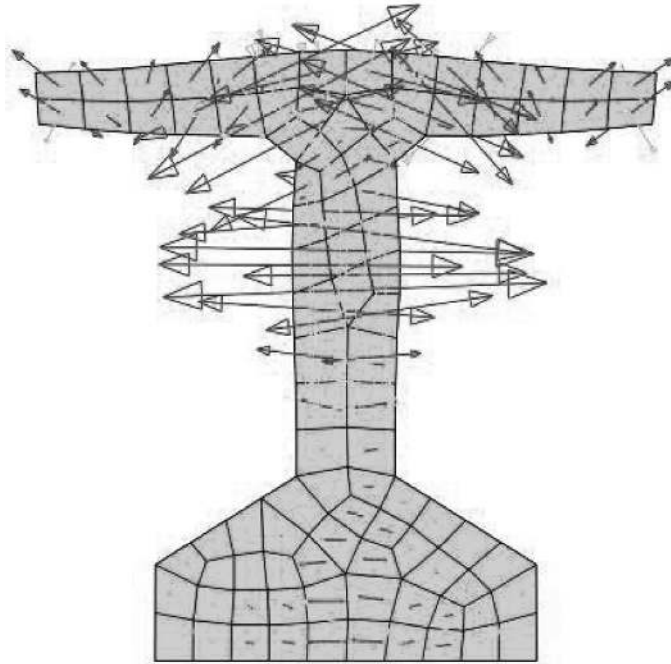
Fig. 10. Web plastic strain from blast above the girder.

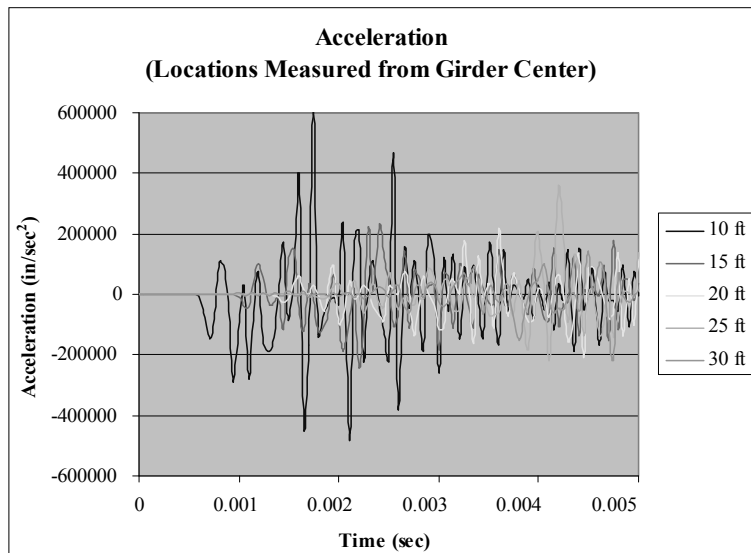
Fig. 11. Acceleration time history for blast above the girder.

Accelerometers were also placed on the test specimen. A peak acceleration of approximately $6.5e5$ in./sec² was measured at ten feet from midspan. Within the finite element model, a peak acceleration of approximately $6.0e5$ in./sec² was seen at the same location, as shown in Fig. 11. These are very consistent results.

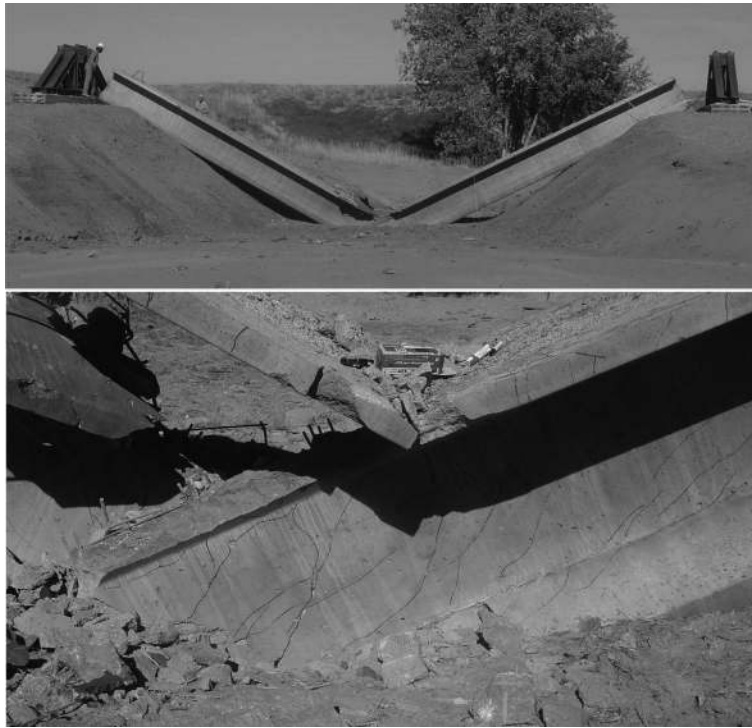
Fig. 12. Damage from the blast below the girder.

The damaged girder after the blast from below is shown in Fig. 12. Examination of the girder after the test indicated that less than a foot of the web had been rubblized, although a length of about nine feet was missing from the top flange. It is noted that the detached top flange may have been a result of the girder falling rather than an exclusive result of the blast wave. Additionally, heavy cracking could be seen for about ten feet on either side of the destroyed web.

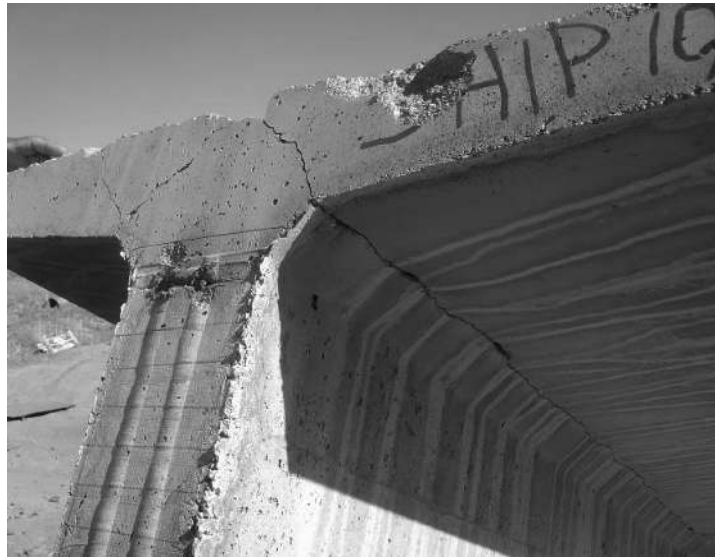
Fig. 13. Longitudinal cracking at web-flange intersection.

location of the blast, similar to the first scenario. Longitudinal cracking was also observed in this case, but to a much larger degree than before. Figure 13 shows this cracking pattern.

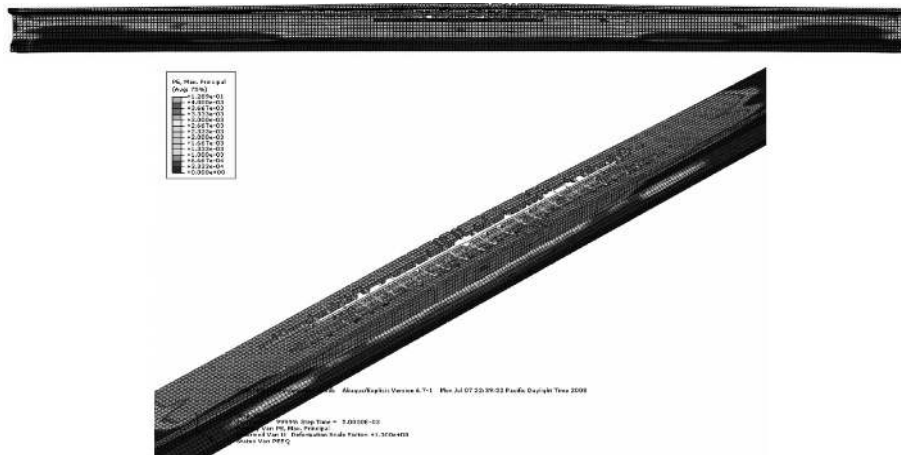
Fig. 14. Maximum principal plastic strain for blast below the girder.

These observations are consistent with the results from the finite element model, in which heavy cracking is indicated through the middle third of the girder. Figure 14 shows maximum principal plastic strain. Once again the gray is associated with heavy cracking while removed elements were subject to very large plastic strain, indicating rubbelized concrete.

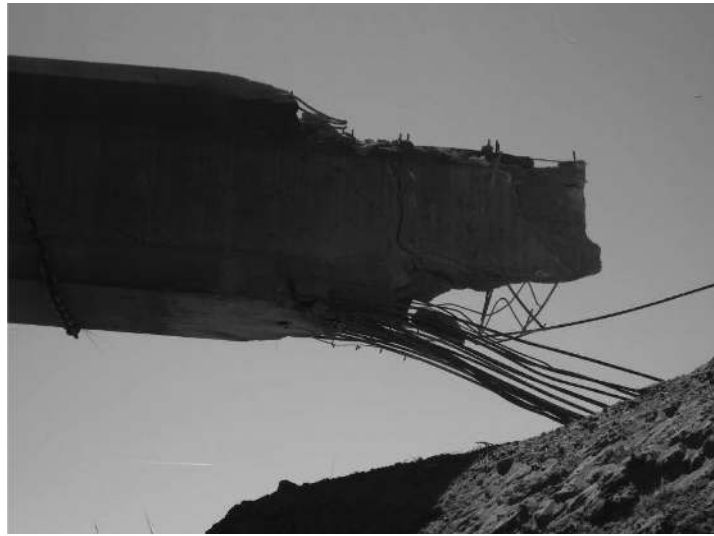
Fig. 15. Damaged section with rubbelized concrete removed (adopted from [12]).

and impact with the ground. However, the results are acceptable considering the simplified pressures applied to the model. Approximately 25 feet of cracking in the web can be seen in the model, similar to the 20 feet observed in the full-scale test.

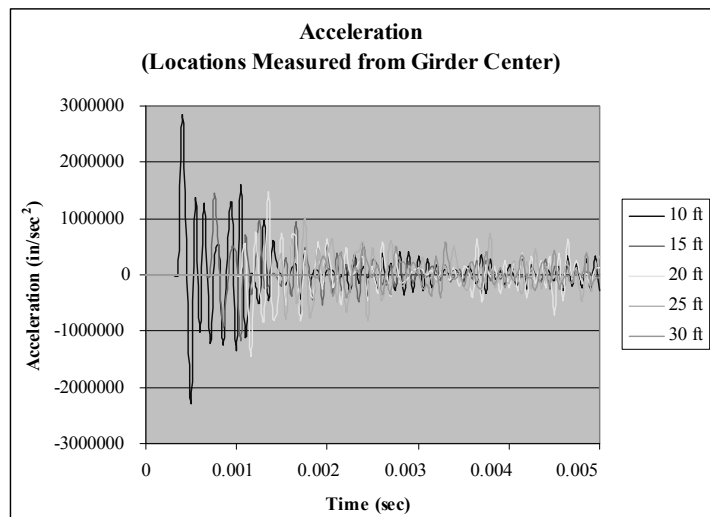
Fig. 16. Acceleration for blast below the girder.

Accelerometers were also placed on this specimen. Maximum acceleration of the girder at ten feet from midspan was measured as approximately $7.5e6 \text{ in./sec}^2$. The finite element model shows a peak acceleration of $3.0e6 \text{ in./sec}^2$ at the same location, shown in Fig. 16. These values are not as consistent as the previous case, but they are of the same order of magnitude and thus reasonable. Overall, the model is acceptable.

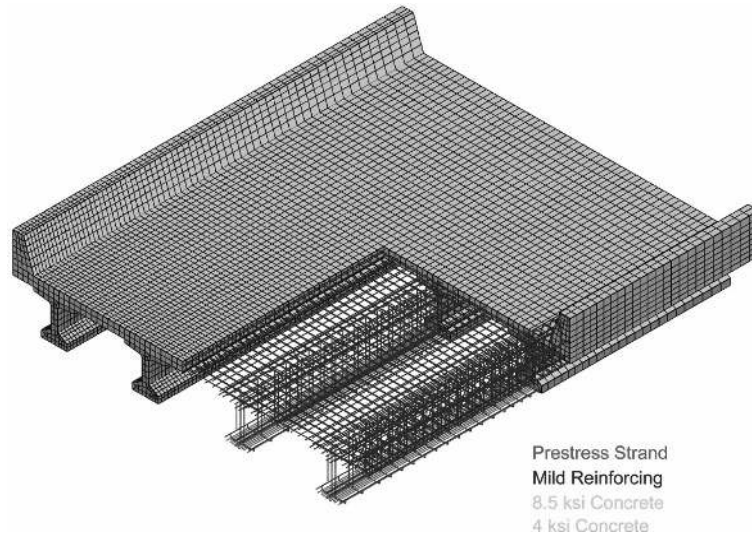
Fig. 17. Finite element model for the bridge deck.

Using the girder model described above, a complete bridge deck model was developed as shown in Fig. 17. Utilizing symmetry, only half of the span was included in the model, thus limiting loading scenarios to blast events

No changes were necessary in the materials, although a lower strength concrete material was created for the deck. This material model is shown in Fig. 18. Along the mirrored surface at midspan, all nodes were fixed out of plane. The outer end of the bridge model remained roller-supported on a theoretical knife edge, as with the girder model.

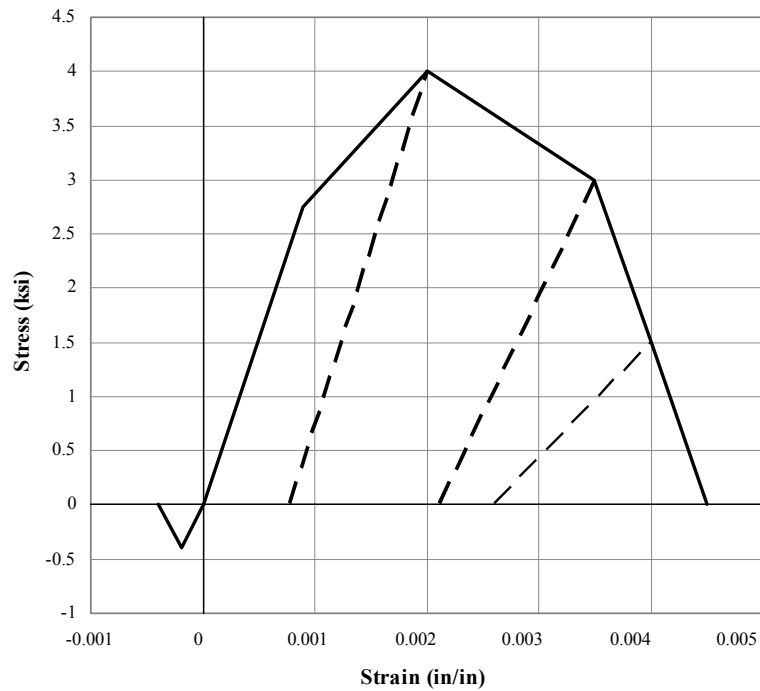
Fig. 18. Slab concrete material properties.

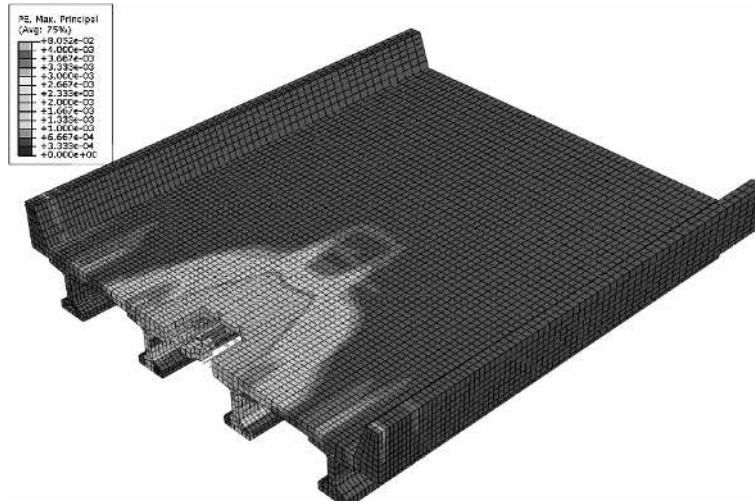
Fig. 19. Maximum principal plastic strain, blast above, between girders. Top view.

Plots of the maximum principal plastic strain for the blast above the bridge and between the interior girders are shown in Figs 19, 20, and 21. Using the same criteria to detect cracking and rubbelized concrete that was used for the girder models, the plot shows that the blast punches a hole in the deck slab. Heavy cracking was also observed surrounding the hole in the region between the girders. The interior girders show a small area of cracking along the

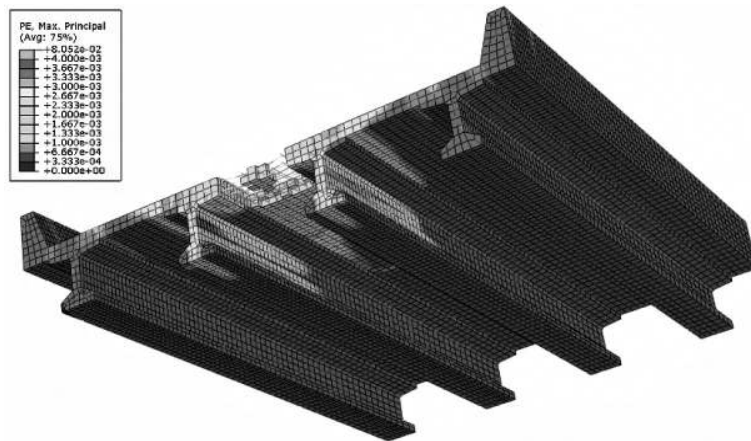
Fig. 20. Maximum principal plastic strain, blast above, between girders. Bottom view.

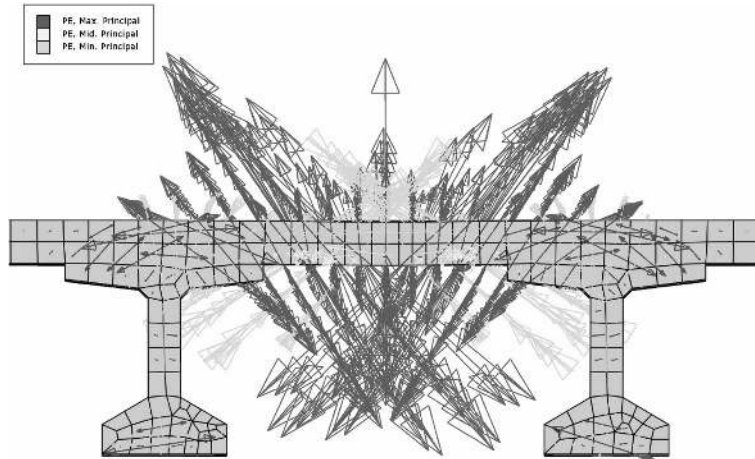
Fig. 22. Principal plastic strain direction, blast above, between girders.

Examining the direction of principal plastic strain illustrates again that shear is the predominant form of failure in the deck. At less than one millisecond into the analysis, when the pressure wave is still being applied, the strong tendency to punch through the deck can be seen. This is shown in Fig. 22.

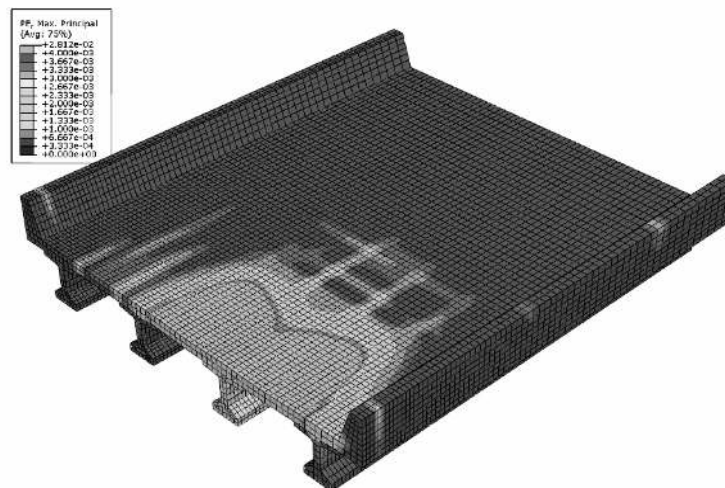
Fig. 23. Maximum principal plastic strain, blast above, centered on a girder. Top view.

Plots of the maximum principal plastic strain for the blast above the bridge and centered on an interior girder are shown in Figs 23, 24, and 25. For this case, it is observed that very little if any concrete is rubblelized, although there is significant cracking. It would appear that having the girder immediately under the center of the blast is enough to stiffen the slab to the point that a punching failure does not occur. Additionally, the slab provides enough protection to the girder to prevent total demolition.

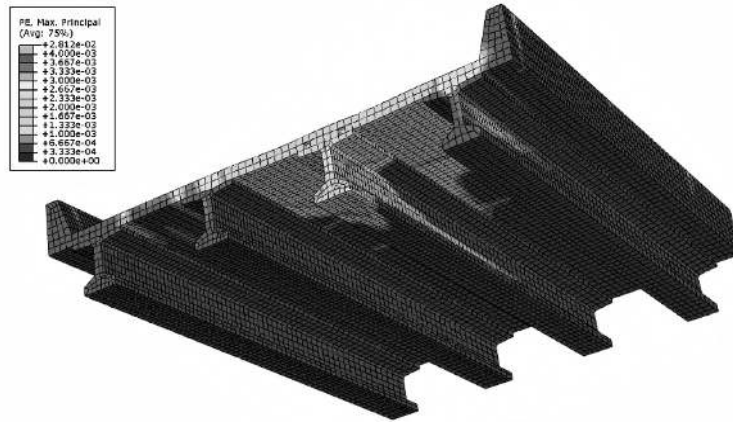
Fig. 24. Maximum principal plastic strain, blast above, centered on a girder. Bottom view.

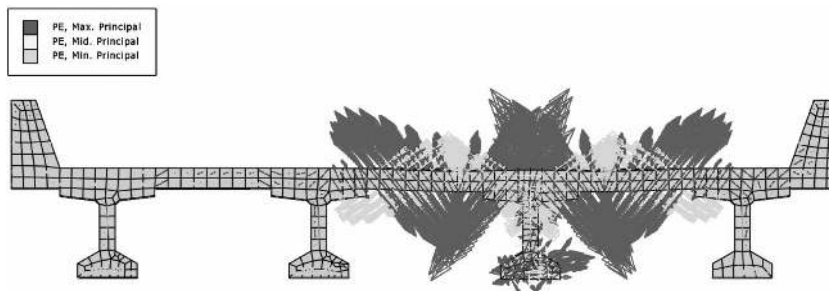
Fig. 26. Principal plastic strain direction, blast above, centered on a girder.

Examination of the direction of cracking at the end of the analysis shows a slight difference in the failure pattern. Instead of seeing a single cone-shaped failure surface where the blast load punches through the deck, it is observed that there is a cone-shaped failure surface on either side of the girder. This trend is illustrated in Fig. 26. This is just further confirmation that the girders offer stiffening and protection to the slab.

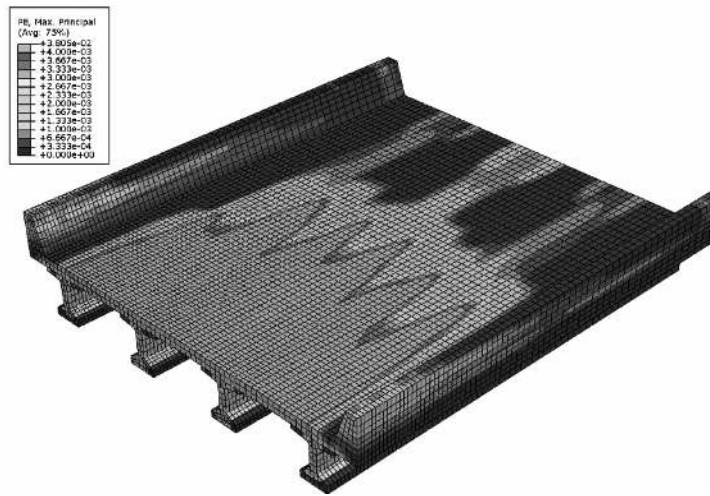
Fig. 27. Maximum principal plastic strain, blast below. Top view.

Plots of the maximum principal plastic strain for the blast below the bridge are shown in Figs 27, 28, and 29. It is once again seen that very little if any concrete is rubbelized. However, the extent of cracking is much greater than for either of the blast scenarios from above. All four girders show heavy cracking through the full depths of their webs. The deck also shows cracking along its full width, and extending longitudinally for about half the total bridge span.

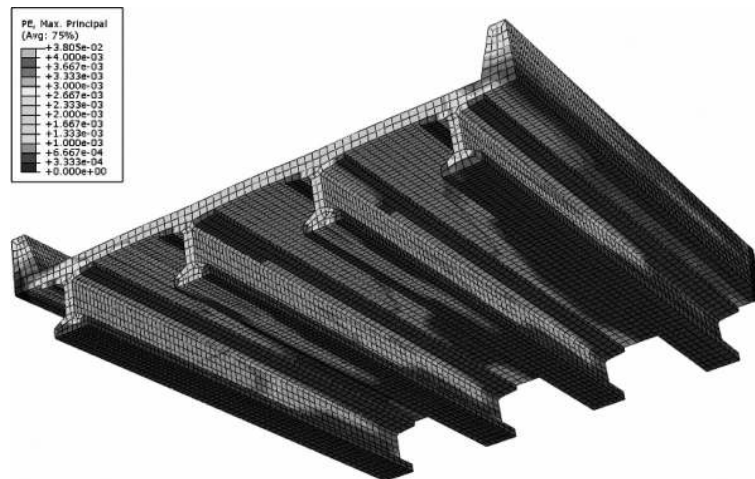
Fig. 28. Maximum principal plastic strain, blast below. Bottom view.
