# Embankment Overtopping Protection Systems

Hubert CHANSON

Abstract: For the last decades, the design floods of numerous embankment reservoirs were re-evaluated and the revised spillway outflows are typically larger than those used in the original designs. As a result, a number of overtopping protection systems were developed for embankments and earthfill dams, with applications encompassing river dykes, coastal barriers for storm surge and tsunami protections. Several design techniques were developed for embankments and earthfill dams. These include concrete overtopping protection systems, timber cribs, sheet-piles, riprap and gabions, reinforced earth, minimum energy loss (MEL) weirs, embankment overflow stepped spillways and the precast concrete block protection systems. Various designs are reviewed herein and discussed based upon prototype experiences. This review highlights that a safe operation of embankment overflow protection systems relies upon a sound design and a good quality of construction, suitable flow conditions, together with regular maintenance.

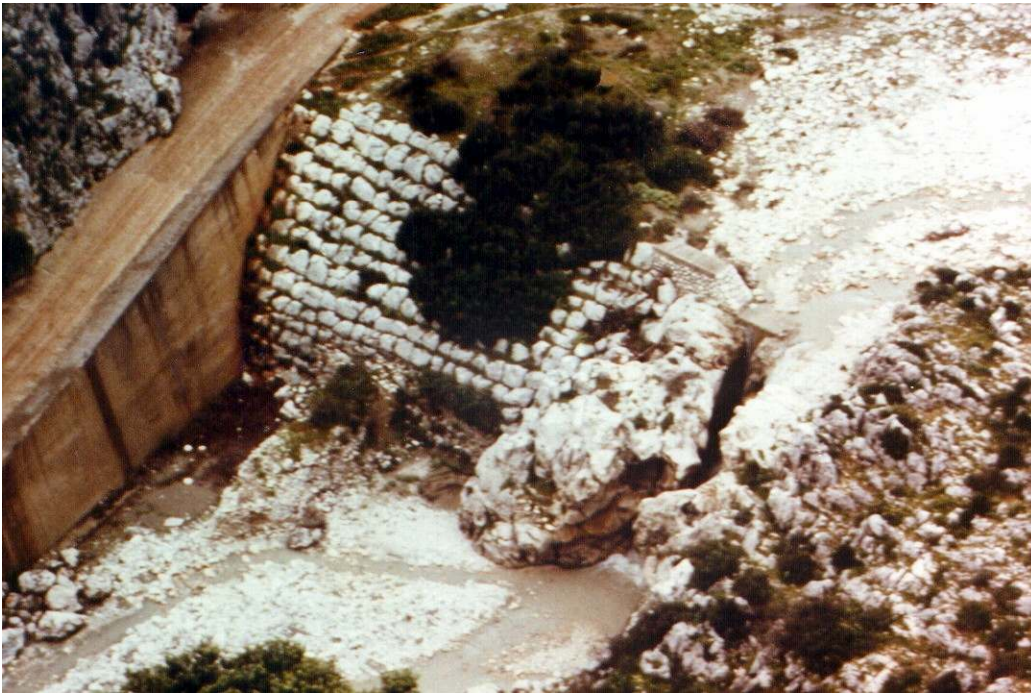
(A) Embankment dam with overtopping stepped spillway: stepped weir in Akarnania (Greece)

(Courtesy of Professor Knauss) - Completion: BC 1,300, H = 10.5 m, L = 25 m

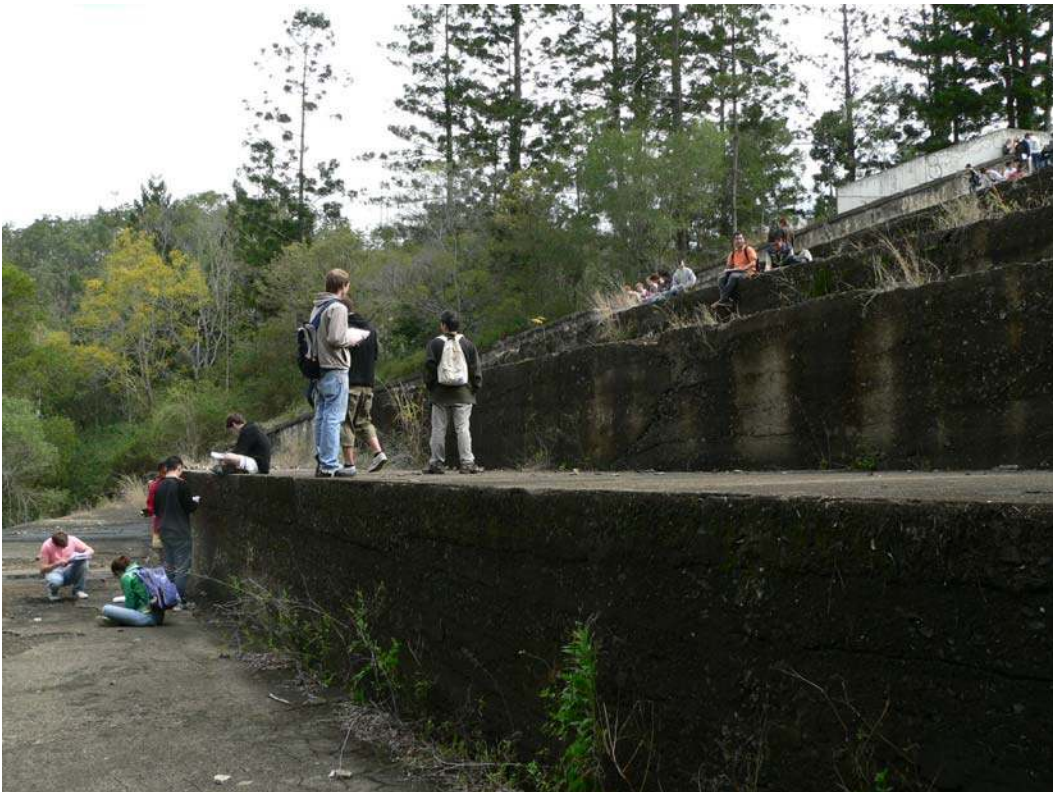
(B) Concrete stepped spillway of Gold Creek dam (Australia) with the embankment dam in the background - Completion: 1885, H = 26 m, L = 187 m - The concrete spillway was built over the right abutment

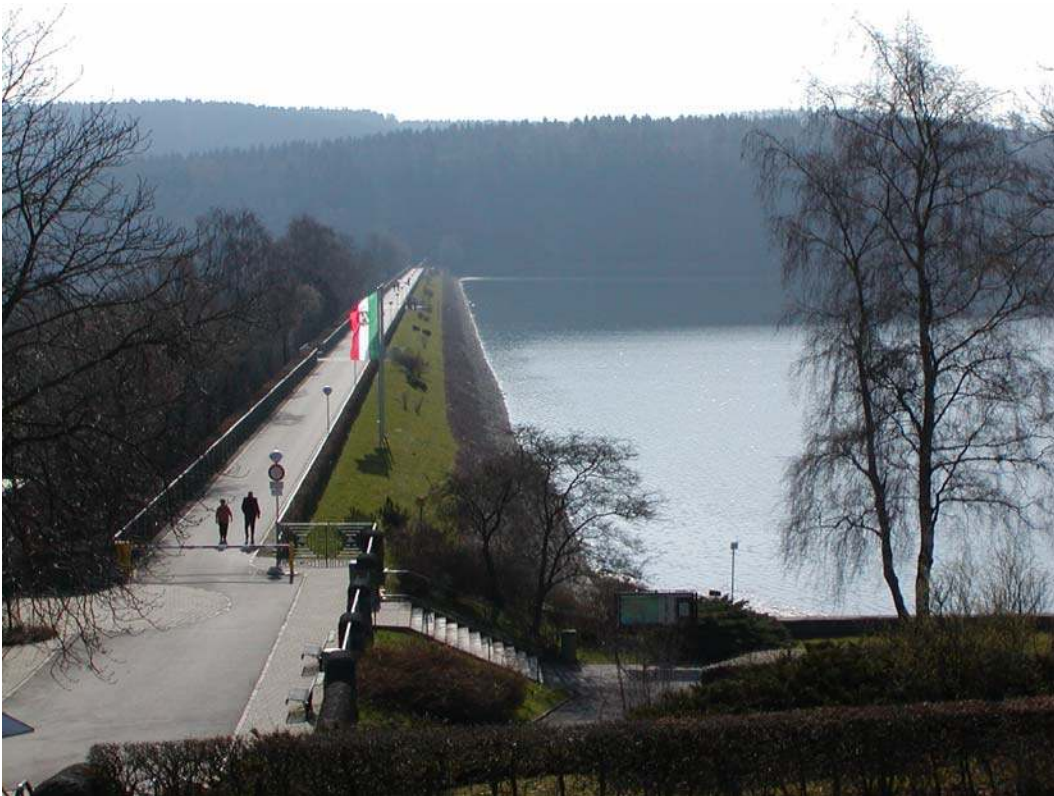
(C) Embankment dam: Sorpe dam (Germany) on 31 March 2004 viewed from left bank -  
Completion: 1935, H = 69 m, L = 700 m

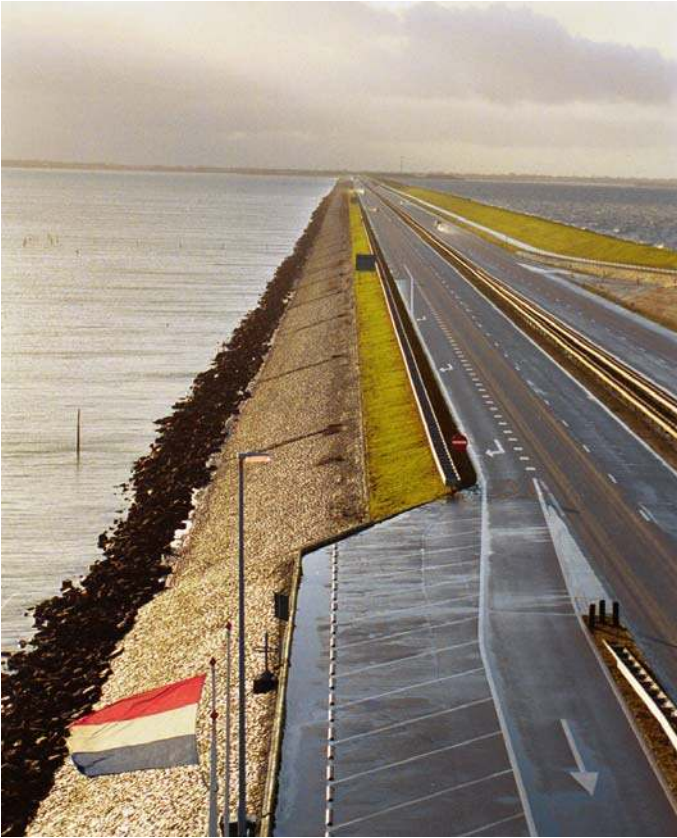
(A) Coastal barrier in Netherlands: Zeidersee enclosure dam (Courtesy of Ronald De Heer)

considered as an earthfill structures designed to hold water. This definition encompasses river dykes, coastal barriers for storm surge and tsunami protections, as well as natural lakes and landslide dams (Fig. 1 and 2). Figure 1 presents some typical embankment dam structures, and Figure 2 shows some embankments for coastal protection.

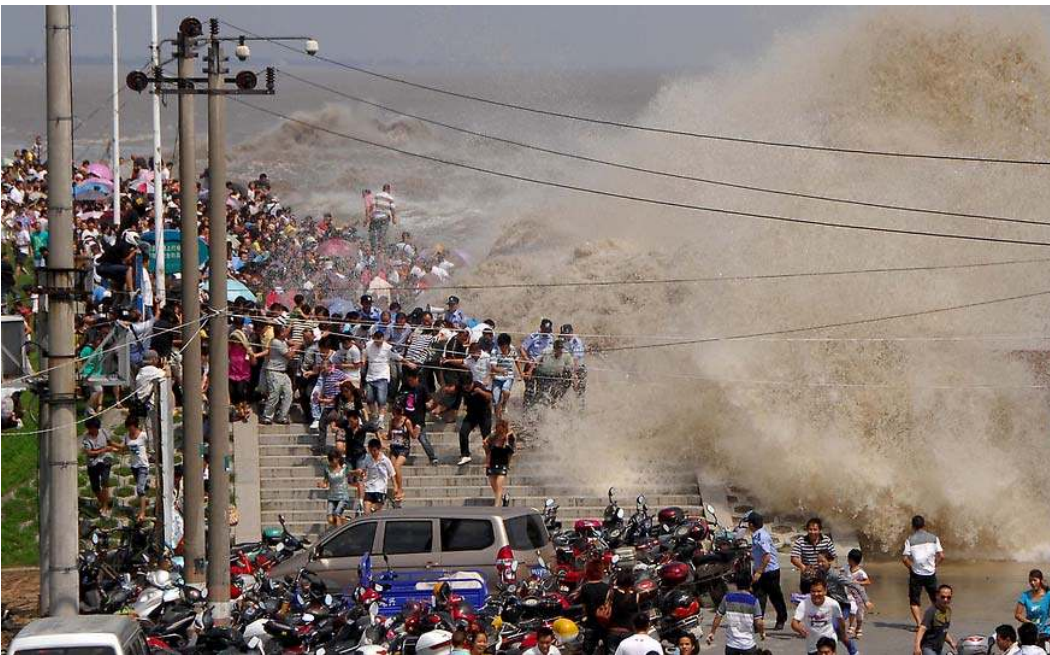
(B) Tidal bore of the Qiantang River (China) overtopping a river dyke on 31 August 2011

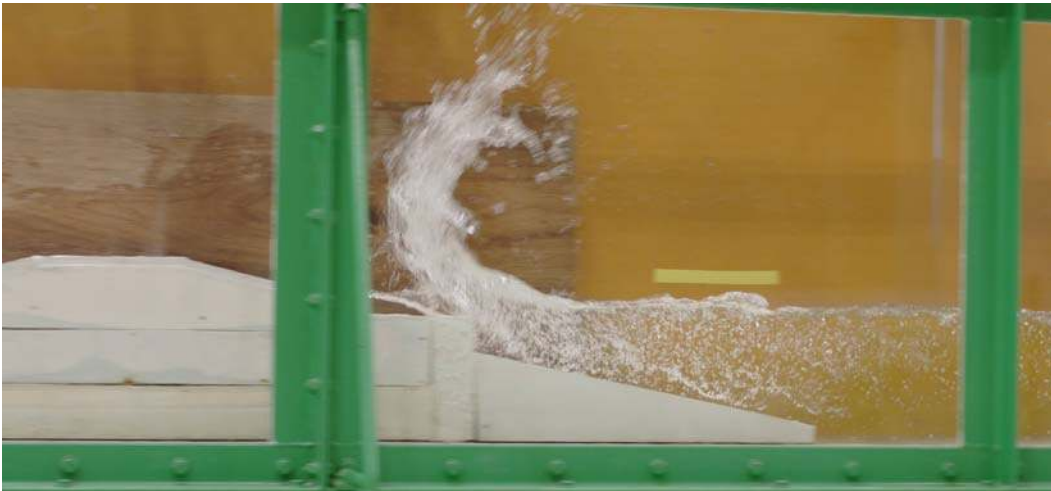
(C) Physical model of a coastal barrier during a tsunami - Physical test with tsunami wave model propagating from right to left and impacting the embankment

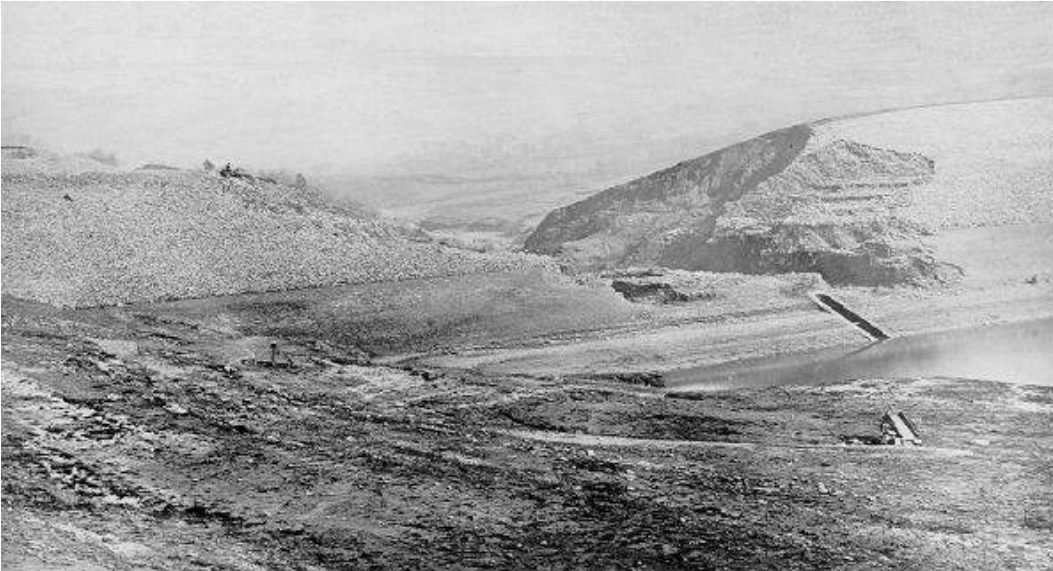
(A) The ruptured Dale Dyke dam embankment (UK) viewed from inside the reservoir, a few days after the disaster - Completion: 1863, Failure on 11 March 1864 because of piping and poor construction standards, 150 lives lost

All these structures are potentially erodible when overtopped, unless an overtopping protection system is designed. During the 19th to 21st centuries, numerous embankment structures failed worldwide (Fig. 3). With embankment dams, the two most common causes of failures were dam overtopping and cracking in the earthfill. The former issue is linked with inadequate spillway capacity, while the latter is the result of a combination of poor understanding of geotechnical concepts, inappropriate construction standards and internal failure (Fig. 3A). In recent years, a number of large floods caused dam overtopping because of the insufficient storage and spillway capacity of existing reservoirs. Figures 3B, 3C and 3D illustrate some examples of catastrophic failures. In each case, the spillway capacity became insufficient during a major hydrological event. A related form of embankment dams is the "natural dam" created by landslides and rockslides. For example, during the May 2008 earthquake in the Sichuan Basin (China), several lakes were formed, and some were artificially breached because they were natural hazards (Yin et al. 2009).

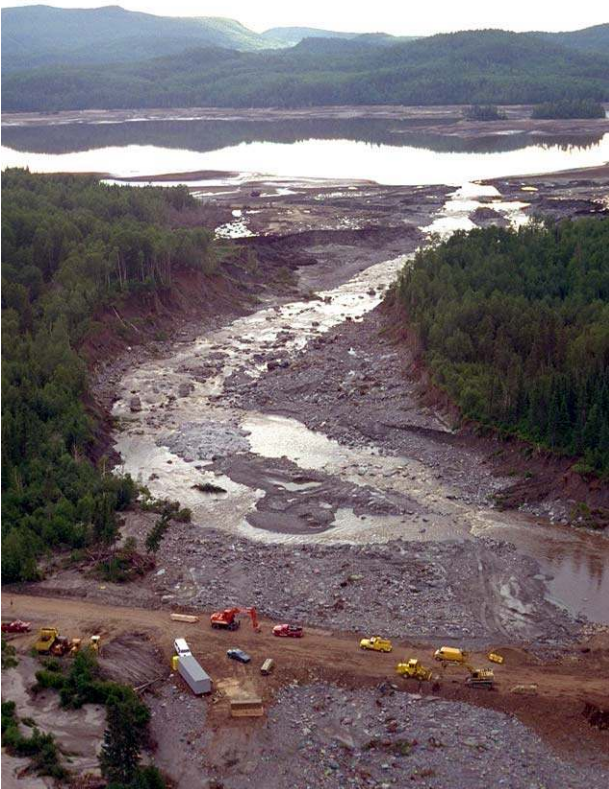
(B) Lake HaHa! failure (Canada) (Courtesy of Natural Resources Canada) - Failure in July 1996 because of inadequate spillway capacity

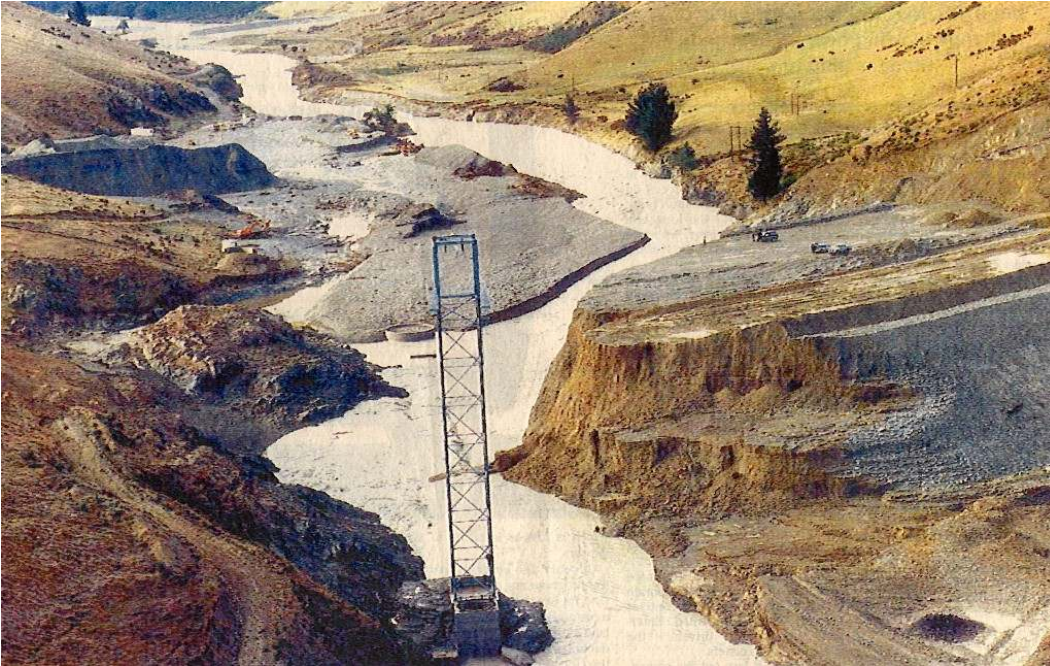
(C) Failed Opuha embankment dam (NZ) on 6 February 1997 (Courtesy of Tonkin and Taylor) - Completion: 1999, H = 50 m, L = 100 m, Failure by flood overtopping during construction

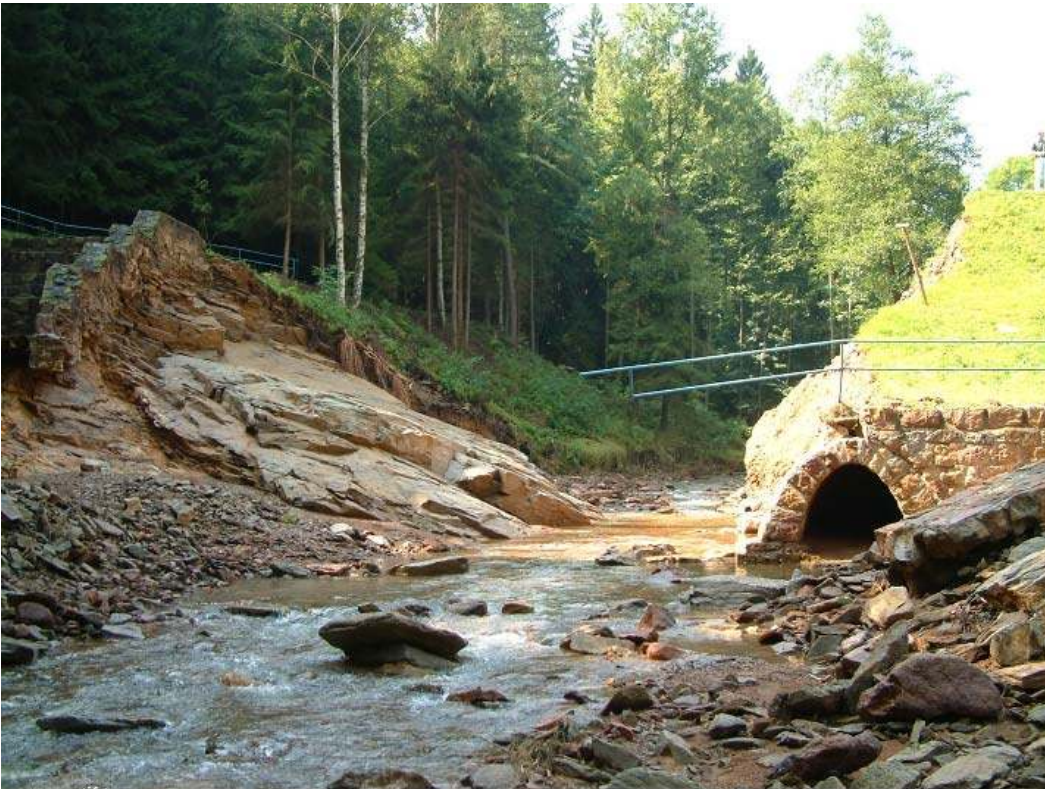
(D) Failed Glasshütte embankment dam (Germany) looking upstream (Courtesy of Dr Antje Bornschein) - Completion: 1953, H = 9 m, Failure on 12 August 2022 because of inadequate spillway capacity

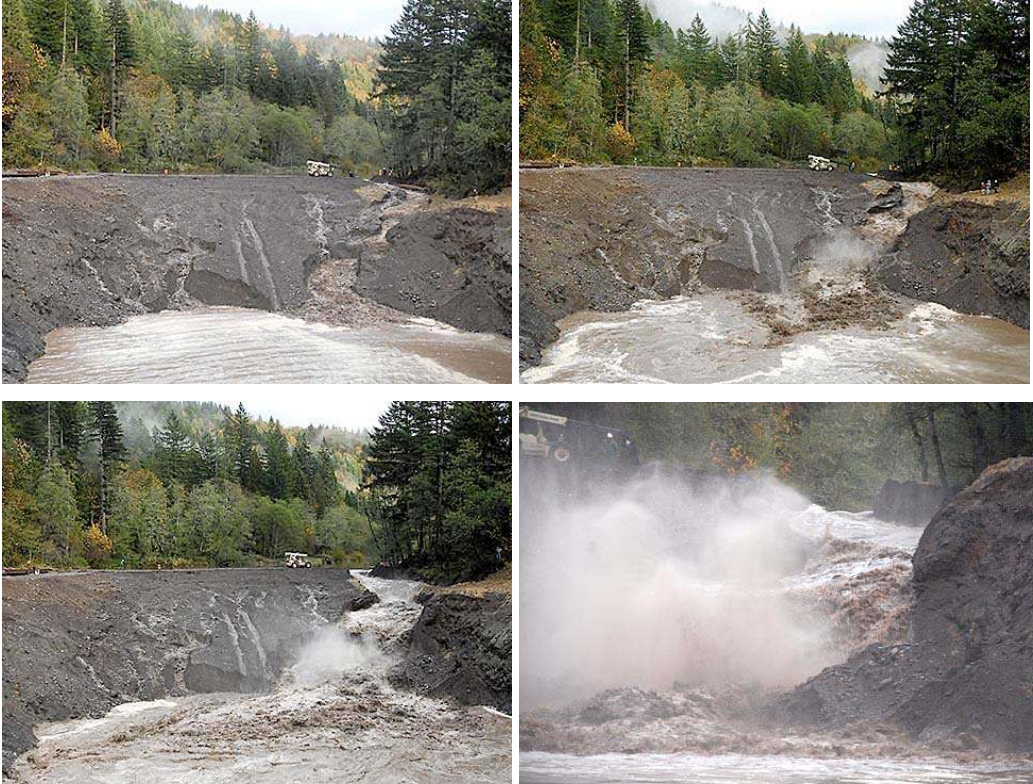
(A) Marmot Dam cofferdam breaching (USA) on 19 October 2007 (Courtesy of Portland General Electric) - The cofferdam was built as part of the Marmot (concrete) dam removal to restore fish migration along the Sandy River

The breaching of an overtopped embankment is a relatively slow process, for example in comparison to the failure of a concrete dam. While the latter may be a sudden, explosive failure, an earthfill structure may sustain some overtopping for some times before the breach develops and progressively opens leading to the complete failure (Fig. 3). For example, the Glashütte dam (Fig. 3C) was overtopped for near 140 minutes before the wall failed within 30 minutes (Bornschein and Pohl 2003). Figure 3 shows several examples of embankment dam failures, and Figure 4 presents some photographs of the embankment breaching process.

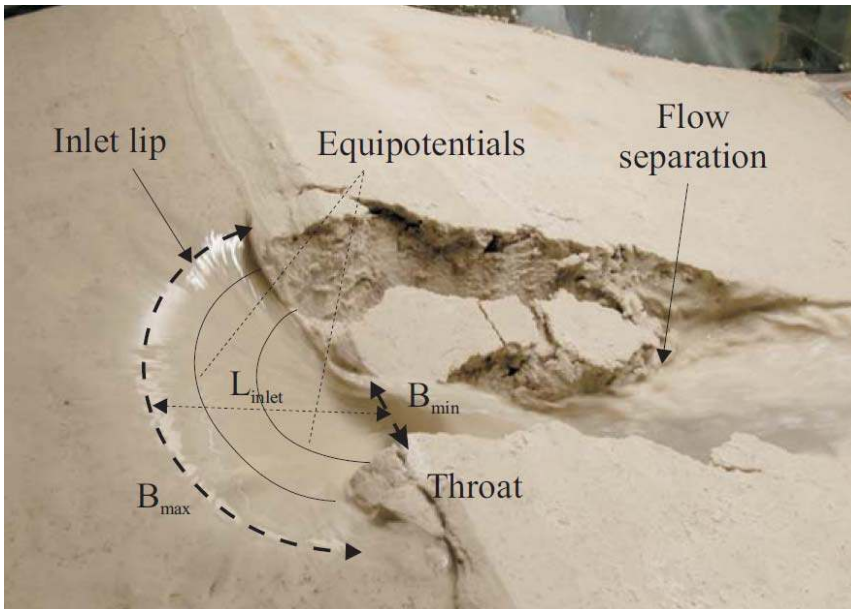
(A) Definition sketch

Fig. 5 - Physical measurements of non-cohesive embankment breaching - Data set: Coleman et al. (2002), data re-analysis by the author, embankment height;  $H_1 = 0.30$  m, length:  $L = 1.7$  m, upstream and downstream slopes: 1V:2.7H, 1.6 mm sand, constant upstream head experiment

Several studies on embankment breach were conducted during the last decade (Coleman et al. 2002, Rozov 2003, Vaskinn et al. 2004, Chanson 2005, Dai et al. 2005, Hanson et al. 2005, Hunt et al. 2005, Morris et al. 2007, ASCE/EWRI Task Committee on Dam/Levee Breaching 2011, Orendorff et al. 2011). Most physical studies under carefully-controlled laboratory flow conditions, together with prototype observations, showed that the embankment breach starts with an initiation phase, followed by a rapid development of the breach, and then an enlargement of breach width once the breach invert reaches the channel bed rock. Observations of embankment breach scour showed a challenging similarity with the flow in a minimum energy loss weir inlet during the breach development (McKay 1970, Visser et al. 1990, Chanson 2004). This was nicely illustrated by two seminal physical studies of the breaching of non-cohesive embankment structures (Coleman et al. 2002, Rozov 2003). It is also seen in Figures 4B and 5A, and movie 2 (Appendix A, Table 1). Figure 4B show the initial stages of the breach development (first 5 photographs), with some basic definitions in Figure 5A, while the movie 2 shows the progressive enlargement of the breach during the development. Figure 5 presents some quantitative data by Coleman et al. (2002).

where  $H_1 - z_{\text{crest}}$  is the upstream head above spillway crest and  $B_{\max}$  is the crest width (see definition in Fig. 5A). A MEL spillway channel could be designed to achieve critical flow conditions at any position along the chute and, hence, to prevent the occurrence of a downstream hydraulic jump with high tailwater conditions. Assuming negligible energy loss along the inlet, the channel width  $B$  at any elevation  $z - z_{\text{crest}}$  beneath the crest above the weir toe should satisfy:

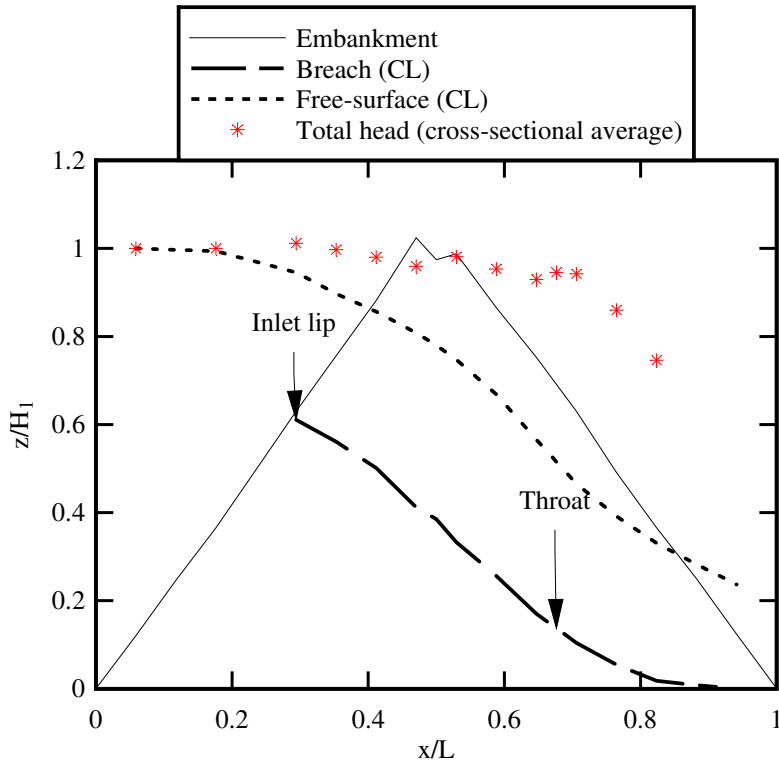
(C) Longitudinal bed elevation and total head along breach centreline,  $t = 87$  s,  $Q_{\text{breach}} = 0.024$  m<sup>3</sup>/s

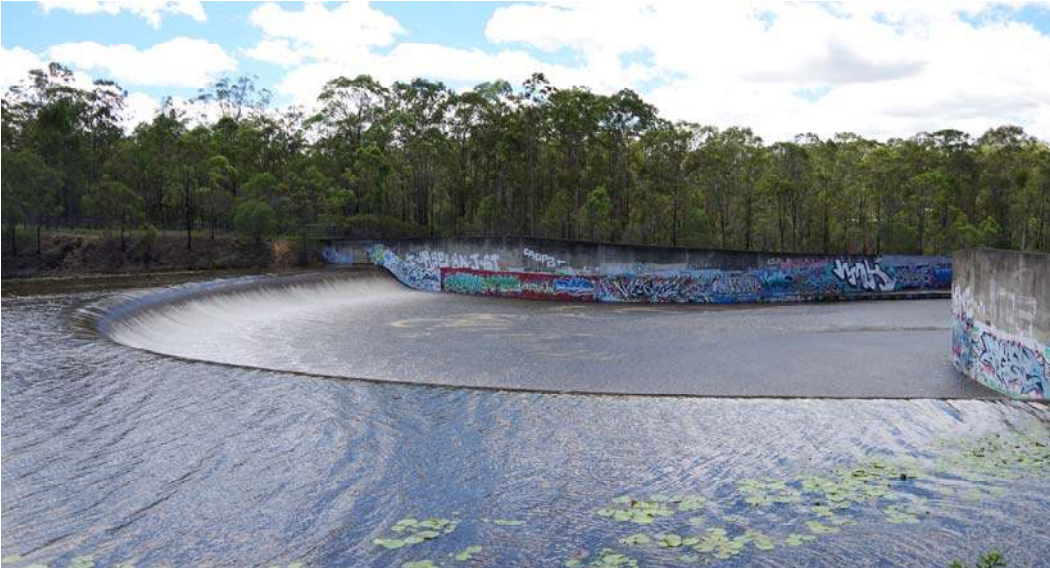
(A) Minimum energy loss spillway inlet of Lake Kurwongbah (Brisbane, Australia) in operation on 29 January 2013

inlet lip to throat was somehow similar to the flow through a minimum energy loss (MEL) spillway inlet (see next paragraph). For example, let us compare Figure 4B with Figure 6A.

The MEL overflow spillways are typically earthfill structures protected by concrete slabs (Fig. 6) and the construction costs must be minimum. The operations of a number of MEL spillways and weirs were documented, with a complement of field inspections and discussions with designers (Table 2) (Chanson 2003,2009). A number of MEL structures were observed to operate at design flow conditions and for floods larger than design. Inspections during and after flood events showed the sound operation together with little maintenance. The successful operation of several structures for over 40 years has highlighted further considerations. Some improper approach flow conditions could affect adversely the spillway operation. MEL weirs are typically earthfill structures and the spillway section is protected by concrete slabs. An efficient drainage system must be installed underneath the chute slabs. A known issue is the overtopping risk during construction as for the Sandy Creek weir and Chinchilla weir (twice).

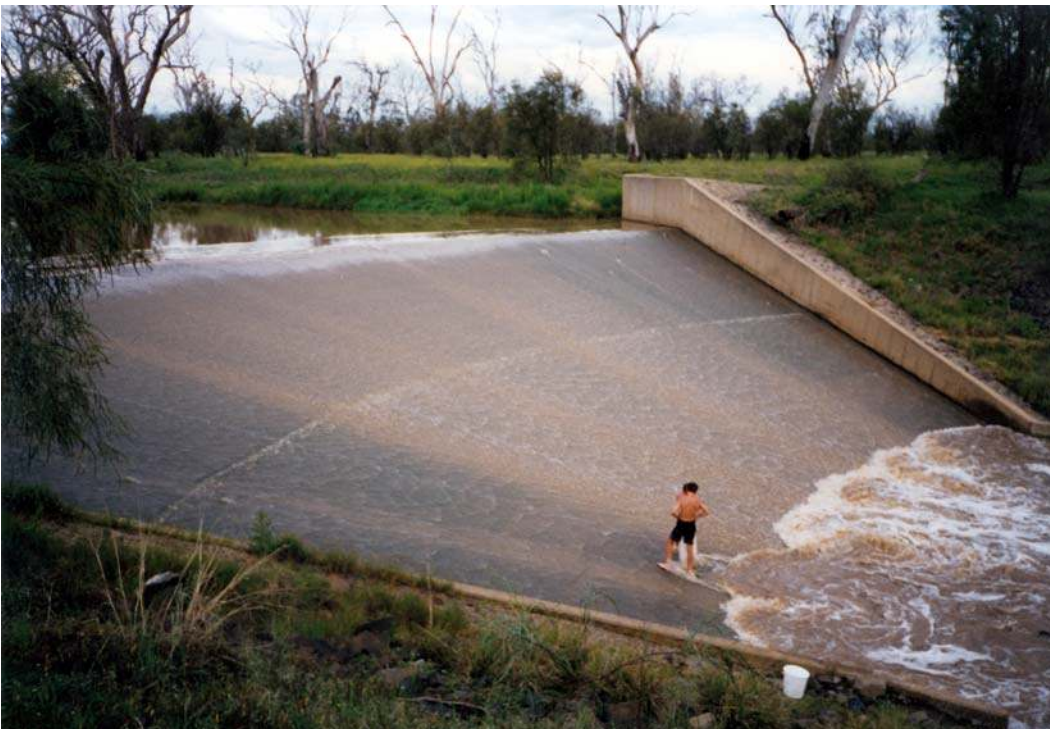
(B) Lemontree minimum energy weir (Australia) on 8 November 1997 for a small discharge ( $Q \ll Q_{des}$ )

An unusual embankment overflow protection system is the minimum energy loss (MEL) inlet design introduced in Australia during the 1970s (McKay 1971,1978). The first MEL inlet structure was the Redcliffe storm waterway system (1960); the inlet system is still in use and passed floods greater than its design flow ( $Q_{des} = 25.8 \text{ m}^3/\text{s}$ ) without damage (McKay 1970, Chanson 2007). The minimum energy loss (MEL) inlet was developed to pass large floods with minimum energy loss and afflux, where the afflux is the rise in upstream water level caused by the presence of the embankment structure. Commonly used in culvert design, the afflux is a quantitative measure of the upstream flooding caused by the hydraulic structure. In the approach flow region, the water discharge is smoothly converged towards a streamlined chute, the MEL inlet system, and the design yields a nearly-constant total head along the waterway (Fig. 6). Figure 6 presents two prototype applications during a low flow operation. The approach flow region and MEL waterway are streamlined to avoid significant form losses. At design conditions, the flow may be critical from the inlet lip to the chute toe. The MEL inlet system was developed for embankment dam applications where the river catchment is characterised by large rainfalls and a very small bed slope. Figure 6A shows the MEL inlet at Lake Kurwongbah dam spillway: the efficient inlet design allowed and extra 0.457 m of water storage for the same maximum discharge capacity (McKay 1971). Figure 6B presents an overflow MEL embankment weir.

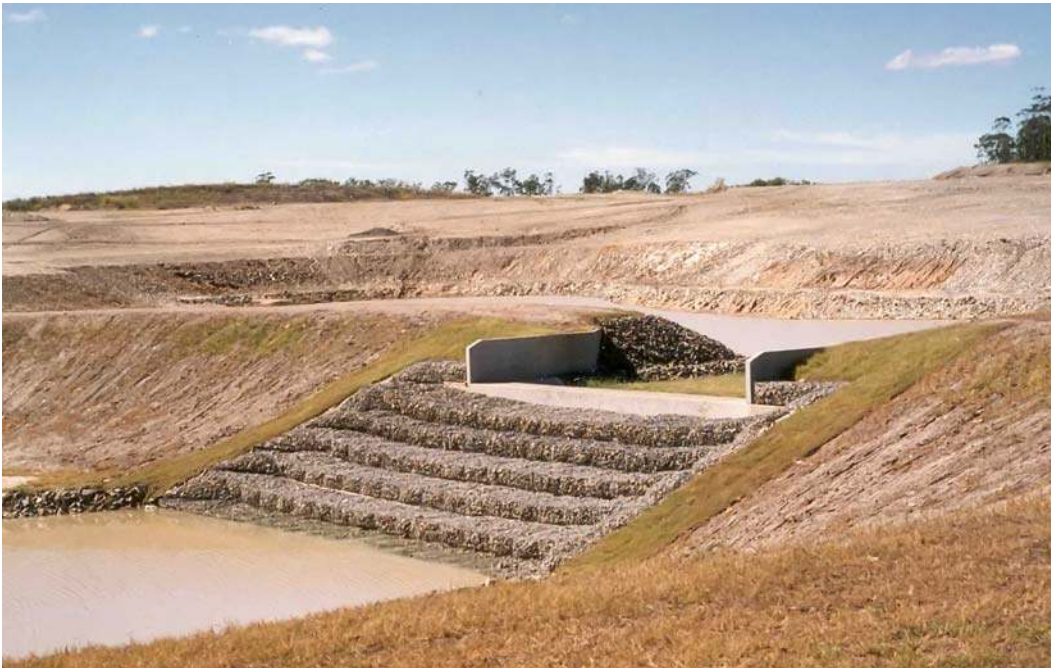
Fig. 7 - Gabion weir: Robina stepped weir No. 1 (Gold Coast, Australia) on 2 April 1997, shortly after completion:  $h \sim 0.5$  m,  $h/l \sim 0.5$

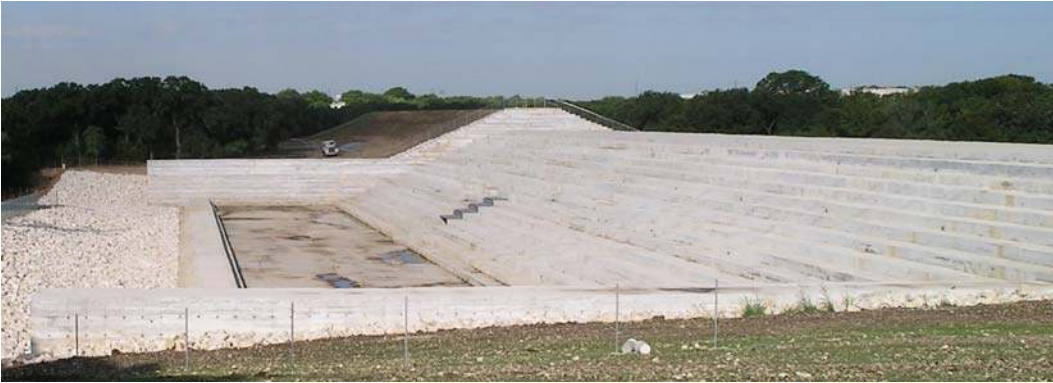
(A) Salado Creek Dam Site 15R in February 2005 (Courtesy of Craig Savelle, USDA)

During the last decades, a number of embankment dams were equipped with an overflow concrete stepped spillway (Chanson 2001) (Fig. 8). Applications included both primary and secondary spillway structures: Figure 8A illustrates a recent embankment dam equipped with a primary embankment overflow stepped spillway. Most modern stepped spillways consist of flat horizontal steps, although different step configurations may be considered (Andre et al. 2004, Gonzalez et al. 2008, Guenther et al. 2013, Felder and Chanson 2014). The preferred construction method is the placement of roller compacted concrete (RCC) overlays on the downstream embankment slope (Ditchey and Campbell 2000). Roller compacted concrete (RCC) is defined as a no-slump consistency concrete that is placed in horizontal lifts and compacted by vibratory rollers. During the construction, the RCC is placed typically in a succession of 0.2 to 0.4 m thick overlays with a width greater than 2.5 m for proper hauling, spreading and compacting. The advantages of RCC construction are the cost effectiveness and the short duration of construction. For an embankment overtopping protection, exposed RCC is frequently used for secondary spillways with infrequent overflows. In harsh climatic conditions, or for a primary spillway, a conventional concrete protection layer may be installed to protect the RCC. In all the cases, a drainage layer beneath the concrete overlays is essential to prevent uplift pressures. Its purpose is to relieve pore pressure at

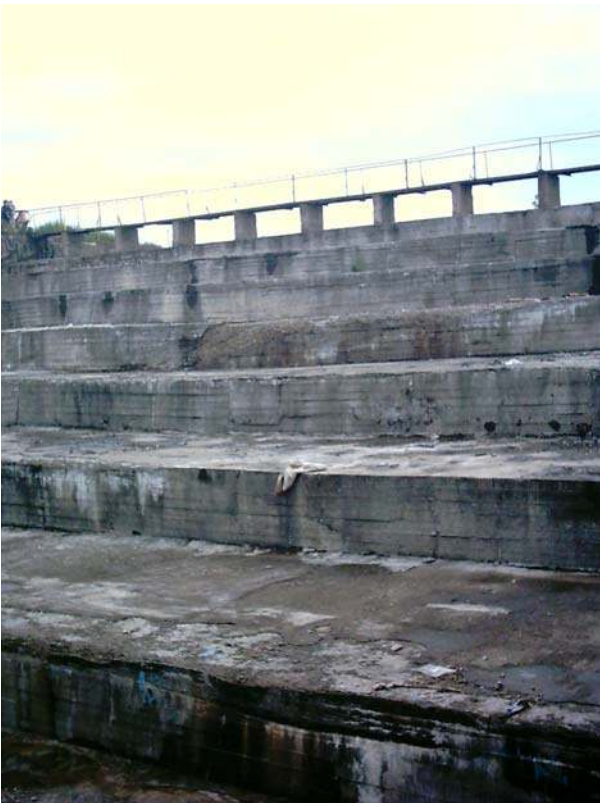
(B) Old 17th century rockfill embankment with timber crib overflow near Moscow (Russia)

(Courtesy of Dr Marat Mirzoev) - A concrete stepped chute was installed in the last twenty years

The performances of gabion stepped weirs are often restricted by the gabion resistance to damage and their stability. Sediments and debris carried by the stream flow may affect and fracture the gabion mesh. With large-size debris, it is common practice to protect the step surfaces with timber, steel sheets, concrete facing or even reinforced concrete slab (Agostini et al. 1987, Peyras et al. 1992). Figure 8B show a more extreme example of concrete facing.

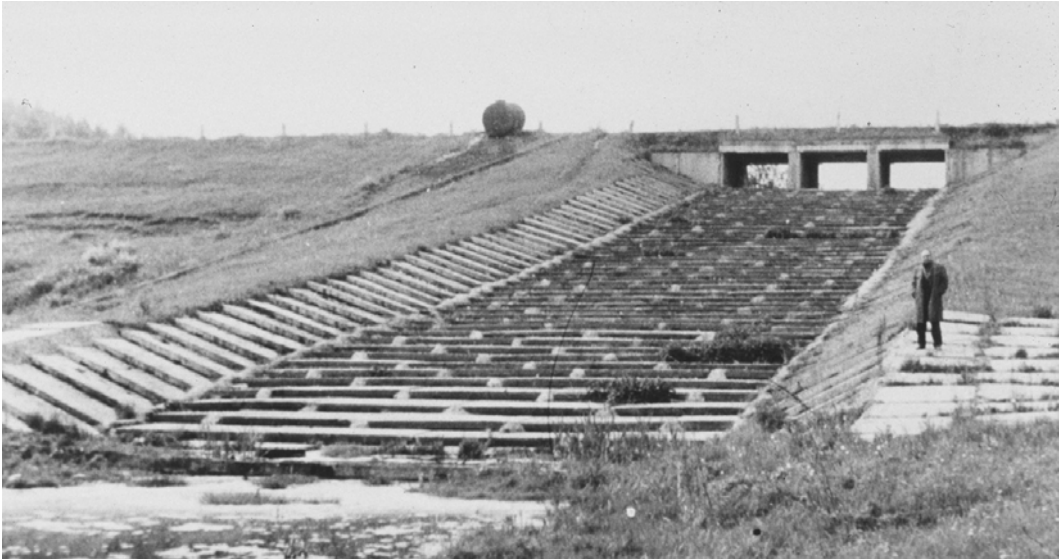
(A) Sosnovsky dam (Russia) (Courtesy of Prof. Y. Pravdivets)

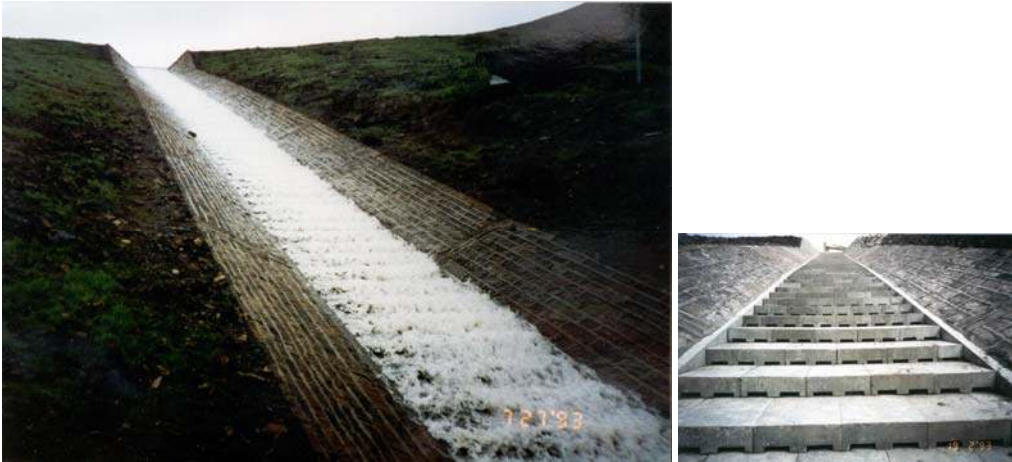
(B) Brushes Clough dam (UK) in 1993 (Courtesy of Mr Gardiner, NWW) - Left: small overflow; Right: details of the concrete block placement

blocks, possibly made of reinforced concrete. A step height-to-length ratio in the range 1:4 to 1:6 may ensure maximum stability of the blocks during the overtopping. Drains must be placed in areas of sub-atmospheric pressure to relieve uplift pressures (Fig. 10B). Figure 10B illustrates some drains on the vertical step face.
