CHAPTER 240

EMERGENCY SITUATION IN THE SHORELINE REACH OF AN OFFSHORE OILFIELD PIPELINE AND REMEDIAL MEASURES

Abstract

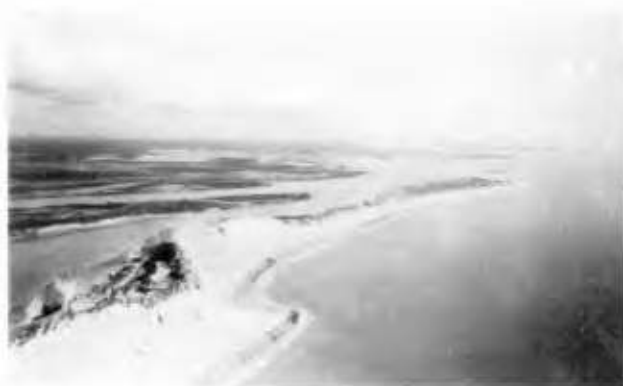
Figure 3. Galinhos Spit

The region is a flat sand beach, with a mean slope 1/1360 between 0 and -10m depth contour, in a coast with an E-W alignment (Fig. 2) and subjected to the action of waves coming from the NE quadrant and winds blowing from N to SE. The currents outside the breaker zone, with velocities up to 0,5m/s, have a westward resultant and are also influenced by the tide which is semi-diurnal and has amplitudes ranging from 1.0 to 3.1m (INPH 1981) (Moreira et al. 1987). In consequence, there is a westwards littoral drift which promotes the growth of spits in the region (Fig. 3).

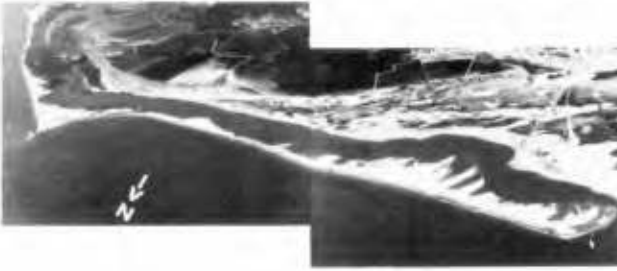
Figure 5. Spit at the Pipelines Region
Date: 03/16/88 Hour: 15:30 W.L.= +3.1m (H.W.)

When the pipelines were buried, the shoreline presented no problems. Nevertheless, there existed eastwards a spit, almost parallel to the shoreline, originating in a nearshore island situated in front of Guamaré village. With the growth of this spit (Fig. 5), which defines, between it and the mainland, a double-entrance estuary, the pipelines region, in the shoreline, was submitted to a tidal current that eroded severely the seabottom under the two western pipelines, due to a narrowing of the tidal channel right in their placement, leaving in suspension an extension of about 40m of both lines (Fig. 6, 7, 8 and 9). One of them is a gas and the other an oil pipeline, both with an outside diameter of 0,66m and lined with a concrete coating, 7,6cm thick.

but, for environmental reasons and ease of construction it was situated at the narrowest section of the channel, near the mangrove region and west of it, as indicated in Figure 5, which was taken at the high water of a spring tide. In this way there was an increase in the tidal prism flowing through the eastern entrance.

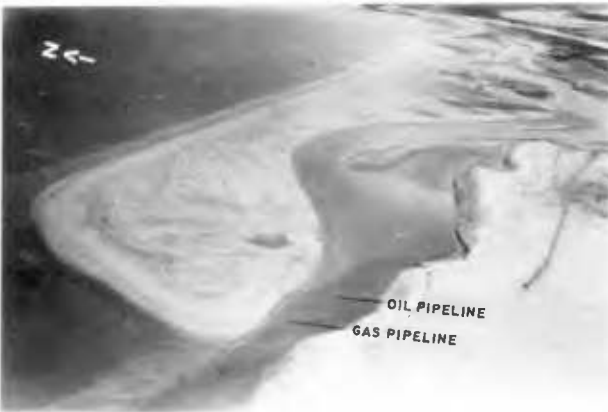
Figure 6. Undermined Pipelines
Date: 03/02/88 Hour: 10:24 W.L.= +0.7m

a) the oil pipeline was in a situation dangerously close to resonance conditions because: for a free length of the order of 50m its natural frequency of vibration would coincide with the vortex frequency caused by a current of 2.8 knots (1.4m/s) flowing in its surroundings. Indeed, the extremities of the suspended portion of the oil pipeline had already presented deep fissures in the concrete lining;

b) the gas pipeline, lighter than the oil pipeline and with a higher natural frequency would be in resonance for a free length of 70m and then it was in a situation of lesser risk than the oil pipeline.

The real free length of both pipelines were greater than the measured ones, as the pipelines would find effective support, only some metres inside the margins of the channel.

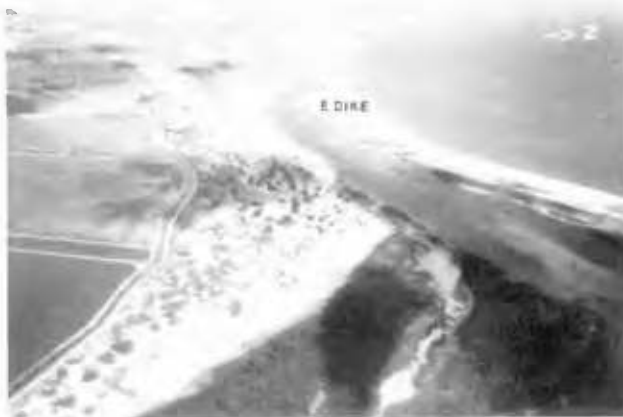
Figure 10. East Dike and Mangrove Region
Date: 04/07/88 Hour: 08:25 W.L. = +2.2m

The E dike was not constructed in the region where the tidal waves, entering the channel by both entrance, meet each other (mangrove region in Figure 10)

For the construction of the sand dikes, PETROBRAS made use of two bulldozers which piled sand in the two sides of the dike sections, and plastic bags filled with sand. Shortly before the low water of a neap tide, the plastic bags were placed in the deepest part of the channel section and, after that, the bulldozers, simultaneously from both sides, pushed the piled sand over the section, completing the closure.

The E dike (Fig. 10 and 11) was built on March 22, 1988 and the W dike (Fig. 12) three days after. There was a strong sediment deposition westwards of the western dike as expected (Fig. 12, 13 and 14) and on March, 1989, a rupture in the spit portion between the two dikes occurred during an equinoctial tide and is presently being monitored.

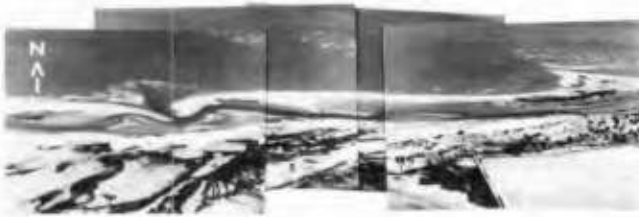
Figure 15. Disrupted Spit with the E Dike Opened
Date: 12/27/89 Hour: 9:55 W.L.= +0.7m

Then, when the rupture of the spit occurred (Fig. 15 and 16), PETROBRAS decided to open the E dike in order to re-establish the original tidal circulation in the mangrove area and in the eastern entrance (e.g. a decrease in the tidal prism flowing through this entrance). This action caused a correspondent increase in the tidal volume flowing through the new western entrance.

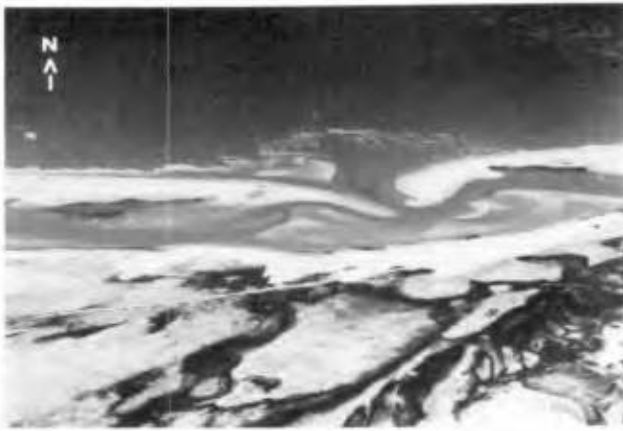
Figure 16. New Western Entrance
Date: 12/27/89 Hour: 10:00 W.L.= +0.7m

This new western entrance has now a greater tidal volume flowing through it than the original one (which is estimated in $425,000\text{m}^3$ relatively to the average tide amplitude), when the extremity of the spit was situated in the same region as the entrance. Now, there is a contribution of the tidal prism western of the mouth (in the channel between this mouth and the W dike) which is estimated in $326,000\text{m}^3$, giving a total tidal prism of the order of $751,000\text{m}^3$. This increased tidal volume flowing through the mouth added to the fact that now the flood flow branches E and W after crossing the mouth and the ebb flow coming from these two directions converges upon the entrance, may have an influence in the rate of advance of the mouth to W, compared to the velocity of migration of the spit when its extremity occupied the same region of the present mouth, from which there is no record.
