Engine Damage to a NASA DC-8-72 Airplane From a High-Altitude Encounter With a Diffuse Volcanic Ash Cloud

NASA/TM-2003-212030

August 2003

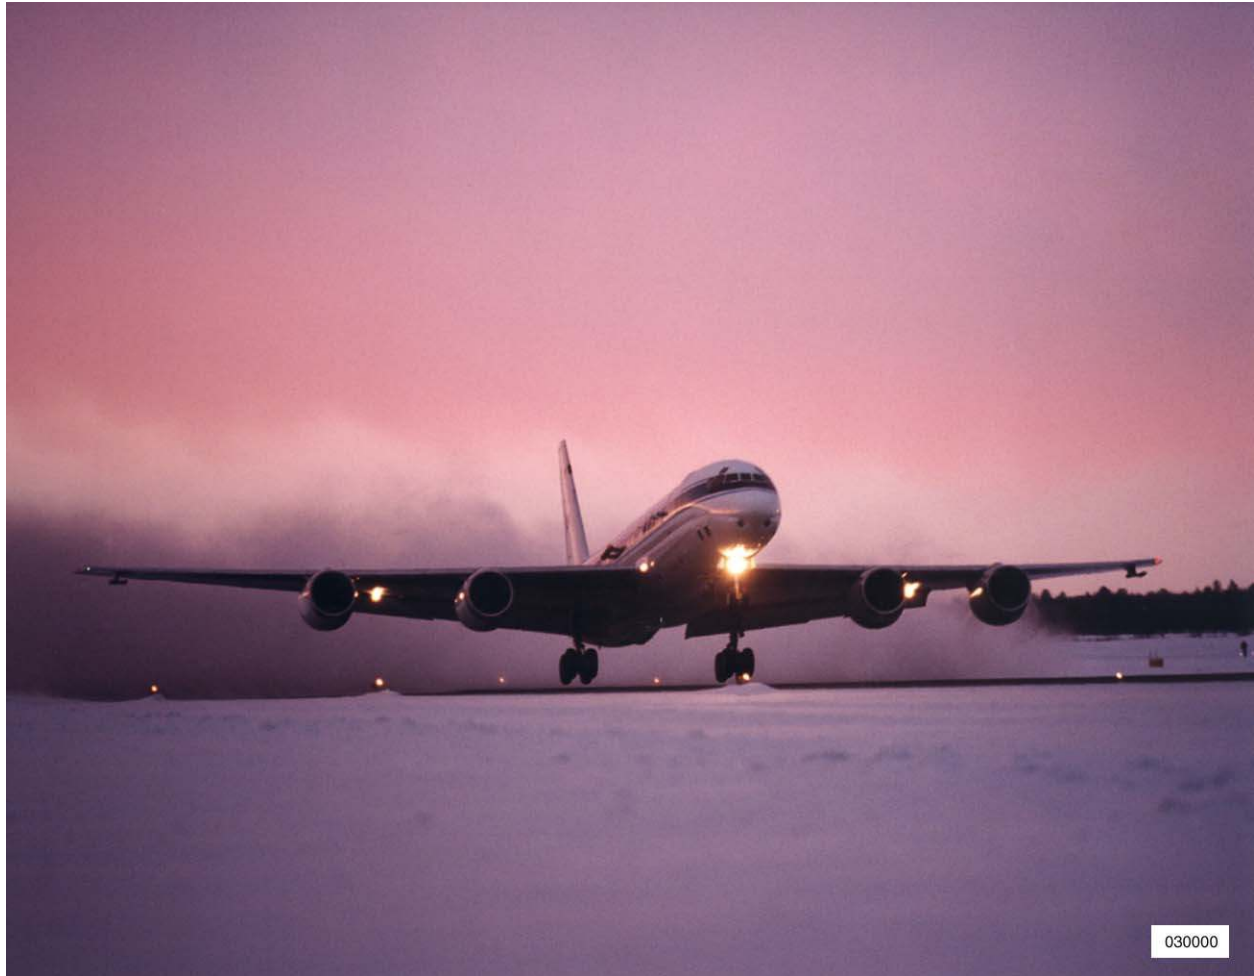
Figure 1. NASA DC-8 airborne sciences platform aircraft on takeoff from Kiruna, Sweden.

The NASA Airborne Laboratory DC-8 shown in figure 1 and described in reference 9 is a -72 configuration airliner specifically modified to serve as an airborne science platform airplane. It is 157 ft long, and has provisions for up to 17 experiment stations onboard. For the SAGE III Ozone Loss and Validation Experiment (SOLVE) missions the aircraft was configured for airborne chemistry research as described in reference 10. The DC-8 can fly in excess of 12 hr at altitudes up to 41,000 ft and Mach numbers up to 0.88. The airplane was re-engined with four CFM56-2 engines prior to delivery to NASA. The aircraft environmental system uses conditioned engine bleed air for aircraft pressurization and temperature control. Incoming outside air, which is filtered to remove particulate matter and moisture, is used to cool the bleed air as it passes through the aircraft heat exchangers.

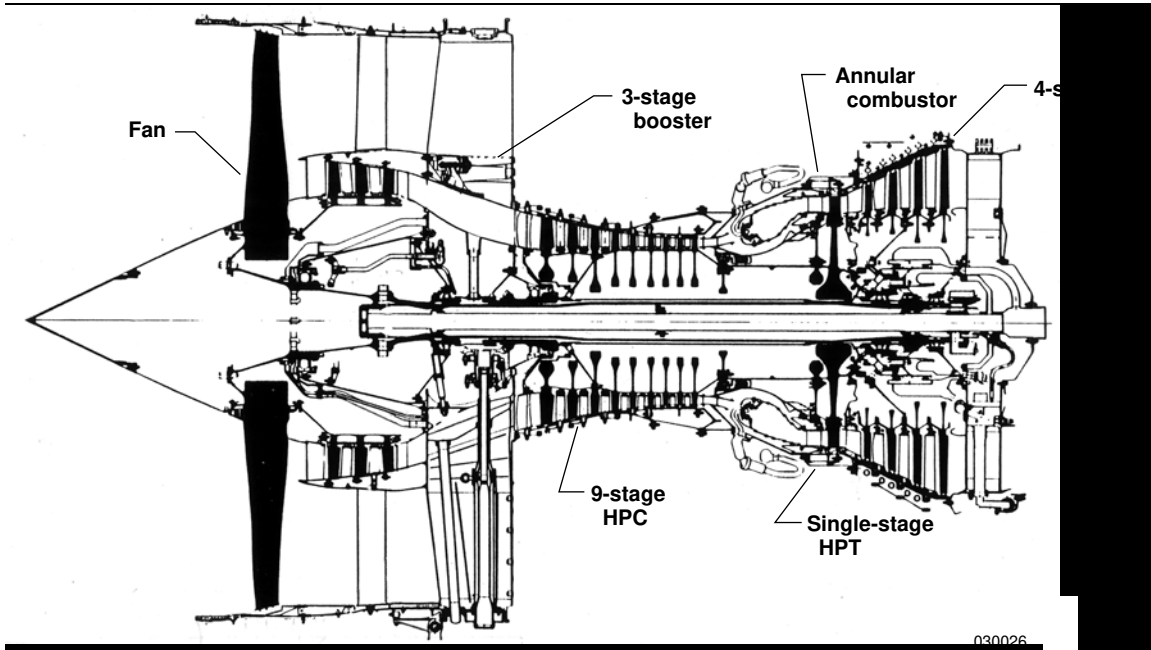
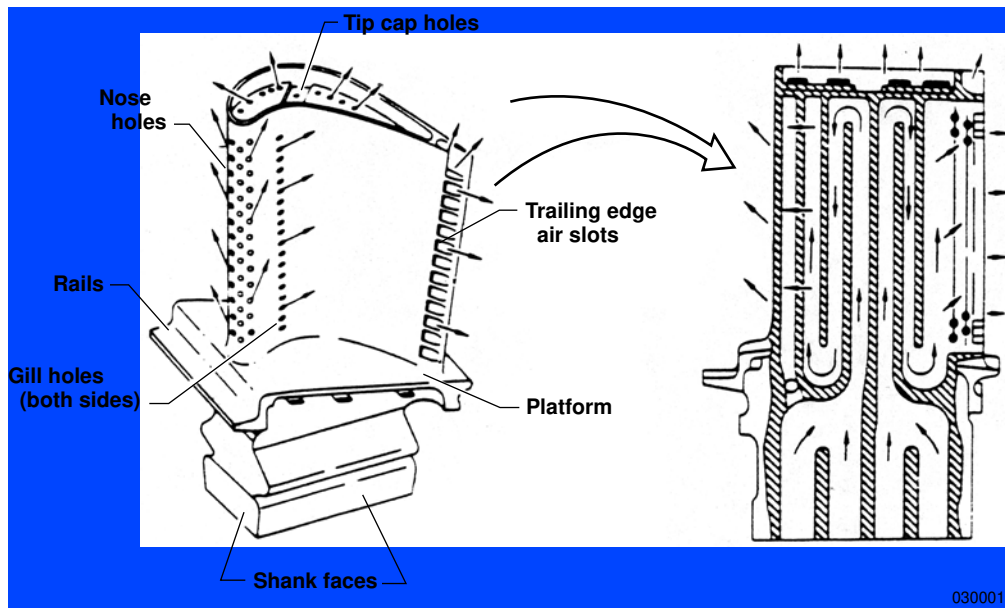
Figure 2. GE CFM56-2 high bypass turbofan engine.

(a) Cutaway view.

(b) High pressure turbine rotor blade cooling.

Figure 2 shows the CFM56-2 engine, which is a high bypass ratio, separate flow turbofan with a sea level static thrust rating of 22,000 lb, nominal bypass ratio of 6:1, an overall pressure ratio of 28:1, and a maximum exhaust gas temperature (EGT) of 1598 °F (870 °C). As shown in figure 2(a), the single-stage fan and three-stage booster compressor is driven by a four-stage low pressure turbine (LPT); only the first-stage LPT nozzle is cooled, using fifth-stage high pressure compressor (HPC) bleed air. A single-stage cooled high pressure turbine (HPT) drives the nine-stage high pressure compressor. The HPT blades and vanes feature air cooling through nose holes, gill holes, and trailing edge slots, using cooling air from the HPC discharge as shown in figure 2(b). The crew monitors the performance of the engine throughout each flight. At the start of cruise on each flight, performance data is manually recorded for engine trending.

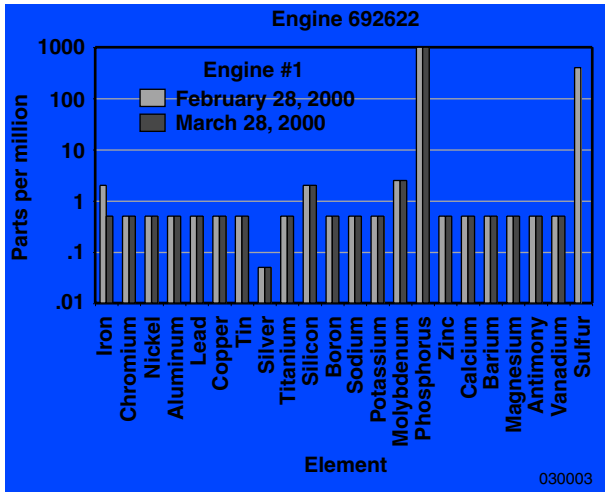
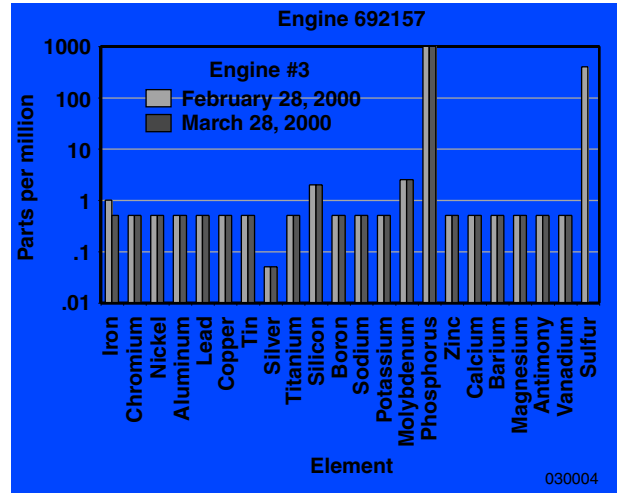
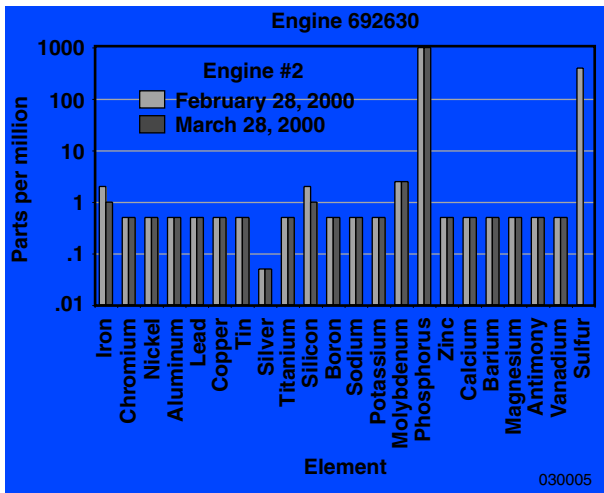
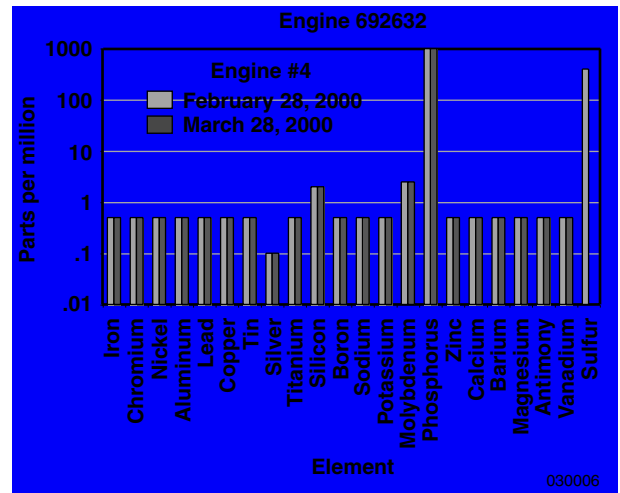
(a) Engine 692622.

(b) Engine 692157.

(c) Engine 692630.

(d) Engine 692632.

Figure 4. Engine oil sample results before and after oil change at Kiruna, Sweden, showing high sulfur content from ash encounter.

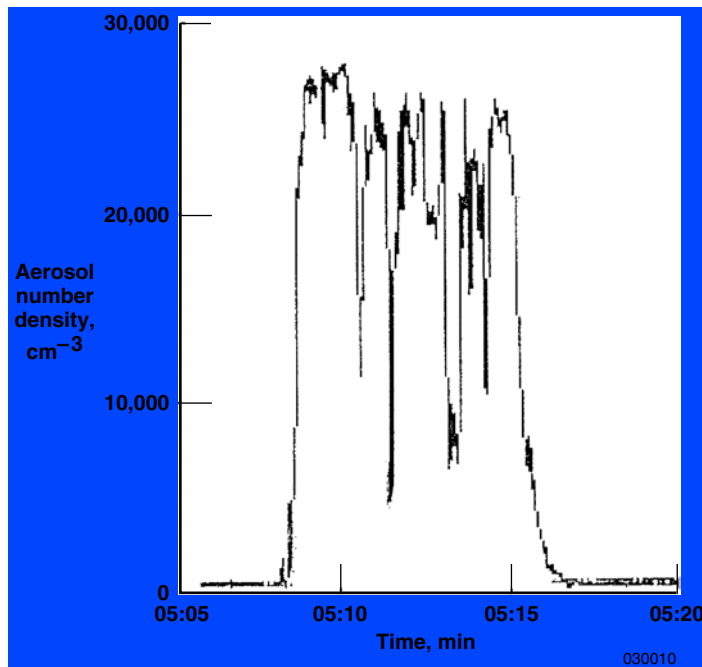
Figure 7. Onboard sensor data for the DC-8 volcanic ash encounter.

(a) SO₂ concentration, airborne Fourier transform infrared spectrometer.

(b) Aerosol data; airborne Langley condensation nuclei counter, 12 nm–1 micron.

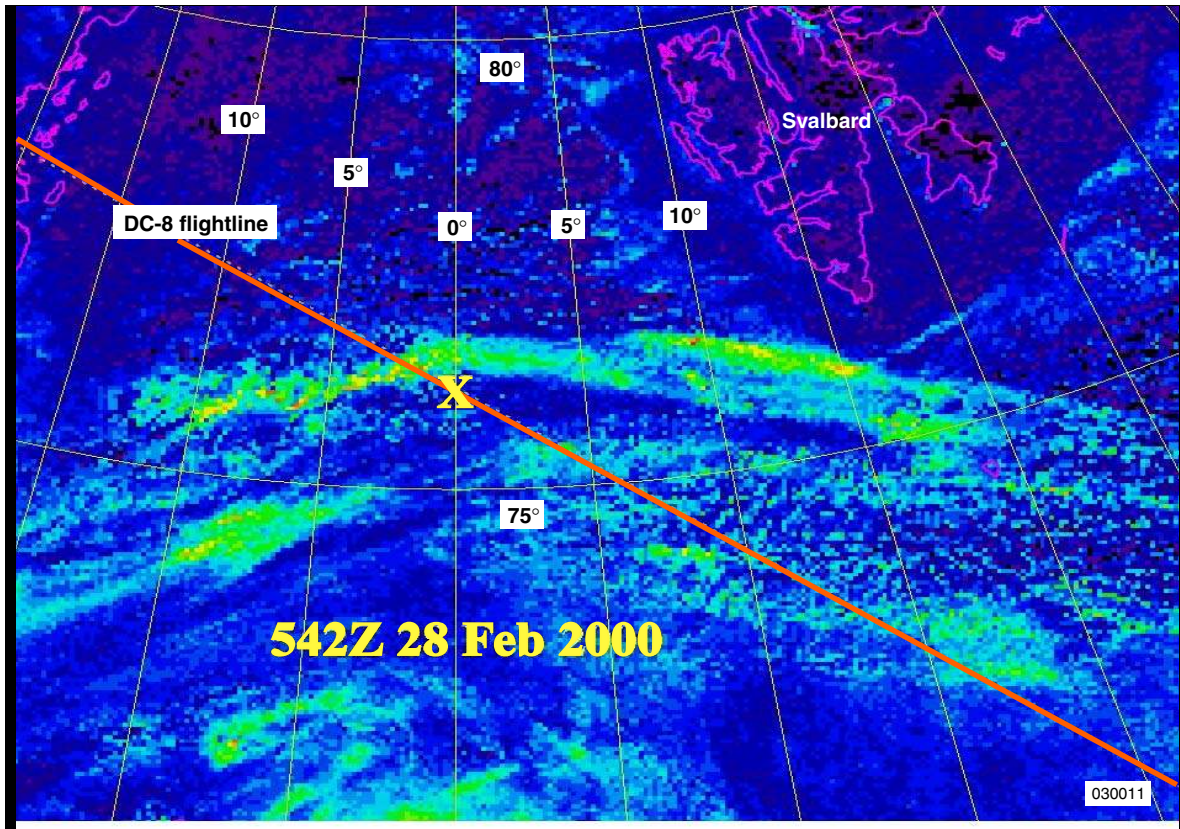
Figure 8. DC-8 flight track and ash cloud, inferred from satellite infrared radiometer data, 30 minutes after encounter.

Data from the weather satellite AVHRR was analyzed after the encounter and is shown in figure 8 with the DC-8 flight track. The difference between bands four and five is plotted, with the lightest shade being the largest difference. The satellite scan, taken 30 min after the end of the encounter, shows a band across the DC-8 flight track. Considering the probable slow northerly drift of the ash cloud, this appears to coincide very well with the ash cloud encounter time and duration. Other AVHRR data was analyzed and shows the movement of the ash cloud. This data is presented in reference 11 but was not available to the VAAC forecasters.

AVHRR satellite data (ref. 11) showed that a cloud band was traversed by the DC-8 at the time of the encounter (fig. 8). One investigator (ref. 11), using the inferred temperature difference between band four and band five of the AVHRR, concluded that the cloud was composed mostly of ice crystals and little ash. Another investigator (ref. 12), surmised that ash particles were present and likely formed condensation nuclei for the abundant moisture in the volcanic ash plume; thus most of the ash particles were believed to be ice-coated. Ice-coated particles are much less destructive to airplane parts such as windscreens and leading edges (ref. 5), but would still be damaging to engines as the ice would melt in the compressor — possibly explaining engine damage unaccompanied by airplane damage.

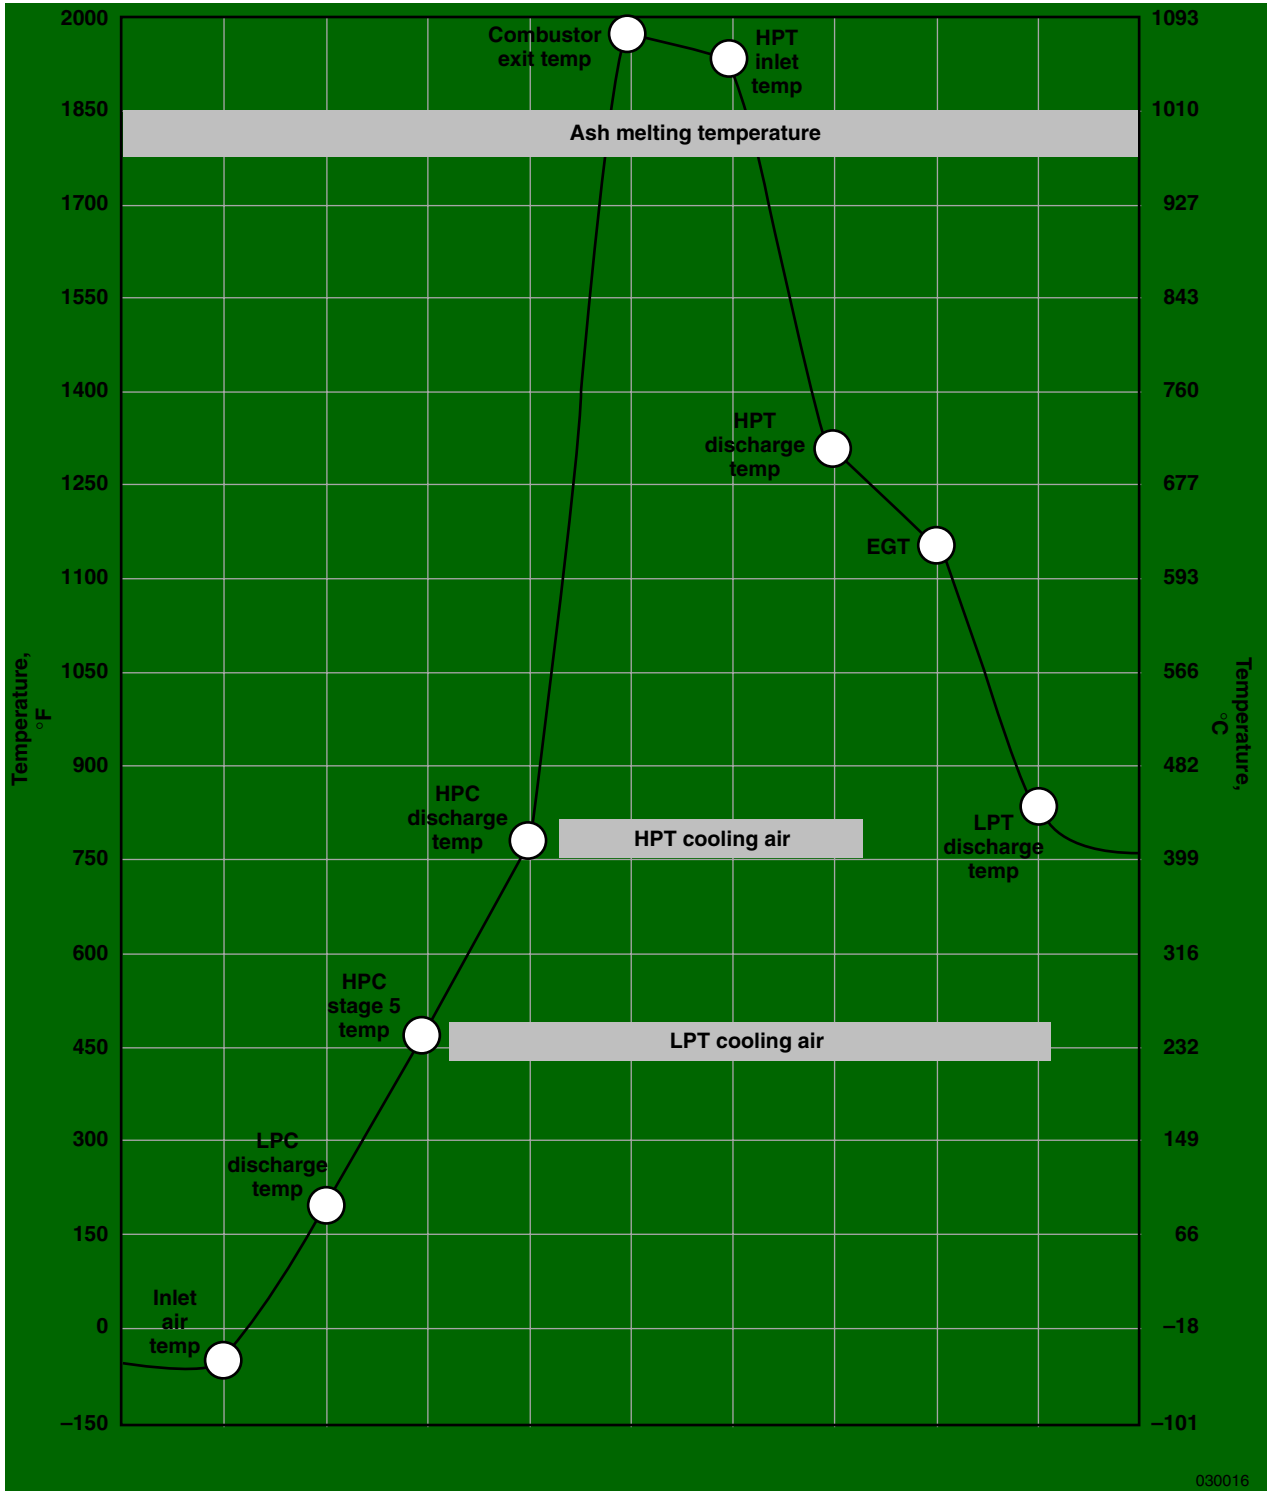
Figure 10. Estimated temperatures through the CFM56-2 at ash encounter conditions.

The engines were being operated in the “long range cruise” mode at the time of the encounter. Figure 10 shows estimated temperatures through the engine. Thrust was about 4300 lb per engine, and HPC discharge air (used for HPT cooling) temperature was 779 °F (415 °C). The combustor exit and HPT inlet temperatures were estimated to be well above the 1832 °F (1000 °C) ash melting temperature (ref. 3). The ash would have been expected to melt and fuse to the HPT vanes and blades both outside and on the inner cooling passages. The second- and third-stage LPT temperatures were estimated to be below 900 °F (482 °C), and since those blades are uncooled, no damage would be expected.

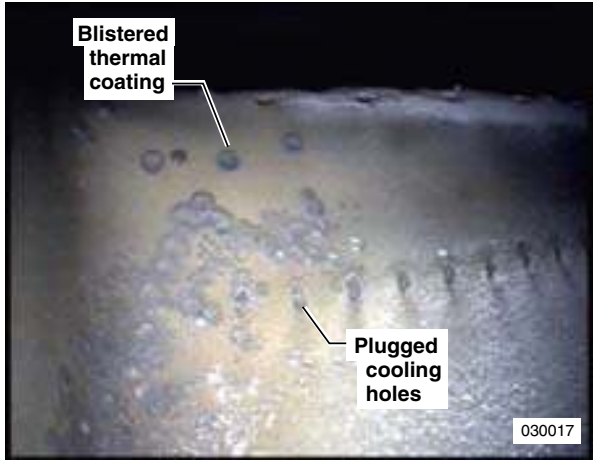
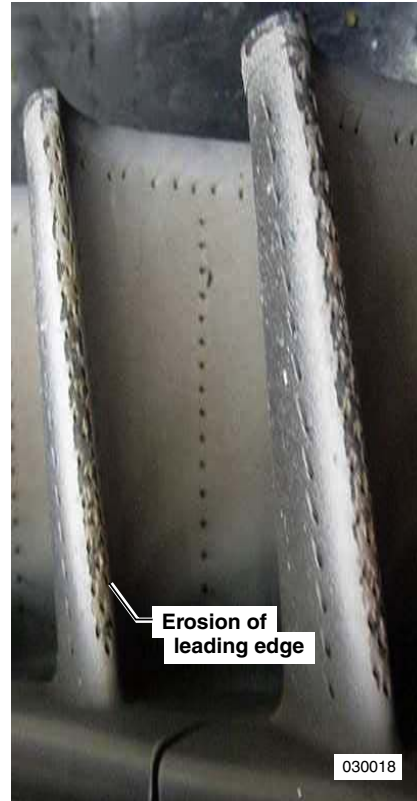
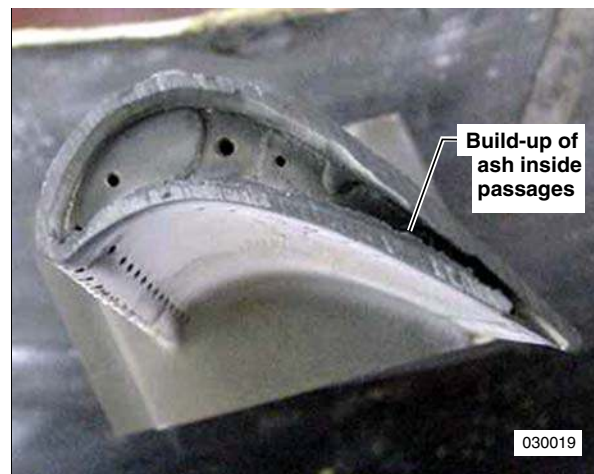
Figure 11. Photographs of damaged turbine blades from engine number 692632.

Even though this was a diffuse ash cloud, the exposure was long enough and engine temperatures were high enough that engine hot section blades and vanes were coated and cooling air passages were partially or completely blocked. The uncooled blades still performed aerodynamically but necessitated expensive overhauls. The insidious nature of this encounter and the resulting damage was such that engine trending did not reveal a problem, yet hot section parts may have begun to fail (through blade erosion) if flown another 100 hr.

(a) Blistered thermal coating, and plugged cooling holes.

(b) Erosion of leading edge.

(c) Build-up of ash inside passage.

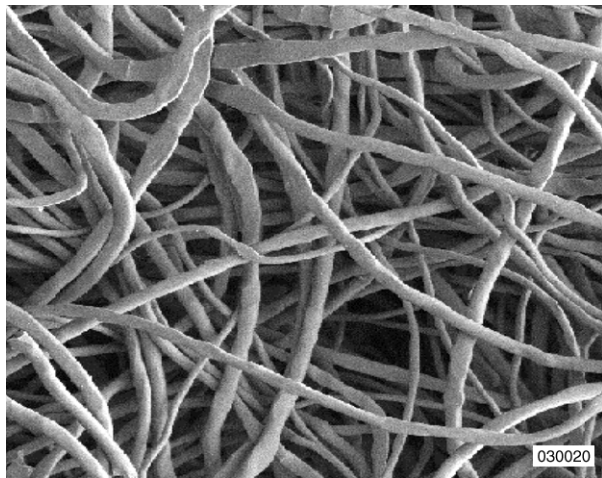
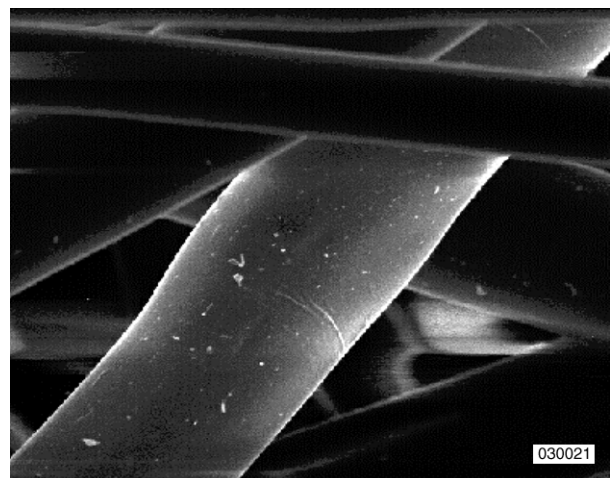
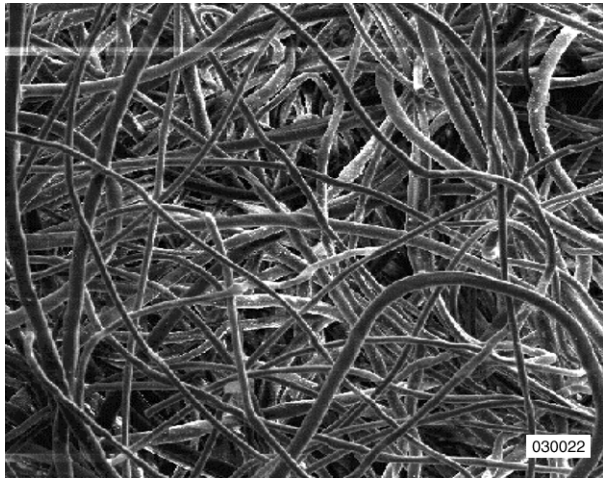
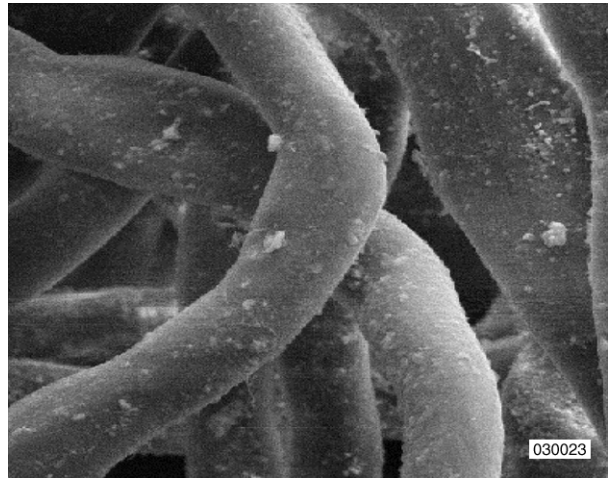
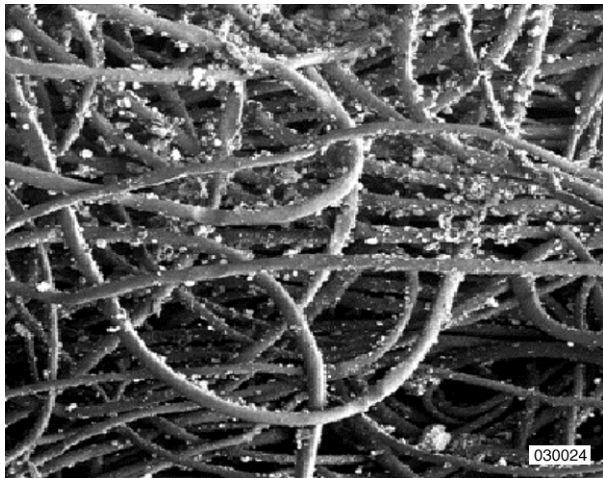
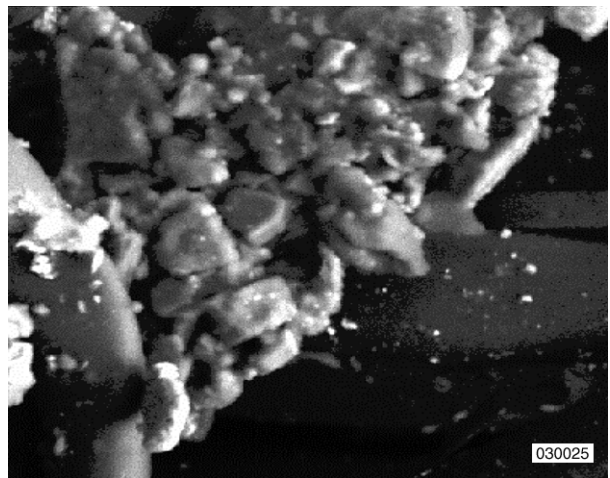
Figure 12. Photomicrographs of DC-8 heat exchanger filters.

(a) New unused filter 100 μm 150X.

(b) New unused filter 100 μm 2000X.

(c) Used filter—typical dirt, no ash 100 μm 150X.

(d) Used filter—typical dirt, no ash 10 μm 1500X.

(e) Filter after Hekla ash encounter 100 μm 150X.

(f) Filter after Hekla ash encounter 10 μm 1500X.

Samples of ash from the cabin air heat exchanger filters and the engine hot section were sent to two investigators experienced in analysis of volcanic plumes (refs. 11 and 12). Interpretations of findings differed. The heat exchanger filter, which was removed immediately after the encounter flight, showed clear evidence of basaltic volcanic ash particles between one and ten microns in diameter and clumped together in the fibers (ref. 12) (fig. 12). X-ray emission spectra from these samples were consistent with samples of the Mt. Hekla volcanic ash collected on the ground. The high sulfur content in the engine oil samples is also indicative of flight through the Mt. Hekla plume. Analysis of material removed from the engines was not so definitive, probably since 68 additional hours were accumulated before teardown.
