Research Paper

Engineering Geological Investigation of Adama Town: Implication to Engineering Practice

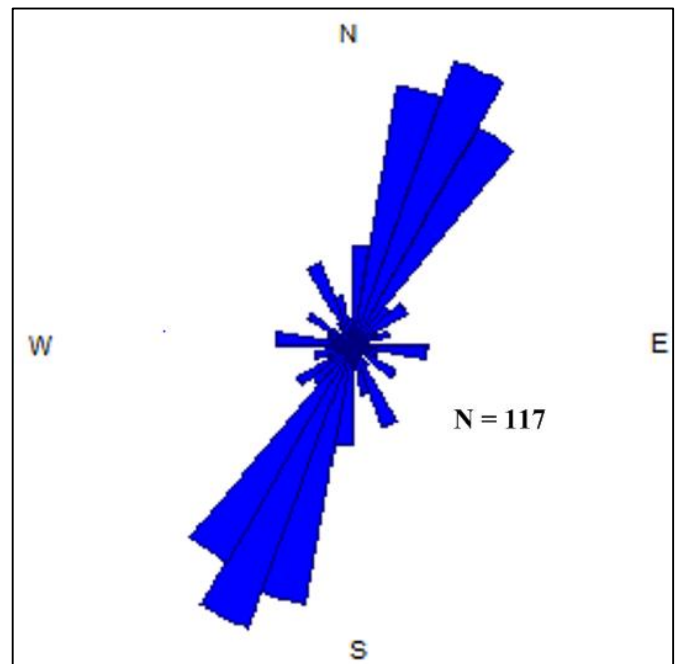
Figure 4: Rose Diagram of joints

The joints are the second common geological structure observed on all types of rocks found in the study area except volcanic ashes/pumice and scoria. About 117 joint orientation measurements and characterization are conducted at different part of the study area for the regularly oriented joint systems. Most of the joints are vertical (steeply dipping) and parallel to

the local faults. The major joint sets observed are N to NE strike. Not only this common range of structural orientations, but also there are some exceptional NW and E-W striking joints as shown on rose diagram (Figure 4).

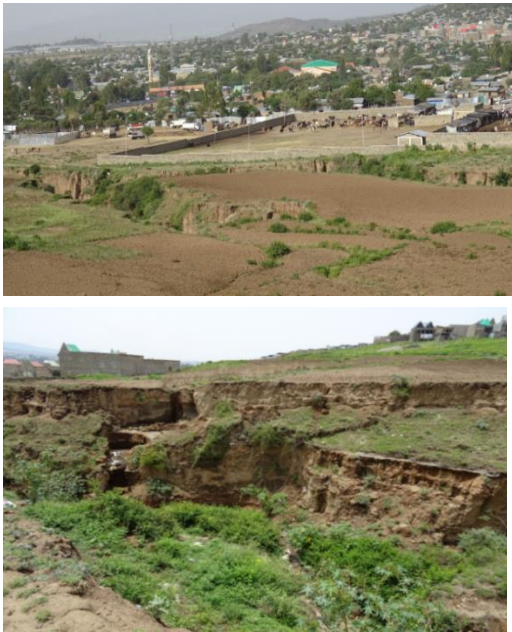
Figure 5: Partial view of active gully erosional features in southern (top) and south western (bottom) part of the town

study area is gully erosion. It formed deep gorges (gully) in different part of the town along drainage line by eroding loos soil and ash deposits. It posed major problem on land use of the town by modifying the landscape (Figure 5). Construction of cheek dams and gabions can considerably reduce the erodabilty and further increase of width of gully.

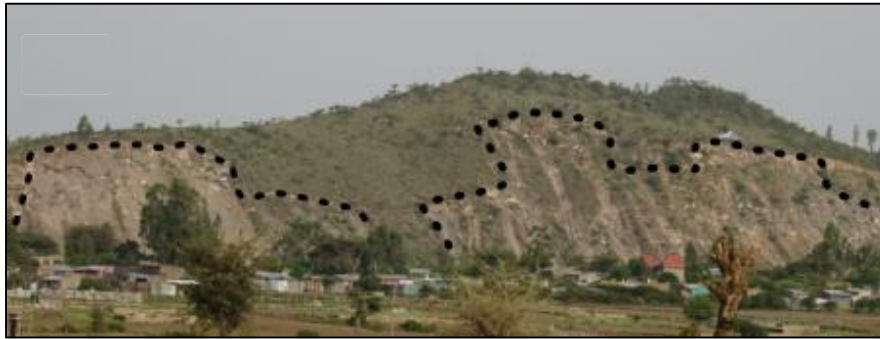
Figure 6: Land (debris) slide in the North-East part of the study area

Slope movement can be classified based on mode and rate of movement, the shape of sliding plane, type of sliding material and other criteria (Bell, 2007). From different types of slope movement, debris slide is observed in the north-east part of the study area on the fault scarp and ridge (Figure 6) in which fragmented rock (debris) slide down slope. Intense fracturing, weathering and human interference (quarrying at the base of ridge) are causative factors.
