# EROGRASS

Failure of Grass Cover Layers at Seaward and  
Shoreward Dike Slopes

*- Design, Construction & Performance -*

April 2009

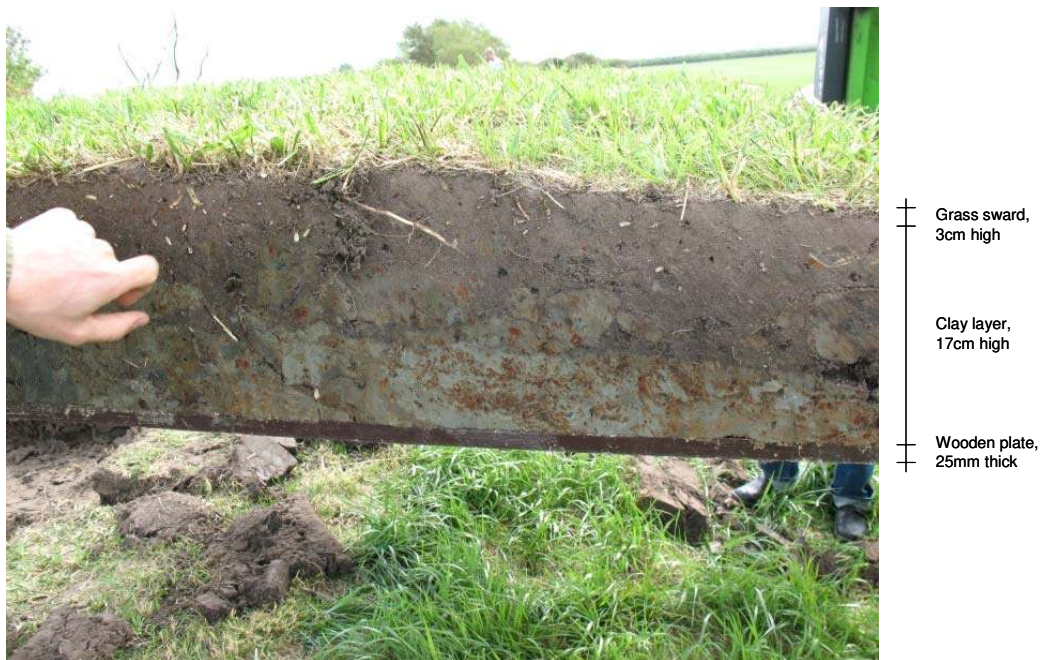
Figure 2.8 Cross section of a 20cm thick excavated grass sod.

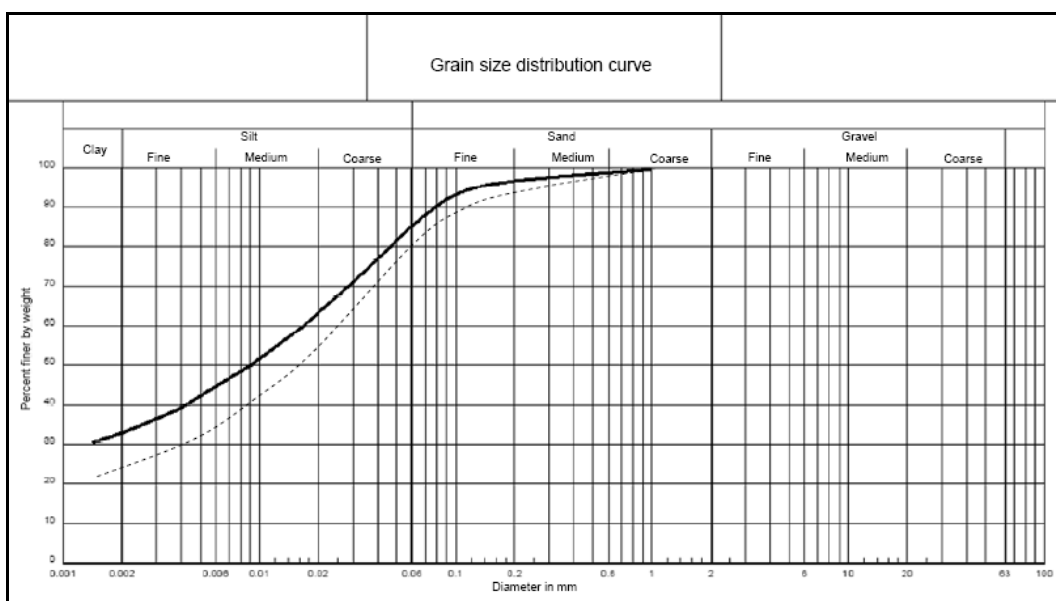
Figure 2.10 Grain size distribution of clay type A (continuous line) and clay type B (dashed line).

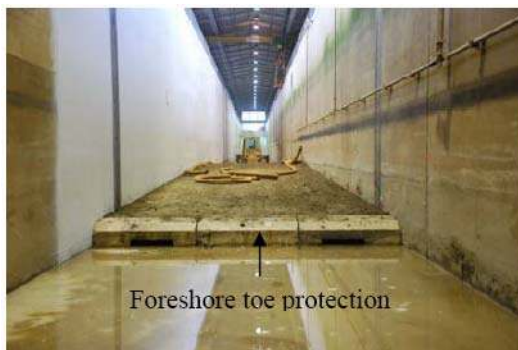
The construction of the dike model started with installation of the foreshore (Figure 3.1). The compaction density of the applied clay was measured several times during installation and ranged between 1.52 and 1.612t/m<sup>3</sup> with a moisture content of about 22.0% and 22.8%. The applied foreshore clay (Type A) was different to the clay (Type B) which was used for the clay layer at the dike model (cp. Table 2.4). The clay for the foreshore (Type A) was available at the Large Wave Flume. The toe of the foreshore was protected by three 1.33m long and 40cm high concrete blocks to avoid erosion of the foreshore toe (Figure 3.1).

Figure 3.1 Foreshore with toe protection (view from sea side).

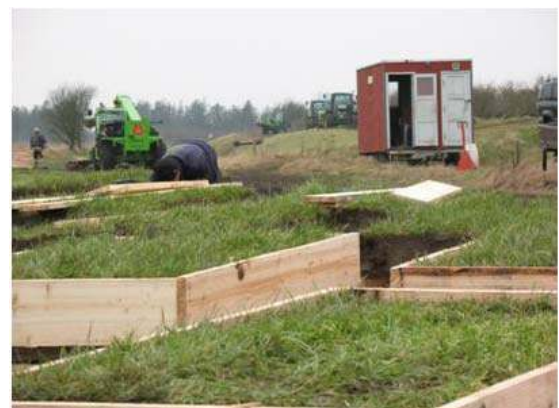
Figure 3.19 Construction of wooden frames around each grass sod.

For further handling and transportation four wooden beams were installed under the plate (Figure 3.18) and a wooden frame was built around the sod to avoid any damage or the appearances of additional fissures (Figure 3.19). All grass sods were stored on the field close to the wing dike for 1-3 days before the transport to Hannover started.

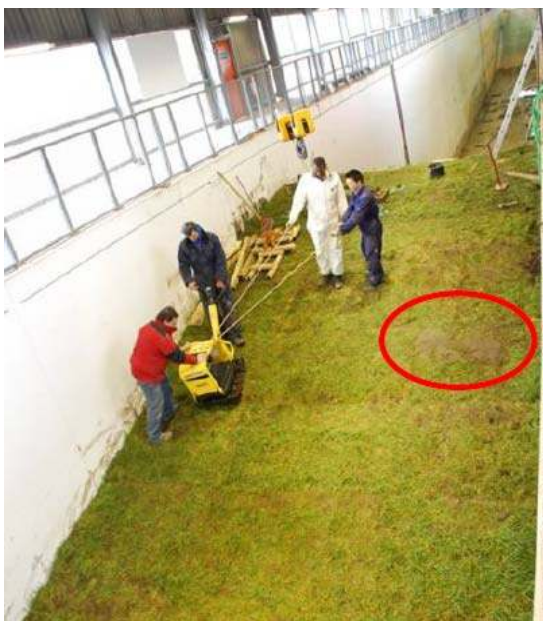
In order to plane the grass surface and to strengthen the connection between the grass sods and the underlying clay layer, the grass sods were compacted by using a vibrating plate (Figure 3.36). After a couple trials on the seaward slope, local damage of the grass cover occurred (red circles in Figure 3.36 and Figure 3.37) and the compaction of the grass sods was stopped.

Figure 3.36 Compaction of grass layer on seaward slope.

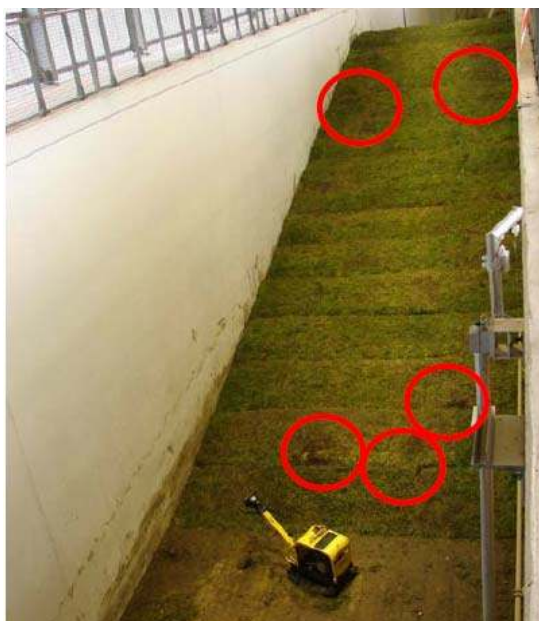
Figure 3.37 Damaged grass surface due to compaction.

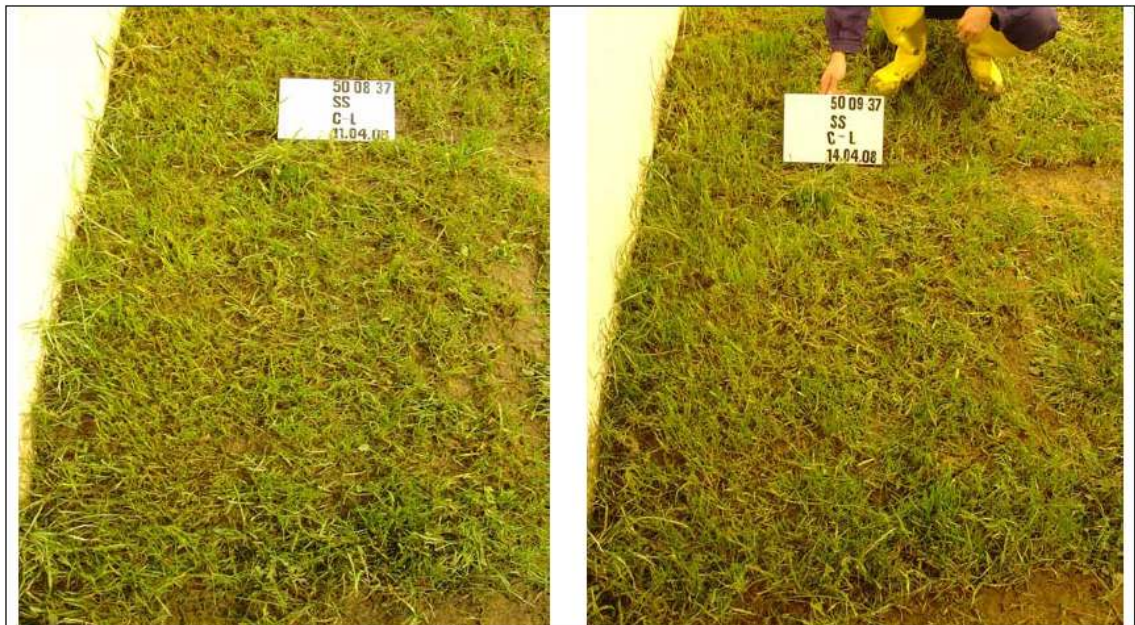
Grass sods, which were damaged during wave impact tests, were photographed after each test run. Degradation of a grass sod, being located at the northern flume wall in the third row (row C), is shown in Figure 5.24. The signboard in Figure 4.23 shows the hydrodynamic parameters of the test performed before the photo was taken. The first number in the first row defines the peak period  $T_p$  ('50' = 5.0sec.). The second number represents the significant wave height  $H_s$  ('08' = 80cm) and the last number stands for the water depth  $d$  ('37' = 3.7m). The abbreviations in the second and third row stand for 'SS' = seaward slope and 'C-L' is the identification code of the grass sod ('C' = row C; 'L' = left grass sod of the row from the middle). Identification of the rows starts with 'A' at the seaward toe in upward direction. The

Figure 4.24 Degradation of grass sod L in row C after a series of wave impact tests.

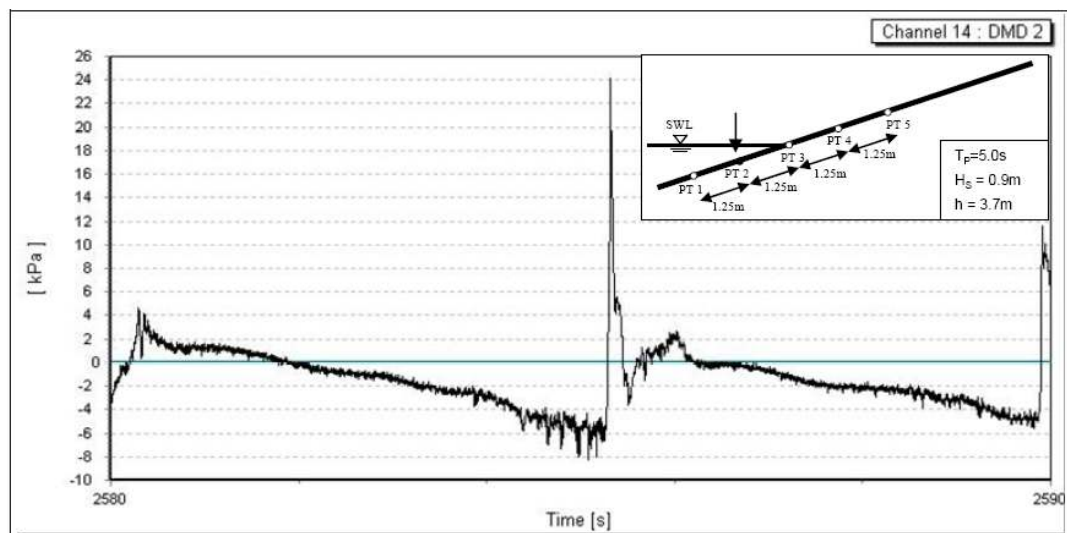
Figure 5.5 Recorded wave pressure on PT 2.

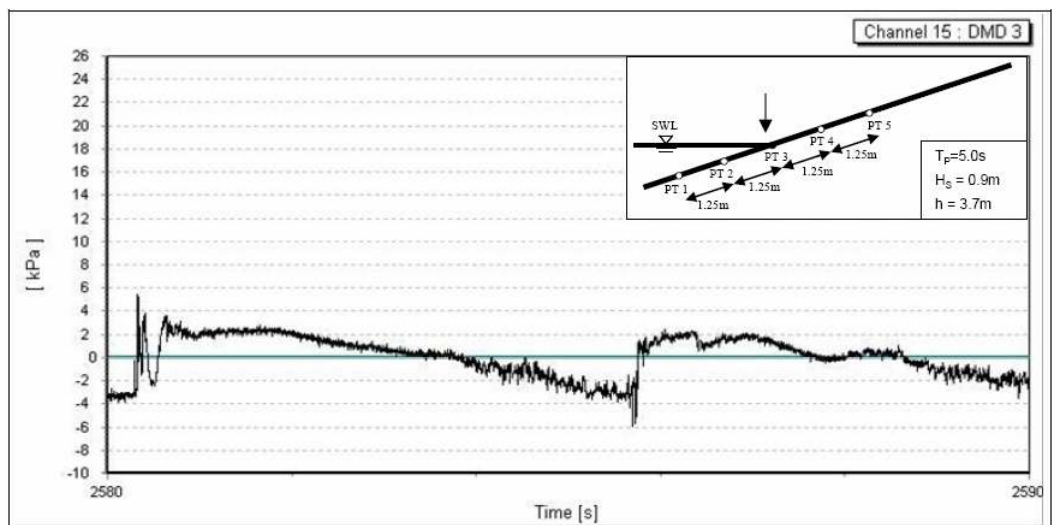
Figure 5.6 Recorded wave pressure on PT 3.

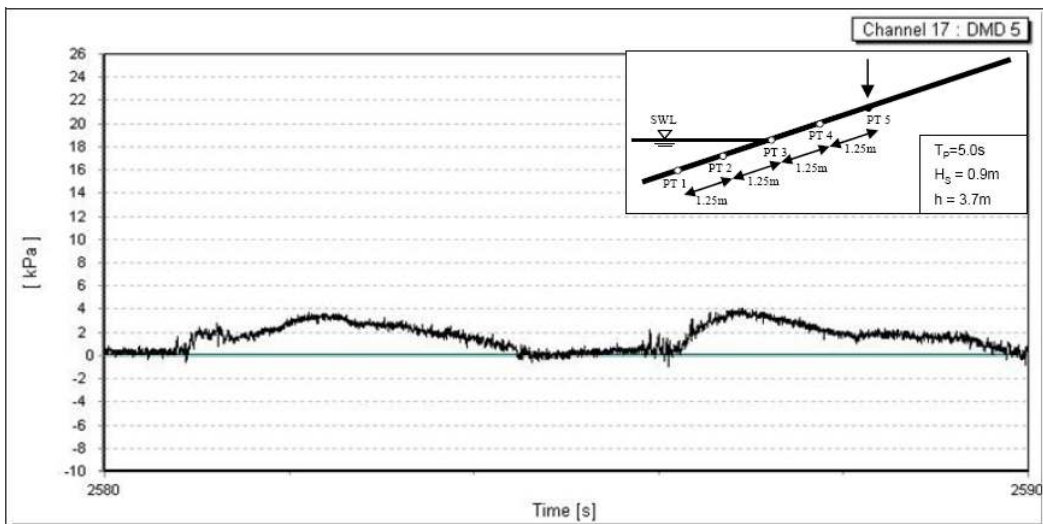
Figure 5.8 Recorded wave pressure on PT 5.

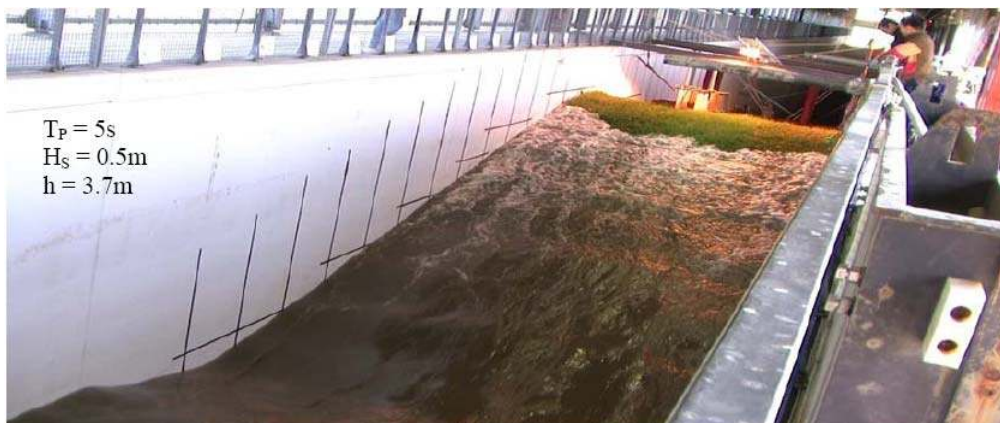
Figure 5.13 Wave run-up height of 5.65m.

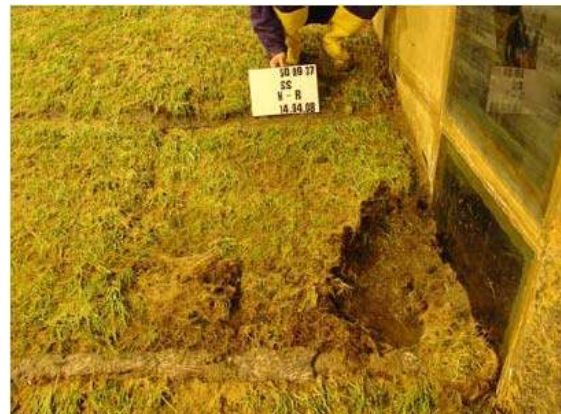
The first damage of the grass cover occurred at the observation window in the flume wall during the tests on April 11<sup>th</sup>, 2008. The wave parameters were  $T_p = 5.0s$ ,  $H_s = 0.9m$ . The water depth was about 3.7m. The damage was caused by a single impact. As shown in Figure 5.15, only a part of the 90cm wide grass sod was damaged. The original stage of the grass sod is shown in Figure 5.14. The dimensions of the damaged area are illustrated in Figure 5.16. The marked area A in Figure 5.16 shows, however, an area that was directly located at the observation window and not eroded. After investigation of the soil surface of the damaged part, it was noticed that the visible clay was not part of the clay layer, rather the clay of the grass cover as the hole was just 10cm deep (Figure 5.17).

Figure 5.15 First damage on the observation window (after impact).

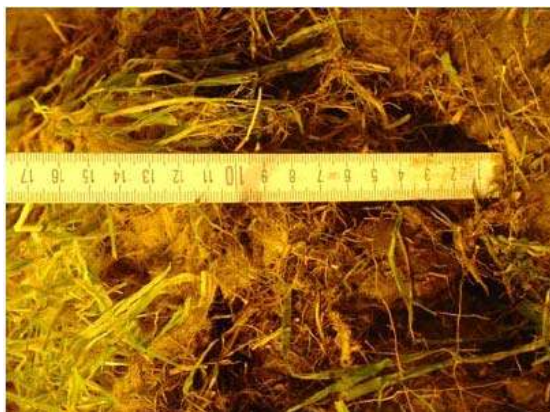
Figure 5.17 Depth of hole.

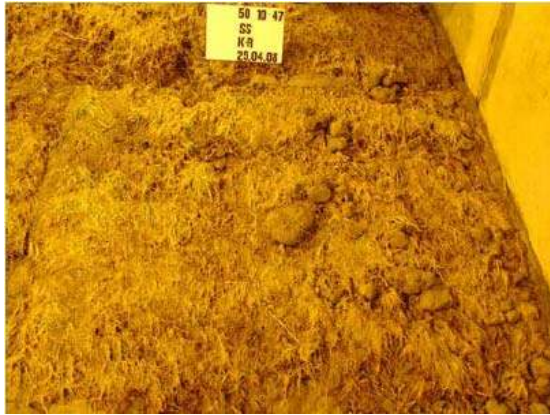
Figure 5.21 Formation of clay balls lying on the slope surface.

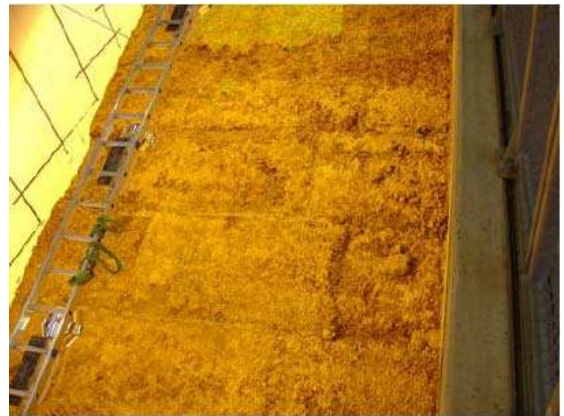
Figure 5.24 Degradation of the grass cover in the breaker zone.

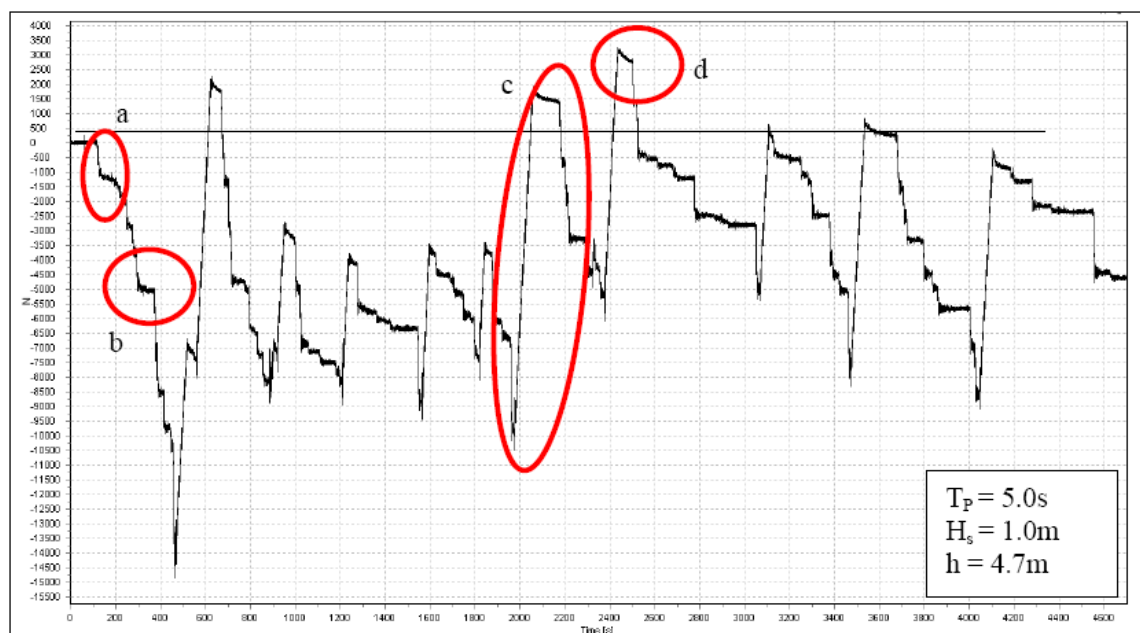
Figure 5.27 Record of the changing water volume in the overtopping container (Test 28040802).

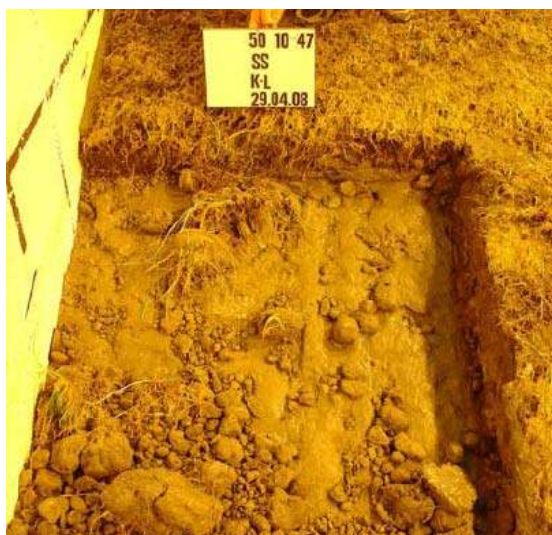
Figure 5.28 Damaged grass cover on the seaward slope during wave overtopping tests.

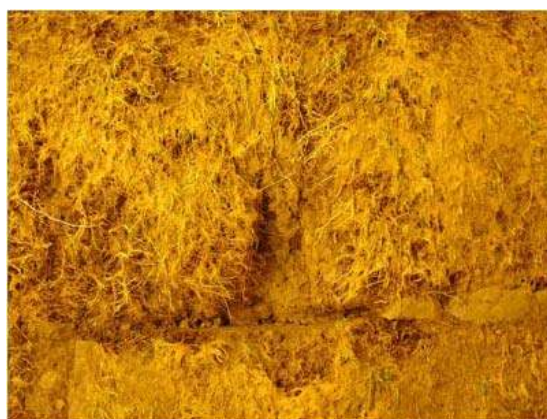
Figure 5.29 Damaged joint on the seaward slope during wave overtopping tests.

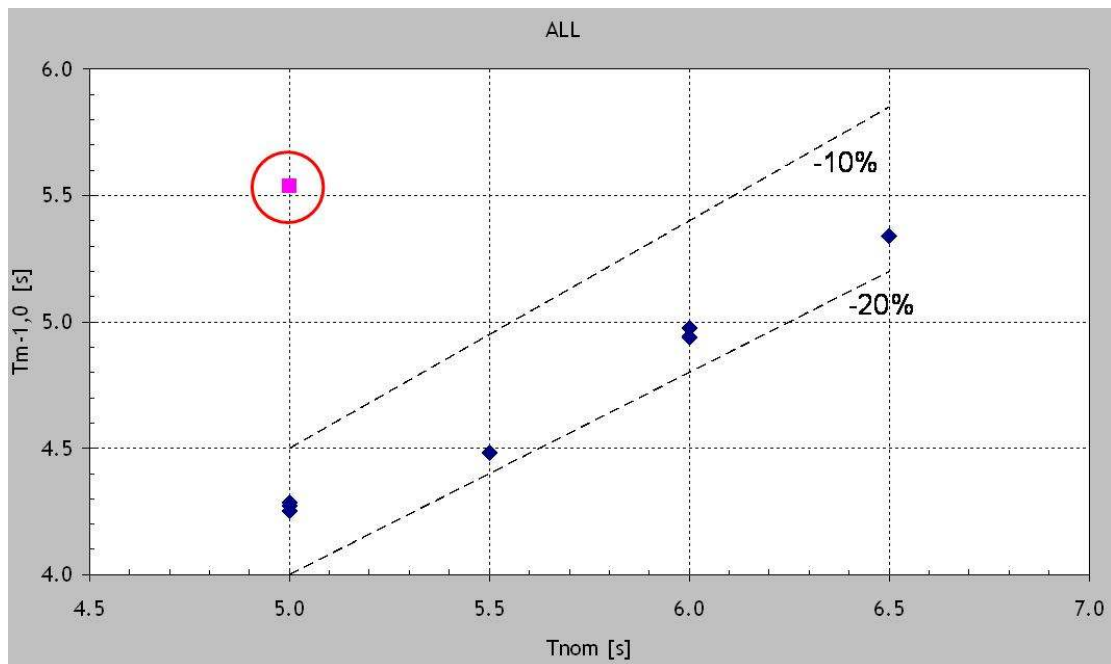
Figure A2.4 Measured wave periods during the test phase 2.
