Erosion and Sediment Delivery Following Removal of Forest Roads

Mary Ann Madej

ABSTRACT

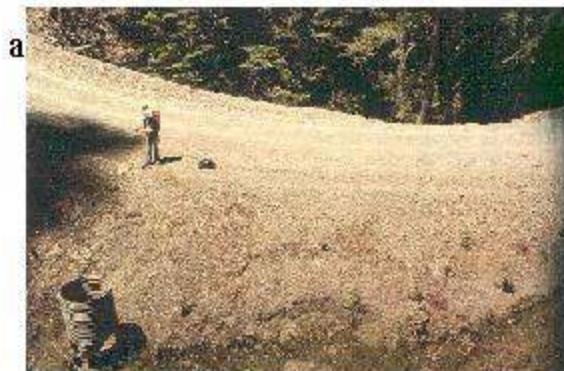
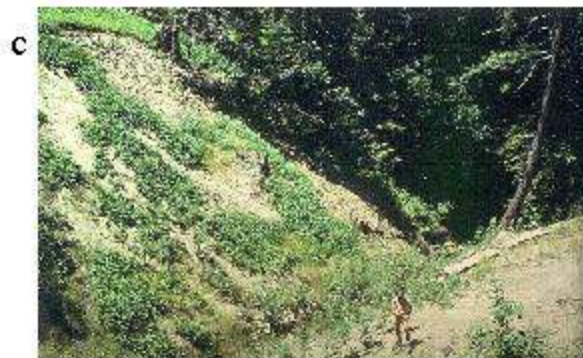
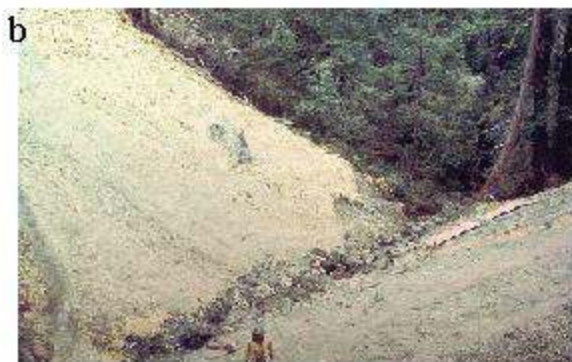
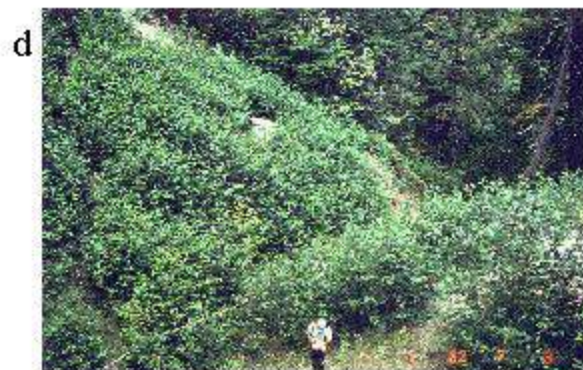
Figure 2. Typical stream channel excavation. a) Abandoned logging road with intact culvert before treatment. b) Immediately following stream crossing excavation. In this case, rock armor and check dams were installed on the channel bed to prevent downcutting. c) Less than one year later, revegetation of the streambanks is well underway. d) Three years after treatment, alders have revegetated most of the ground disturbed during treatment.

The first step in treating forest roads was to map the geomorphic and hydrologic features of the road and adjacent hillslopes. Erosion features, drainage structures, the stream network, and the location of all roads, skid trails, seeps, and springs were identified on enlarged aerial photographs at a scale of 1:1200. Following the mapping phase, road removal treatments were designed and implemented. In the early 1980's, road treatment work focused on removing culverts and pulling back road fill from streambanks (Figure 2a-d). In some cases, newly excavated stream channels were protected with check dams or large rocks (Figure 2b). The crossing excavations surveyed in this study varied from 100 to 7500 m³ in volume, and averaged about 1000 m³. Stream gradients of excavated stream crossings ranged from 1 to 50 percent.

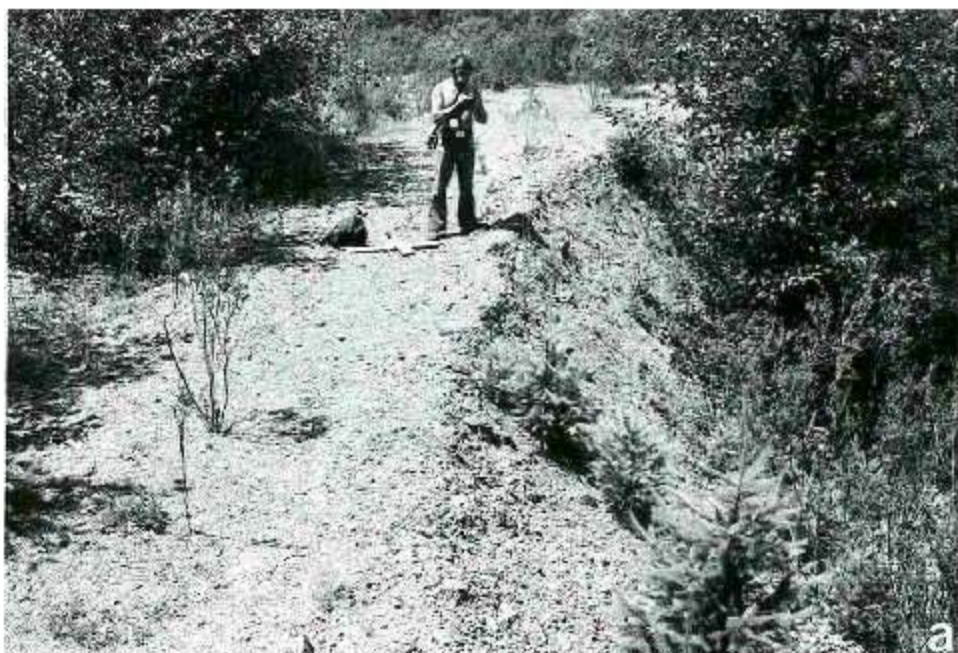
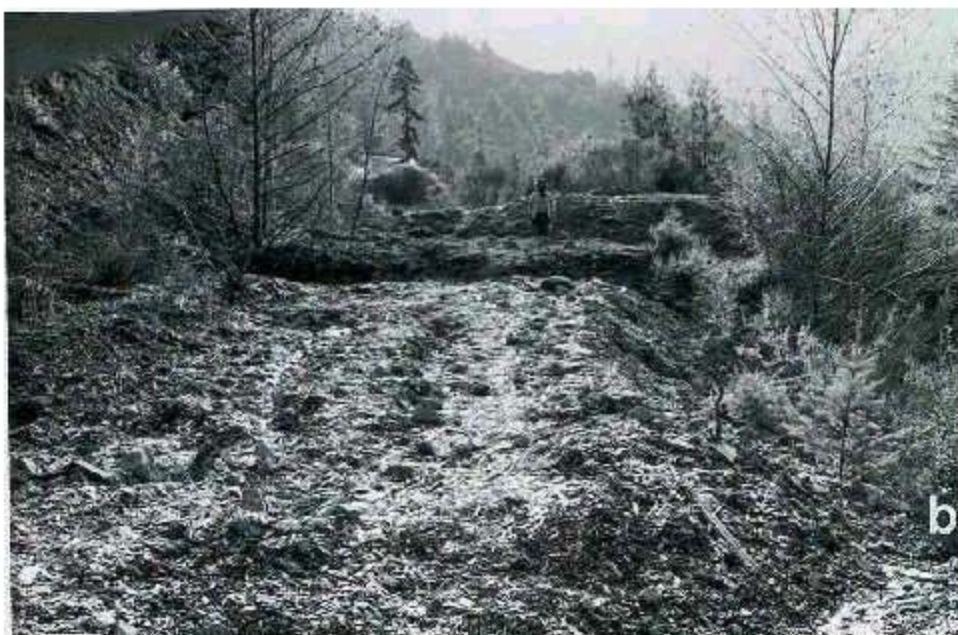
Figure 4. An example of the least intensive road rehabilitation technique. a) Abandoned logging road before treatment. b) The road surface is decompacted, and ditches are constructed perpendicular to the road alignment to drain the road. The road bench and road fill remain in place.

On road reaches between stream crossings, a variety of techniques were used, which varied in the amount of earth moving involved (Figure 3a-d). Treatments in the early 1980's decompacted the road surface and constructed drains perpendicular to the road alignment to dewater the inboard ditch (a technique referred to as "ripped and drained"). Typically, 200 to 500 m³ of road fill were moved for every kilometer of road treated with this method. This approach is the least intensive treatment (Figure 3b). Following this treatment, the roads were mulched with straw and seeded and replanted with native vegetation (Figure 4a and b).

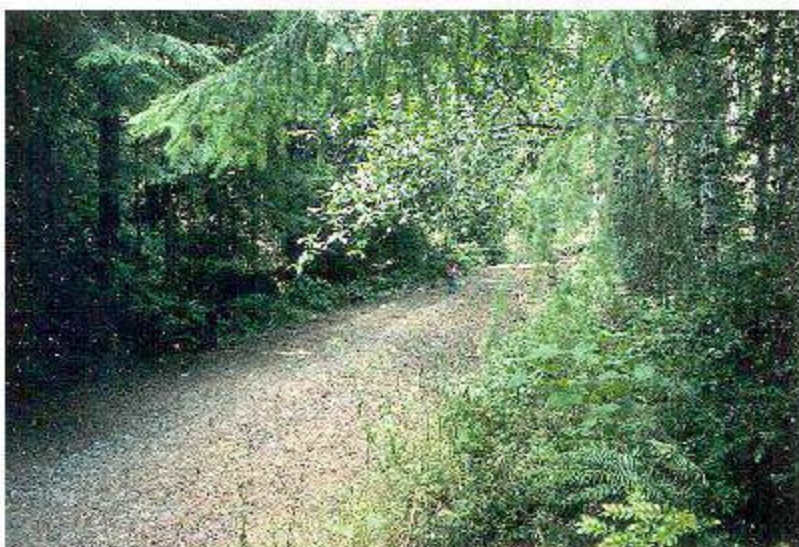
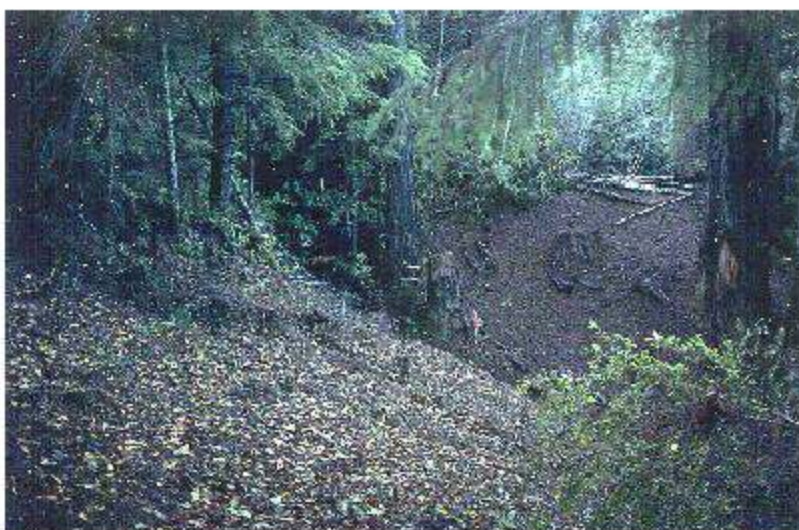
Figure 5. An example of the most intensive road rehabilitation technique. a) Abandoned logging road before treatment. b) The road bench is obliterated and the hillslope is recontoured (total outsloping of the road bench, and total excavation of the stream channel). Stumps uncovered during excavation indicate the location and elevation of the original hillslopes.

As the program progressed, park geologists began to use more intensive treatment methods, which included partially outsloping the road surface by excavating fill from the outboard edge of the road and placing the material in the inboard ditch at the base of the cutbank (Figure 3c). This technique required more earth moving (1000 to 2000 m³/km of treated road). By the 1990's, geologists commonly prescribed complete recontouring of the road bench (total outslope), in which the cutbank was covered by excavated fill, original topsoil from the outboard edge of the road was replaced on the road bench where possible, stream channels were excavated to the original channel bed elevation, streambanks were extensively reshaped and the road bench was fully recontoured (Figures 3d, 5a and b). Total outsloping involved moving an average of 6000 m³/km of treated road. Channel armoring was seldom used in this phase, but trees felled during road treatment were later placed in the stream channels and on the treated road surface. On some road segments, excavated road fill was removed from the road bench and transported to a more stable location, and this technique is termed export outslope (Figure 3e). The locations where the road spoils were placed are called fill sites. Export outsloping involved the greatest amount of earth moving (15,000 to 20,000 m³/km of treated road). Because surface erosion is not considered to be a major sediment source (Kveton *et al.*, 1983), and natural revegetation is

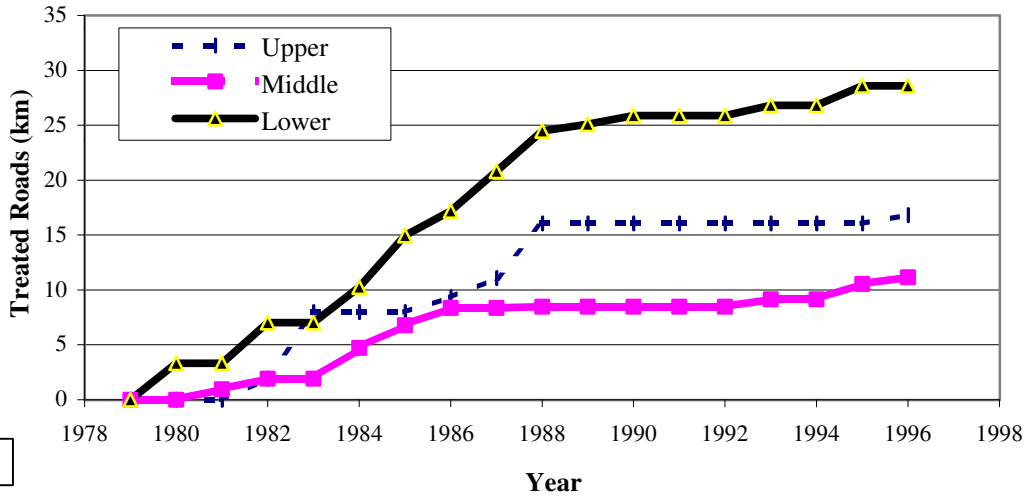
b

Cumulative Length of Road Treated by Date and Hillslope Position

The cumulative length of road treated by the different methods is shown in Figure 6a. Most roads that were ripped and drained were treated prior to 1988, and most export outcropping occurred after 1988. This means that most minimally treated roads were subject to more storms than roads which had more intense levels of treatment. A greater length of road was treated in early years, when treatments were still being refined. Due to budget constraints and more intensive treatment in later years, fewer road segments were treated in more recent years. Figure 6b shows the cumulative length of road treated by hillslope position. More lower hillslope roads were treated in the first few years of the restoration program than roads in upper and middle hillslope positions, and overall more lower hillslope roads were treated. The implications of these interactions among date of treatment, treatment method and hillslope position will be discussed more fully later.

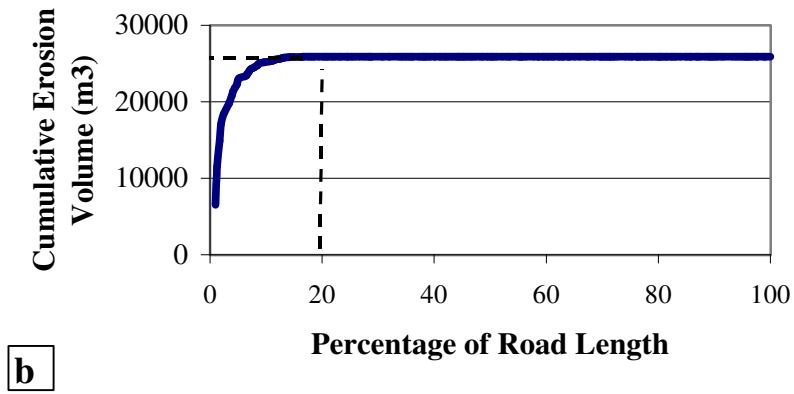
Figure 7

7b. Cumulative plot of total erosion from treated road reaches. Twenty percent of the treated road length accounted for 99% of the total erosion.

Cumulative Erosion Volume from Road Reaches

The total amount of material eroded from treated road reaches was 25,900 m³. Most (77%) of this erosion was attributed to mass movement processes, primarily road fill failures. Of the total erosion from road reaches, 74% of the eroded material was delivered to a stream channel. Most treated road reaches performed well and produced very little sediment. The cumulative distribution of erosion from road reaches is even more highly skewed than that for road crossings (Figure 5b). Twenty percent of the treated road reach length produced 99% of the total erosion from treated road reaches. Total post-treatment erosion from 61 km of road, including both fill failures and stream crossing erosion, was 36,400 m³ (600 m³/km of road); total sediment delivery was 29,500 m³ (480 m³/km of road).
