Evaluation of 10MeV Proton Irradiation on 5.5 Mpixel Scientific CMOS Image Sensor

Paul Vu, Boyd Fowler, Brian Rodricks, Janusz Balicki, Steve Mims, Wang Li
Fairchild Imaging
1801 McCarthy Blvd., Milpitas, CA 95035, USA

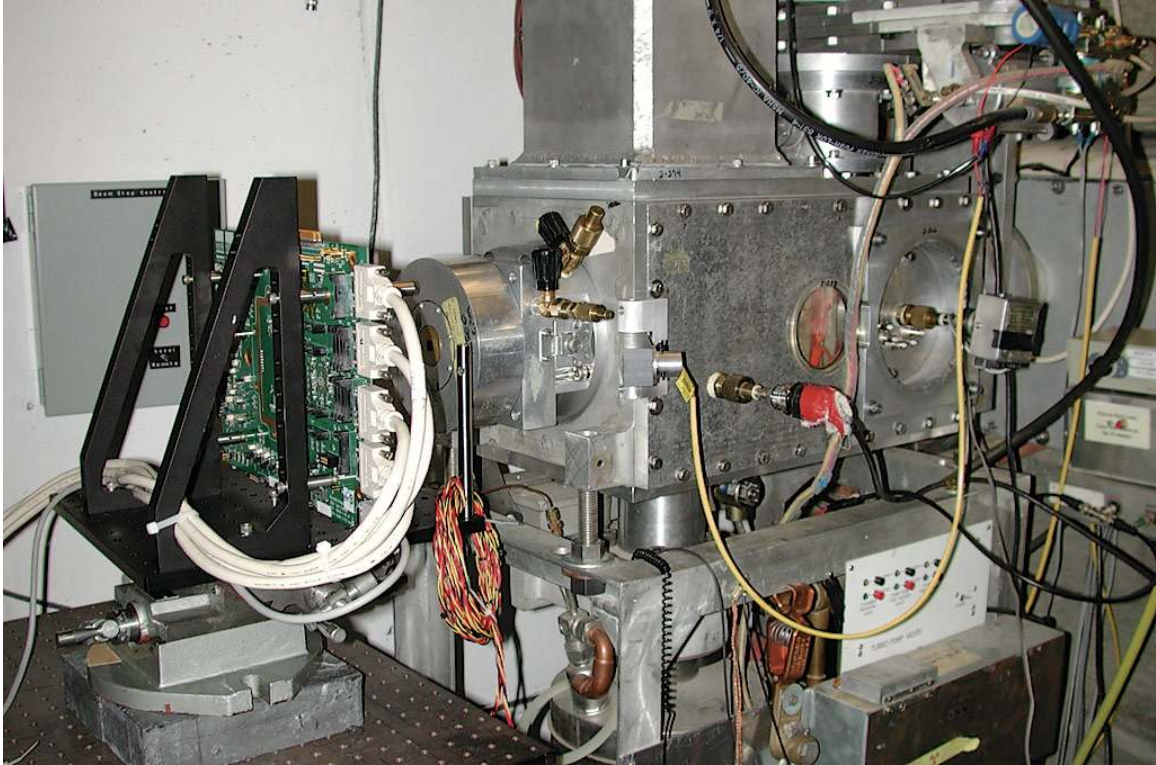
The proton radiation tests were performed at the Crocker Nuclear Laboratory at UC Davis. Dosimetry was performed by the staff of Crocker Lab. The image sensor was mounted on a test development sensor control board and the sensor operation was remotely controlled and monitored from the control room next to the proton irradiation chamber. The test setup is shown below in Figure 3.

Figure 3. Proton test setup

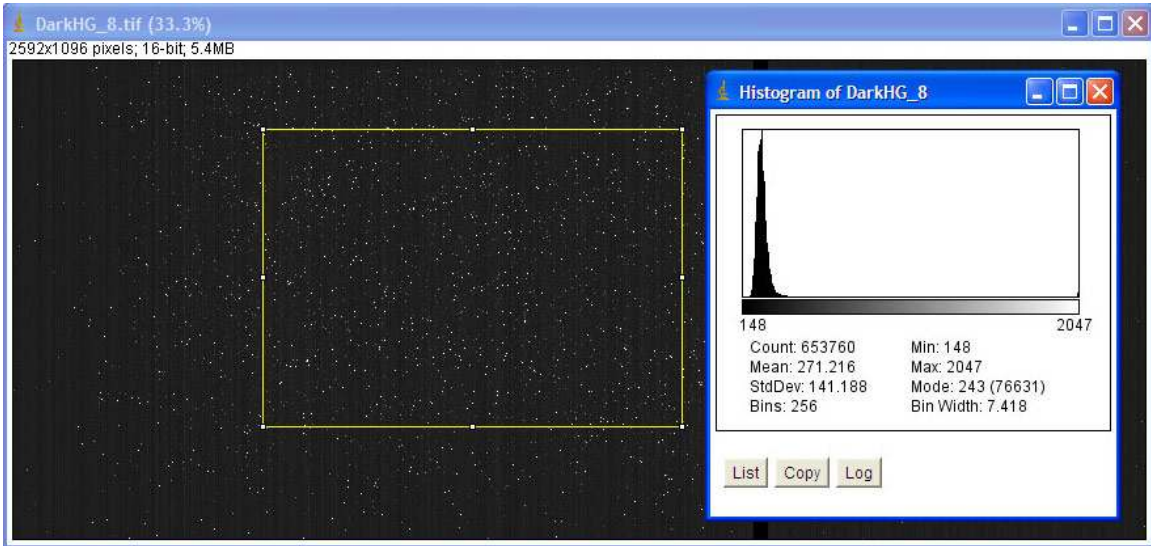
Figure 9. Image frame histogram at 3.8×10^9 p/cm², 2 krad(Si)

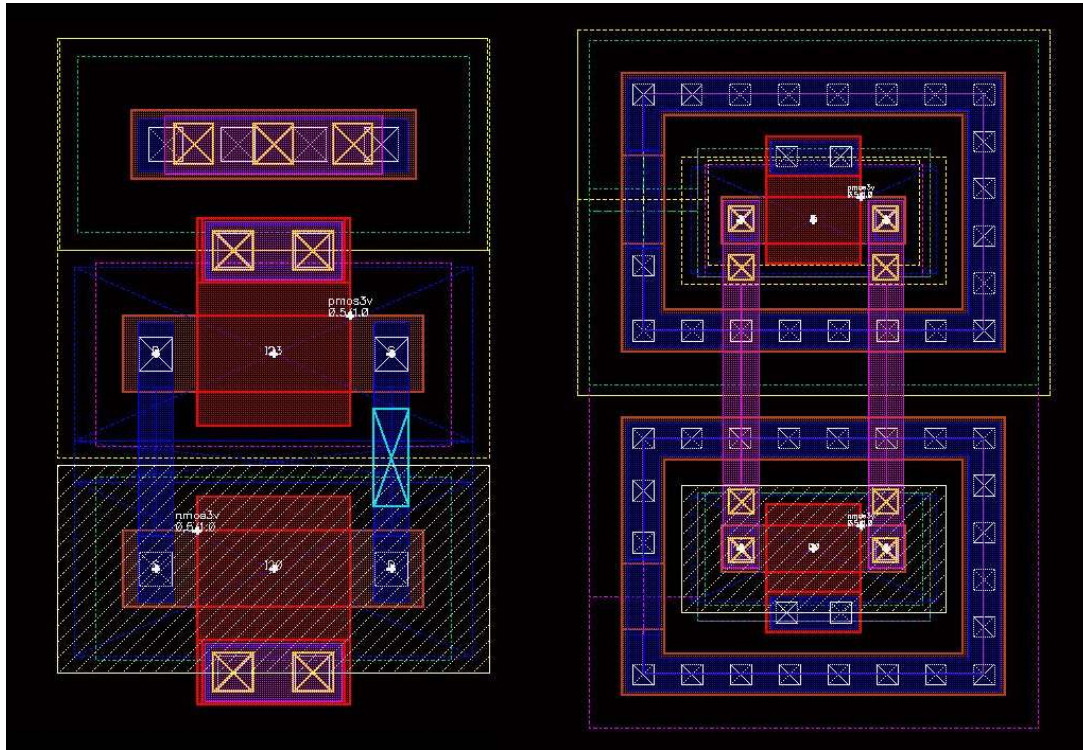
Figure 11. Layout of transmission gate: Standard (Left) vs. Radiation Tolerant (Right)

Although we did not encounter any catastrophic failures during the proton irradiation tests on a device that was not designed to be radiation tolerant, we are implementing the following changes in the design of a new sensor intended for space applications to improve its tolerance to radiation: p-channel and n-channel devices are enclosed with dedicated guard rings which effectively increases the distance between complementary devices, and a large number of additional substrate contacts and well contacts are placed at regular intervals. The changes in the layout of a transmission gate (TG) to improve the radiation tolerance of the device are shown in Figure 11, the changes significantly increase the size of the cell. Other precautions we have implemented to help minimize the increase in dark current due to leakage current in the pixels include increasing the separation between the n-photodiode region in the pixel from the shallow trench isolation (STI) structures.
