MISCELLANEOUS PAPER GL-86-34

EVALUATION OF ASPHALT RUBBER AND ENGINEERING FABRICS AS PAVEMENT INTERLAYERS

R. C. Ahlrich

November 1986

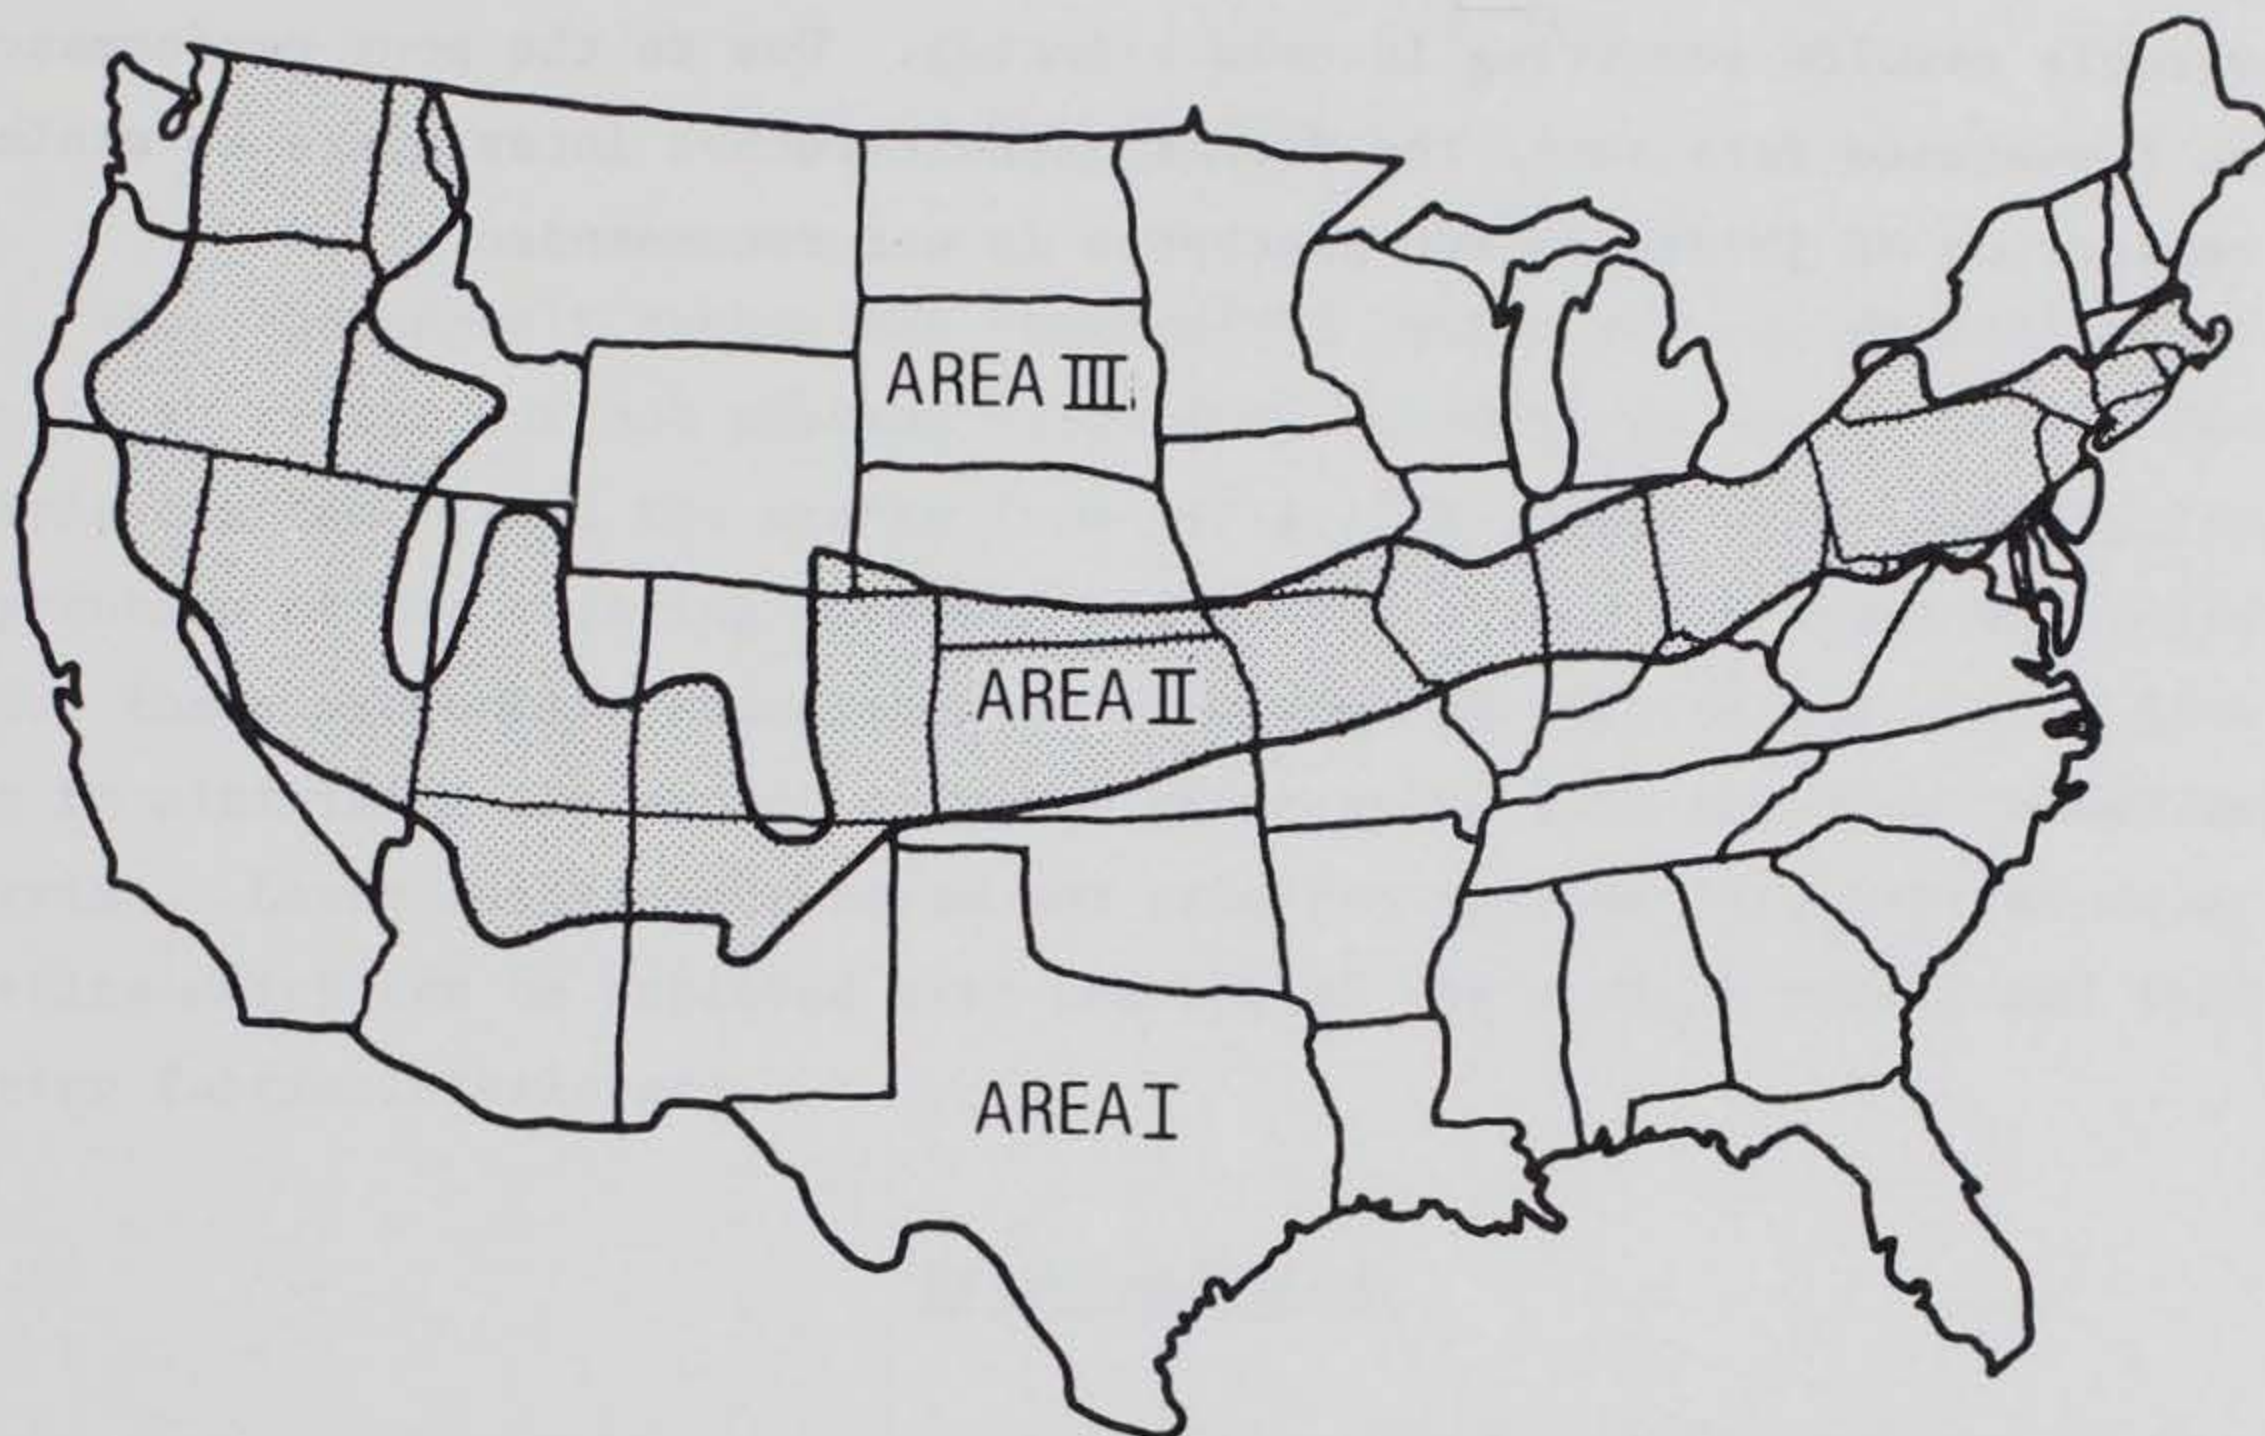
Figure 28. Location guide for overlaying AC pavements to minimize reflective cracking

AREA I - INTERLAYERS ARE RECOMMENDED WITH MINIMUM OVERLAY THICKNESS OF 2 IN.

AREA II - INTERLAYERS ARE RECOMMENDED WITH OVERLAY THICKNESS OF 3-4 IN.

AREA III - INTERLAYERS ARE NOT RECOMMENDED.

41. Using the figures for the AC pavements and the mean freezing index chart (Figure 27) from TM 5-812-2 (Headquarters, Department of the Army 1983), a geographic boundary was developed for the use of interlayers to minimize reflective cracking. Figure 28 shows a map of the United States which is divided into three areas. Area I is the section of the country that has a mean air freezing index below 0. Area II is the portion that has a mean air freezing index between 0 and 500, and Area III is the northern region with a mean air freezing index above 500.

Area I should obtain satisfactory results with the use of interlayers and a minimum overlay thickness of 2 in. (5.08 cm). Pavements in Area II should have favorable results when interlayers are used with a minimum overlay thickness of 3 in. (7.62 cm). The interlayers are not recommended for use in reducing reflective cracking in Area III.
