Evaluation of Dredging Operations for Tigris River within Baghdad, Iraq

River Tigris divides Baghdad, capital of Iraq, in two parts. The reach of the river within Baghdad is about 60 km long. Many islands and bars are obstructing the flow of the river within Baghdad. To overcome this problem, dredging operations started along most of Tigris River inside Baghdad City to remove many islands and side bars, which reduced the flooding capacity and the efficiency of water intakes. An examination for the dredging plan under process and two proposed additional plans was performed using the Hydrologic Engineering Centers River Analysis System software (HEC-RAS) for a 50 km long river reach to investigate whether they can recover the designed flooding capacity of the river or just improving it. Calibration and verification processes were implemented in the model using observed water levels at Sarai Baghdad gauging station and along the last 15 km of the river reach. Comparisons of computed water levels were conducted with those of previous studies and historical data. Some improvement of flood capacity was achieved based on the recorded data of the last three decades. Cautions about the wat

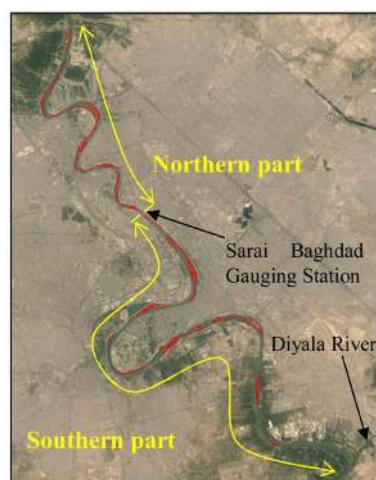
Figure 1. Tigris River inside Baghdad (islands and side bars surround by red borders) (the raw image from Google Earth[®]).

River for a distance of 60 km, 50 km of which are located within the urban areas, and the rest is in rural parts (**Figure 1**).

Tigris River reach within Baghdad has compound meanders, single channel and alluvial plain characteristics. According to the meandering characteristics, Tigris River can be divided into two parts. The northern part, starts from Al-Muthana Bridge north of the city and ends at Sarai Baghdad gauging station in the centre of the city. This part is characterized by a series of small meanders. While the southern part, which is characterized by its large meanders, starts from Sarai Baghdad gauging station and ends at the confluence between Tigris and Diyala rivers to the south of the city (**Figure 1**).

Tigris River has many growing islands, side and point bars along its reach inside Baghdad City (surrounded by red borders in **Figure 1**). The obstacles in the river course can be briefly summarized by the presence of 10 islands and 17 side bars. Dimensions, types and distribution of most of these obstacles were discussed in details by Ali [4].

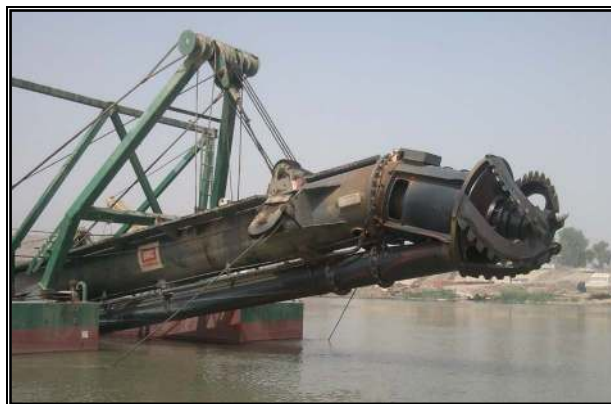
Figure 2. A dredger of type cutter suction working on Tigris River (the photo was taken by the authors).

The dredging work was executed at limited locations on the river for the period 2004-2007 using excavators and one dredger at that time. OERDW imported many dredgers and supplementary equipment in 2008. Most of the dredgers are of cutter suction type (Figure 2) and some of the backhoes type (Figure 3). Large staff was trained to execute this operation. The dredging extended over twenty sites along the river as well as purging of ten water intakes (Figure 4).

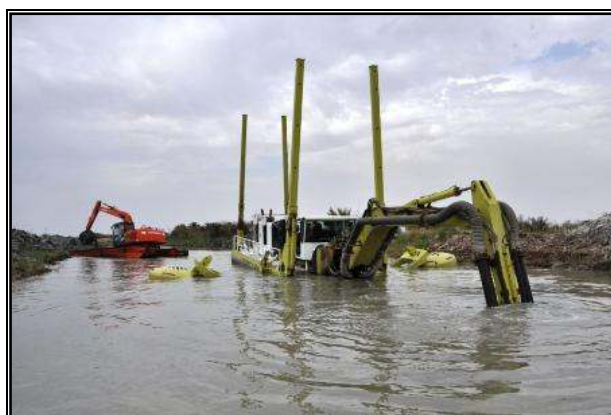
Figure 3. A dredger of type backhoe working on Tigris River (source [8]).

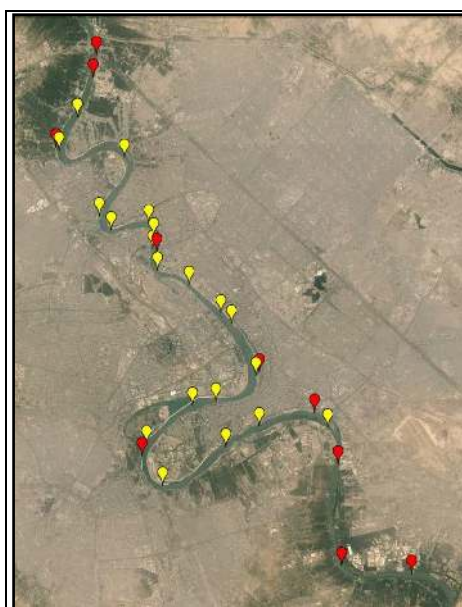
Figure 4. Dredging (yellow) and water intakes (red) sites along Tigris River (the raw image from Google Earth[®]).

Figure 4 shows the locations to be dredged from the main obstacles in the whole northern part of the river reach and about the half of the southern part as planned by OERDW. The remainder of the southern part of the river was not taken into consideration because it has fewer numbers of obstacles and passes through industrial and agricultural areas only.

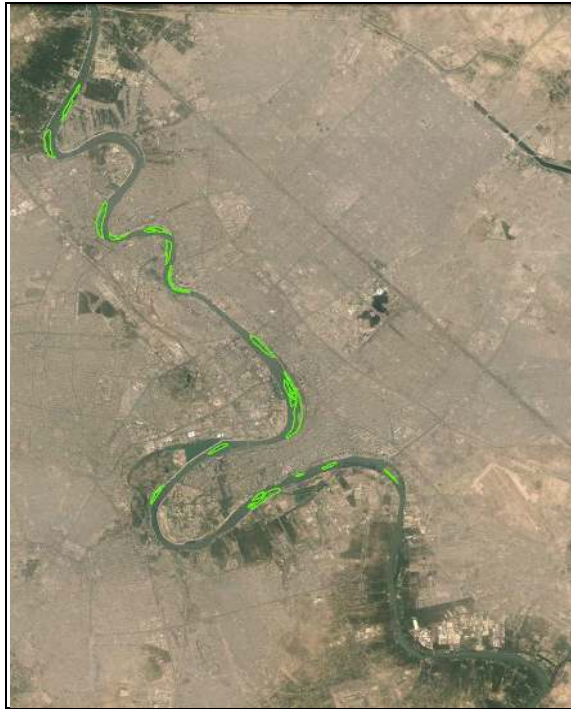
Figure 5. The considered areas in the dredging plan of OERDW [6] (the raw image from Google Earth[®]).

The areas that were considered in the dredging plan are shown in Figure 5. There were many exceptions in the plan. One of the main obstacles in the northern part (Kura'at Island) which was ignored from the plan due to an investment decision which was taken by the local authorities considering the site as tourist area. The second exception was the biggest island along the river reach (Dura Island) at the middle of the southern part of the river, as well as the side bar just upstream that island (Figure 6).

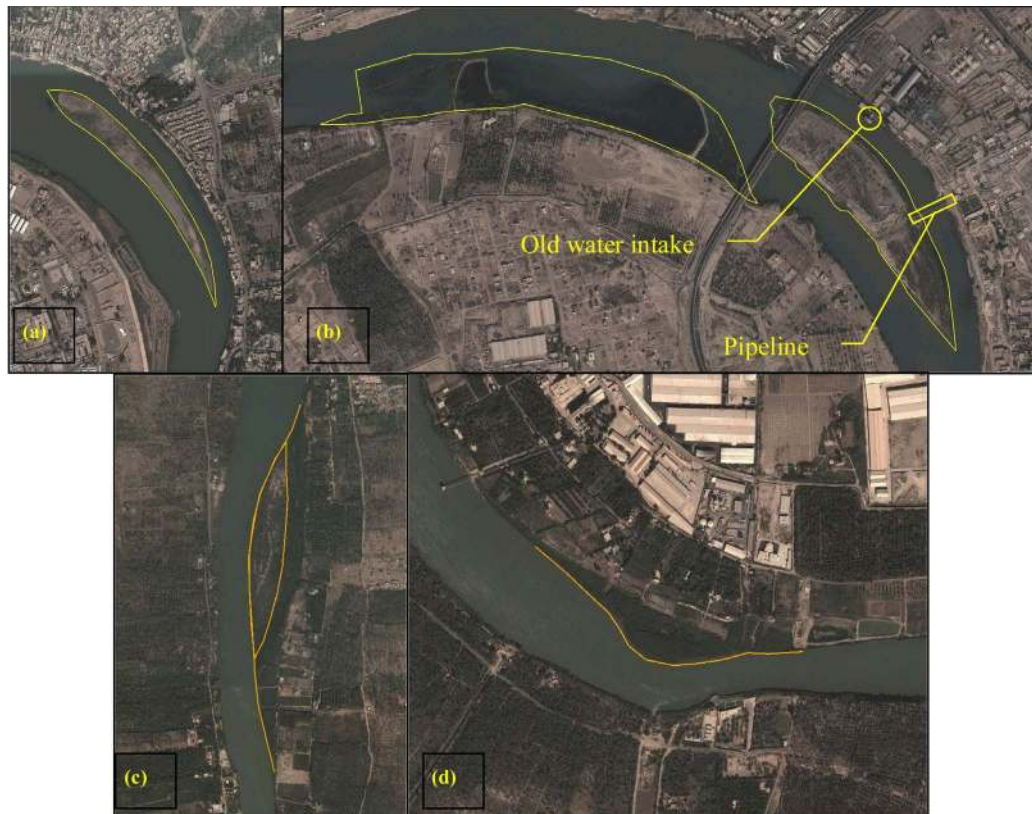
Figure 6. The excepted obstacles from OERDW dredging plan ((a) Kura'at Island; (b) Dura Island and the side bar; (c) Al-Rasheed Camp Island and D. PEPSI Factory Island) (the raw images from Google Earth[®]).

The second additional program included the dredging of Dura Island (see **Figure 6(b)**) in the southern part of the river reach. This is due to the fact that it takes about 59% of the river width and bisects a large meander. In addition, the outer arm of the meander has some obstacles represented by an old intake for a power plant on the left shore and small truss bridge to pass pipes of the new intake from the island to the power plant. The sediment quantity that was suggested to be removed was about 610,000 m³.

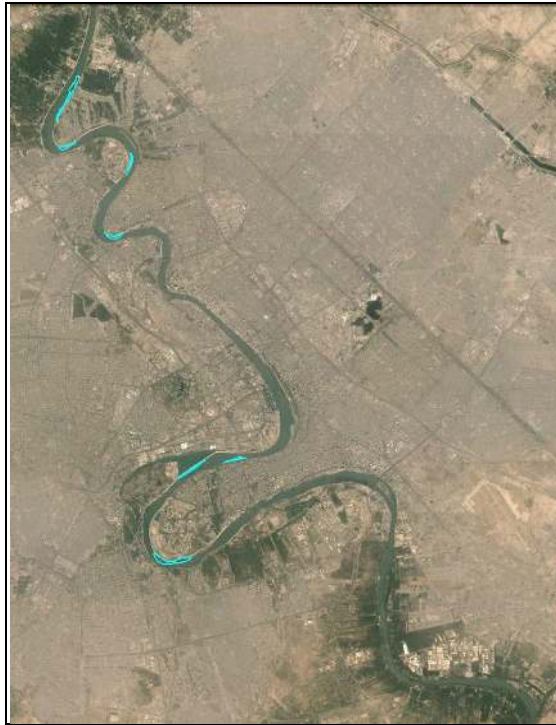
Figure 7. The suggested areas for dredging according to the first additional plan (the raw image from Google Earth[®]).

In addition to the plan above, two more dredging programs were suggested. The first, is dredging most of the sediment deposition locations, especially within the upper banks depositions and the stacks of the dredged materials, which were originally excluded from OERDW plan along the northern river reach and the first half of the southern river reach as shown in **Figure 7**.

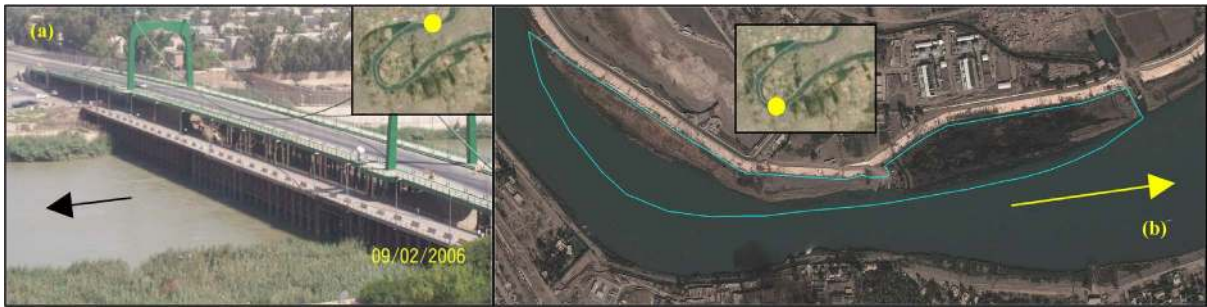
Figure 8. The narrowest sections of Tigris River reach ((a) The suspension bridge; (b) Dura power plant) (the raw images from Google Earth[®]).

The suggested locations that have more effect on the flooding capacity are those of the narrowest sections where the high detentions for the flow may occur at their sections which influence water levels upstream during high discharges as that at the suspension bridge and Dura power plant locations (**Figure 8**). It should be noted that, the suspension bridge was destroyed in 1991 and re-built with two auxiliary bridges of huge number of piles. This represented a source of additional disturbance for the flow which was associated with deposition of sediment. One of these auxiliary bridges was removed during 2011 and 2012 while the second remains (**Figure 8(a)**). On the other hand, Dura power plant location (**Figure 8(b)**) is the narrowest part of the river reach where its width doesn't exceed 80 m. Furthermore, it is located at sharp meander with lined outer bank.

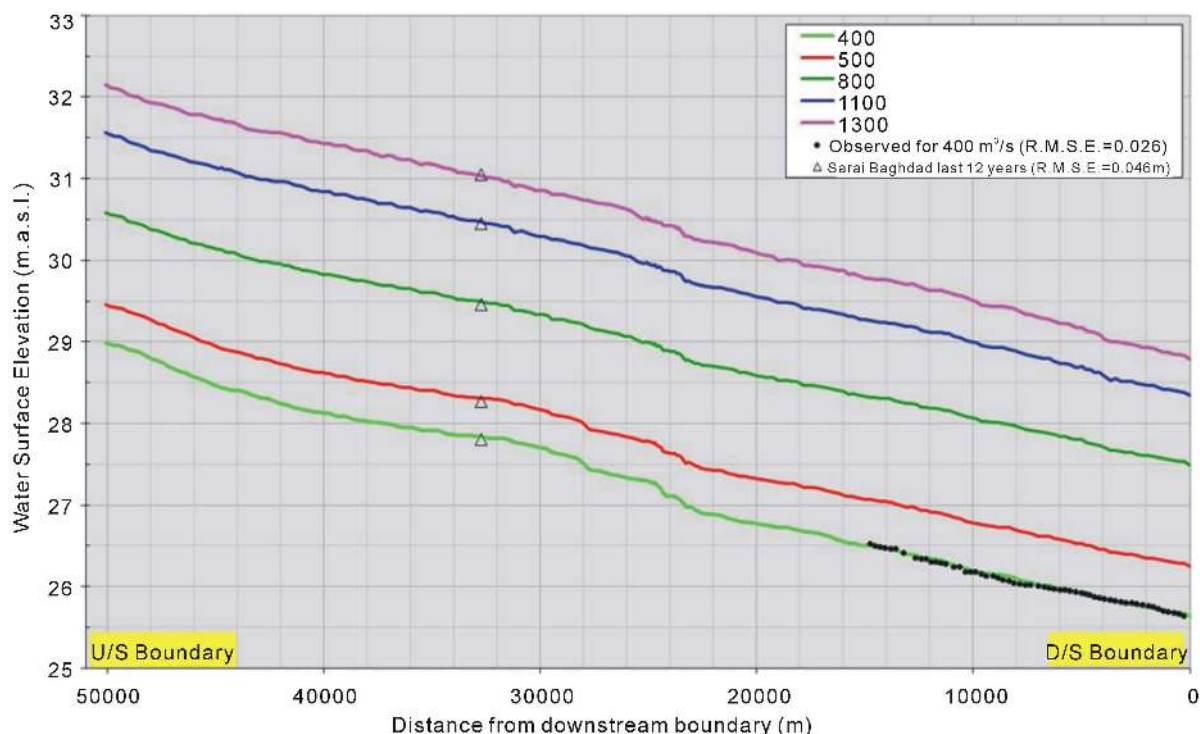
Figure 9. Water surface profiles of tigris river for calibration and verification processes.

The Hydrologic Engineering Centers River Analysis System (HEC-RAS) software was used to perform one-dimensional simulation for a range of steady flows in Tigris River and obtain the associated water surface profiles. Calibration is an important step for such kind of mathematical models to get valid results. For this purpose, 59 water surface observations along the last 15 km of the river reach were used to calibrate Manning's roughness coefficient along the river. These observations were measured for 400 m³/s discharge which represents low discharge for the river. The upstream boundary condition was the same discharge for the measured water levels. While the downstream boundary condition was stage-discharge rating curves for Tigris River downstream the confluence. The contribution of Diyala River was represented by 5 m³/s lateral inflow which represents the average annual flow. The best calibration was achieved by the mean of minimum Root Mean Square Errors (RMSE) between the observed data and computed water surface profile for several iterations of finding suitable Manning's *n* values for the main channel and the flood plain. These iterations culminated by obtaining Manning's "*n*" of 0.0285 for the main channel and 0.042 for the flood plain with RMSE equalled to 0.026 m (**Figure 9**).

Verification process is the next step on the way of modelling. A set of recorded discharges with their water levels at Sarai Baghdad gauging station during the last 12 years were used in the verification process. These discharges (400, 500, 800, 1100 and 1300 m³/s) were classified from low to moderate discharges according to the historical records. Good agreement was achieved between observed water levels for the recorded data and those computed by HEC-RAS for the same discharges. The RMSE for verification was 0.046m at Sarai Baghdad (**Figure 9**).

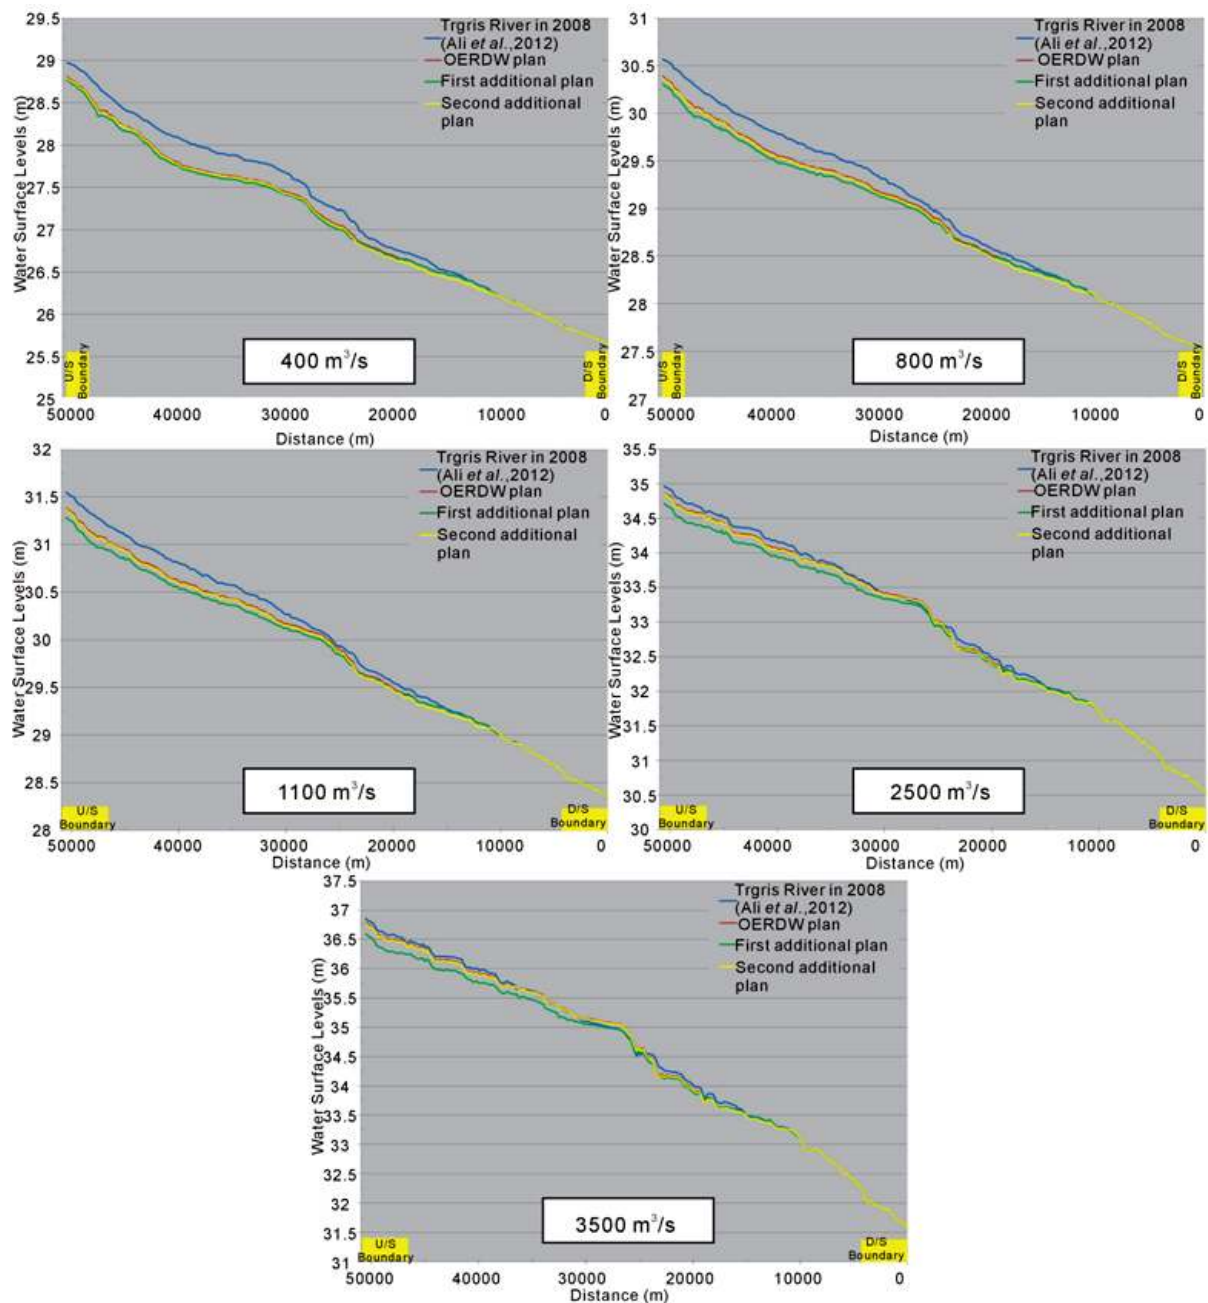
Figure 10. Water surface profiles related to selected discharges for all dredging plans and pre-dredging condition.

Water surface profiles related to selected discharges (400, 800, 1100, 2500 and 3500 m³/s) were plotted for all dredging plans as well as the pre-dredging condition in **Figure 10**. The selection of these discharges was based on different criteria, where the predominant discharge in Tigris River now a day is around 400 m³/s, while a discharge of 800 m³/s represents the moderate discharge for the river during the last decade. The University of Technology [6] concentrated on two discharges, 1100 and 3500 m³/s, assuming that the first one is the operational discharge for the river and the second is the critical indication for the flooding capacity of the river and it was also the significant discharge in evaluating the flooding capacity for 2008 [1]. The discharge 2500 m³/s was chosen for bridging the gap between 1100 and 3500 m³/s discharges.

The drop in water levels was clear for the low discharges (400, 800 and 1100 m³/s) along the river reach that was included in the dredging program and the profiles are mostly identical for all plans. That drop will affect the operation levels of the water intakes especially along the northern part of the reach, so more caution should be taken to keep the water intakes functional. The effect of the second additional plan seems to be very limited and took place only at the location of Dura Island and its vicinity. The differences between the first two dredging programs are restricted to the upper portions of the river cross sections, while the second additional dredging program was concerned with the removal of the island.

During high flooding discharges (2500 and 3500 m³/s) there are convergences between the profiles of the dredging plans and the pre-dredging condition (**Figure 10**). It should be mentioned, however, there is a very little advantage for the first additional plan which indicates that the effect of the banks deposition is more significant on the flooding capacity of the river. Computed water levels at Sarai Baghdad gauging station were compared with those obtained from the previous works [1] [5] [6] and with a summary of historical records for the last four decades as shown in **Figure 11**. From this figure, the following conclusions were noticed:

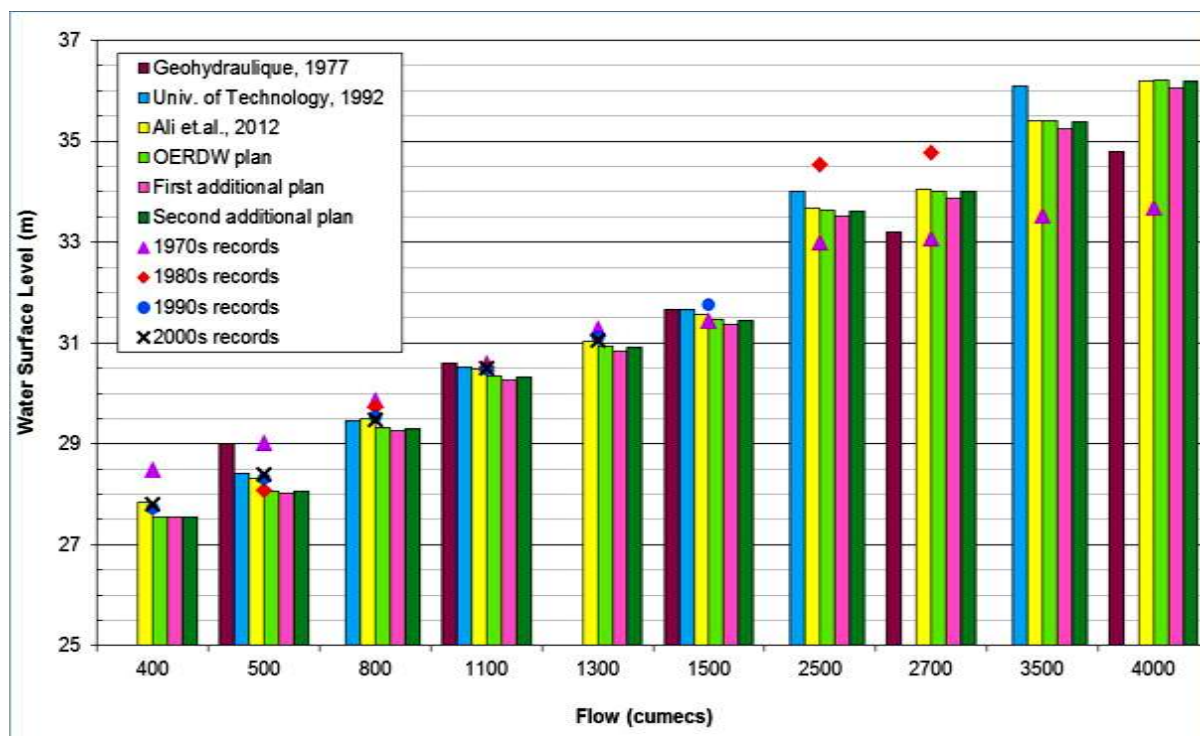
Figure 11. Computed water levels at Sarai Baghdad gauging station for all dredging plans with the results of previous studies and the observations of the last four decades.

-**1970s:** Many high peaks were recognized. They ranged between 2230 and 3890 m³/s, but the maximum was 4480 m³/s in 1971. This suggests that the patterns of erosion and deposition were not stable due to the oscillation between the amount of sediment brought by floods and flashing process.

The recorded water levels were higher than the results of the dredging plans for 400, 500 and 800 m^3/s discharges and very close to 1100, 1300 and 1500 m^3/s discharges and significantly lower for higher discharges. For this reason, the dredging plans cannot achieve the water levels for the flooding cases of the 1970s, because the river at that period was not protected at the banks and had milder bed slope than it is now [1].

-1980s: The available water levels are only restricted for the periods between October 1987-September 1988 and October-December 1989. The maximum peak recorded was 3060 m^3/s at water level 35.03 m in April 1988. Other peaks (894 to 1998 m^3/s) were lower than the previous. The effect of head water dams that were constructed during that decade was clear on the values of the peaks. The available records were close to the results of the dredging plans for the 500, 800 and 1100 m^3/s discharges, while they were higher for the 2500 and 2700 m^3/s discharges. No records of water levels are available for the rest of the discharges in range.

-**1990s:** The peaks were between 990 and 1825 m³/s. The recorded water levels were very close to those of the previous decade. The river seemed more tranquil. The results of the dredging plans are closer to the recorded water levels which covered the discharges 400 - 1500 m³/s from the examined range.

-**2000s:** The range of peaks in those records were the lowest (515 - 970 m³/s) relative to the last four decades. The maximum peak did not exceed 1315 m³/s in 2004. The recorded water levels were very close to those of 1990s but they covered a narrower range (400 - 1300 m³/s) of the examined discharges.

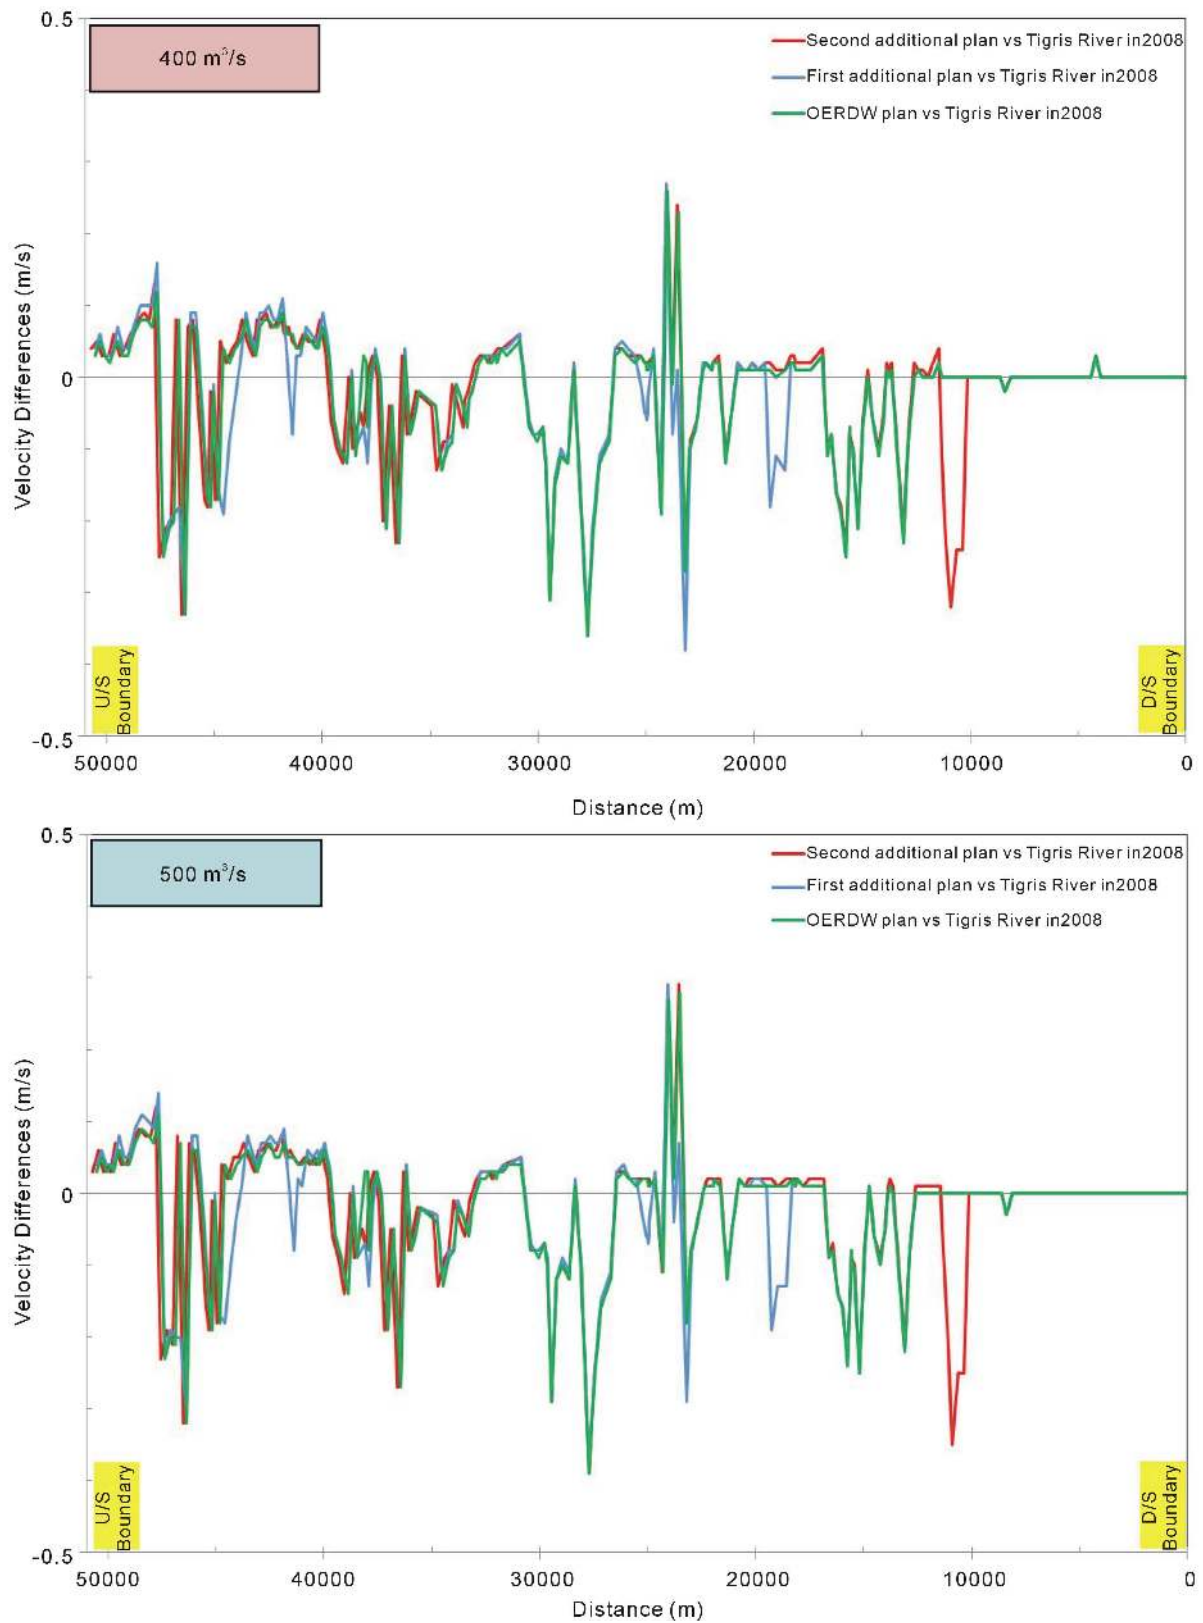
Figure 12. Velocity differences along the river reach between the average velocities of pre-dredging condition and the results of the dredging plans for the low discharges.

A comparison was made to the changes in the longitudinal average velocities along the river reach. This comparison includes the velocities before implementing dredging operations, after implementing dredging operations and for the suggested two plans (Figure 12). This figure shows the negative and positive differences. When the average velocity of the river increases due to dredging with respect to the pre-dredging condition then, this was considered positive. This might keep the deposition rate as it is. Negative differences (which are the most dominant along the river reach) however, are exactly opposite to the first case. Repetition of dredging at some locations on the river can enhance this concept.
