Technical Report ARWSB-TR-11011

Evaluation of Flash Bainite in 4130 Steel

JULY 2011

ARMAMENT RESEARCH, DEVELOPMENT AND ENGINEERING CENTER
Weapons & Software Engineering Center
Benét Laboratories

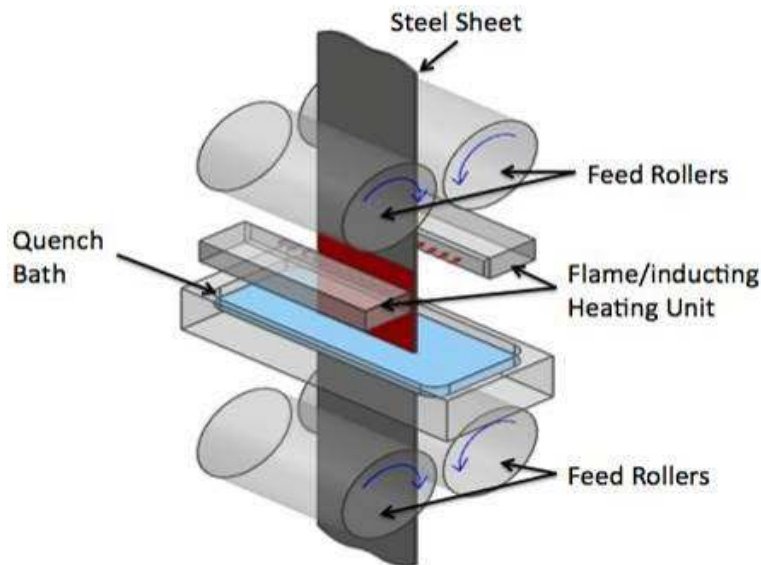
Figure 1. Schematic of Flash Bainite (FB) process for steel sheet/plate [1]. Copied with permission from G.M. Cola, Jr., Sirius Protection LLC.

FB processing occurs in less than 10 seconds. Typically, the time above 300°C is less than three seconds. As such, it is an extremely energy efficient and environmentally friendly process. The

steel is heated (austenitized) to above 1050°C ($>A_3$) using either oxy-propane or induction heating. After heating, the material is purportedly quenched within milliseconds to near room temperature [1]. Figure 1 shows a schematic of the FB process. Recent improvements have included horizontal processing which enables continuous handling of thicker plates. However, typical plate thicknesses are only 6-9 mm, and the process runs into physical limitations at about 12 mm thickness.

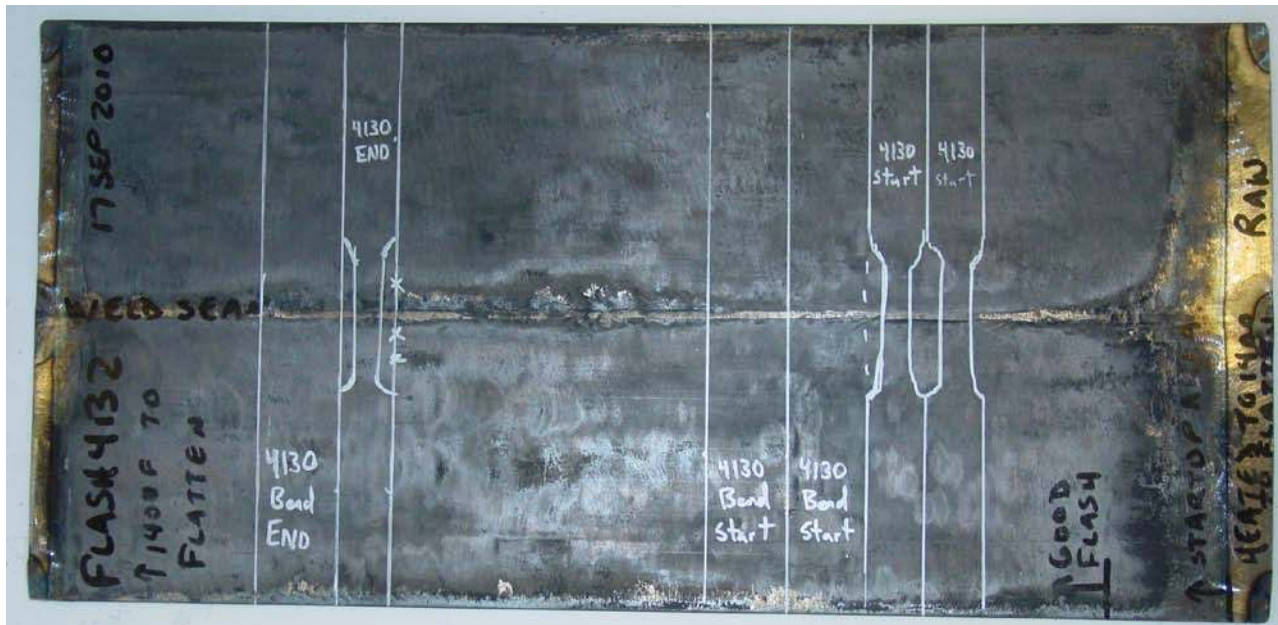
Figure 2. Conventional plate that was cut longitudinally then welded back together and subsequent FB processed. Note location of bend and tensile specimens welded back together.

A single conventional plate and a single FB plate were cut lengthwise and welded back together using a butt weld (Figure 2). To determine the effects of post-weld heat treatment, the conventional 4130 plate was welded with 4130 filler metal. When restraints were removed, significant distortion was noted. To flatten, the plate was sandwiched between two heavy plates in an oven at 760°C (1400°F). Then, the welded and flattened plate underwent the FB process. For comparison to a shorter process, the FB plate was welded with ER120 filler.

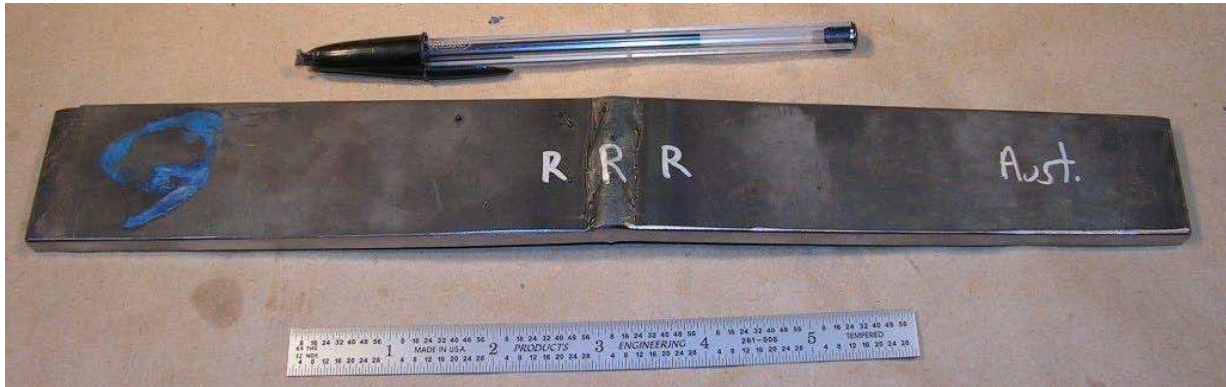
Figure 3. Location of three residual stress and one retained austenite measurements on top of the plate.

Five residual stress measurements were taken in and around the ER120 joint to characterize the stress distribution around the weld. Figure 3 shows locations of three residual stress and one retained austenite measurements on top of the plate, and Figure 4 shows location of two

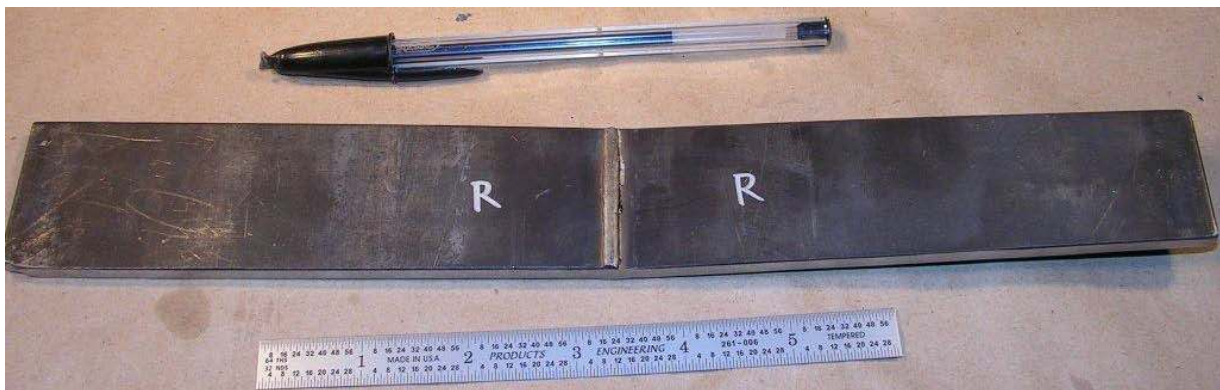
Figure 4. Locations of two residual stress measurements on bottom of the plate.

residual stress measurements on bottom of the plate. A 6th residual stress measurement (not shown) was taken away from the weld on bottom of the plate.

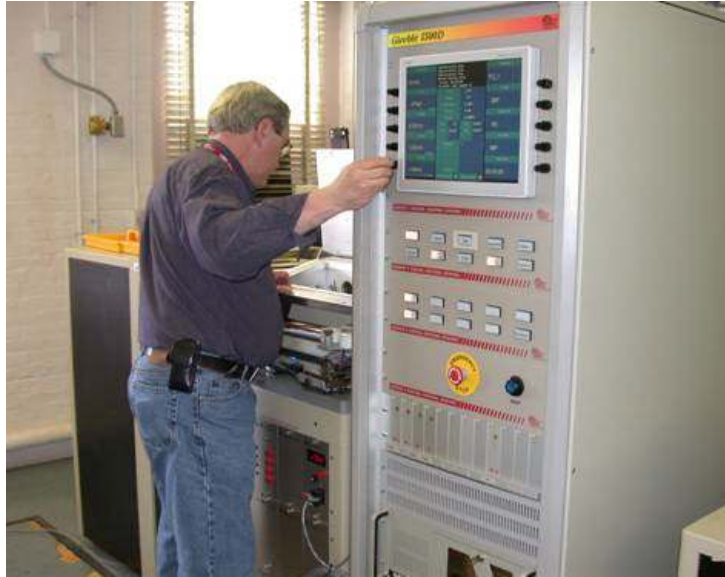
Figure 5. Gleeble 1500 at Benét Laboratories used for HAZ simulation testing.

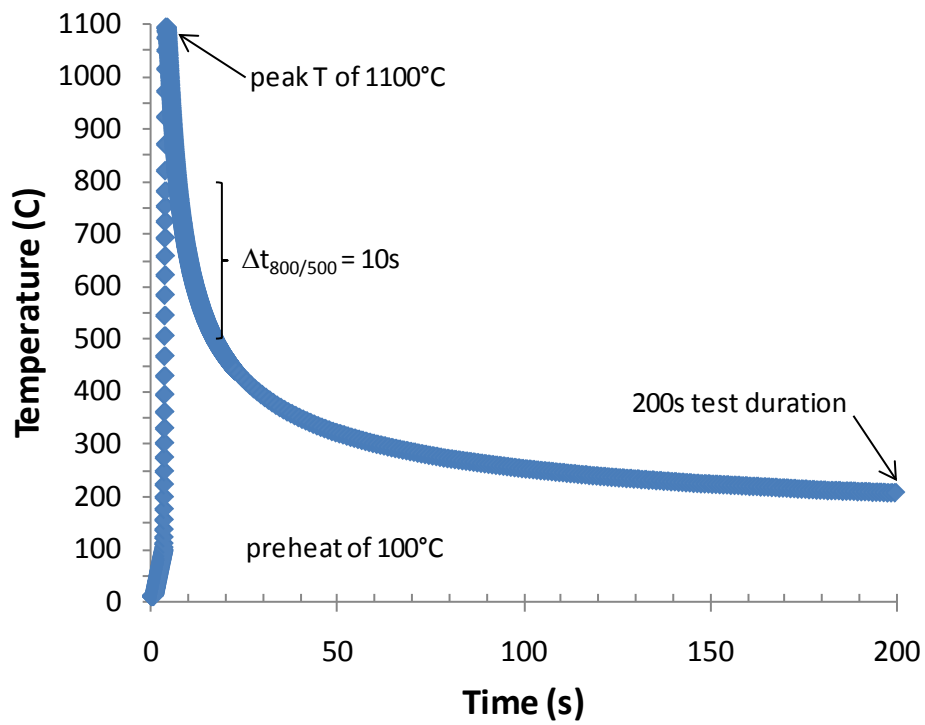
Figure 6. Plot of Gleeble HAZ thermal cycle.

For the Gleeble HAZ testing, a Hannerz thermal cycle program was used. Inputs included a 1MJ/m heat input, a peak temperature of 1100°C, a cooling time from 800-500°C in 10 seconds ($\Delta t_{800/500}$), and a total processing time of 200s. The $\Delta t_{800/500}$ cooling time was ascertained based on empirical relationship for cooling rate [5]. Figure 6 shows the temperature vs. time profile for the Gleeble HAZ thermal cycle.

Based on the thermal profile in Figure 6, the Gleeble HAZ processing raised the temperature of the blanks into the austenite region (1100°C) followed by cooling to the martensite start temperature (~350°C) over approximately 35 seconds. A microhardness traverse was taken across the Gleeble HAZ region. The results can be found in Figures 28 and 29. The HAZ processing on the FB plate and Q&T plate resulted in a mixed microstructure with a microhardness of HV₅₀₀331-417 and HV₅₀₀330-361, respectively. The subsequent CVN specimens were fabricated from the blanks with the notch in the center of the specimen (center of the HAZ).

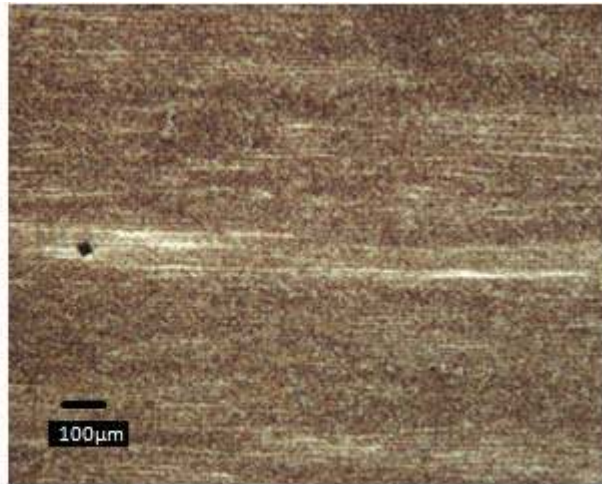
Figure 7. Typical banding at mid-thickness.

Banding was prevalent at mid-thickness of “baseline” FB material (Figure 7). Banding, which is common in steel, was observed in all specimens. It is usually attributed to chemical segregation. A brief literature search finds that reducing the banding by thermomechanical treatment might not be practical (economically), and that reducing the banding might not improve mechanical properties. Conversely, at these high strength levels, 4130 is sensitive to inhomogeneities and reducing the banding may improve properties. This merits additional evaluation [6].

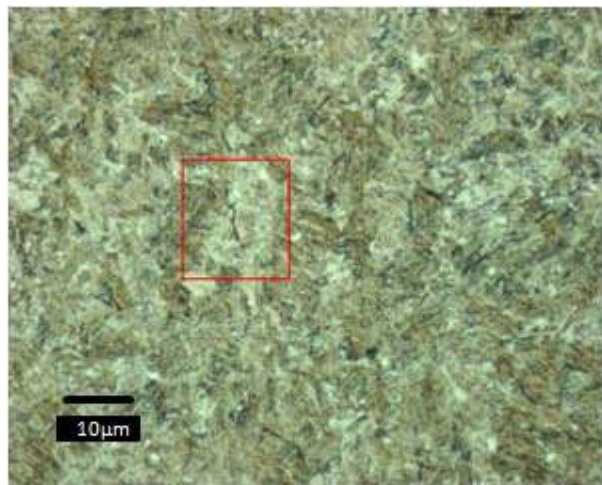
Figure 8. Representative FB microstructure. The red box indicates possible micro-crack. n
possible lack of penetration at root of weld (Figure 9). Ignore the decarburization layer from flattening. The microhardness indents numbered in bottom image correlate to the microhardness indent number in the chart.

Figure 8 shows typical FB microstructure. The red box highlights a possible micro-crack. Photo confirms previous work that FB produces a microstructure consisting of approximately 20% bainite and 80% martensite [7].

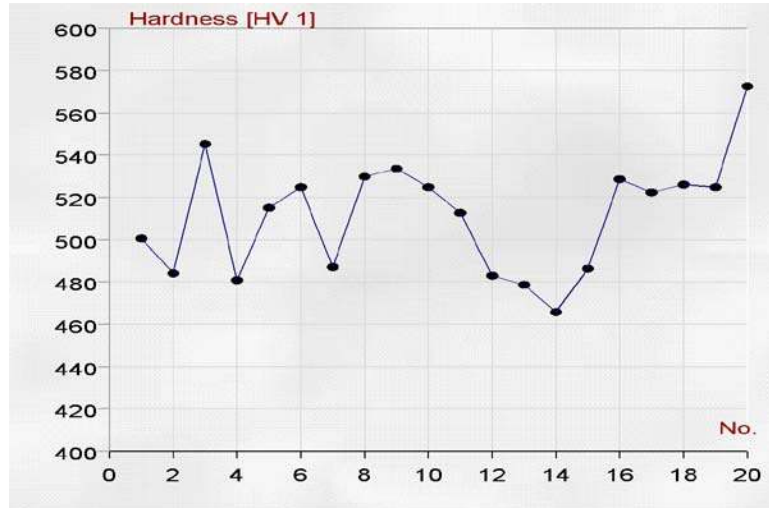
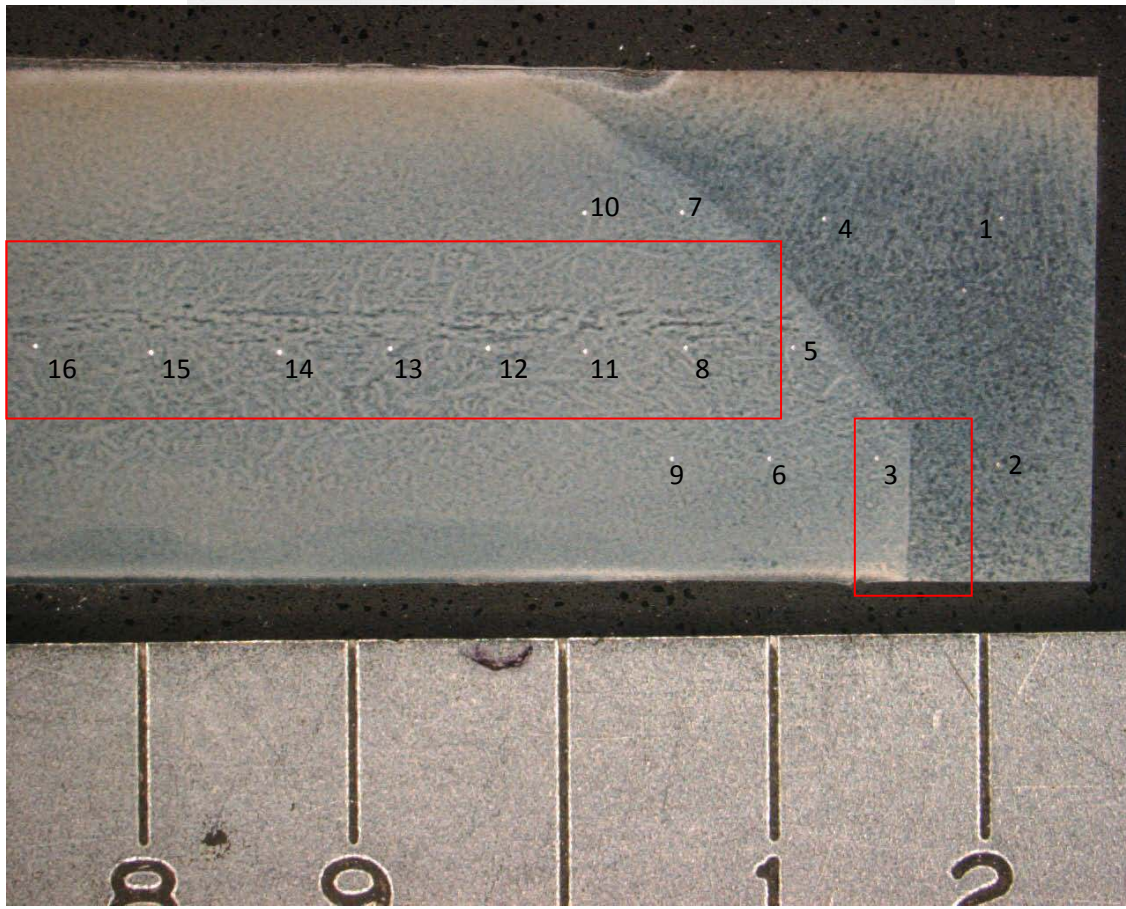
Figure 9. Microhardness of post-weld FB (top) and indent locations in the weldment (bottom). Red boxes indicate banding and possible lack of fusion.

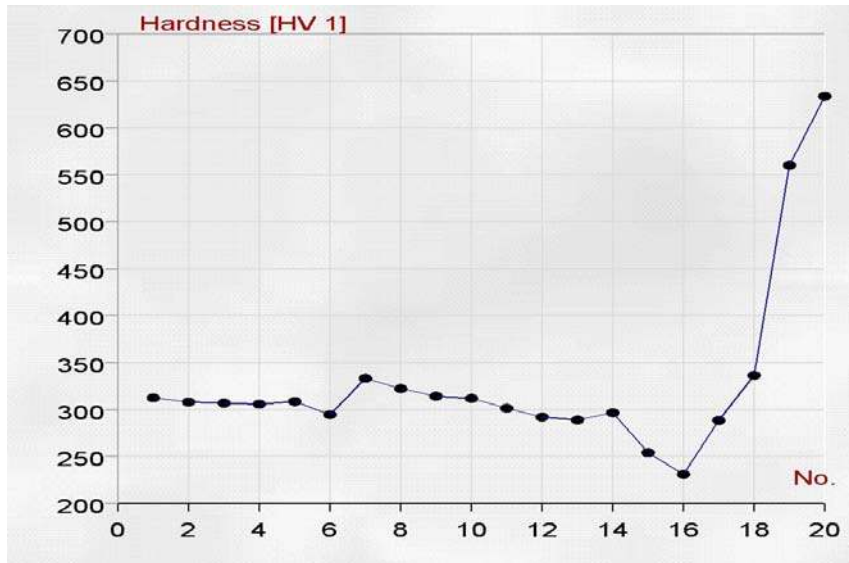
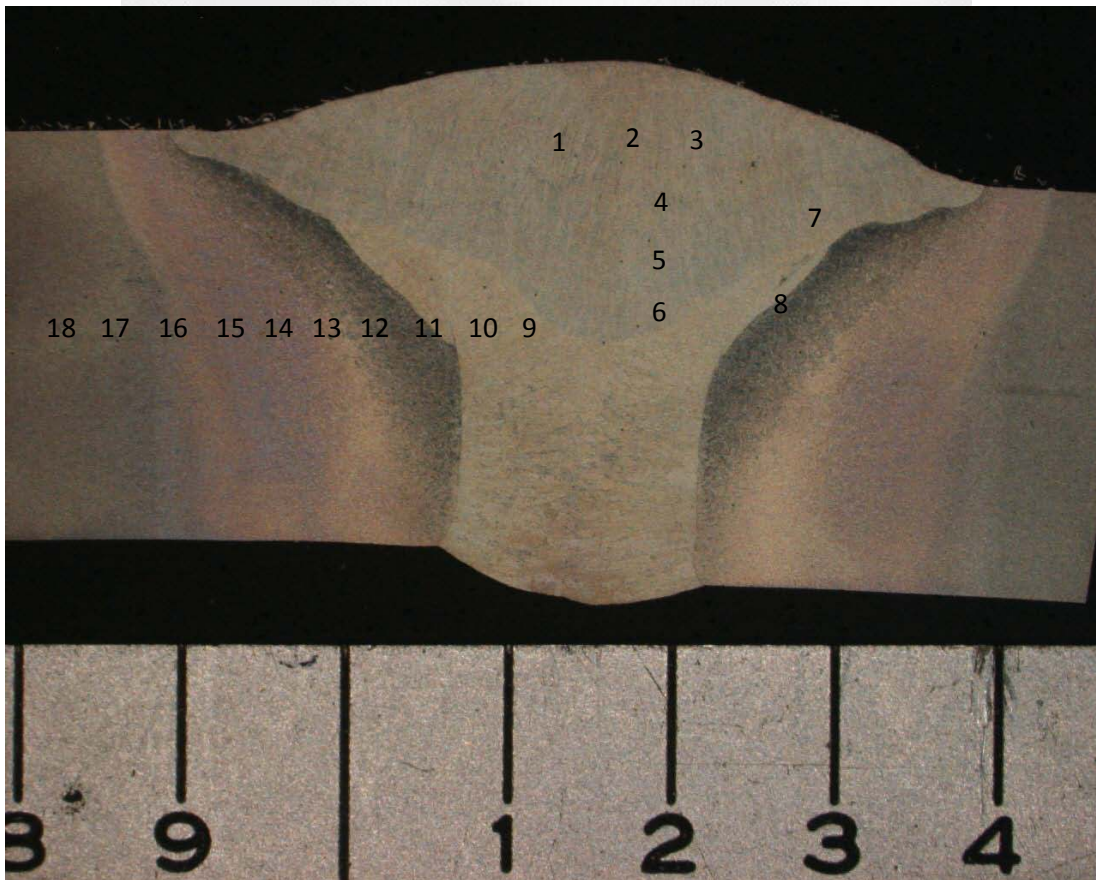
Figure 10. Low magnification photo of ER120 weldment (bottom) with microhardness indents labeled (top).

Figure 10 (bottom) is a low magnification photo of ER120 weldment with microhardness indents labeled. Note the two-pass weld and HAZ. As expected, the ER120 has a weak link in weld metal and HAZ. Note that away from the weld (indents #19 & 20 not in photo), in a banded area, a microhardness of HV634 was measured.

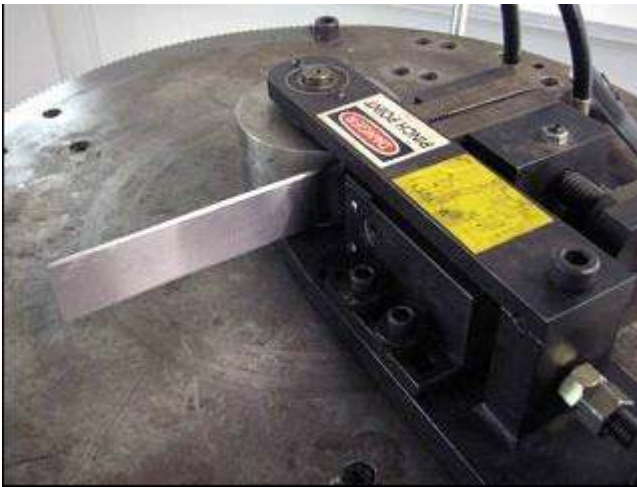
Figure 11 (left). Bend specimen before test.

Figures 11 and 12 show a welded specimen before and after the bend test. All specimens passed the bend test; however, there is significant non-uniformity of the ER120 welds without post-weld heat treatment (see Figure 13, specimen DE1). The ER120 HAZ is the weak link. The post-weld FB specimen, shown as “DD1” in Figure 13, bent uniformly. Prior to testing, there were no visual weld defects on any specimens.

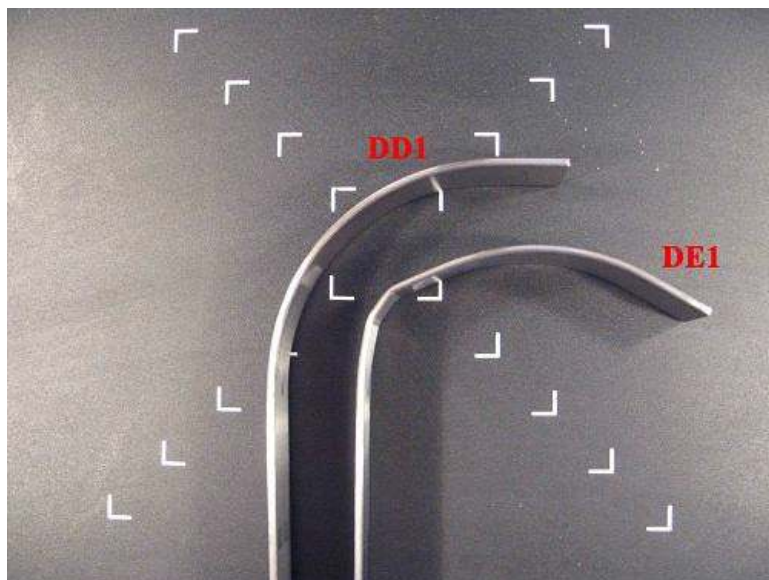
Figure 13. Note non-uniformity of the ER120 welds without post-weld heat treatment.

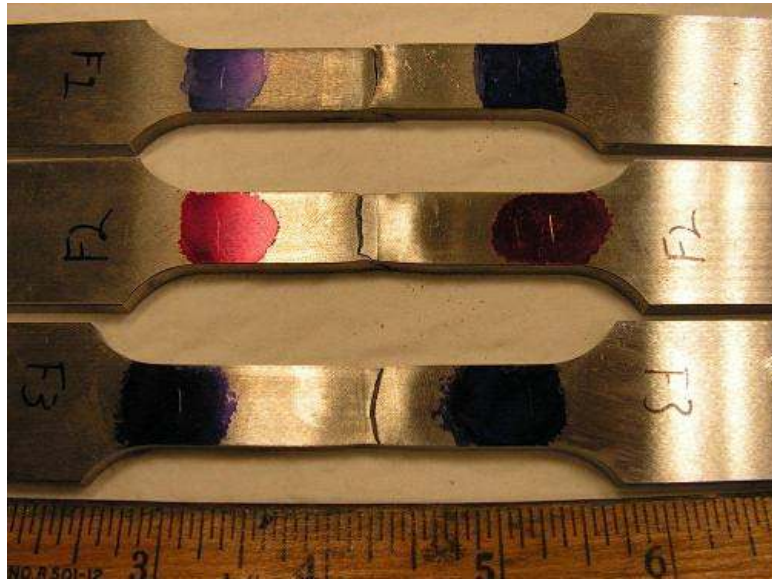
Figure 14. Post-weld FB tensile specimens failed at/near the interface of weld metal / base metal.

Welding with 4130 wire followed by FB post-weld heat treatment produces the same yield strength as unwelded FB; however, at least half of the ductility is lost in the welded area. A welding engineer observed lack of penetration, which might have contributed to loss of ductility. That is, there appears to be a lack of penetration at weld root. These post-weld heat treated tensile specimens failed at or near the interface of weld metal / base metal (Figure 14).

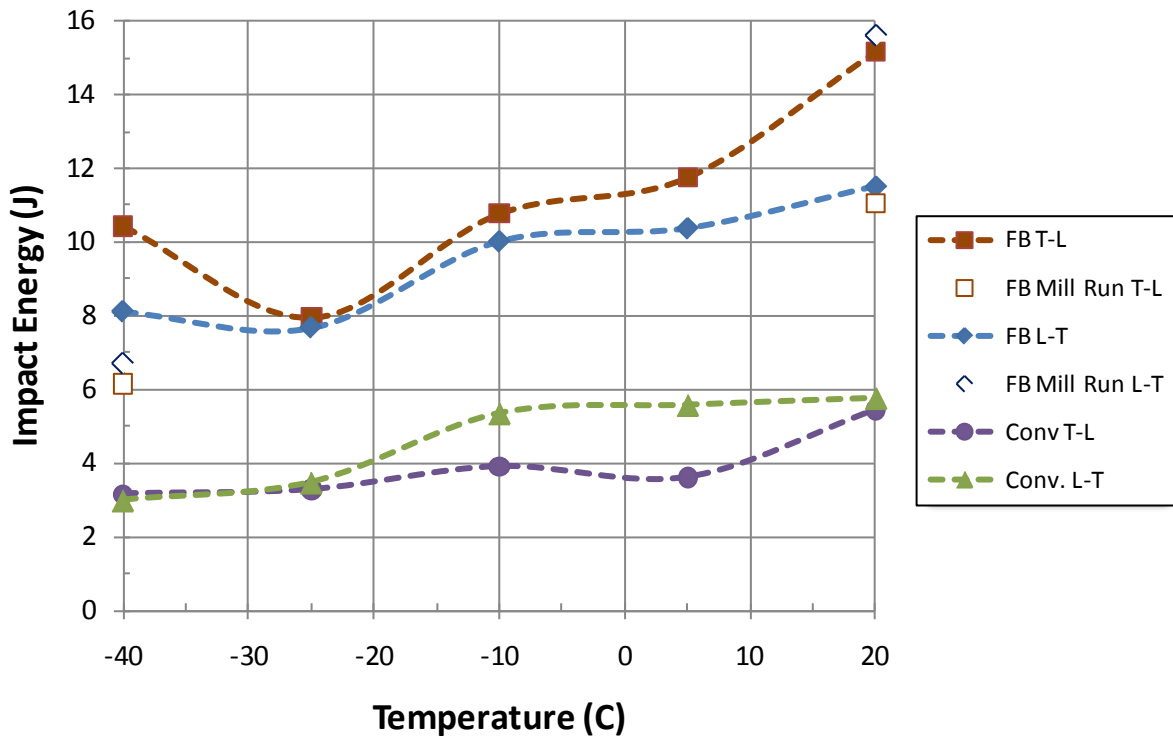
Figure 15. Average CVN impact energy on Flash Bainite vs. Conventional Q&T 4130 steel.

The averaged results on the CVN testing can be found in Table 3 and Figure 15. For the complete CVN results, please see Appendix F. Note that the average FB data from the “mill run” plate are shown as separate data. The FB impact energy at all temperatures was consistently and significantly higher than the conventional, Q&T specimens. Because these are subsize specimens, the energy absorbed cannot be compared to full size specimens. The correlation in impact energy from one-half size to full size specimens is approximately 1.5x [9, 10]. Therefore, for this subsize geometry used, an impact energy of 10 J roughly corresponds to 15 J for a full-size specimen.

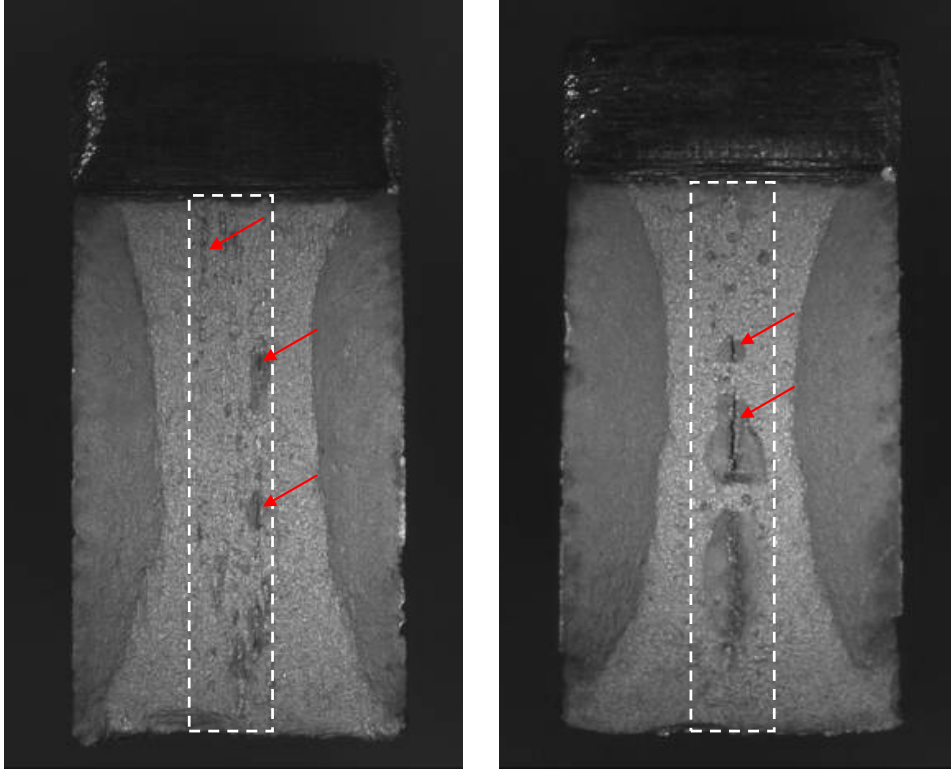
Figure 16 (Left). Example of cracking near the centerline of specimen FB TL-F5 (from “mill run” plate).

Figure 17 (Right). Cracking and tearing along the centerline of specimen FB LT-F1 (from “mill run” plate).

After CVN testing, specimens from each material condition, orientation, and test temperature were evaluated using light microscopy and Scanning Electron Microscopy (SEM). Of the 14 FB specimens subsequently evaluated, seven contained clear evidence of intergranular cracking in “veins” along the center 20-25% of the specimen. All (4) FB specimens from the “mill run” plate and three of ten FB specimens from the spheroidized plate exhibited intergranular cracking near the centerline. *None of the Q&T specimens examined exhibited any evidence of intergranular cracking.* Figures 16 and 17 clearly show evidence of cracking and tearing along the centerline of (2) FB specimens from “mill run” plate. Contrast that with Figure 18 in which no secondary cracking/tearing is observed (Q&T plate). Figures 19 and 20 are SEM fractographic images of the same FB specimen. In the higher magnification image (Figure 20), intergranular cracking is evident. In many cases in which intergranular cracking was observed, the region surrounding the cracking was ductile and exhibited features which appeared to be shear lips (e.g. Figure 21). All intergranular facets appeared clean and free from an oxide. This was confirmed by Energy Dispersive Spectroscopy (EDS). Therefore, the occurrence of intergranular cracking is believed to be due to the material condition rather than a quench crack during processing. This is more evident after metallographic examination, discussed next. The Q&T specimens exhibited a mixed mode (predominantly cleavage) fracture. Figure 22 is a representative image from a Q&T specimen after CVN testing.

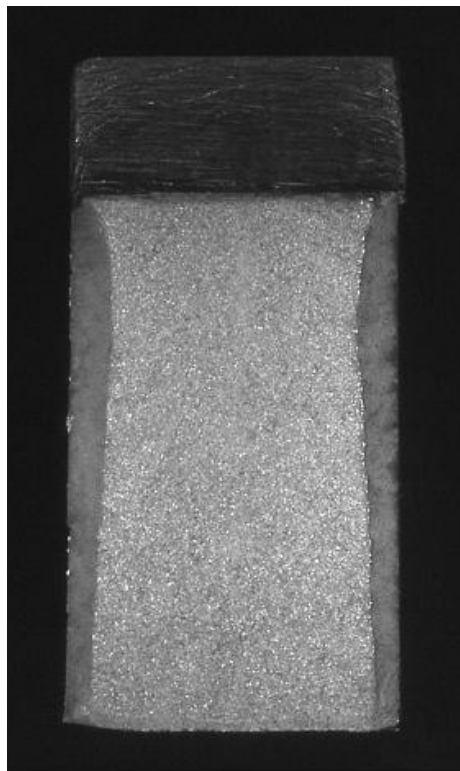
Figure 18. Fracture surface of Q&T specimen C LT-6.

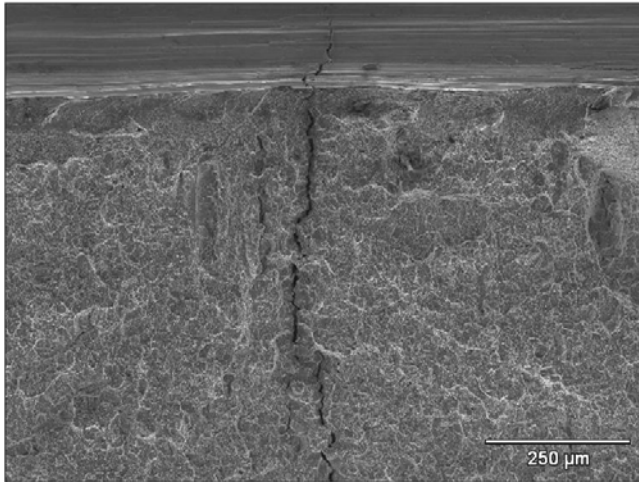
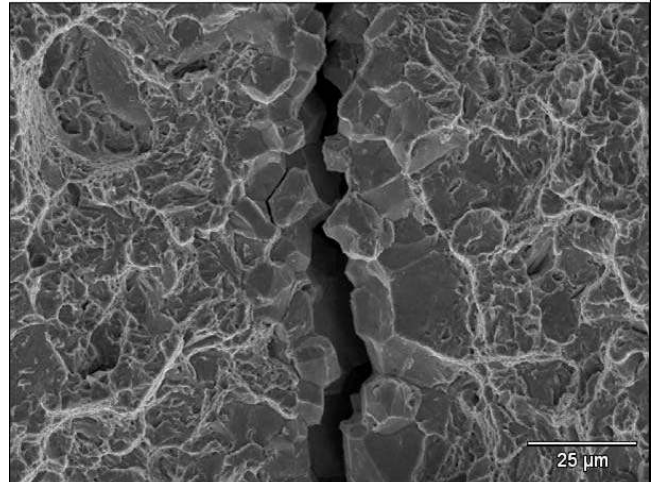
Figure 19 (Left). Secondary cracking evident on fracture surface (FB TL-F2, “mill run” plate).

Figure 20 (Right). Higher magnification image of crack reveals intergranular cracking.

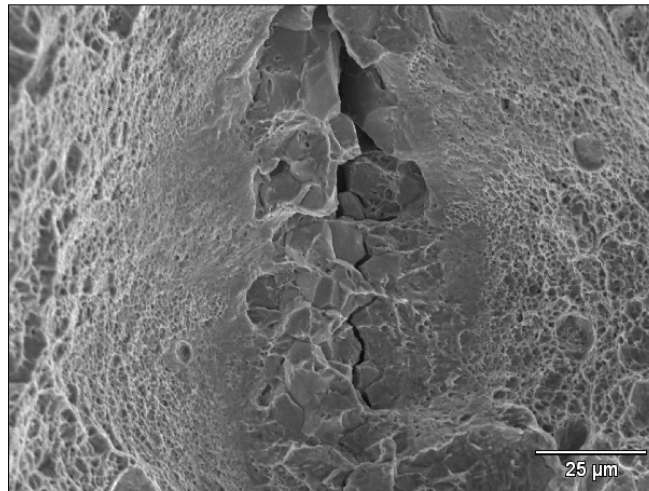
Figure 21. Evidence of what appears to be ductile shear lip surrounding the intergranular crack (FB TL-F5, “mill run plate”).

Interestingly, the region surrounding many of the intergranular cracks and tears in the CVN specimens contained what appeared to be shear lips, an indicator of ductility (e.g. Figure 21). Moreover, the intergranular cracking occurred normal to the primary crack plane. This off-axis cracking could actually be beneficial as it would increase the amount of energy absorbed.

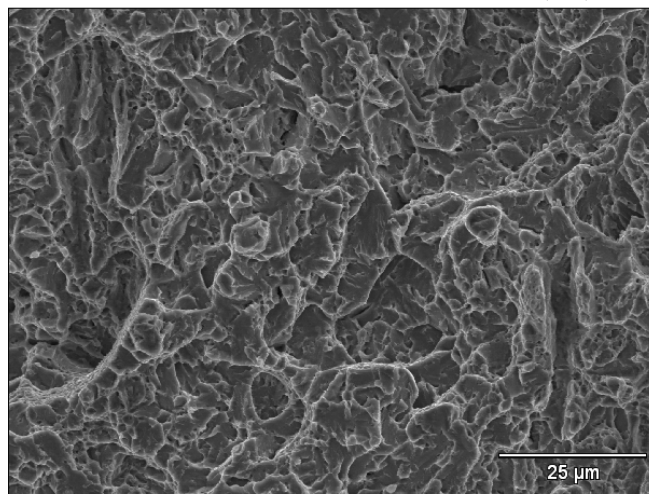
Figure 22. Mixed mode fracture (predominantly cleavage) on a Q&T CVN specimen (C LT 10).

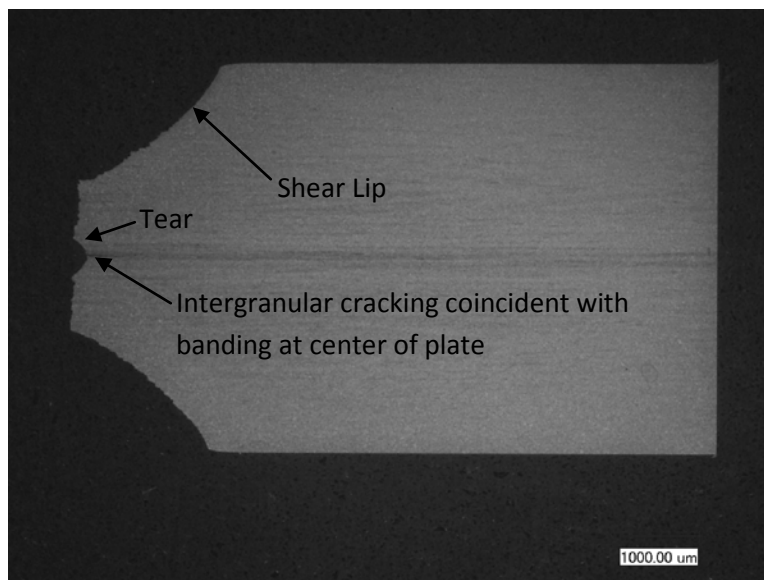
Figure 23. Low magnification light microscope image of a cross section of specimen FB LT-F1 through region of intergranular cracking. Note that the crack is coincident with the banding in the center of the plate. Etched with 2% Nital.

After CVN testing, select specimens were cross-sectioned and metallographically prepared. After etching with a 2% Nital solution, banding was evident. While banding was present on all of the metallographic specimens examined, it was most evident and extreme in a specimen from “mill run” plate. Figure 23 shows a low magnification image of the cross section of CVN specimen FB LT-F1 (from “mill run” plate). A large band is clearly evident along the centerline of the specimen. Intergranular cracking was coincident with the banded region in the center of the specimen. This banding is a result of chemical segregation during the steel making process. It is plausible that the banding was more severe on the “mill run” plate because that microstructure (pearlite and ferrite) is more heterogeneous than a spheroidized microstructure. Figure 24 shows a magnified view of Figure 23 in which the intergranular secondary cracking is clearly evident.

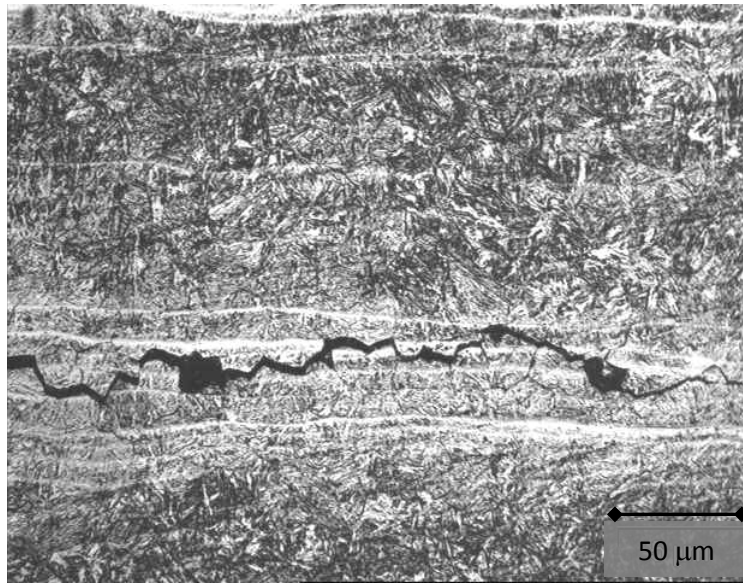
Figure 24. Intergranular secondary cracking in CVN specimen FB LT-F1. Note the concentration of banding where the cracking occurred. MAG 400x.

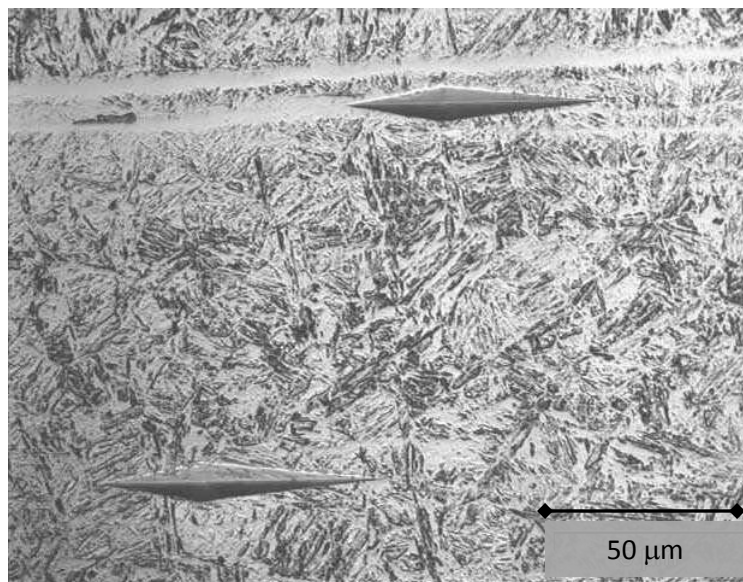
Figure 25. Knoop microhardness indents in etched (2% Nital) CVN specimen FB LT-F1. Note that the indent in the banded region at the top right of the image is smaller (harder) than the indent in the bottom left (softer). MAG 600x.

Knoop microhardness readings taken on specimen FB LT-F1 clearly demonstrated that the lightly banded regions were considerably harder than the dark banded regions. This is evident in Figure 25 in which the indent in the upper right of the image (in the light band) is smaller than the indent in the lower left of the image (in a dark band). Note in Figure 25 that the Knoop microhardness indents are not symmetric. This could be due a perpendicularity issue or an indenter alignment issue. However, the conclusion (hardness difference) remains the same. The hardest microhardness reading taken was $HK_{1000}920$ at the center of the specimen in a light band. As per ASTM E140, this corresponds to HRC 68, considerably higher than the maximum hardness (macro) that is attained with 4130 steel. However, heterogeneous chemical segregation could certainly account for the locally high microhardness (and could influence the

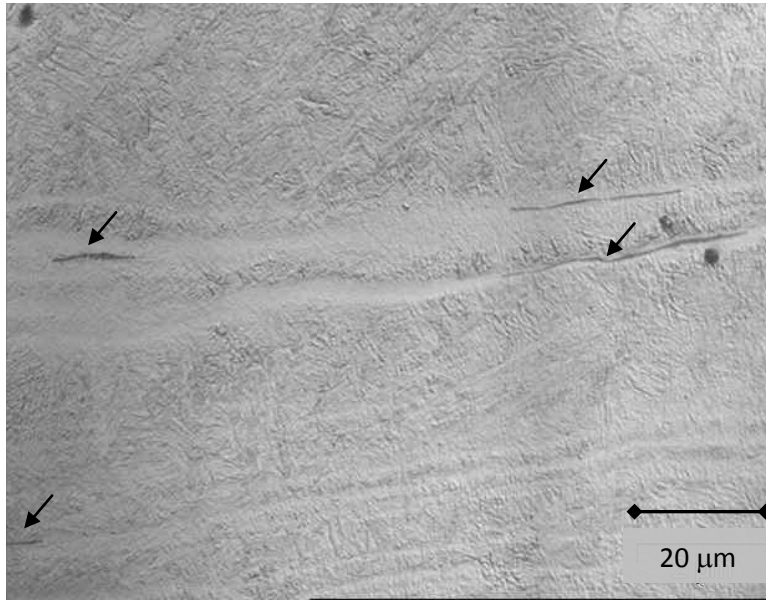
Figure 26. Lightly etched (2% Nital) CVN specimen LT F1. The arrows point to Mn-S inclusions which are preferentially located in lightly banded regions. MAG 1000x.

kinetics of tempering). Additionally, Mn-S inclusions appeared to be preferentially located along the lightly banded regions near the center of the specimen (Figure 26). Though the sulfur (S) and phosphorous (P) measured in the chemical analysis are well within the limits for 4130 steel, their presence in the microstructure (as Fe-S and Fe₃P) are well known in causing embrittlement of steels [12]. Segregation of these tramp elements to the centerline of the plate during steel making would only exacerbate the tendency for embrittlement.

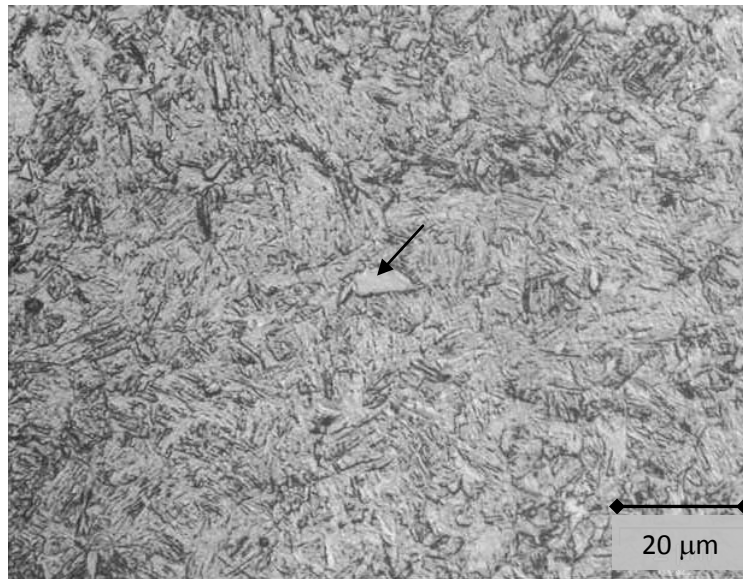
Figure 27. Etched microstructure (2% Nital) of Q&T 4130 plate (CVN C LT 6). The arrow points to a blocky region of ferrite. MAG 1000x.

Figure 27 shows the microstructure of a Q&T CVN specimen. The microstructure is predominantly martensite with other austenite decomposition products such as bainite and some blocky ferrite (arrow).

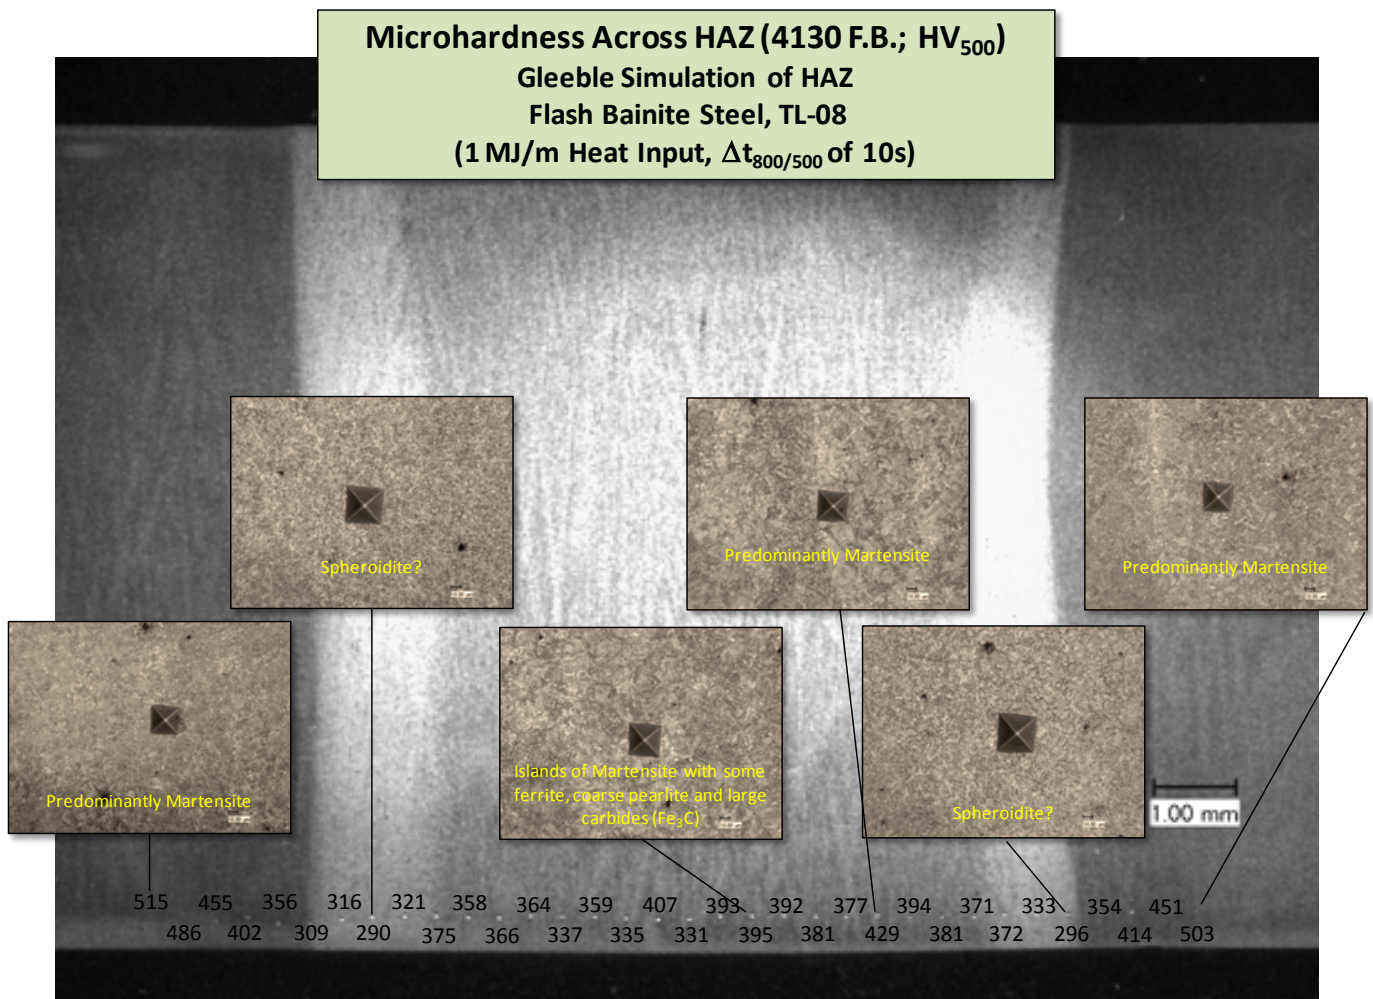
Figure 28. Photomicrographs and microhardness reading across the Gleeble HAZ in FB 4130 plate.

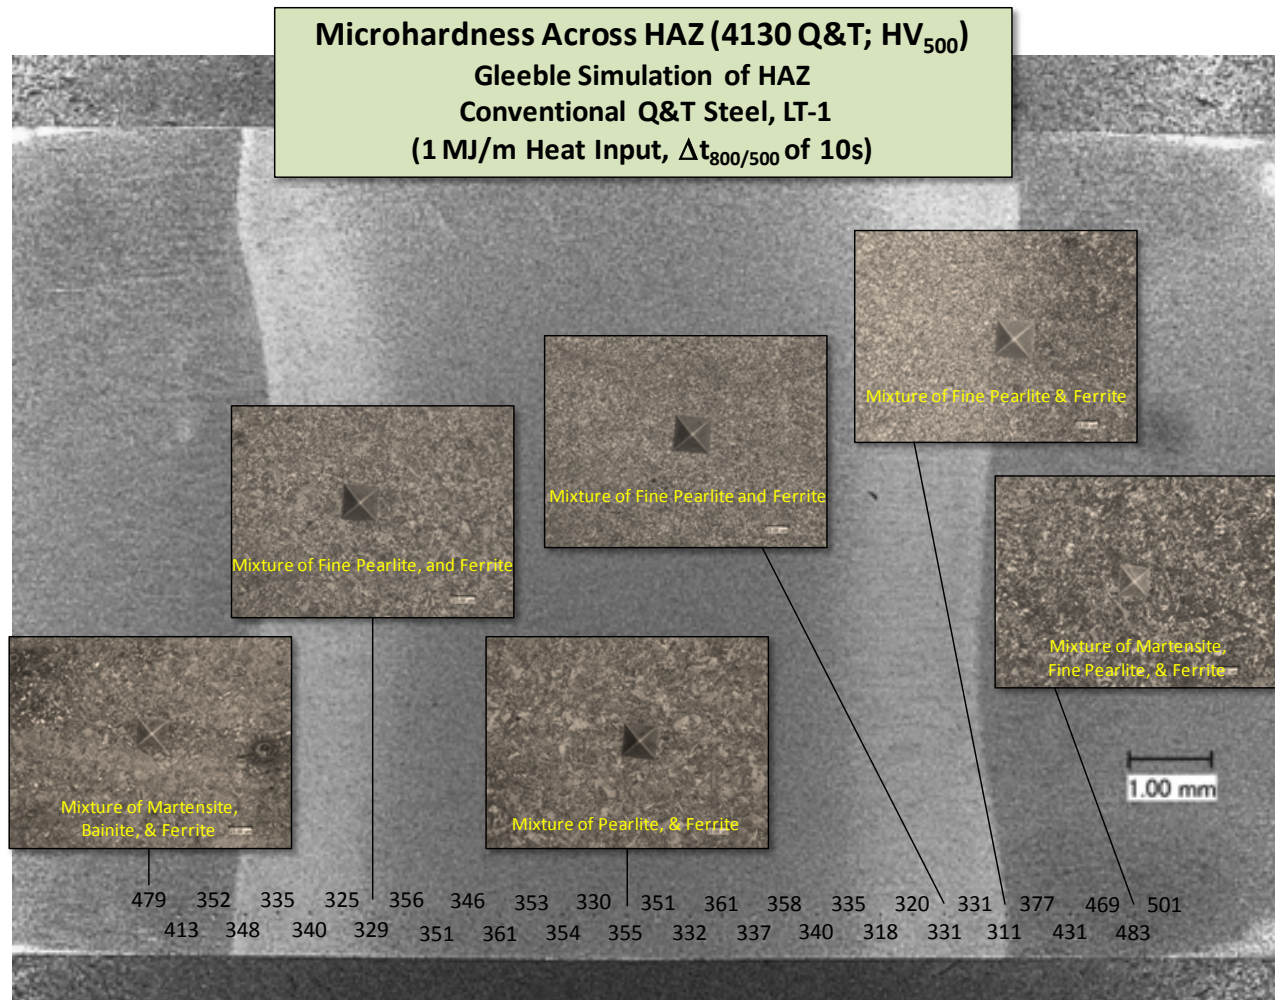
Figure 29. Photomicrographs and microhardness readings across the Gleeble HAZ in Q&T 4130 plate.

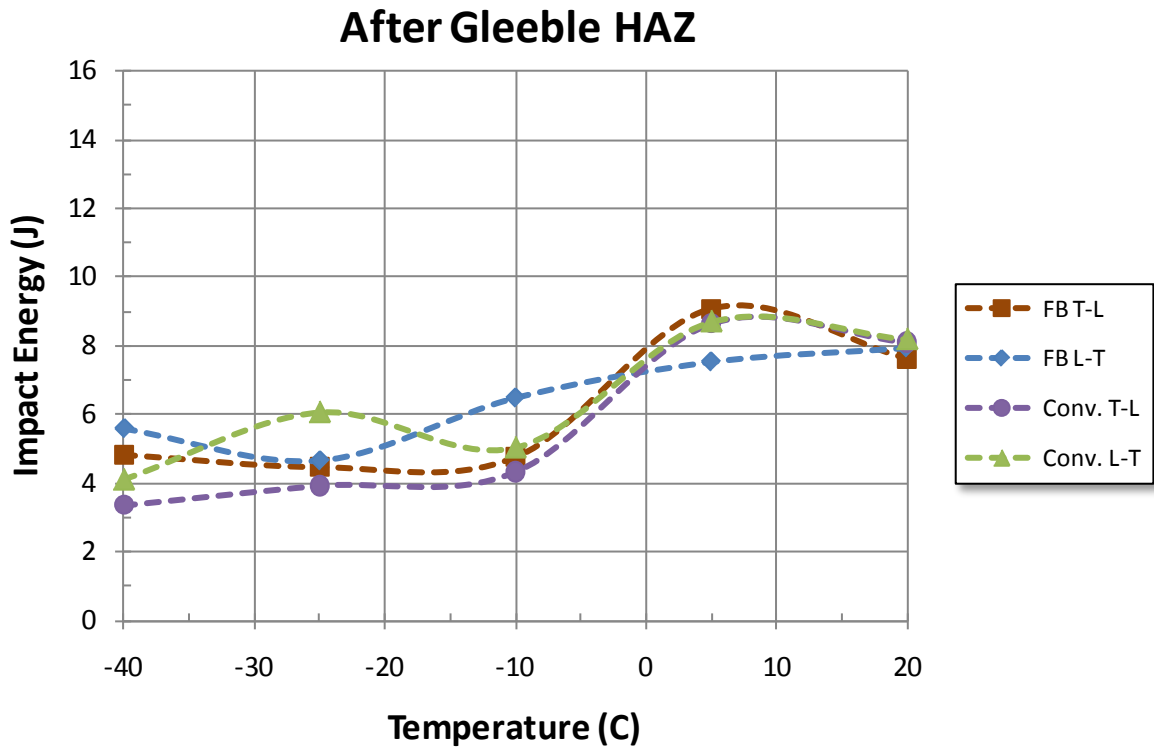
Figure 30. CVN impact toughness after Gleeble HAZ processing. Note the similarity in results between the FB and Q&T 4130 steel.

The CVN impact toughness is essentially the same for the FB and Q&T specimens tested after Gleeble HAZ processing. Results for the average impact energy for each condition can be found in Figure 30. The entire data is found in Appendix G. Figure 31 clearly shows that the predominant failure mode for the Gleeble processed CVN specimens was cleavage. This was not surprising considering the microstructure of the material (predominantly fine pearlite and ferrite).

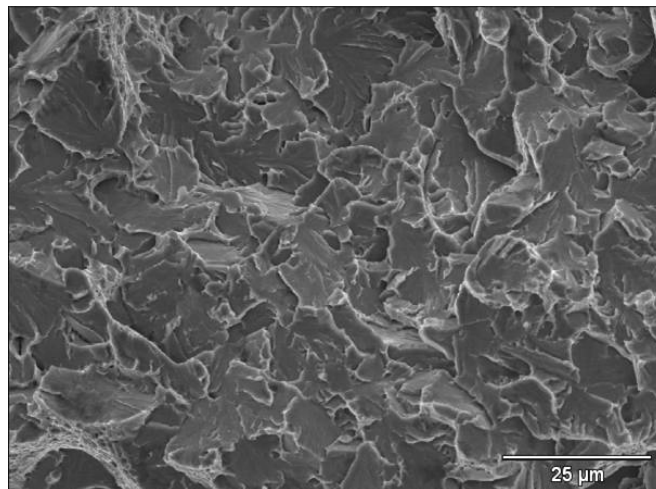
Figures 31. The predominant failure mode of the CVN Gleeble HAZ specimens was brittle cleavage fracture (the above specimen is C TL 04; 3.2J @ -40°C).
