Evaluation of Grouting as a Strengthening Technique for Earthen Structures in Seismic Areas: Case Study Chiripa

A Thesis in Historic Preservation Presented to the Faculties of the University of Pennsylvania in Partial Fulfillment of the Requirements for the Degree of Master of Science in Historic Preservation 2007.

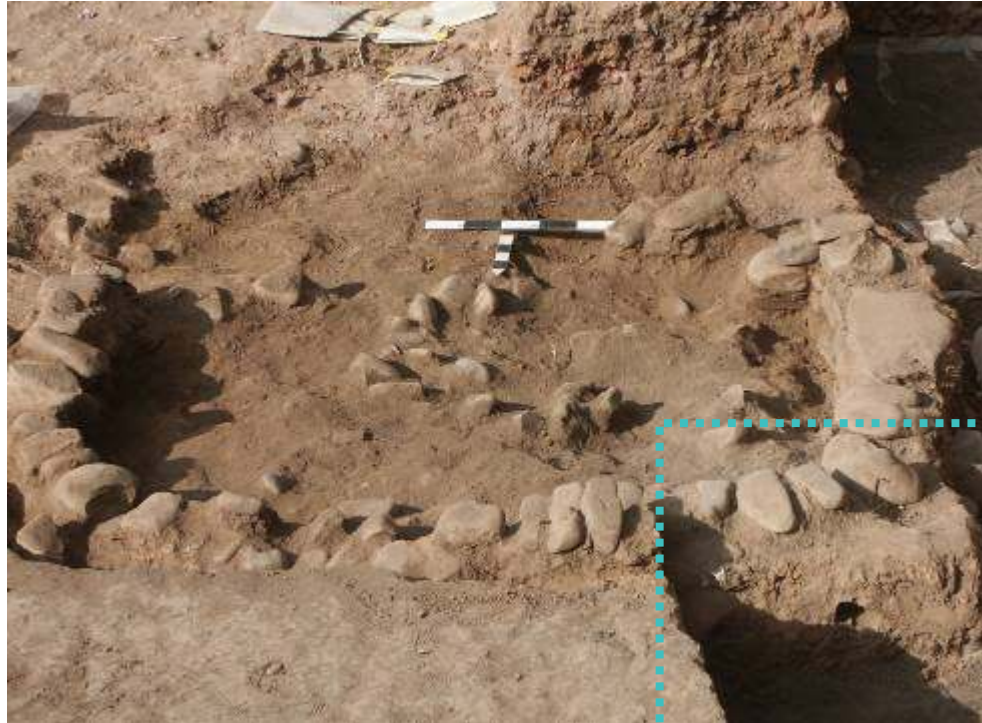
mud. The foundations were constructed of roughly squared stones set in earthen mortar upto a height of approximately 70 cms above grade. Two or three courses of large cobbles were set over the stones, over which the walls were built. No data regarding the depth of foundations is presented.

Figure 2.8: View of the Foundations (TAP 2006) Note original grade has been removed in the right hand corner to reveal foundations

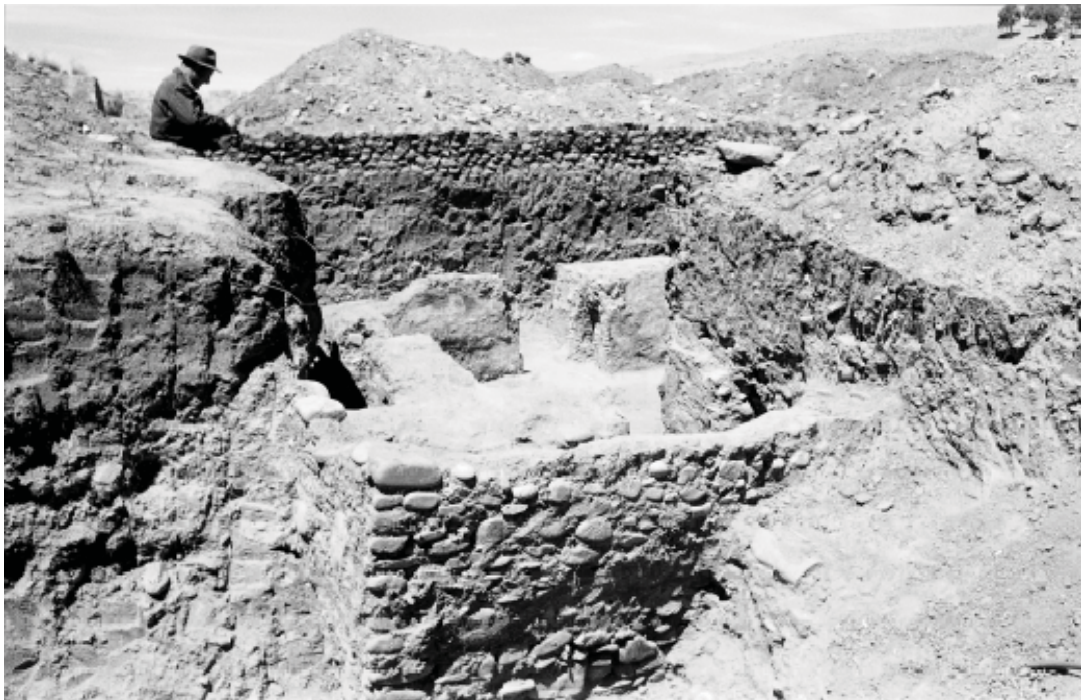
Figure 2.11: View of House One showing a general decay; no roofs; no drainage (Kidder Collection 1956)

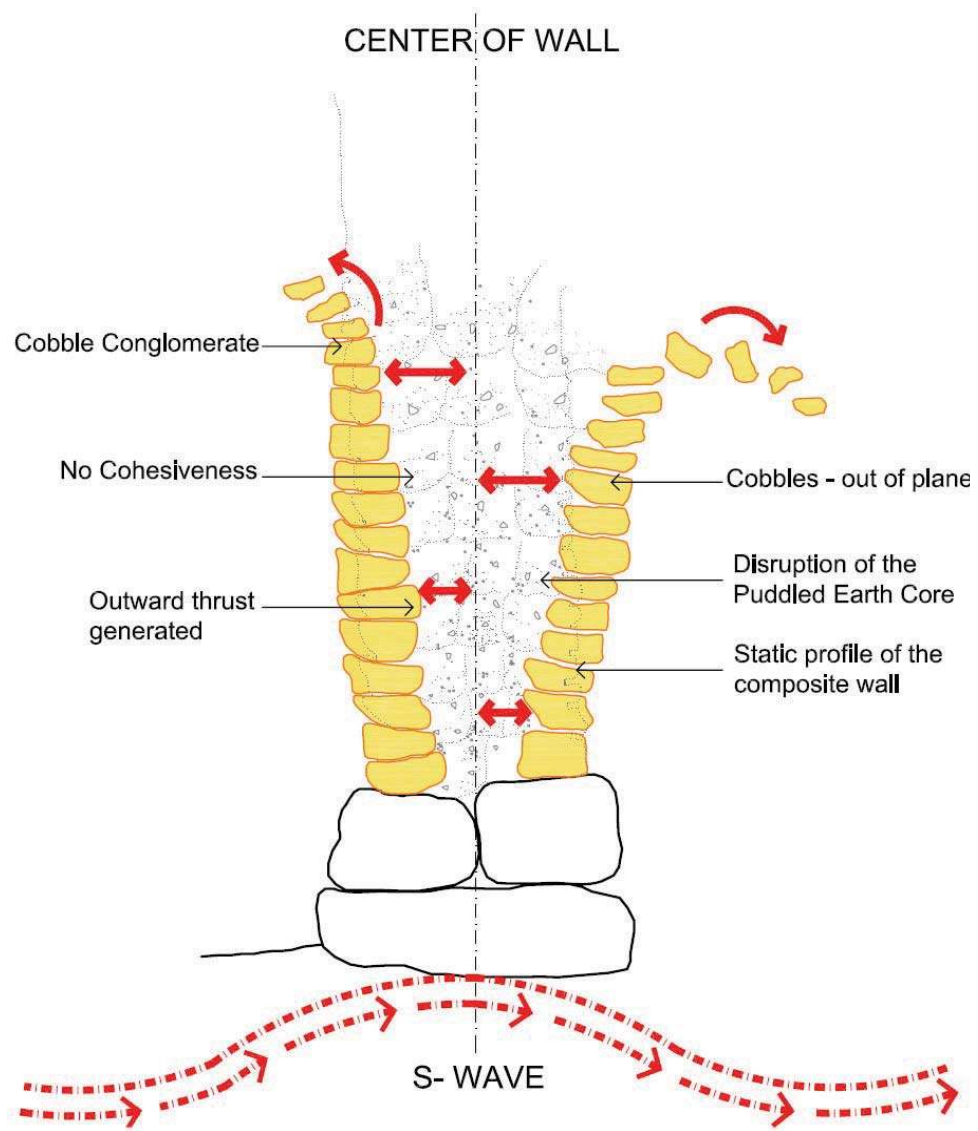
Figure 3.1: Illustration of the behavior of composite wall in seismic event (Chaudhry' 07)

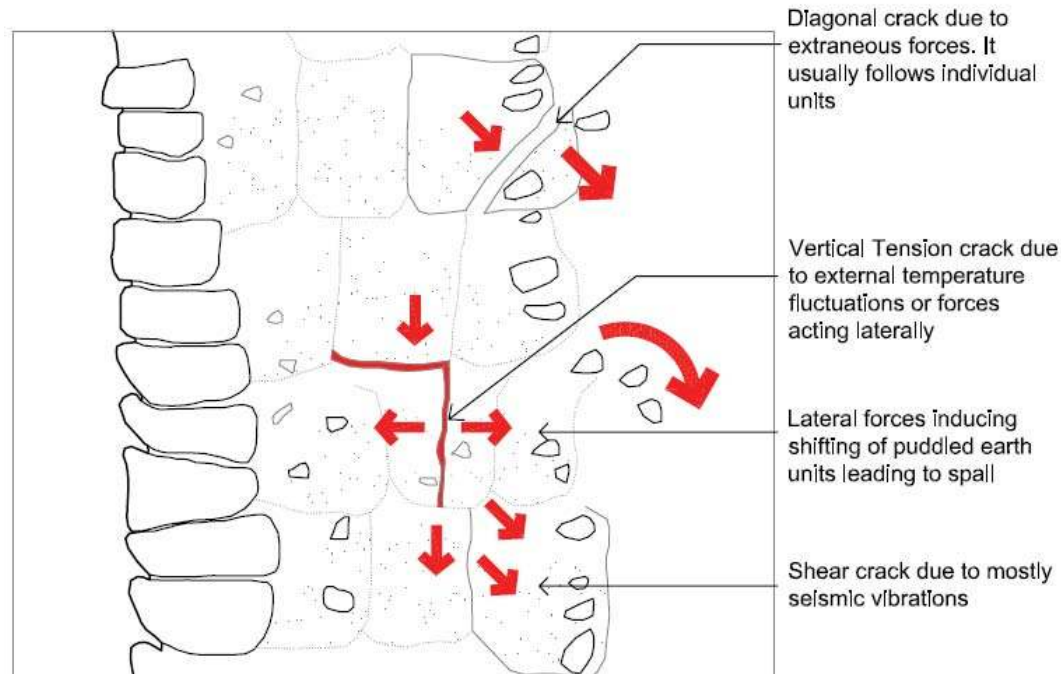
Figure 3.2: Illustration of puddled earth units and stress distribution (Chaudhry' 07)

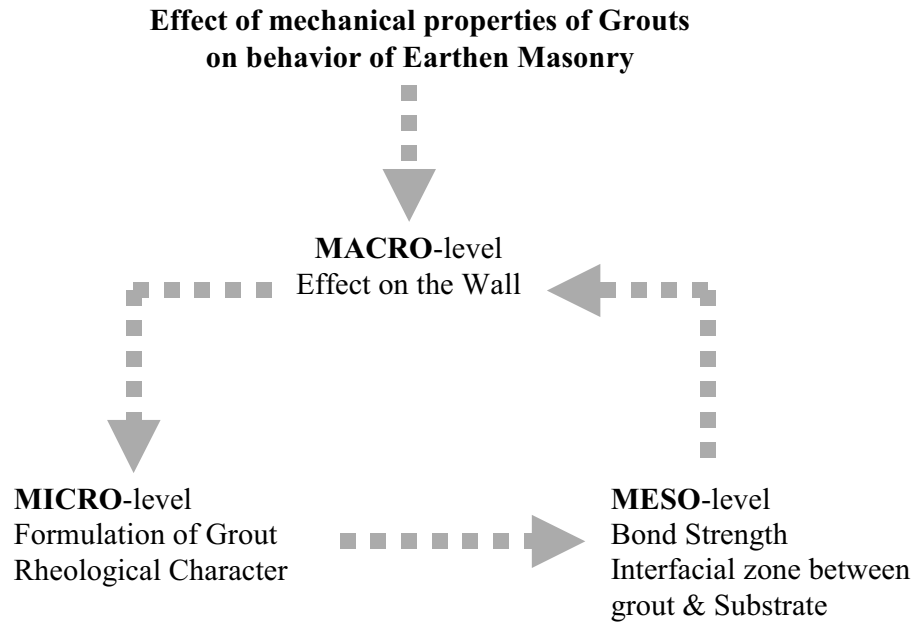
Figure 6.1: Conceptual Sketch of the effect of grout on masonry (Toumbakari E-E, 2001)

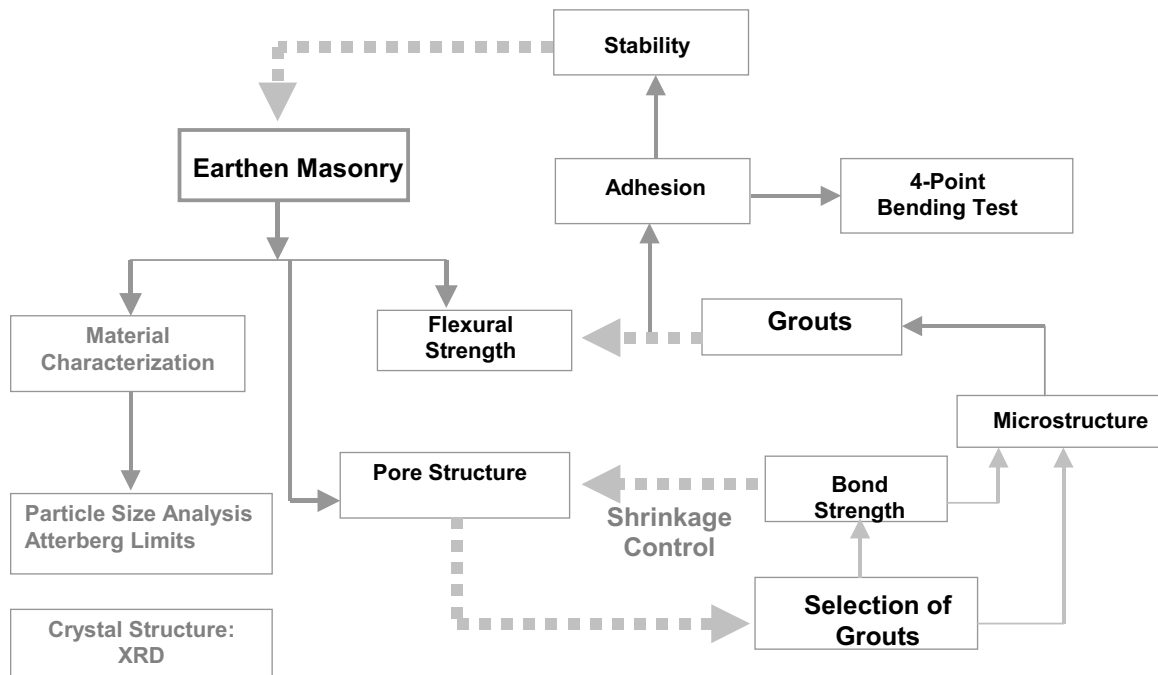
The selection of an optimum grout for the earthen walls at Chiripa involved parallel studies on the earthen masonry and the grout. A comprehensive set of tests was designed to define the material and physical characteristics of the historic puddled earth samples of Chiripa preceded the selection of the grout. This laid a set of performance criteria (physical, chemical and mechanical) for the selection of the grout and the interfacial bond was tested for its adhesion and compatibility with the historic earthen masonry, see Figure 6.2.

Figure 6.2: Relationship between properties of earthen masonry and grout as considered for tests. (Chaudhry' 07)

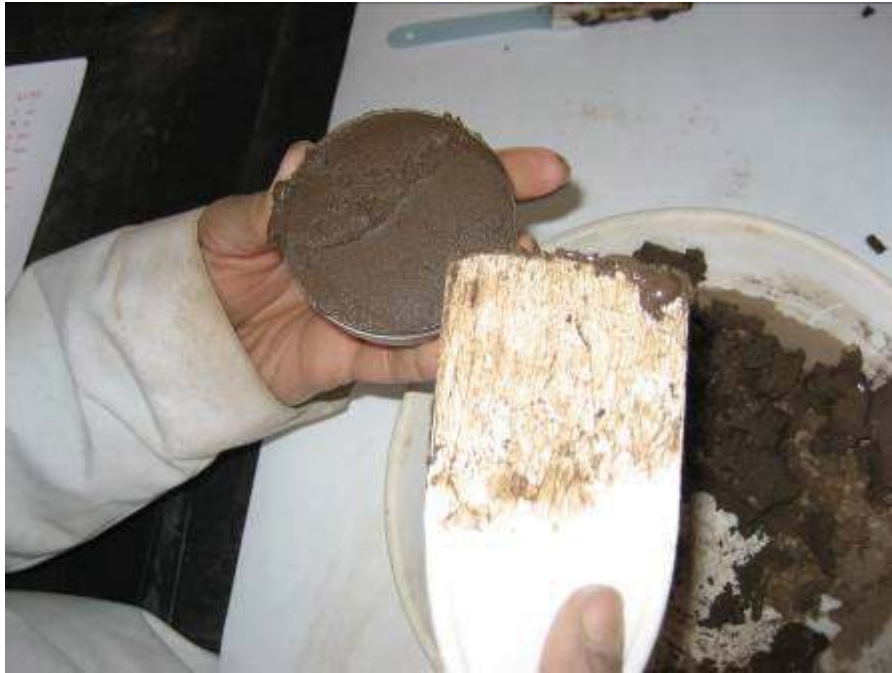
Methodology: The process of determining the soil shrinkage by volume is more complex than simple linear shrinkage. The method involves casting the soil in a mold of known dimensions which is adequately greased, and then coating the dried soil with paraffin, and weighing the coated soil in water also called as Hydrostatic weighing.

Figure 6.12: Casting the wet soil into shrinkage dishes

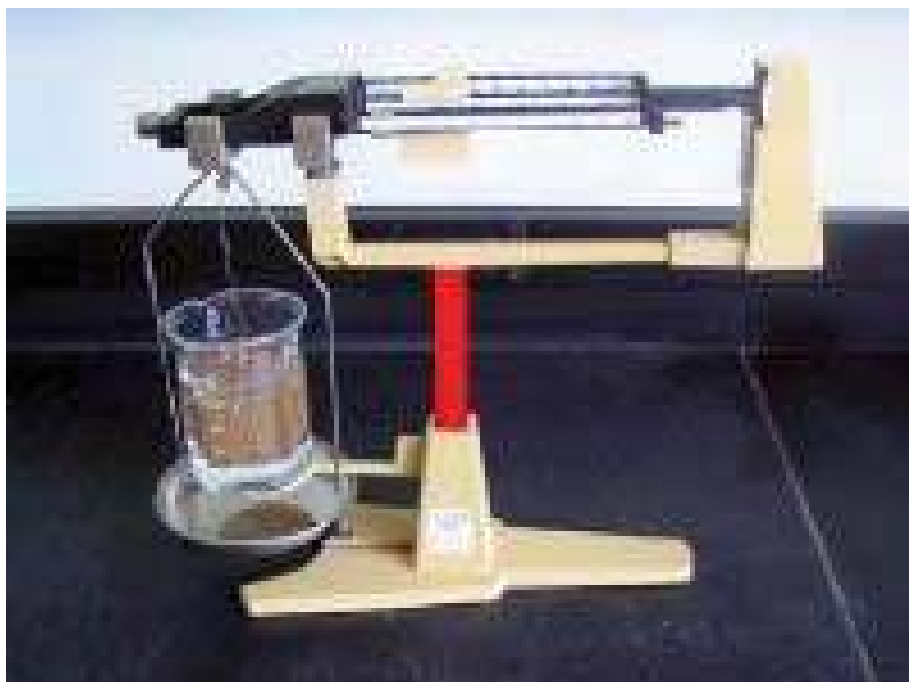
Methodology: The object was suspended on a thin metal thread and weighed twice - measuring the force of pull on the thread when suspended in air and immersed in the liquid.

Figure 6.15: Triple beam Balance for hydrostatic weighing of samples

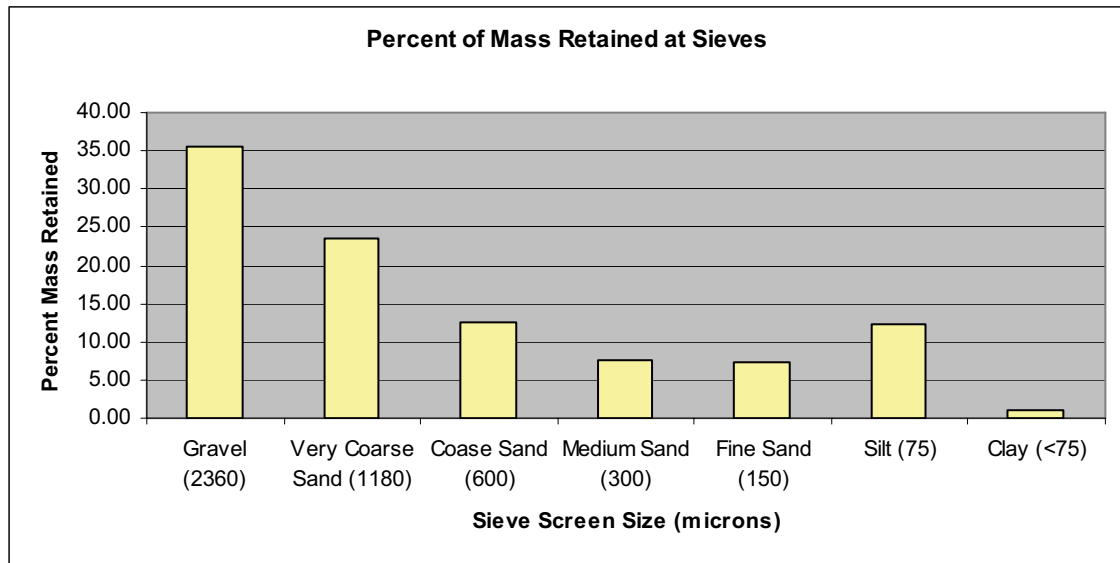
Graph 7.1: Percent Mass Retained at Sieves for Sample 8547

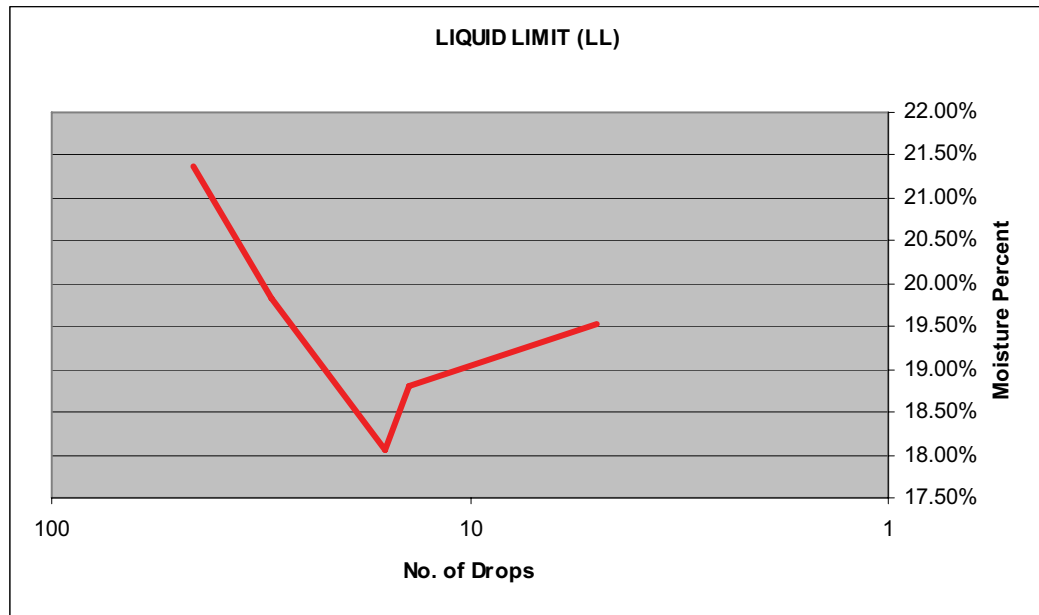
Graph 7.3: Plot illustrating the Liquid Limit of Unburnt Puddled Earth

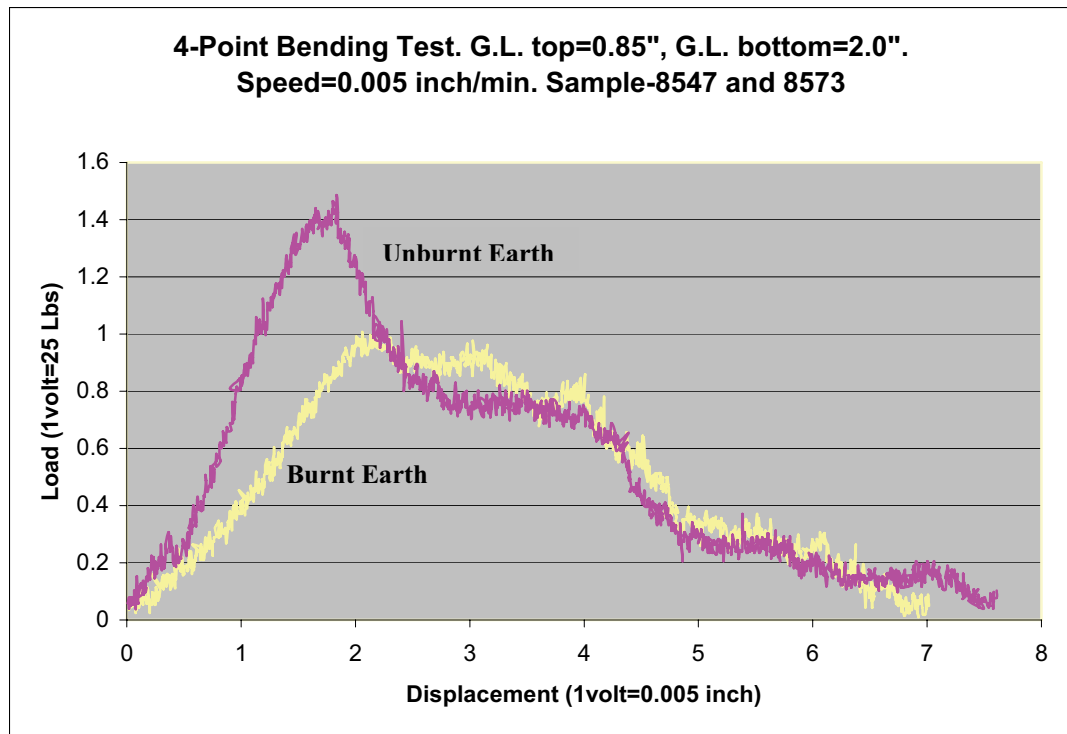
Graph 7.4: Comparative Analysis of Stress-Strain Behavior of Burnt and Unburnt Sample

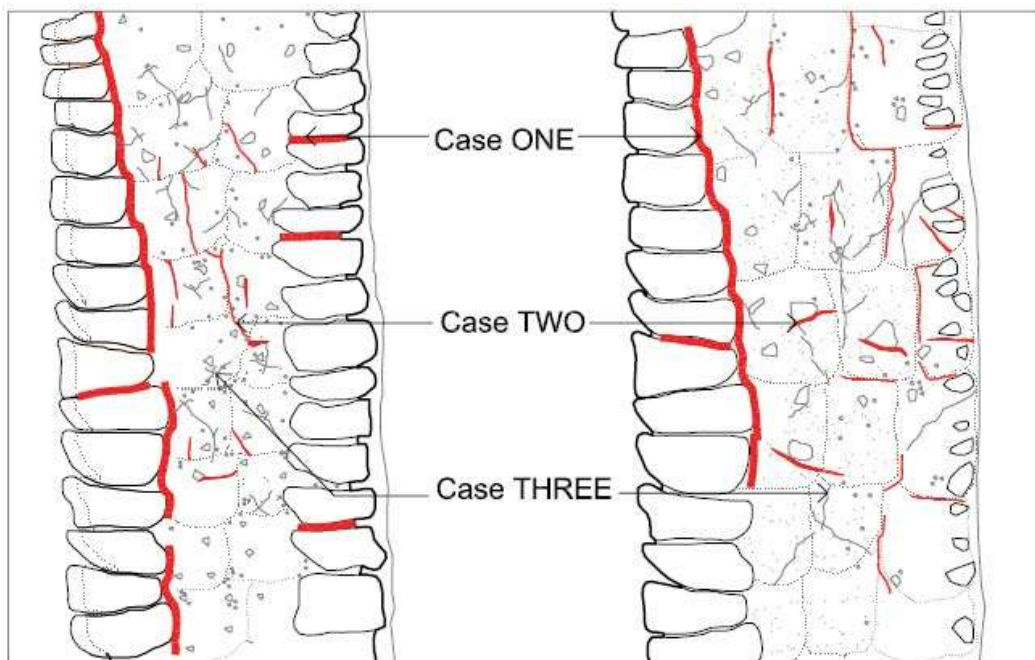
Figure 8.1: Illustration of the walls indicating locations of grouts (Chaudhry' 07)

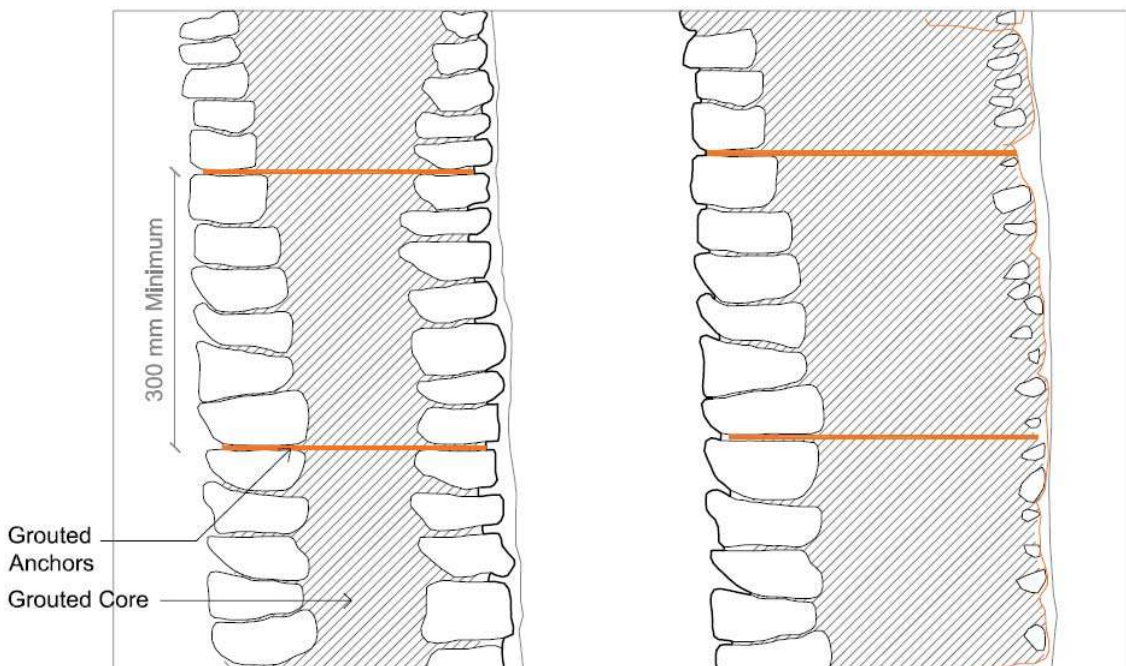
Figure 10.1: Illustration of grouted anchors (Chaudhry' 07)

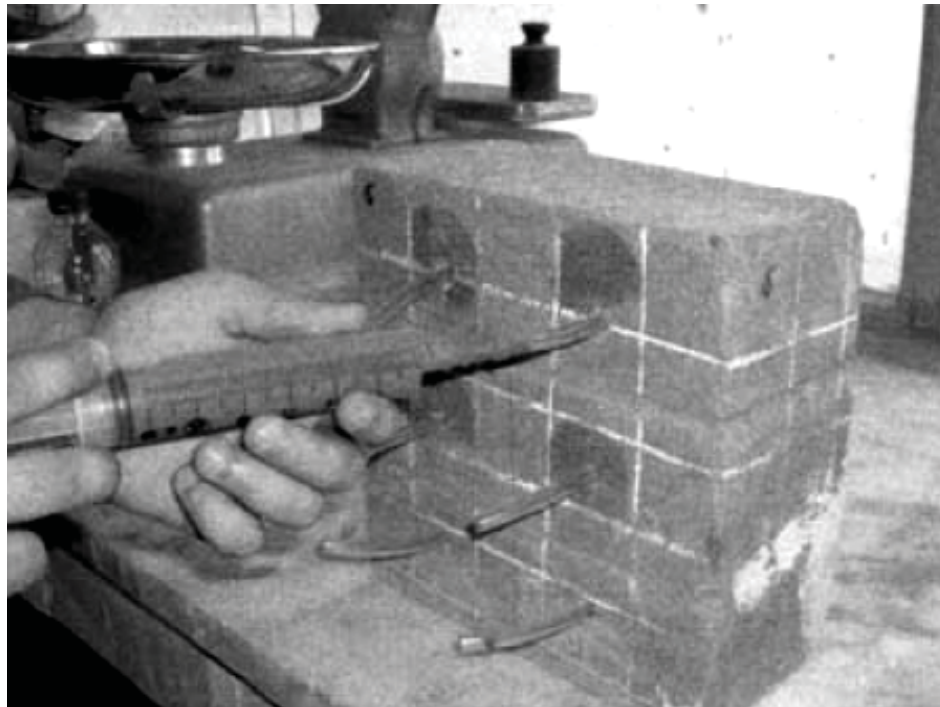
Figure 10.3: View of Clay-Lime-Pozzolan bars to create stronger zones in Masonry. (Vintzileou. E, 2006)
