Evaluation of the leakage origin in Abu Baara earthen dam using electrical resistivity tomography, northwestern Syria

W. Al-Fares and J. Asfahani*

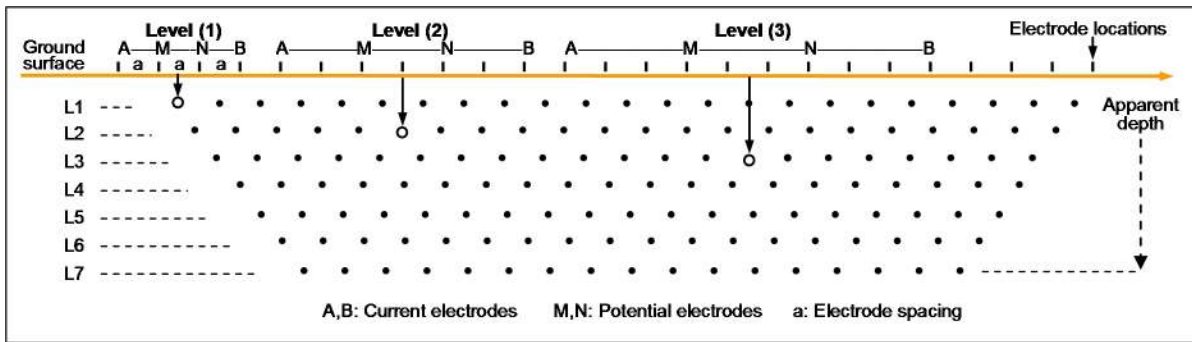
Figure 3. Electrical resistivity tomography configuration. Increasing the distances between current electrodes implies a deep penetration depth.

Traditionally, the direct-current (DC) electrical survey is used to determine the subsurface resistivity distribution by measuring the electrical potential difference between a pair

of potential electrodes M and N, as shown in Figure 3. on the ground surface with a current applied through a pair of current electrodes A and B. The apparent resistivity ρ_a in Ohm.m ($\Omega.m$) is then computed from Ohm's law:

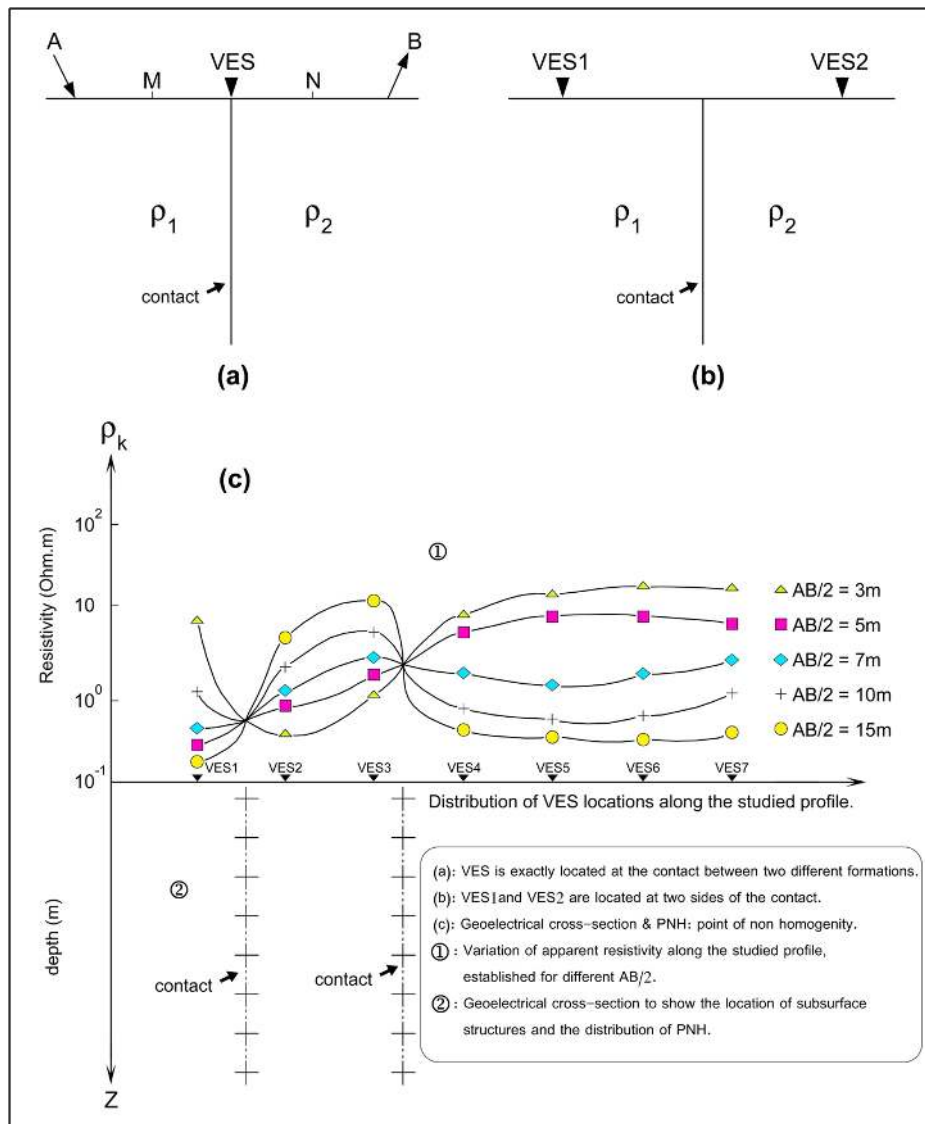
Figure 4. Principal of Pichgin and Habibullaev technique (modified after Asfahani, 2011).

The theory behind the Pichgin–Habibullaev technique can be summarized as follows: Suppose two vertical electrical soundings, VES1 and VES2 are performed on either side of a vertical contact. For every given current electrode half-spacing ($AB/2$), all the resistivity profile curves will be intersected at a point located directly over this vertical contact. The locations of the vertical electrical soundings carried out on a given profile are therefore plotted on the abscissa, and the corresponding measured apparent resistivities for each given $AB/2$ are plotted on the ordinate, as shown in Figure 4.

Points (NHP), are plotted on a 2-D (x, z) geological section. The depth (z) of each NHP can be determined from the following equation:

$$z = [(AB/2)_i + (AB/2)_j] / 2$$

where $(AB/2)_i$ and $(AB/2)_j$ are the half-spacings between the electrodes A and B , at which two horizontal resistivity curves are intersected. The sub fractured zones are determined according to the distribution and interpretation of NHP along the studied profile.

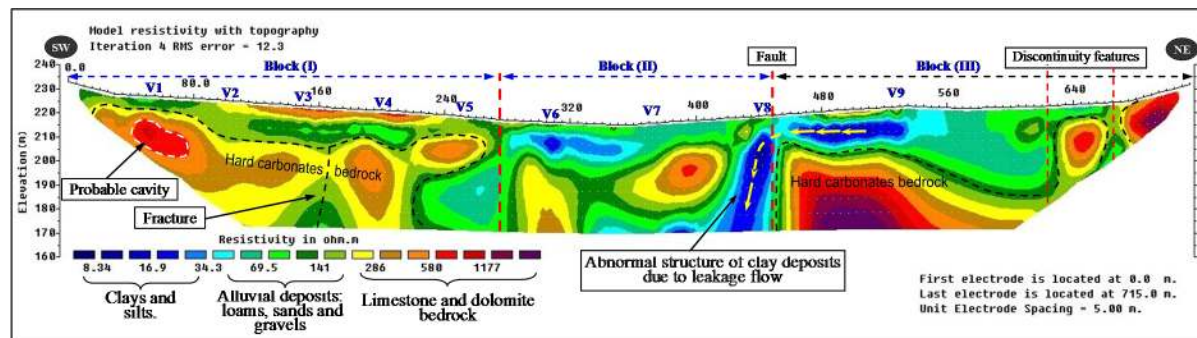
Figure 5. Inverted geoelectrical section of the ERT-P1 profile carried out behind the dambody (upstream site), V: locations of VES.

The ERT-P1 profile was carried out in upstream side at a distance of 10m from the dam body (Figure 2). The profile starts from the western edge of the embankment to end up at the eastern edge traversing a distance of 715m. Figure 5. shows the inverted ERT-P1 geoelectrical section, which can be divided into three principal distinguished blocks:

The first block runs from the beginning of the ERT-P1 section to the distance of 280m. This block includes a subsurface layer, of 10m thickness in average, which corresponds to the Quaternary alluvial deposits (Q_3), composed of loams, sands and gravels. The electrical resistivity values of these formations are ranging between 50 and $200\Omega\text{m}$. The alluvial deposits overlay a layer of hard limestone and dolomite Cenomanian-Touronian (Cr_2cm-t) rocks. These rocks are characterized by an irregular feature due to fractures and cracks, which makes them heterogeneous chromatically in the geoelectrical section. The limestone and dolomite rocks have resistivity values of more than $1100\Omega\text{m}$. These rocks constitute the main hard bedrocks of the dam lake. Otherwise, a distinctive resistive anomaly was noticed between the distance interval 60 and 80m of the ERT-P1 section (Figure 5). This anomaly is distinguished by a high electrical resistivity value (up $1200\Omega\text{m}$), which most likely could be associated with probable karstic cavity developed within the limestones bedrock. Evidently, the presence of a possible cavity constitutes a suitable potential pathway for water leakage occurrence, especially when the water storage reaches high levels in the lake.

The second block extends within the distance between 280 and 440m of the ERT-P1

section. This zone seems well matched with the course of the main valley behind the dam body. The alluvial deposits are prevailing in this part of profile and filling the valley with exception of the existence of two big scattered masses of limestones. The right boundary of this block (at the point 440m) is determined by a vertical hard rocks edge. This almost could be related to the occurrence of a tectonic event such as a fault struck the main valley. Moreover, a distinct anomaly of clay was identified adjacent to the mentioned vertical edge; this abnormal structure may due to a vertical groundwater flow towards the deeper formations. This finding may indicate the existence of hydraulic connection between the shallow and the deep geologic formation. It is obvious that significant leakage most likely occurs through this sector along the tectonic contact zone between the alluvium and the limestone rocks.

The third block extends from the point of 440m to the end of the geoelectrical section (Figure 5). The alluvial deposits thickness ranges between 10 to 20m, with resistivity values reach $150\Omega\text{m}$. Those deposits overlay the resistive hard limestone bedrock (more than $1100\Omega\text{m}$). A discontinuity features were observed in two locations at the end of the profile (at 630 and 670m), these features are corresponding to fractures in the limestones and dolomite rocks. These discontinuities in the bedrock form additional possible pathways for water leakage from the dam's lake.

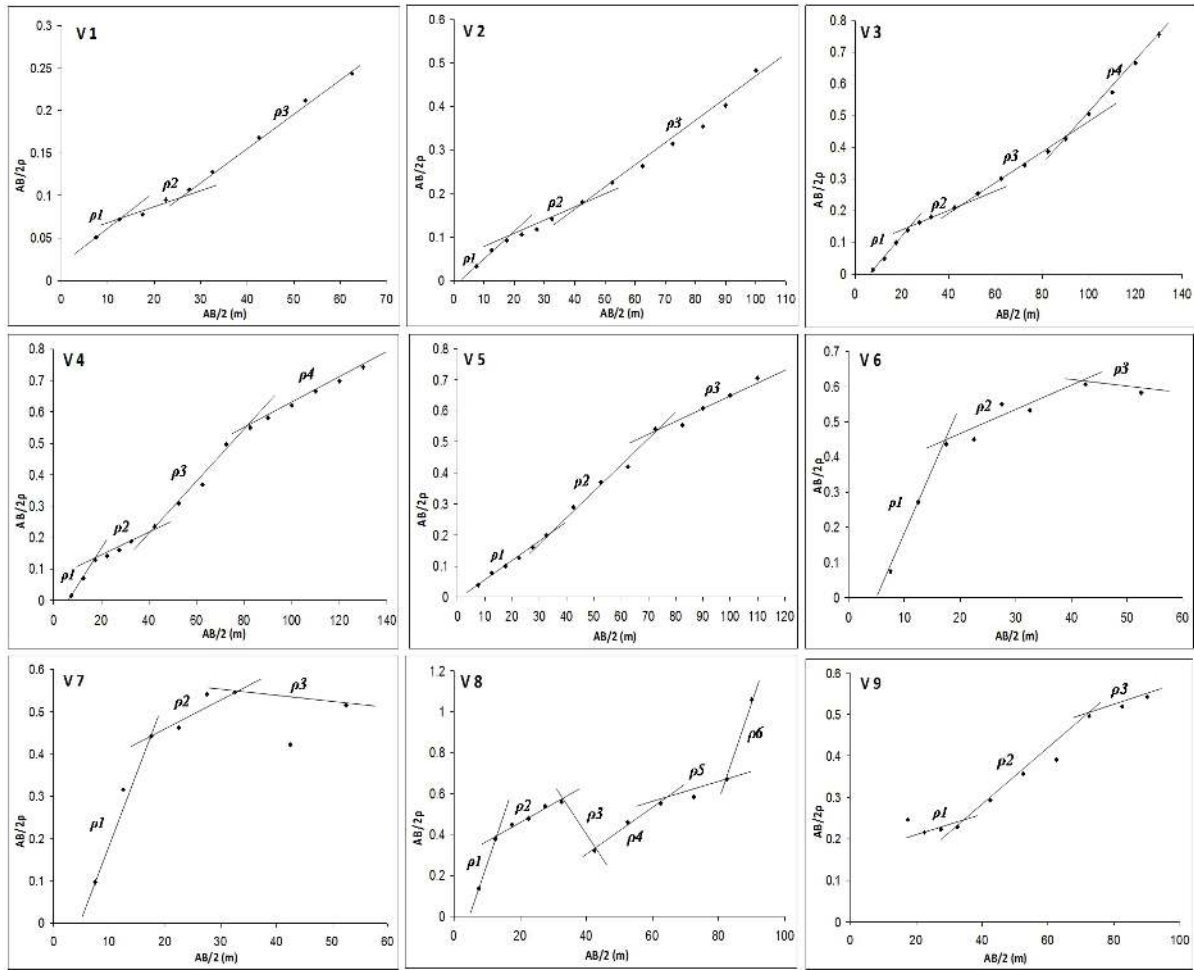
Figure 6. Quantitative 1D interpretation results of nine VES measurements carried out along ERT-P1 profile obtained by ISM.

Inverse slope method *ISM* with adapting 1D assumption has been applied in this research for interpreting the nine Schlumberger VES distributed along P1 as shown in Figure 6. True thicknesses and resistivities for the corresponding layers under the study profile P1 have been obtained as shown in Table 1.

The most important remark observed while interpreting those nine VES is the presence of negative slopes, indicating high resistivity values in the studied P1 section. Those high values clearly reflect the hard limestone and dolomite rocks existed in the study region (Ponikarov, 1963). The advantages of applying *ISM* is that it easily distinguishes between the different layers under the study VES. The low resistivity values are attributed to the Quaternary alluvial deposits, while the high ones are attributed to the Cretaceous hard limestone and dolomitic rocks. The *ISM* results obtained confirm well those obtained by the ERT measurements and discussed above, particularly the low and high resistivity distributions.

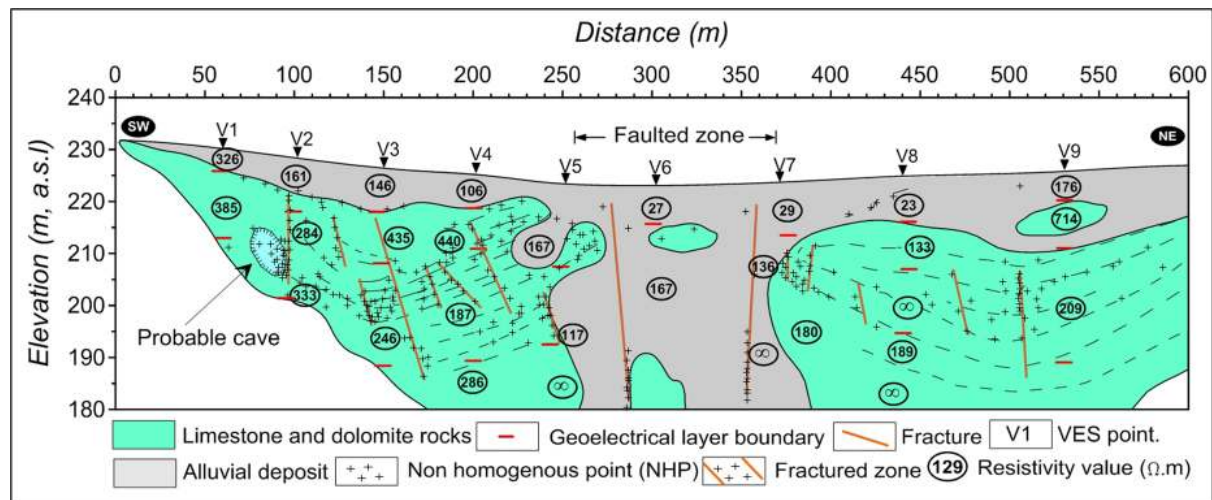
Figure 7. Quantitative interpretation of VES data carried out along ERT-P1 profile by using Pichgin and Habibullaev technique.

The same nine VES distributed along profile P1 have been interpreted by Pichgin and Habibullaev technique explained above. The geometry distribution of the Non Homogeneous Points (NHP) in the 2D (X-Z) section shown in Figure 7 clearly indicates the presence of three main blocks. The central one of more than 150 m wide could be related to a faulted zone, representing the main alluvial valley. The two other right and left blocks are related to the Cenomanian-Turonian limestone and dolomitic rocks. At a detailed level, the NHP clearly shows a basal structure, and the positions of the fractured zones in those two blocks. Their locations are the main leakage points in the study dam under profile P1. It is worth mentioning that the results obtained by interpreting VES data using Pichgin and Habibullaev technique confirm well those obtained by ERT measurements along Profile P1.

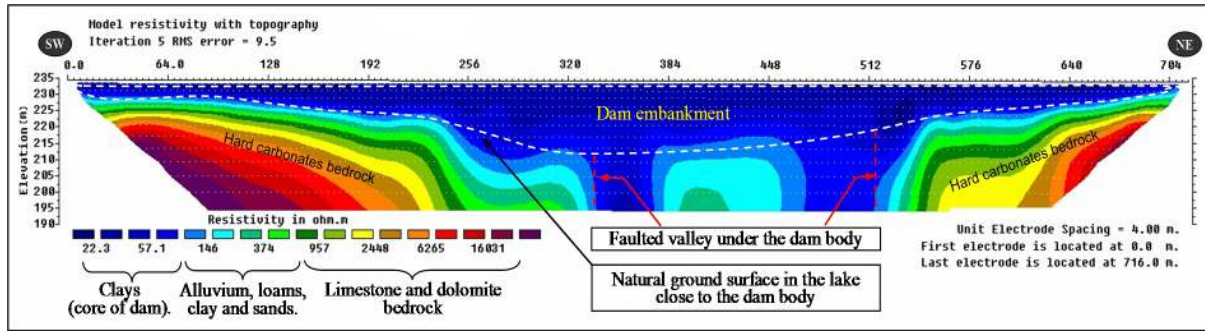
Figure 8. Inverted geoelectrical section of the ERT-P2 profile carried out at the top of the dam body.

profile (Figure 2). This ERT profile, located on the top of dam body, has been carried out by using an electrical driller to dig holes, 4m apart, in the hard asphaltic layer to facilitate the electrodes plantation. The planted electrodes were wetted with salty water and some clay added to ensure a good contact with the underlying soil and to reduce the noise. This profile has length of 716m and 234.5m above sea level (a.s.l) as a constant topographic elevation. Figure 8 shows the inverted geoelectrical section of the ERT-P2 profile, where two main zones can be vertically distinguished; the first zone is directly related to the clayey core of the dam body, marked by clear blue color in Figure 4. The white dotted line represents the lower boundaries of the dam body with the original land surface of the lake. The resistivity values of this zone range between 20 and 50 Ωm and the thickness increase towards the main valley to reach 25m. The clayey core of the dam seems to be intact and structurally homogeneous and the lower boundaries are clear and distinct especially at the contact with the underlying bedrocks. The second zone of the ERT-P2 section represents the hard limestones and dolomites bedrock. The general structural of this zone is similar to the ERT-P1 structure. It is consisting of two units of massive carbonates rocks separated by the main valley: the first unit extends from the beginning of the geoelectrical section until the point 320, while the second starts from the point 512 to the end of the section. Both units are well differentiated and characterized by high resistivity values.

The central part of the second zone extends along the distance between 320 and 512m, this part corresponds to the main valley course

underneath the dam body. It is believed that the absence of hard bedrock at this part of section could be attributed to dissolution processes of the carbonates rocks by the influence of the water flowing stream, or probably related to tectonic activities such as faults leading to the formation of a subsidence faulted structure filled up later by alluvial deposits (Figure 8). The absence of the bedrock under the central part of the dam body could pose problems in future related to the safety and stability of the dam, particularly when the water reaches high levels during the rainy seasons. Many cracks covering the top of the dam were observed during the fieldwork in the asphaltic layer. This seems to be a negative indicator and must be taken into consideration through the implementation of a permanent monitoring program in order to prevent probable failure of the dam. It is consequently believed that most of the vertical leakage occur through this sector at the contact between alluvial deposits and the hard limestones rocks.

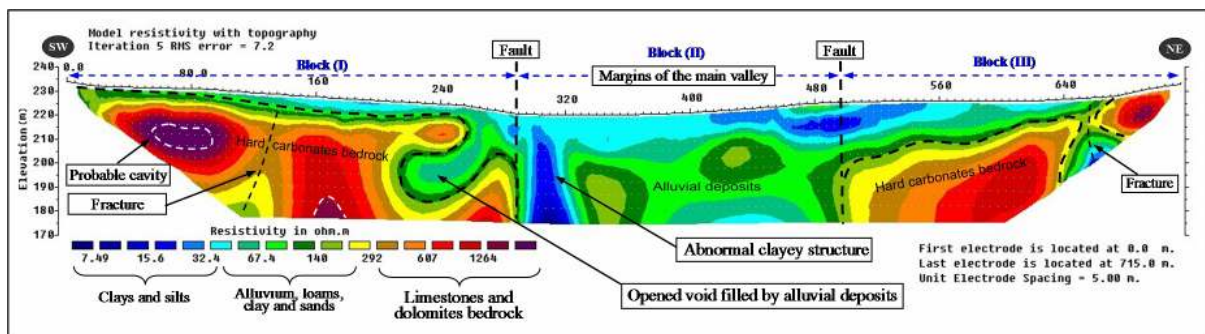
Figure 9. Inverted geoelectrical section of the ERT-P3 profile carried out on downstream site of the dam body.

The ERT-P3 is implemented in the downstream side adjacent to the dam body (Figure 2). This profile extends as the other profile along 715m of length with inter-electrode spacing of 5m. A topographic survey was performed for the natural ground surface of the lake along the profile. Figure 9 shows the interpretation of the geoelectrical ERT-P3 section, which seems to be structurally similar to the ERT-P1 section. It can be therefore also divided into three main blocks differentiated horizontally:

The first and third blocks are interpreted together because they are composed of the same formations. The first block extends from the beginning of the section to a distance of 300m, while the second one starts from 500m to the end of ERT section. The two blocks include a surface layer of alluvial deposits (Q3). The thickness of these deposits ranges between 1 to 5m in the block(I), and reaches 20m at the third block, since it increases towards the main valley. The resistivity values of these deposits vary as mentioned above from 40 to 150Ωm. The alluvial layer covers the bedrock of the hard limestones, which are characterized by high resistivity values (300-1200Ωm), as shown in the geoelectrical section. The bedrocks are dipping about 7° (block I) and 15° (block II) towards the main valley. On the other hand, a resistive anomaly is observed between the interval 60 and 90m of the section, this anomaly has been also observed in the ERT-P1 section. It is characterized by a high electrical resistivity value (1200Ωm), which is most likely related to a karstic cavity within the limestone bedrock. The appearance of this anomaly in the ERT-P1 and ERT-P3 sections at the same location probably indicates

the presence of a subsurface karstic conduit passing under the dam body at this sector. This subsurface conduit certainly constitutes a suitable pathway for the occurrence of intensive leakage from the lake to outside the dam, especially at the high water storage levels.

Another abnormal structure is also observed between the distances 215-280m of the ERT-P3 section. This structure seems as a void or an opened cavity filled with alluvial deposits (40-150Ωm). This void or cavity could be resulted by the influence of a tectonic activity followed by erosion and dissolution processes of the limestone and dolomite rocks by the act of water flow effect. Moreover, the discontinuity features identified at the ERT-P1 section is also present in ERT-P3 section at the same location, this feature is almost correspond with a fracture extending perpendicular to the dam body within the subsurface carbonate bedrocks. This fracture expands with the depth, and it is filled with alluvial and clay deposits of low resistivity (Figure 9). Existence of those fractures constitutes an additional causative of the water leakage from the dam lake.

The second block is stretching along the distance from 300 to 500m, and forming the central part of ERT-P3 section. The margins of this sector are in concordance with the main valley and they are delineated by two vertical rocky edges. This part of the section is completely composed of alluvial deposits, where their thicknesses reach more than 50m. Moreover, an abnormal structure of clay, located between 300-320m, is observed at the left edge of this block. This structure represents additional evidence of the presence of a vertical water leakage between the surface and the deep formation. This block is structurally considered as the most significant part of the profile, where many structural anomalies are localized and identified. The filtration and the leakage processes are mostly occurring through this sector. The table (2) globalizes the resistivity values for the different subsurface detected structures obtained from the inverted ERT sections.

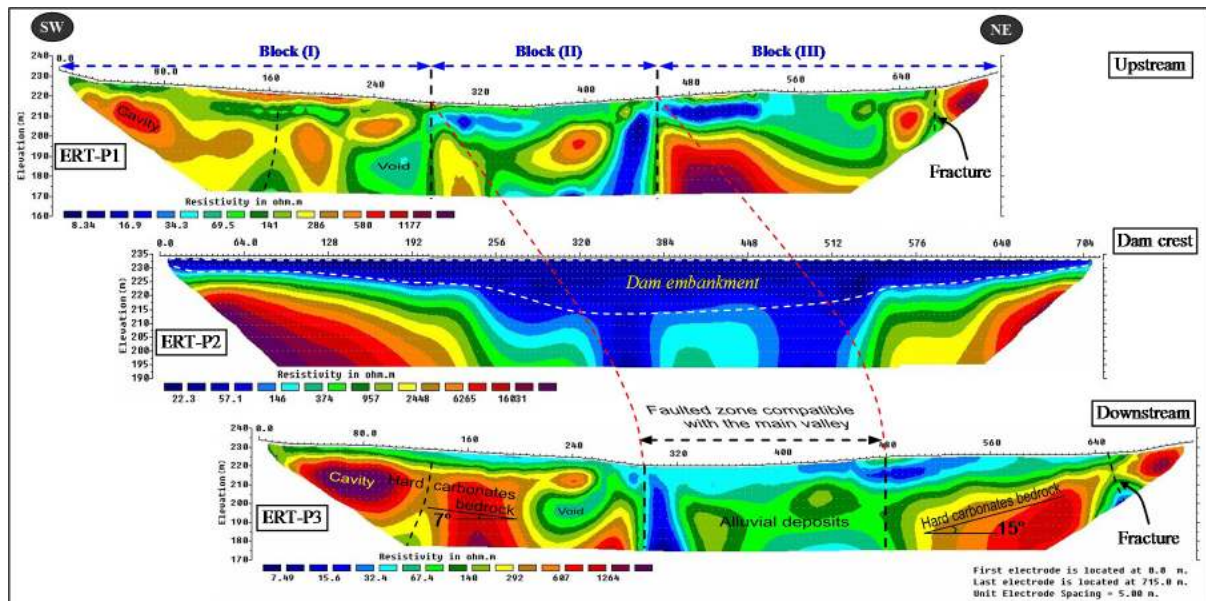
Figure 10. Comparison between the general structure of the inverted geoelectrical ERT profiles carried out in upstream, dam crest and downstream of Abu Baara dam body.

A global structural comparison between the geoelectrical ERT sections of the three profiles is illustrated in Figure 10. The general structure of these sections seems to be similar and they are composed of three distinct structural blocks. A remarkable faulted zone can be traced within the interval 300 to 500m of the ERT sections. This zone is compatible with the main valley. Moreover, a karstic cavity located at the beginning of the ERT sections can be observed as well as the presence of discontinuity features at the end of the sections. It is worth mentioning, that many field observations have been noted during the implementation of the field measurements, which point to the role of the tectonic activity and other karstic features in the leakage processes. Figure 11 shows some of these features, where small sinkhole of more than 50 cm of diameter and a large fracture extended for more than 200m parallel to the dam lake margin are observed in many places throughout the lake and behind the dam body.

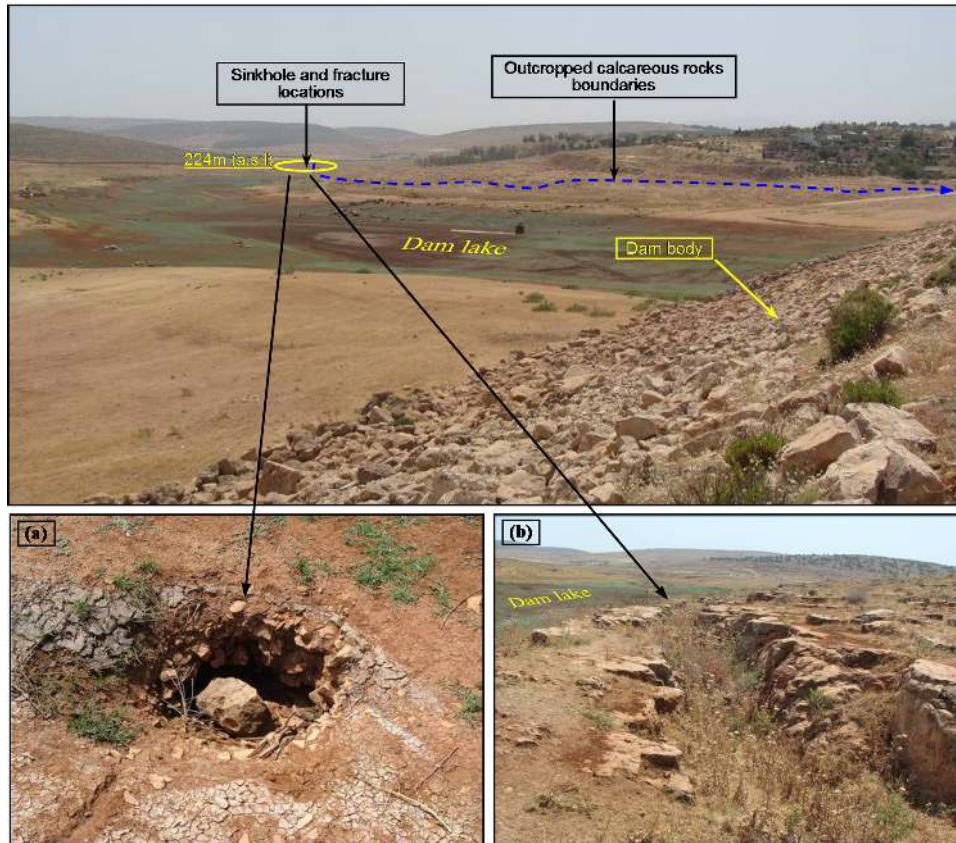
Figure 11. Locations of some leakage features observed at the right bank of Abu Baara dam lake, (a): one of the sinkholes which is located nearby the limestone and dolomite rocks boundary (more than 50cm of diameter), (b): a large fracture of 2-3 depth extends for more than 200m in parallel with the dam lake margin.
