# Experimental characterization of the impact-damage tolerance of a cross-ply graphite-fiber/epoxy laminate

In this study, the impact-damage tolerance of a graphite-fiber/epoxy composite laminate is studied by examining the correlation between the impact force and the resulting delamination area in the laminate. The cross-ply  $[0_2/90_2/0_2]_s$  composite laminate was made of thermosetting P7051S-20Q-1000 prepregs (Toray Composites America). A Hopkinson pressure bar (HPB) was employed to create the impulsive loading with varying magnitude. Transient impact force, displacement, impact power, and transmitted impact energy were calculated using the transient signals recorded from the strain gage mounted on the HPB. Impulsive loads with controllable magnitude were used to induce delamination damage with varying size in the composite samples. Nondestructive evaluation based on a novel ultrasonic pulse-echo reflector technique was used successfully for characterizing the delamination areas in the thin composite samples with thickness  $\sim 2$  mm. The present experimental results indicate that there exists a very good linear correlation between the impact force (e.g. the peak force, i

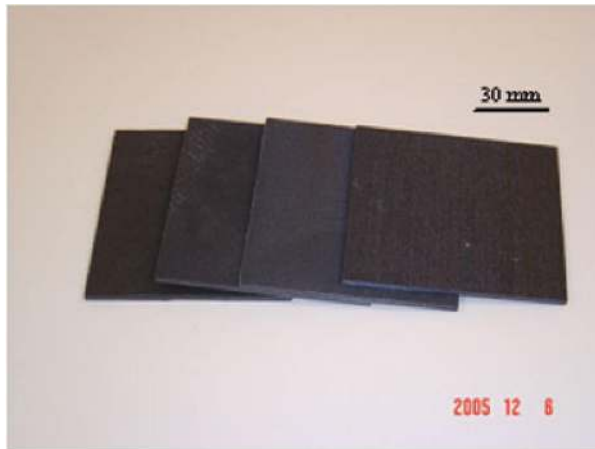
**Figure 1.** Cross-ply polymer composite samples used for the experimental investigation. (P7051S-20Q-1000 graphite-fiber/epoxy pre-pregs provided by the Toray Composites America, lay-up:  $[0_2/90_2/O_2]_s$ , dimensions:  $\sim 2 \times 90 \times 90$  in mm.)

A cross-ply thermal-setting graphite-fiber/epoxy composite laminate made of 12-layer Toray P7051S-20Q1000 prepregs was fabricated. The unidirectional prepregs consisted of T700S graphite fibers in a F250 resin system with typical areal weight 312 g/m<sup>2</sup>. Mechanical properties of the unidirectional laminate were provided by the manufacturer (Toray Composites America) [27] and have also

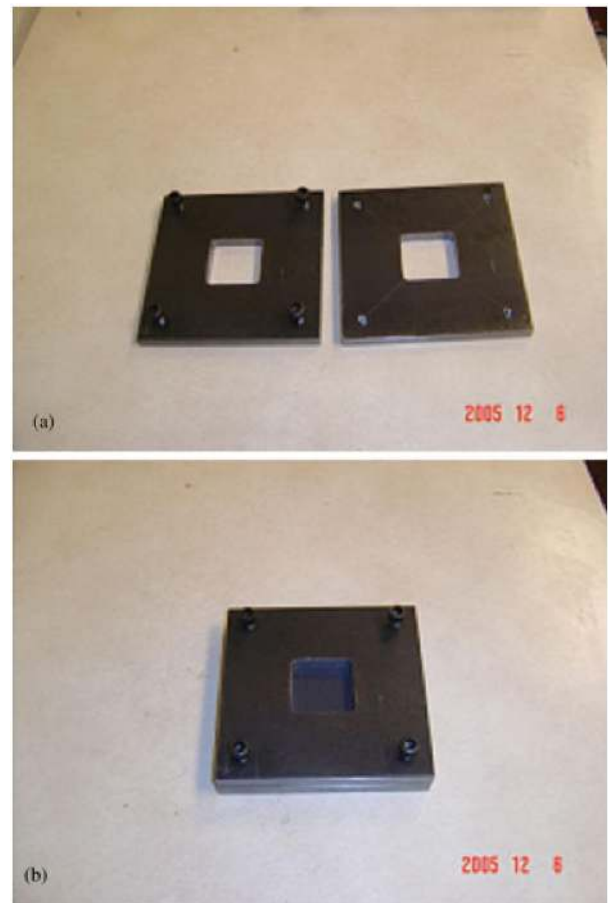
**Figure 2.** (a) Specimen fixture and (b) specimen-fixtured assembly. (Fixture dimensions:  $12.25 \times 165 \times 165$  in mm; dimensions of the centered square opening:  $50 \times 50$  in mm.)

During the process, cross-ply-laminated panels with a lay-up of  $[0_2/90_2/O_2]_s$  were assembled following a hand lay-up procedure and cured in a two-chamber press-clave under controlled temperature, pressure, and vacuum environment in accordance with the manufacturer-recommended curing cycle [27–29]. The thickness of the laminate is around 2 mm after curing. The typical laminate samples used in the test had dimensions:  $\sim 2 \times 90 \times 90$  (in mm), as shown in Figure 1. The specimen fixture used for the impact test was made of two square steel plates (dimensions:  $12.25 \times 165 \times 165$  in mm) with a central opening (dimensions:  $55 \times 55$  in mm), as shown in Figure 2a. During the impact test, the composite specimen

was centered and sandwiched between the two steel plates using four tie-down bolts at the corners. The specimen-fixtured assembly is shown in Figure 2b.

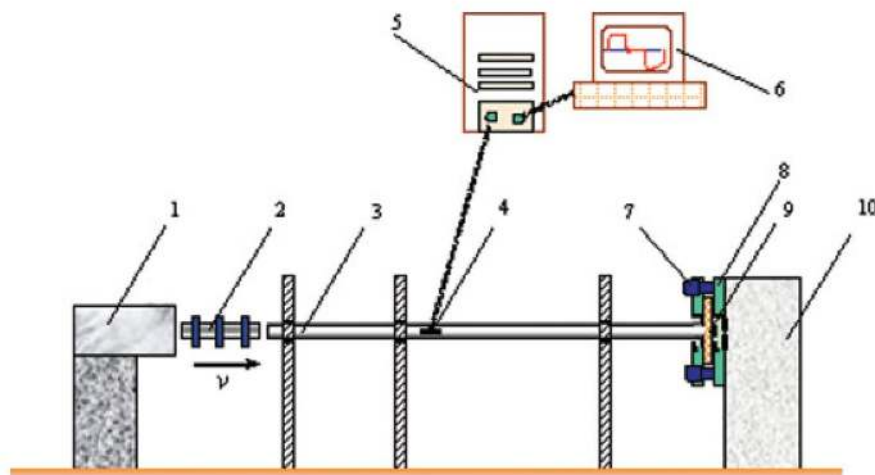
**Figure 3.** Schematic of the Hopkinson pressure bar (HPB) system. 1, Gas gun; 2, striker; 3, incident bar (with machined spherical end); 4, strain gage sensor; 5, digital oscillator; 6, computer; 7, tapped bolts; 8, steel plates; 9, composite specimen; 10, specimen-fixtured supporter.

The impact-damage test was conducted on an experimental setup consisting of a gas gun, a circular high-strength steel striker of length 300 mm, and a HPB of length 1,574 mm, as illustrated in Figure 3 [28, 30]. The diameter of both the steel striker and the HPB is 8 mm. The materials of the striker and the HPB were the same in order to avoid the impedance mismatch during an impact event. The specimen-fixture assembly was fixed on the testing bench using two stiff heavy clamps, and the HPB with a spherical head was directed in contact with the center of the specimen through the square opening of the fixture (Figure 3). The impact force acting on the specimen was created by the impact of the striker bar on the HPB coaxially. The striker was propelled by compressed nitrogen gas in the gas gun chamber. Upon impact, a compressive stress pulse was generated in the HPB and propagated toward the specimen. The incident pulse on the specimen was partially reflected back into the bar and partially transmitted into the composite specimen. The magnitudes and durations of the incident and reflected pulses were recorded exactly using a strain gage sensor mounted in the middle of the HPB, as illustrated in Figure 3. The pulse that was transmitted from the HPB propagated inside the specimen, reflected at the specimen free-surfaces, and finally led to the delamination damage along the weak laminar interfaces. The signals of the stress wave propagating in the HPB were recorded by a high-resolution digital oscilloscope. The transient impact force, impulse acting on the specimen, and kinetic energy transferred were then determined using the recorded strain gage signals.

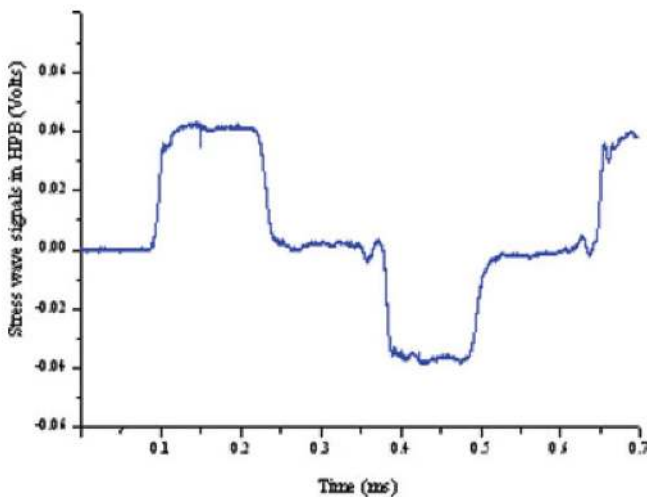
**Figure 5.** Typical stress-wave signals recorded in the HPB system.

In each impact test, to eliminate the spike-like dispersion wave that commonly occurs in high-speed impact tests using a HPB system, a soft thin material sheet ( $2 \text{ mm}$  aluminum or copper sheet) was fixed to the head of the incident bar toward the striker bar. As a result, the typical incident stress-wave signal recorded from the HPB

is shown in Figure 5. The typical impact force, calculated from the recorded strain signals by using Eq. 2, is shown in Figure 6. It is found that the maximum value of the impact force always occurs in the first impact force pulse and the peak values of the following force pulses decay rapidly. For a typical impact test performed in the present study, the peak force value of the second force pulse was 50% of the first one, and therefore the resulting transmitted impact energy of the second force pulse was only around 30% of the first one. Furthermore, there existed a significant interval of time between two neighboring impact force pulses, such that wave interference between two neighboring impact force pulses can be neglected. Therefore, the present

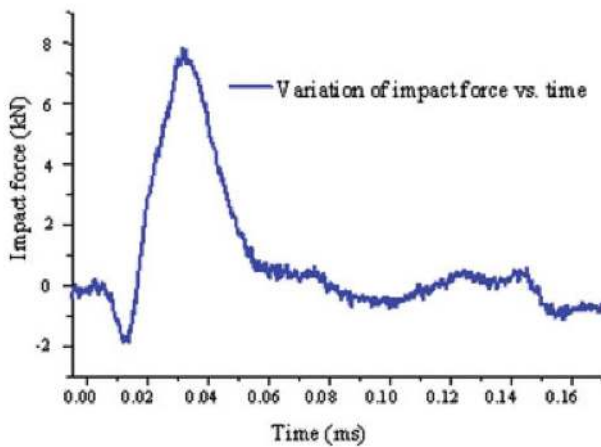
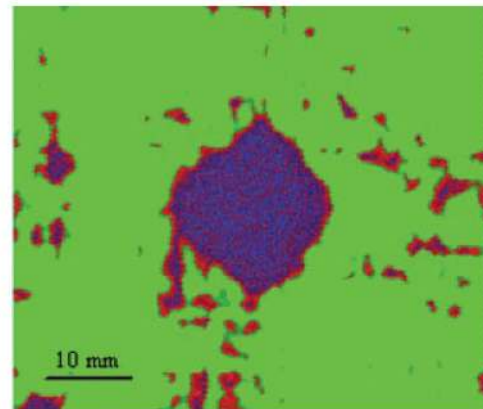
**Figure 8.** Impact force and corresponding C-scan image of delamination damage in the composite laminate (Sample-I). (Lay-up:  $[0_2/90_2/02]_s$ , peak impact force: 7.83 kN, impulse: 0.135 Ns, peak impact power: 41.33 kW, transmitted impact energy: 1.857 J, delamination area:  $\sim 230 \text{ mm}^2$ .)

Figures 8–11 show variations of the impact force versus time of the first impact force pulse and the corresponding PERT-scan images for four typical specimens subjected to varying impact force levels, respectively. The delamination area in each specimen was approximated by counting the number of pixels occupied by the damage in the image with errors around 5% due to the ambiguous boundaries. The results show that subjected to relatively low-velocity impact (Figures 8 and 9) the impact forces grew smoothly in a very short interval of time ( $\sim 0.05 \text{ ms}$ ) that corresponds to the delamination damage mainly along the  $0^\circ/90^\circ$  interfaces, i.e. the diamond-shaped damage as characterized by the PERT scans. In such a loading case given in Figure 8, no obvious damage can be observed visually near the HPB

contact zone at the specimen surface by naked-eyes though delamination damage existed inside the laminate as detected by the PERT. However, in the loading case given in Figure 9, after impact a small dent with depth nearly one-third the thickness of the composite laminate can be found, and no further visible damage was detected at the specimen surface. Figure 12a shows the typical sample surface after the impact, which accords to the impulsive loading given in Figure 9. Furthermore, for impact with relatively high speeds (Figures 10 and 11), impact force jumps were observed. This indicates that the high impact forces have led to macroscopic cracking of the composite laminate along

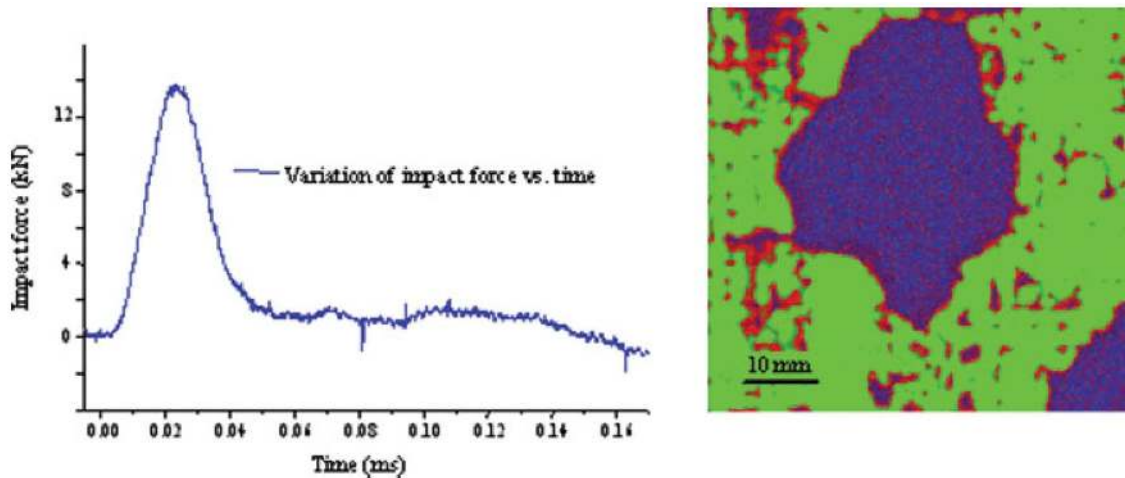
**Figure 9.** Impact force and corresponding C-scan image of delamination damage in the composite laminate (Sample-II). (Lay-up:  $[0_2/90_2/0_2]_s$ , peak impact force: 13.80 kN, impulse: 0.425 N.s, peak impact power: 136.39 kW, transmitted impact energy: 7.32 J, delamination area:  $\sim 740 \text{ mm}^2$ .)

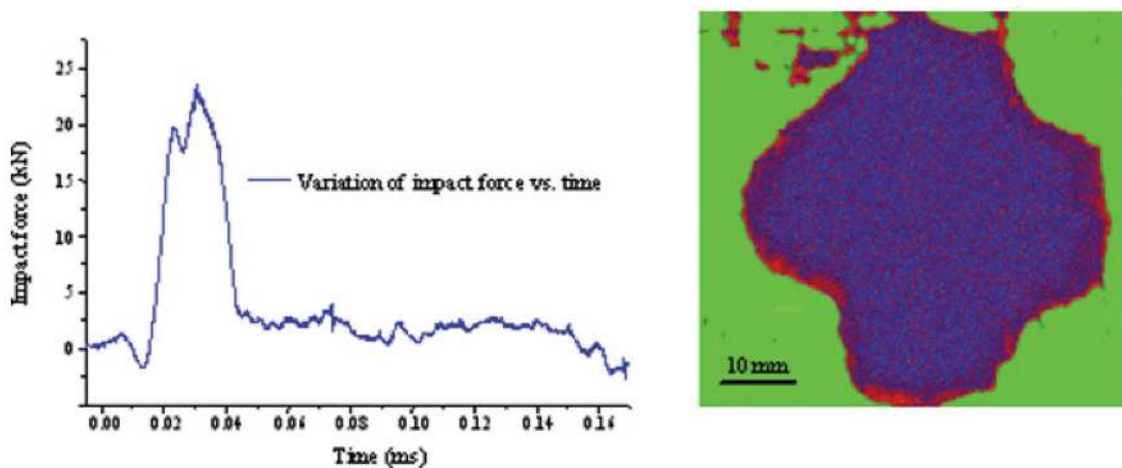
**Figure 10.** Impact force and corresponding C-scan image of delamination damage in the composite laminate (Sample-III) (Lay-up:  $[0_2/90_2/0_2]_s$ , peak impact force: 23.49 kN, impulse: 0.658 N.s, peak impact power: 287.83 kW, transmitted impact energy: 10.73 J, delamination area:  $\sim 1,390 \text{ mm}^2$ .)

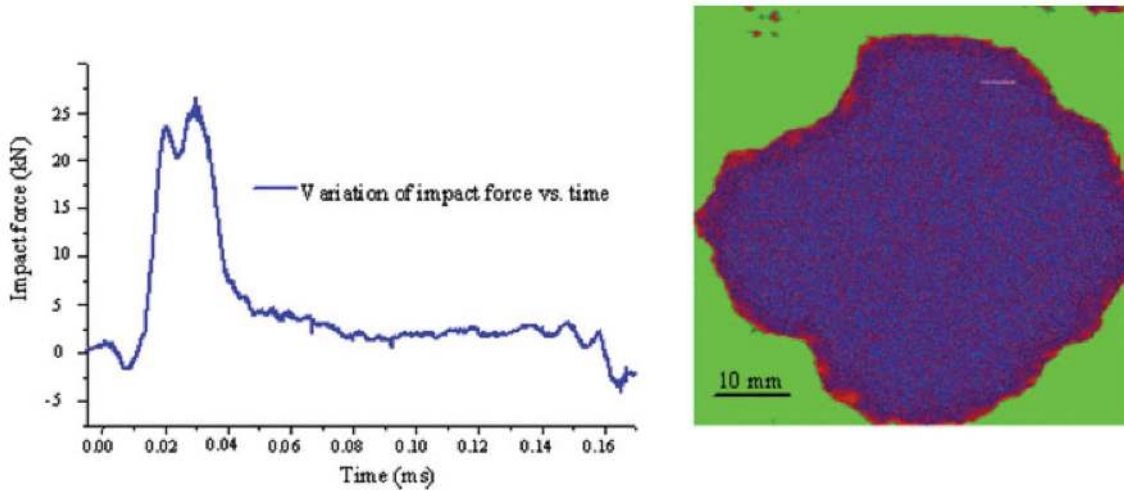
**Figure 11.** Impact force and corresponding C-scan image of delamination damage in the composite laminate (Sample-IV). (Lay-up:  $[0_2/90_2/0_2]_s$ , peak impact force: 26.54 kN, impulse: 0.824 N.s, peak impact power: 424.93 kW, transmitted impact energy: 16.00 J, delamination area:  $\sim 1,660 \text{ mm}^2$ .)

the fiber direction that resulted in the abrupt drop of the laminate stiffness, i.e. the sudden drop of the impact force as measured in the HPB system. This has been validated through examining the macroscopic cracks at the specimen surfaces. In the loading case given in Figure 11, Figure 12b shows the corresponding macroscopic cracking at a typical sample surface back to the HPB head.

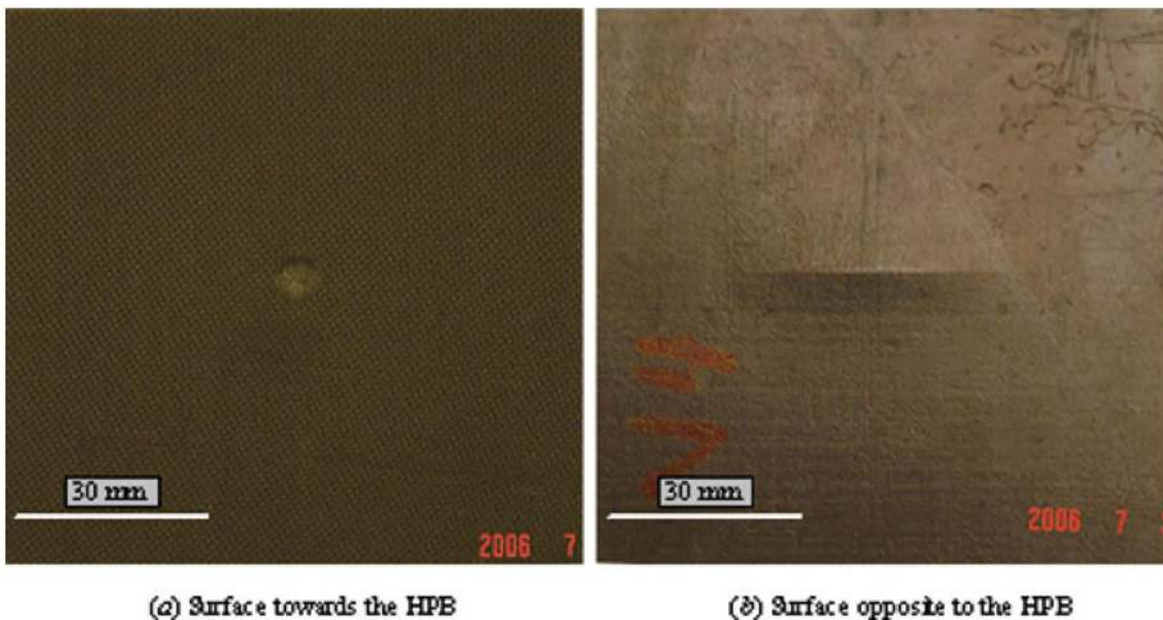
**Figure 12.** Macroscopic damage of the composite samples after impact.

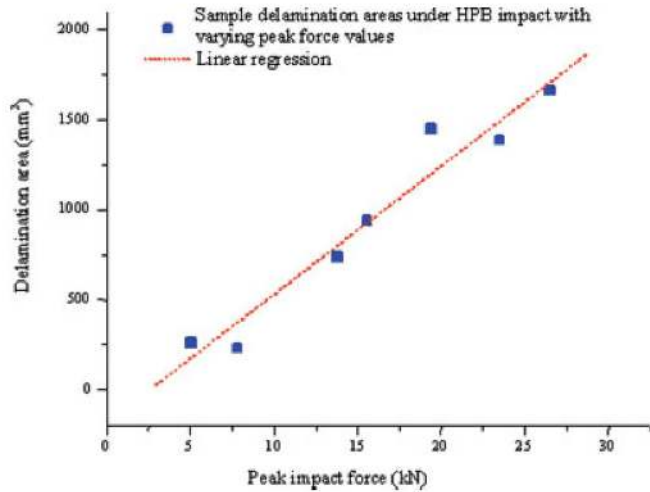
Figure 13. Variation of the sample delamination area versus the peak impact force.

the maximum damage size of the laminate is expected to correlate mainly with the first impact force pulse such that the contribution of the impact force pulses that followed after the first one can be ignored. Experimental data plotted in Figures 13–16 indicate a very good linear relationship between the delamination area and the peak impact force, peak impact power, impact impulse, and transmitted impact energy of the first impulse exerted by the HPB for a wide range of loadings, respectively. From Figures 15 and 16, it can also be found that subjected to the present impulsive loadings the impact energy transmitted into the composite laminate is very low around 2–20 J because of the extremely short duration of each impact event. However, the transient peak value of the impact power is ex-

tremely high, up to 50–450 kW due to the stress-wave with high magnitude propagating within extremely short interval of time (~0.05 ms). From the linear relations obtained by using linear regression of the experimental data plotted in Figures 13–16, it can be concluded that the peak force of the first impact force pulse can be used for characterizing the force threshold to initiate the delamination damage in the composite laminate under present impulsive loading that is close to 2.6 kN. As a result, subjected to impulsive loadings such as ballistic impact or impact exerted by HPB, etc., this linear relation can be employed for characterizing the impact-induced delamination damage in composite laminates and for composite structure design with targeted impact damage tolerance.

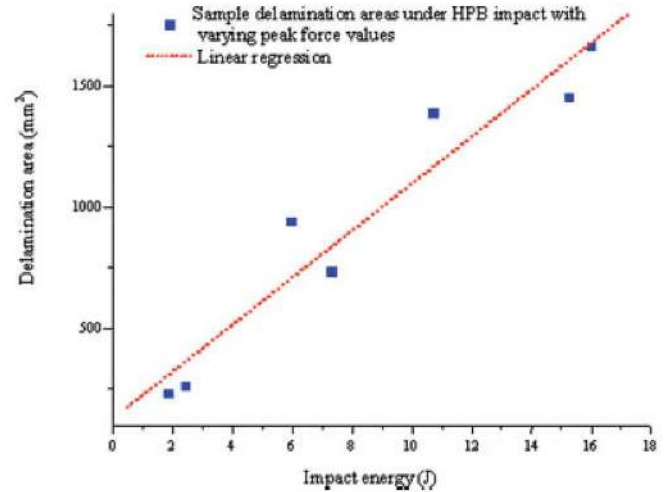
Figure 15. Variation of the sample delamination area versus the transmitted impact energy.

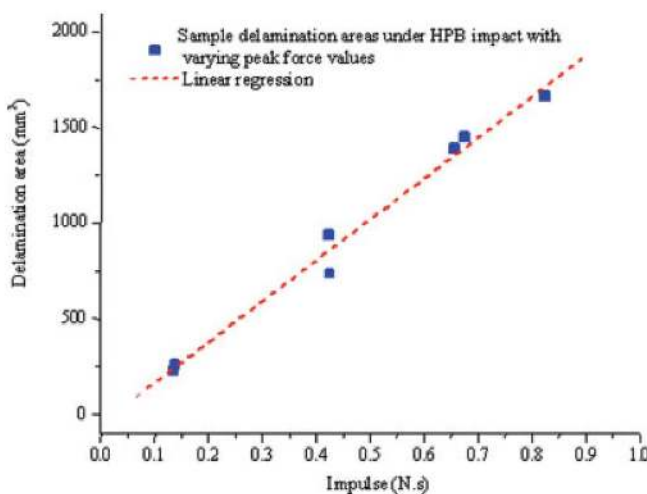
Figure 14. Variation of the sample delamination area versus the impulse of impact force.

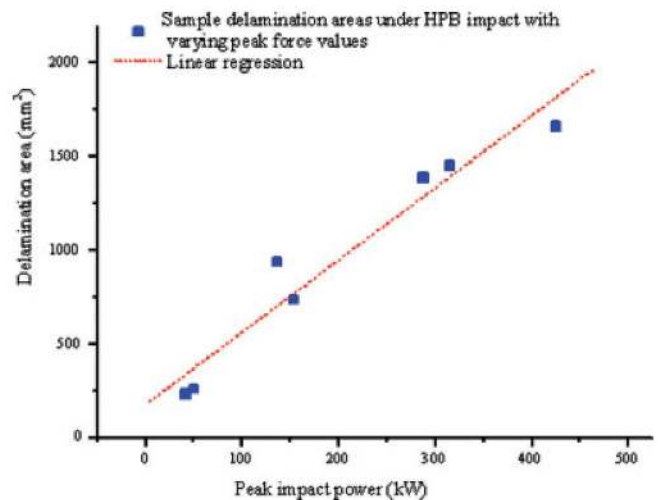
Figure 16. Variation of the sample delamination area versus the peak impact power.
