EXPERIMENTAL CYCLIC TESTS AND RETROFIT OF RC HOLLOW PIERS

SUMMARY

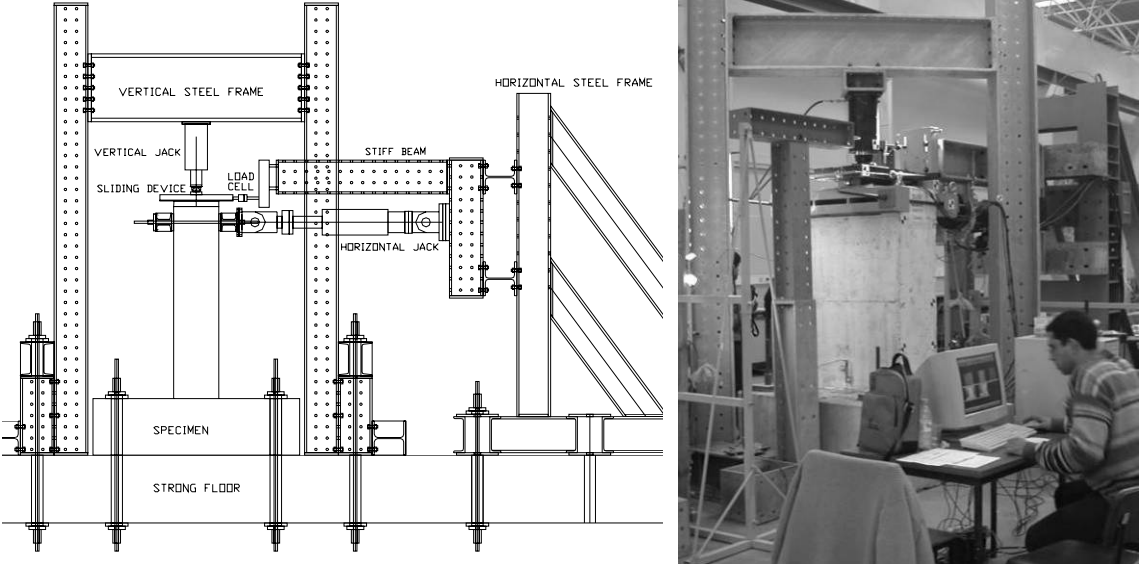
The test setup, shown in Fig. 1, makes use of a 500 kN actuator to apply lateral loads and a 700 kN actuator to apply axial loads. The specimen and reaction frame are bolted to the strong floor with high strength prestressed rods. A constant axial load of 250 kN was applied during the tests, herein described, while the lateral loads were cycled, under displacement controlled conditions.

Figure 1: Schematic layout and view of the test setup at LESE laboratory.

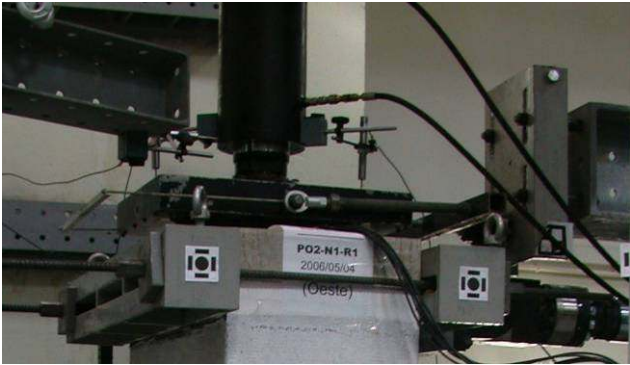
Figure 2: The sliding device used to apply the axial load.

A special sliding device consisting of two steel plates, shown in Fig. 2, was used to minimize the friction created by the axial loads. The lower plate is bonded to the specimen top, whereas the upper is hinged to the vertical actuator, allowing top-end displacements and rotations on the specimens to take place when lateral loading is imposed during the test. The upper plate is also connected to a load cell to measure the residual frictional force between the two plates. During the tests performed to date, an undesired problem occurred with the hydraulic

system used to apply the axial load: the pressure that should remain constant has in fact increased. Actually, the hydraulic system was designed to keep constant the oil pressure, in order to maintain constant the axial force, but a deficient performance of the circuit has blocked the oil return from the vertical actuator; therefore, the axial load increased during the cyclic displacement history, because the axial actuator was forced to remain in the same position when the top-end pier section was rotating and displacing. After this problem was eliminated, an auxiliary test to calibrate all the setup was carried out, by using a steel column hinged at the bottom, illustrated in Fig. 3, instead of the R/C specimen. The main purpose was therefore to accurately measure all the forces involved on the vertical reaction frame.

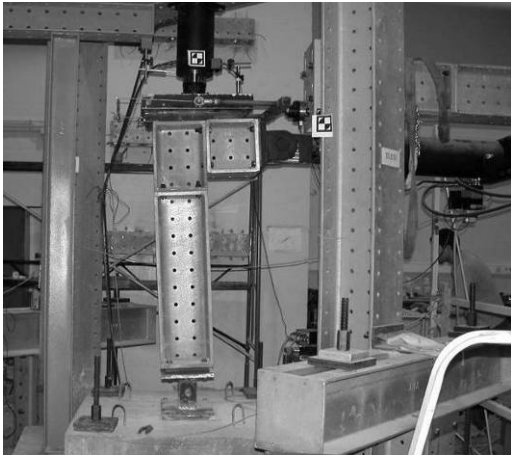
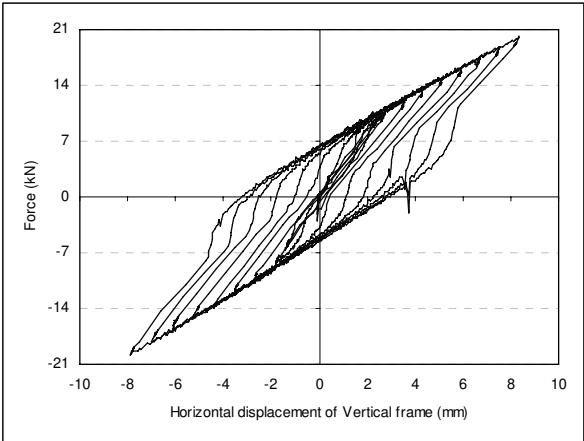
Figure 3: Setup with a steel pier hinged at the base. Figure 4: Relationship between the horizontal force and displacement of the vertical steel frame.

Due to the column hinge the moment of all forces at the base has to be equal to zero. Thus, only three exterior forces are applied to the steel column, which produce moment at the base: the horizontal actuator force, the upper plate force (resulting from the displacement restraint at this point) and the horizontal force of the vertical reaction frame. The two first forces are measured from load cells, whereas, from the null moment equilibrium condition at the base, the horizontal force of the vertical reaction frame can be computed. Considering the same axial load, as for the real specimen piers, the diagram shown in Fig. 4 was obtained relating the aforementioned horizontal force with the horizontal displacement of the vertical frame. These results allowed determining the horizontal stiffness of the vertical reaction frame that can be used later to correct the horizontal force actually absorbed by the column. As it can be seen from the Fig. 4, two parallel lines can be defined on the hysteretic curve envelop, which correspond to the horizontal stiffness of the vertical reaction frame estimated as approximately 2.2 kN/mm. However, it is noteworthy that, probably due to the characteristics of the sliding device, a stiffness discrepancy is observed when the direction of the movement is inverted.

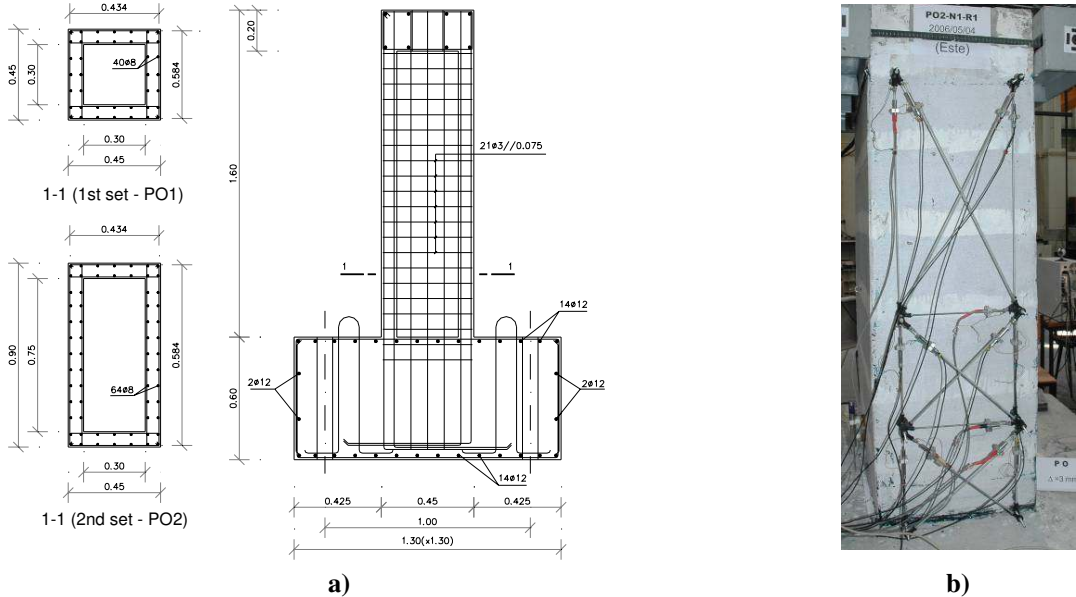
This set of specimens consists of two different rectangular hollow section RC piers: the first, a 450 mm square cross section with 75mm thick walls, is similar to some piers tested at the Laboratory of Pavia University, Italy [Pavese *et al*, 2004] and the results of this specimen tests are to be compared with those obtained at Pavia; the second specimen set, a rectangular section with 450mm x 900 mm, is being tested in order to understand the influence of the cross section geometry of rectangular hollow piers on the cyclic behaviour, bearing in mind the purpose of assessing retrofitting solutions. The thickness of the pier wall was kept constant, 75 mm. The model schemes shown in Fig. 5-a correspond to ¼ scale representations of hollow section bridge piers, herein referred to as PO: PO1 for the square section and PO2 the rectangular section. Instrumentation included strain gages attached to the reinforcement bars and LVDTs to measure curvature and shear deformations along the pier height. This configuration was used in both specimens as clearly shown in Fig. 5-b where the LVDT layout is visible as used for the pier PO2. It is worth mentioning that this instrumentation layout was actually improved

from that of the first PO1 test (in which only two levels of LVDT sets were included from the pier bottom) because important shear deformations were indeed observed in that test. Therefore it became essential to distribute more LVDTs along the entire pier height as illustrated in Fig. 5-b.

Figure 5: Hollow RC piers: a) model schemes and b) lateral LVDT layout for PO2

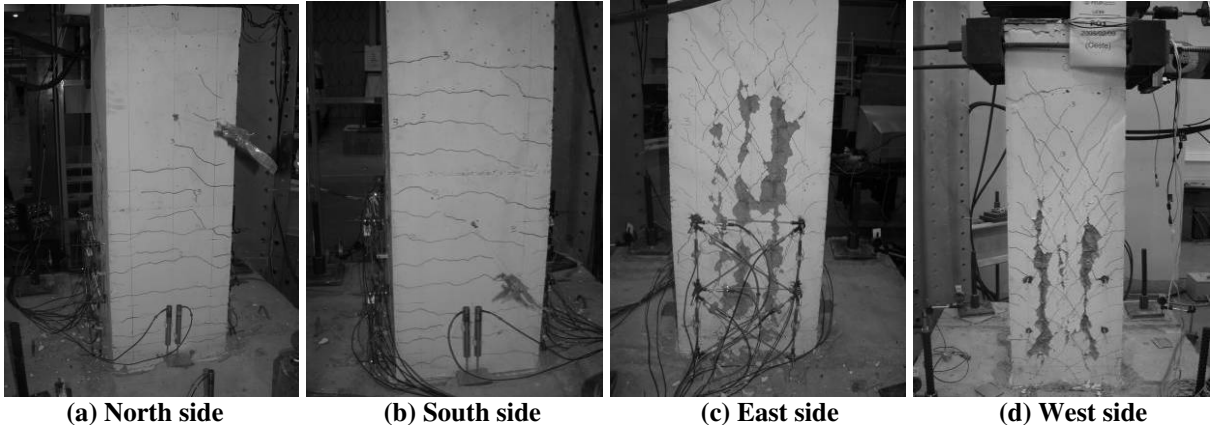
Concerning the results of the PO1 original specimen test, little damage was observed in the north and south sides, as shown in Fig. 6 where well distributed cracks were visible. However, the damage was found strongly concentrated in the lateral sides, east and west, where the concrete cover crushed within the entire pier height. As expected, severe shear damage was observed during the test with significant concrete degradation due to the low efficiency of the transverse reinforcement.

Figure 6: Pier PO1 damage for 2.4% drift.

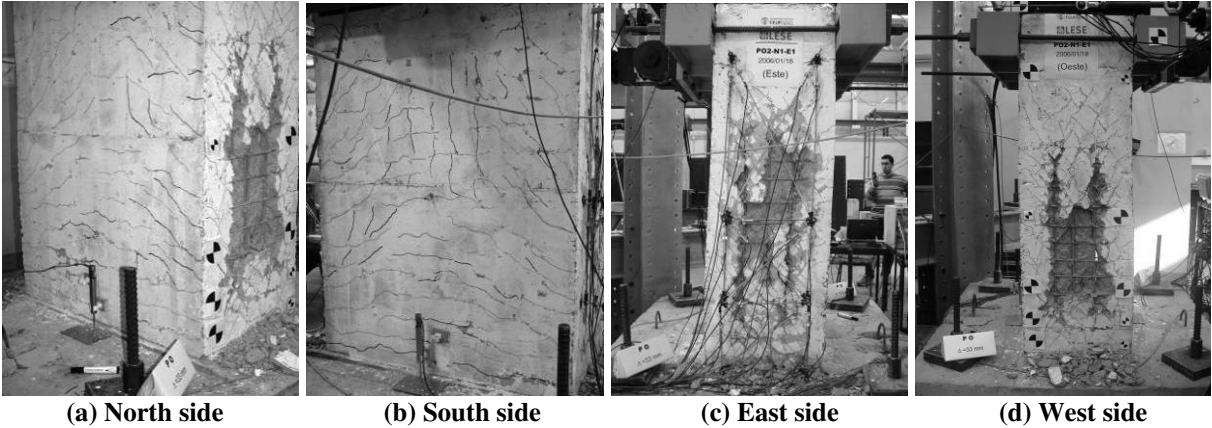
For the PO2 original specimen test, and as also described for the pier, the greatest amount of damage was mainly observed at the lateral sides, east and west, where the concrete cover again crushed within the entire pier height (see Fig. 7) and strong shear damage was achieved due to concrete degradation caused by lack of transverse reinforcement efficiency. Again, little damage was observed on the north and south sides, with well distributed

cracks. However, the cracks observed in those sides are not only horizontal, as for the square pier, but instead they show an angle that increases along the pier height, due the shear lag effect that occurs for this width/height ratio (2:1). Fig. 8 shows the experimental responses of both piers PO1 and PO2 where it is visible that, as expected, higher maximum forces were achieved for the rectangular section (PO2), due to the significant increase of the longitudinal reinforcement and concrete area, when compared with the square pier PO1. From the experimental responses and damage patterns illustrated in Figs. 6 and 7, shear mode failures of both piers were observed around the first cycles of 33mm amplitude (2.4% drift). However, these larger forces in the pier PO2 (only about 1,2 times those of from PO1) is not proportion with the increase of longitudinal reinforcement of pier PO2, about 2 times more when compared with pier PO1, which is related with the shear lag effect quite apparent from the damage pattern really observed.

Figure 7: Pier PO2 damage for 2.4% drift.

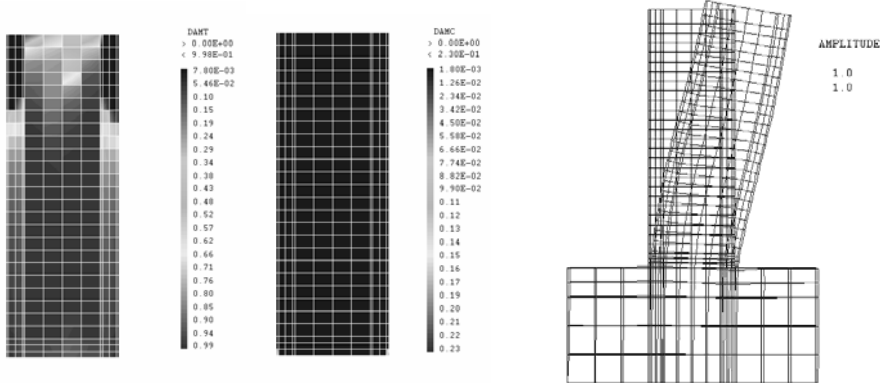
Concerning the numerical response predictions for both monotonic and cyclic loading, two analysis tools were used based on two different model types: *i*) the Seismostruct analysis program [SeismoSoft, 2004], freely on-line available in the internet, is a finite element analysis program based on the fibre modelling technique, where the inelastic behaviour spread along the member length and across the section area is explicitly simulated according to the discretization of the section into several finite area fibres (concrete and steel fibres) and of the beam-column member into several linear elements; *ii*) the CAST3M computer code [CEA, 2003], a general purpose finite element based program, where a wide variety of non-linear behaviour models are available and, particularly, the Damage model developed at FEUP [Faria *et al*, 1998] that has already proved to be suitable for seismic behaviour analysis of RC bridge piers [Faria *et al*, 2004]. The later modelling option involves: a Continuum Damage Mechanics based constitutive model for the concrete zone discretized into 2D finite elements (illustrated in Fig. 8), incorporating two independent scalar damage variables that account for the degradation induced by tensile or compressive stress conditions; the Giuffr -Menegotto-Pinto model [Giuffr  and Pinto, 1970] for the cyclic behaviour simulation of the steel reinforcement discretized via truss elements; the concrete zone discretized into 2D finite elements.

Figure 8: 2D finite element discretization with tensile/compressive damage and deformed mesh of PO1.

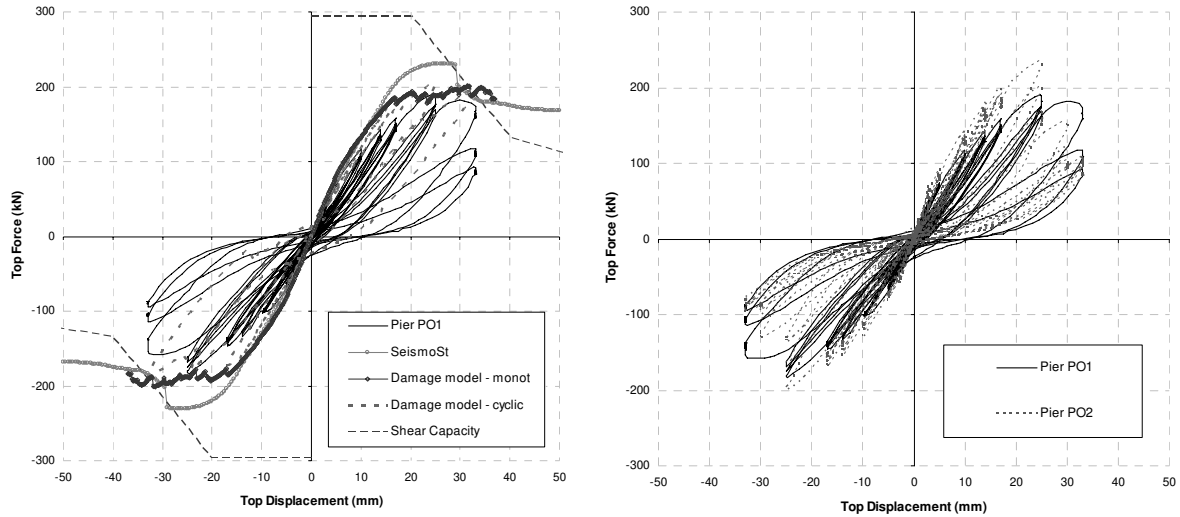
The simulation results with both numerical models for the pier PO1 are included in Fig. 8-a. In addition, the shear capacity curve is also depicted according to the prediction using the methodology proposed by Priestley for the shear strength [Priestley *et al*, 1996], and conveyed by Eq. 1:

where V_c , V_s and V_p are the shear force components accounting for the nominal strength of concrete, the transverse reinforcement shear resisting mechanism and the axial compression force; the term V_{sj} corresponds to the contribution of possible CFRP or metal jackets. As already referred before, the shear mechanism has significant influence on the pier response and this effect was satisfactorily captured by the damage model, for both monotonic and cyclic curves shown in Fig. 9. With the Seismostruct simulation higher maximum forces are achieved corresponding to flexural capacity of the bottom plastic hinge that, in fact, did not occur at the experimental test because it was preceded by shear mechanism. Therefore, the shear failure could not be accurately predicted by intercepting the shear capacity line, since the flexural mechanism and corresponding flexural ductility were not effectively mobilized.

Figure 9: Numerical analysis: a) for pier PO1 and b) experimental result comparison for PO1 and PO2.

The numerical solution obtained with the accurate method, the damage model, agrees very well with the experimental results; besides for the seismostruct model a little higher results were obtained, because the non linear effects due to the shear forces were not included.

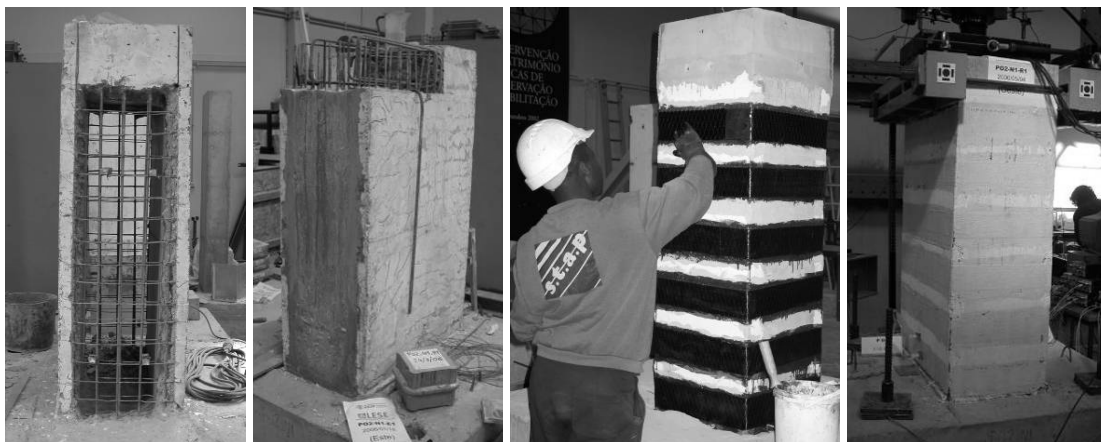
After the cyclic tests of the original specimens up to failure, they were repaired and retrofitted by an external contractor (S.T.A.P.) according to the following steps: 1) delimitation of the repair area; 2) removal and cleaning of the damaged concrete; 3) application of formwork and new concrete (Microbeton, a pre-mixed micro concrete, modified with special additives to reduce shrinkage in the plastic and hydraulic phase); 4) retrofit with the CFRP sheets. In order to provide a general idea of the pier damage and of the retrofit process, the following photographs show the piers during repair and after having been retrofitted with CFRP sheet jackets (Fig. 10).

Figure 10: Hollow piers before and after the shear retrofitting with CFRP sheet

where h is the overall pier section dimension parallel to the applied shear force, f_j is the adopted design jacket stress level corresponding to a jacket strain of 0.004, A_j is the transverse section area of the jacket sheets spaced at distance s and inclined of the angle θ relative to the member axis. This condition is introduced to avoid large dilation strains and hence excessive degradation of the concrete, as well as to provide adequate safety against the possibility of jacket failure. Therefore, using Eq. 1 and for the PO specimens retrofit, one layer strip of CFRP sheet of 0.117mm thickness by 100 mm width and 100 mm spaced along the height of the piers was applied, to retrofit the PO1 and PO2 specimens, as can be seen in Fig. 10.

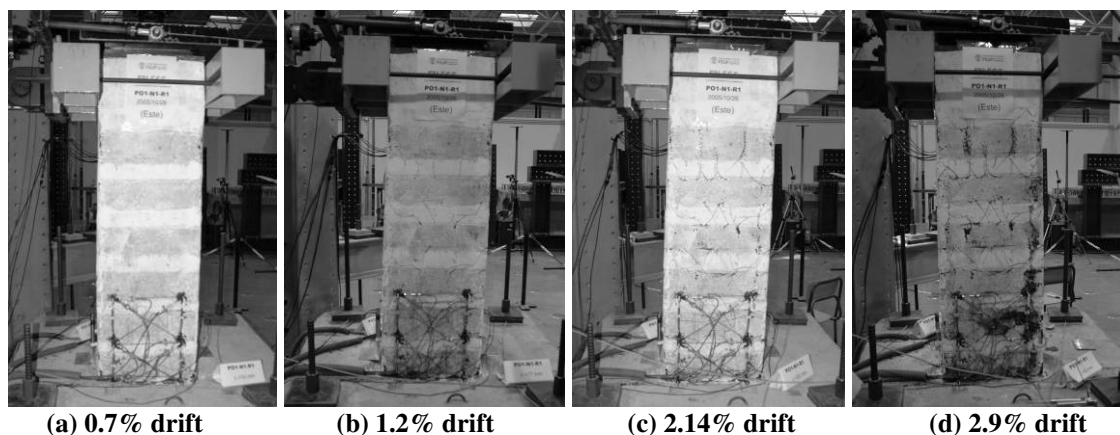
The damage evolution during the experimental test of the retrofitted specimen is illustrated in Fig. 11, for the east side of the pier. The first cracks, about 0.1mm wide, were visible at 0.35% drift, near the pier base. In the subsequent cycles the dimensions of these cracks increased and new cracks were developed along the pier height (Fig. 11a). For the top displacement of 17mm (1.2% drift - Fig. 11b), only the base crack has grown to about 0.5mm. Shear cracks appeared in the next cycles of 1.8% drift and generalized damage started to become visible. In the right hand side of Fig. 11c (2.14% drift), a vertical crack is visible over almost the entire pier height, which caused global damage to the CFRP sheets. Failure of some of the fibres was audible. During the cycles of 40mm top displacement (2.9% drift - Fig. 11d) the bottom carbon sheets failed completely, leading to a drastic collapse of the pier on the compression side of the section, with buckling of the longitudinal reinforcement bars, due to lack of concrete confinement (see also Fig. 12). From these damage illustrations it can be seen that the retrofitted specimen showed a good behaviour in comparison with the original configuration, exhibiting very distributed cracking along the CFRP spacing.

Figure 11: Retrofitted pier PO1 damage from east side view.

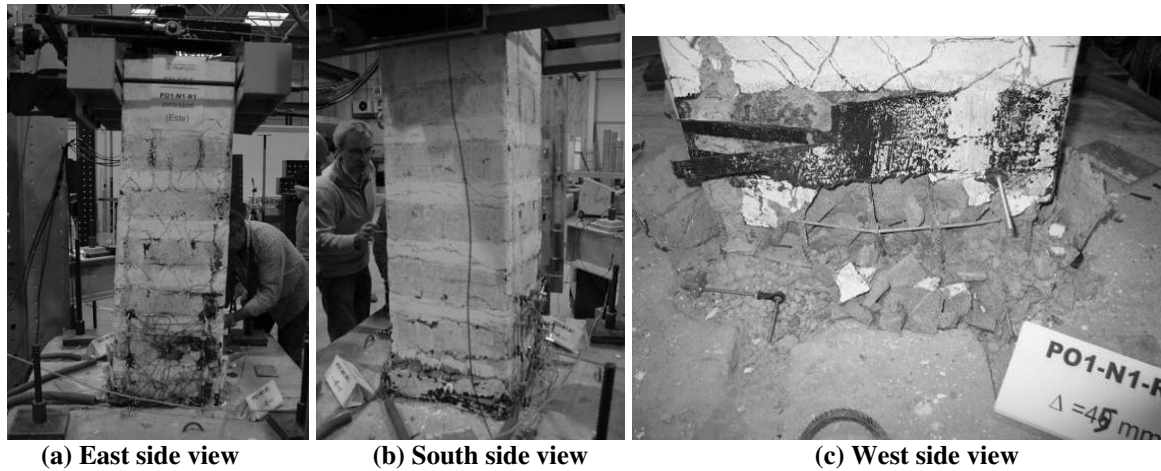
Figure 11: Final damage of the retrofitted pier PO1 corresponding to 3.2% drift ratio.

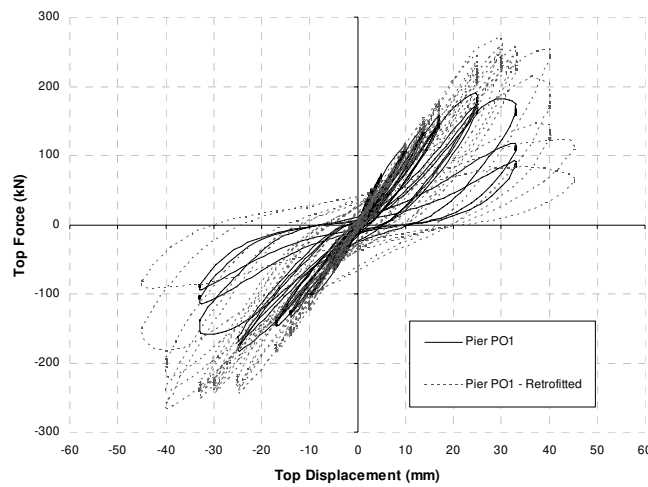
The shear retrofit design used on this pier, showed an excellent performance because the shear failure mechanism was partially prevented and the flexural collapse with buckling of the reinforcement bars was achieved. In Fig. 13 the comparison between the original and retrofitted pier is illustrated, where increases can be found of 30% for the top force and of 30% for the maximum displacement reached without significant reduction of the resistant force.

Figure 13: Experimental results of pier PO1 before and after retrofit.

The CFRP retrofit showed excellent benefits on the two piers behaviour since it avoided the shear collapse and a mixed shear-flexure mechanism was achieved. The ultimate drift increased from 2.4% to 3.2%, on both piers, and a well distributed cracking was obtained. The adopted retrofiting strategy has evidenced good ability for the improvement of the seismic pier behaviour both in ductility and strength. The retrofiting of the PO2 pier evidenced a higher improvement on the horizontal force capacity than the PO1, due the benefits of the CFRP retrofit, both in shear strength and in the shear lag effect, allowing a great participation of the tensile wall of the pier.

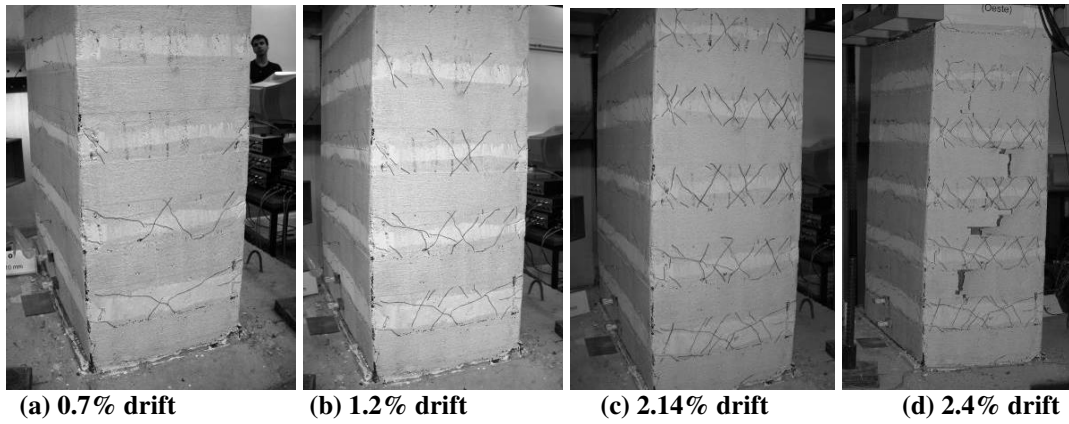
The damage evolution during the experimental test of the retrofitted specimen PO2 is illustrated in Fig. 14, for the pier west side. For small amplitude cycles, corresponding to drift below 0.7%, first cracks about 0.1mm wide occurred at the pier base section (Fig. 14a). In the subsequent cycles the crack widths increased and new cracks were also developed along the pier height. For the top displacement of 17mm (1.2% drift), the damage pattern shown in Fig. 14b was mainly characterized by diagonal cracks in the interval zones between the CFRP strips. Shear damage continued to increase in the next cycles and, for 2.14% drift, (Fig. 14c) some small damage started to become visible on the CFRP sheets. Failure of some of the fibres was audible from this stage on. During the last cycles of 33mm top displacement (2.4% drift) some of the carbon sheets failed completely; however, probably due to some non-symmetric conditions of the pier, more damage was found in the west side. In fact, three CFRP strips collapsed in the pier west face (shown in Fig. 14d) and only one failed at the opposite side, leading to conclude that, at the retrofit stage, the CFRP sheet bonding on the pier faces was well performed and the rupture of one side does not produce the all strip fibre failure. Fig. 15 shows the damage evolution on the pier internal faces also visualized during the test, in correspondence with the exterior damage, presented in Fig. 14. When the first CFRP strips collapsed, for 2.4% drift, the interior cracks increased considerably, as illustrated in Fig. 15d. On the last cycles, generalized damage became visible, with almost all the CFRP strips collapsed (Fig. 16) and a quick reduction of the pier capacity was observed (Fig. 17). The final interior damage is also shown in Fig. 16d. As can be seen in Figs. 14 and 17, the retrofitted specimen showed good behaviour in comparison with the original one, exhibiting very distributed cracking along the CFRP spacing. The shear retrofit design, used for this pier, showed excellent performance since the shear failure mechanism was partially prevented and the collapse was achieved after the CFRP failed, what occurs further after the original specimen. Fig. 17 shows the comparison between the original and retrofitted pier, where about 40% increase of the top force is reached and about 50% more of the maximum displacement is obtained, without significant reduction of the resistant force.

Figure 14: Retrofitted pier PO2 damage from west side view.

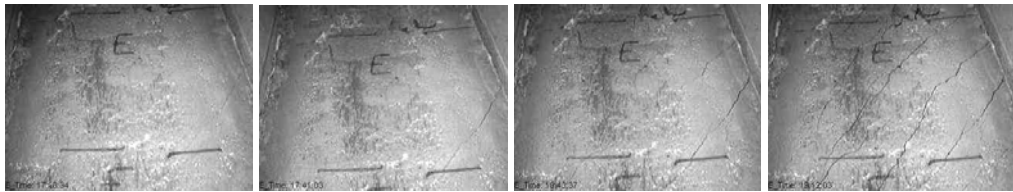
Figure 15: Retrofitted pier PO2 damage from internal east side view.

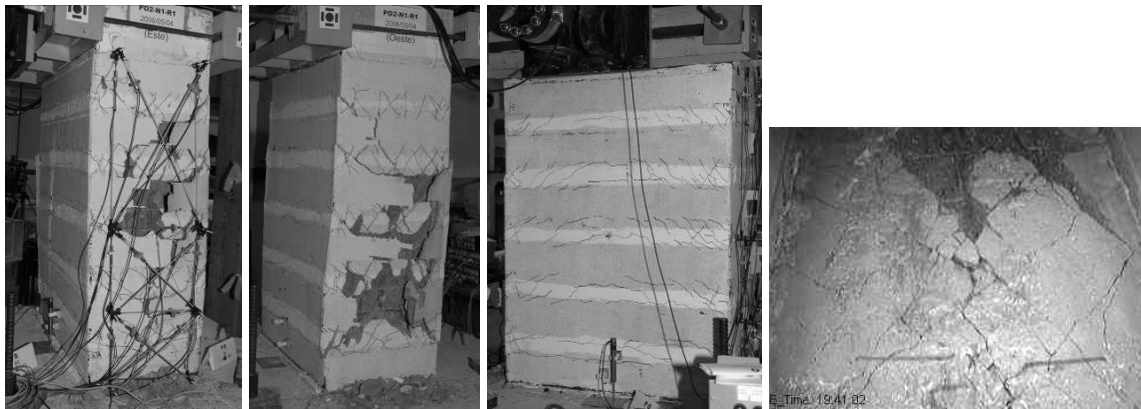
Figure 16: Final damage views of the retrofitted pier PO2 corresponding to 3.2% drift ratio.

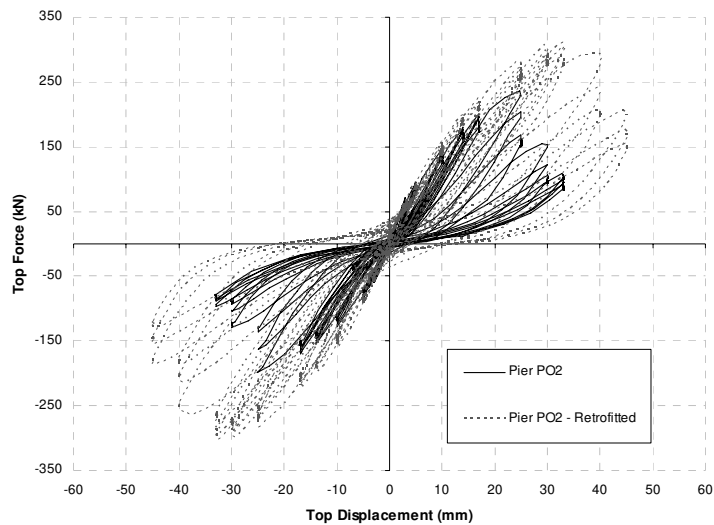
Figure 17: Experimental results of pier PO2 before and after retrofit.
