EXPERIMENTAL EVALUATION OF 350  
MEGAHERTZ RF (RADIO FREQUENCY)  
ACCELERATOR WINDOWS FOR THE LOW ENERGY  
DEMONSTRATION ACCELERATOR

PAC '97 Conference  
Vancouver, Canada  
May 12-15, 1997

# EXPERIMENTAL EVALUATION OF 350 MHz RF ACCELERATOR WINDOWS FOR THE LOW ENERGY DEMONSTRATION ACCELERATOR\*

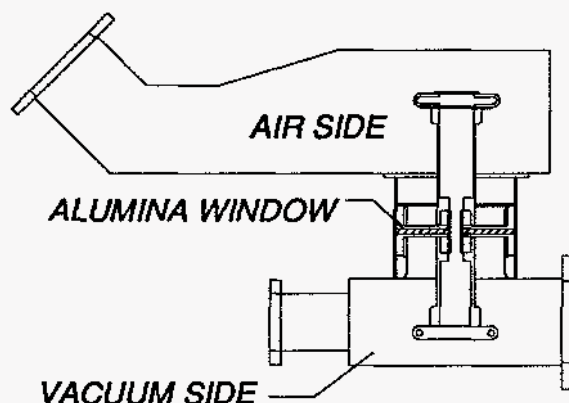
Figure: 3 Sketch of the EEV window

The RF window prototypes from CPI and EEV are both coaxial windows and are illustrated in Fig. 1 and Fig. 2, respectively. The cross section of the EEV window is shown in Fig. 3. Both windows used half-height WR 2300 waveguide and AL995 alumina ceramic. For both

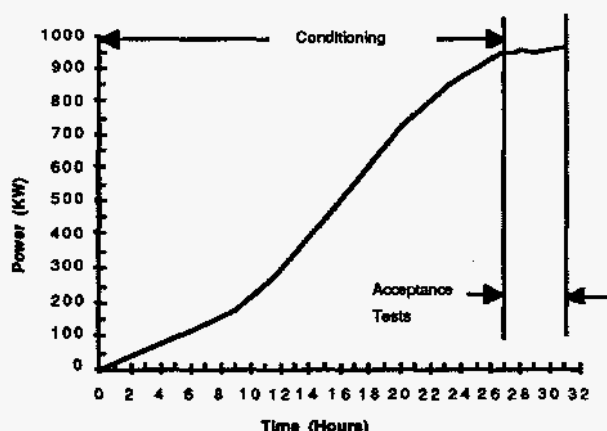
Figure 4 EEV Forward Power vs Time

The air flow rates were measured as 80 cfm and 100 cfm through the two windows. The water flow rate was set to 4.5 gpm on each window. No bakeout was conducted on the EEV window, and it was conditioned using only CW power. The EEV window was conditioned to 950 kW in approximately 26 hours, as illustrated in Fig. 4. At low power levels, the arc detectors would occasionally trip and a corresponding increase in gas pressure was observed. These trips were suspected to be caused by a fluorescence, which was not seen at higher power levels. Saito, et. al. have observed a fluorescence with a monochromator on a test window and correlated it with multipacting associated with the impurities in alumina ceramic [3]. The vacuum pressure interlock was set to  $5E-7$  Torr. Slight increases in the gas pressure over  $5E-7$  Torr lead to a "run away" in the pressure, thus the gas pressure was carefully controlled by reducing the RF power when necessary. The high-power acceptance test for the EEV windows consisted of running the EEV windows at approximately 950 kW for 4 hours. During this time, there were no indications of any problems. The EEV window had both air and vacuum region arc detector viewports. After the high-power acceptance tests, the air
