Experimental Investigation of RC Footings Resting on Sand Strengthened with Concrete Jacketing

Mohamed Attia Fouda^{*1}, Mahmoud Elkateb¹, Tamer Elkateb², Ayman Khalil¹

An experimental study regarding structural strengthening of existing reinforced concrete footing was conducted on six full scale reinforced concrete footings, strengthened with concrete jacketing under concentric and eccentric loads. The footings had constant dimensions and flexural steel reinforcement which was designed to prevent brittle failure due to crushing of concrete before steel yielding. Concrete jacketing was installed on all sides and top of existing concrete for footings subjected to concentric loading, while concrete jacketing was installed on three sides and top of existing concrete for footings under eccentric loading. The bonding between the existing and the new concrete was done either by applying epoxy bonding with dowels or by using an epoxy bonding agent on all sides only. This was to investigate the effect of each strengthening technique on the stress distribution beneath reinforced concrete footings rested on cohesionless soil. The dowels were used and designed to prevent any premature shear

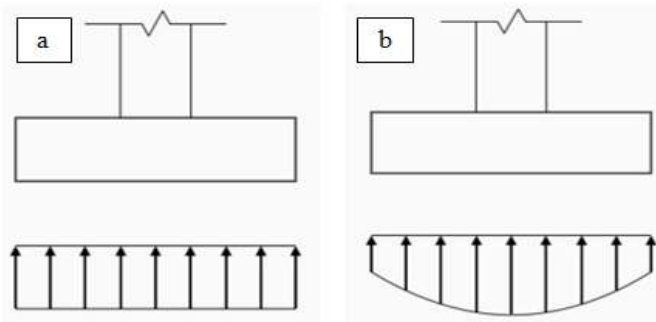
codes [5-7]. The authors stated that the theoretical assumption of uniform distributed stress under footing was conservative. In 2019, Wang-Xi Zhang [8] investigated the punching behavior of RC footings, subjected to eccentric loading, resting on rubber block. The results showed that the stress distribution was linear at low load levels, while it tends to be highly concentrated under the point of load application with load increase. Furthermore, the nonlinearly distributed stress influenced and increased the punching shear strength as well as the punching shear force of the footing. In 1990, Mosley [9] demonstrated the contact stresses distribution beneath a typical rigid footing resting on sand as shown in Figure 1.

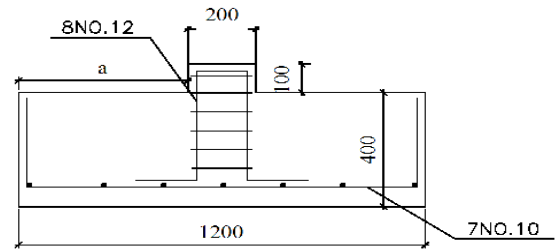
Figure 3: Reinforcement details for (a) a=500 mm for Control-1. (b) a=450 mm for Control-2.

Six full scale square reinforced concrete footing specimens were tested under concentric and eccentric static loading till failure. These footings were divided into two groups; each group consists of three footings, a control specimen and two footings strengthened by concrete jackets (with/without) dowels. Table (1) summarizes the test groups dimensions and illustrates the strengthening methodology. Concrete jackets were used to study the effect of dowels and the bonding agent, on the whole bonding strength under eccentric and concentric loads.

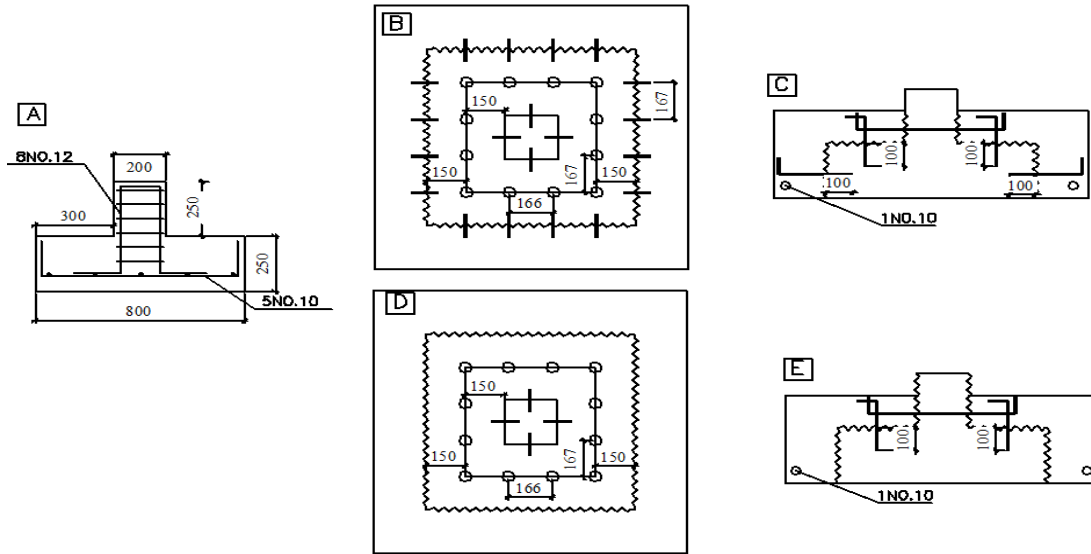
Figure 4: Reinforcement and dowel details for (a) G1F1 and G1F2 before strengthening. (b) G1F1 after strengthening plan view. (c) G1F1 after strengthening elevation view. (d) G1F2 after strengthening plan view. (e) G1F2 after strengthening elevation view.

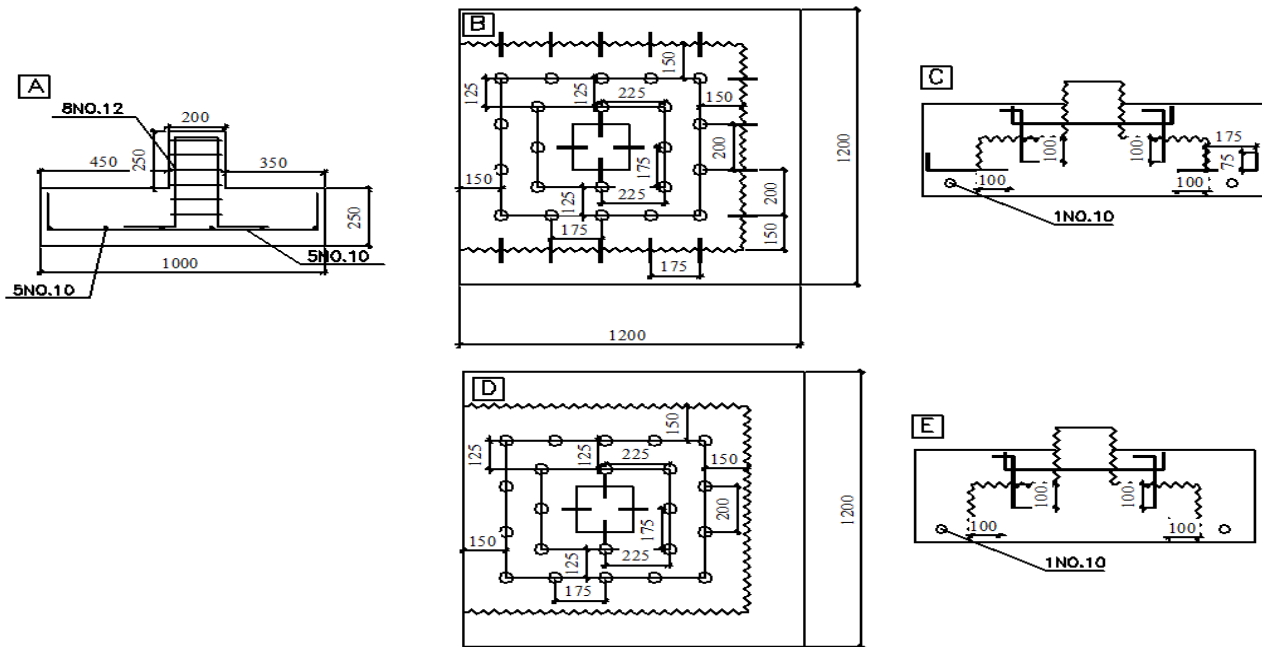
Figure 5: Reinforcement and dowel details for (a) G2F1 and G2F2 before strengthening. (b) G2F1 after strengthening plan view. (c) G2F1 after strengthening elevation view. (d) G2F2 after strengthening plan view. (e) G2F2 after strengthening elevation view.

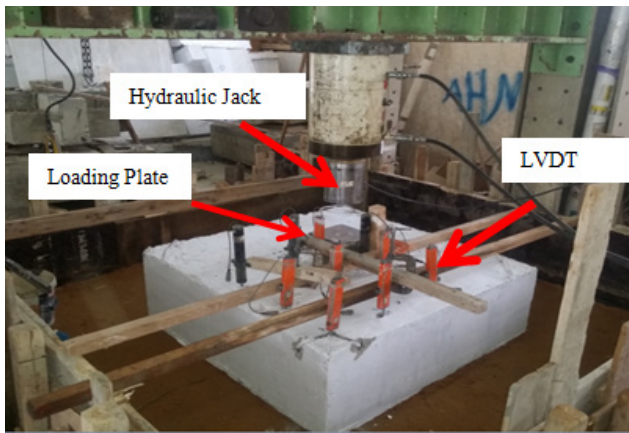
All reinforced concrete footings were tested on compacted dense sand inside a square wooden box with side length, and thickness of 2400 and 800 mm respectively. The box was strengthened with steel pipes from all sides. Figure 3-5 show the reinforcement details in all control and strengthened footings, Flexural reinforcement arrangement in the strengthened footings were constant and similar to the control specimens. Figure 6 shows the test setup for all footings. Each tested specimen was subjected to concentrated gravity load induced a vertical hydraulic jack, using load control mode, at which the load was increased by incremental values of 5 kN until failure load level was attained.

Figure 6: Experimental test setup.

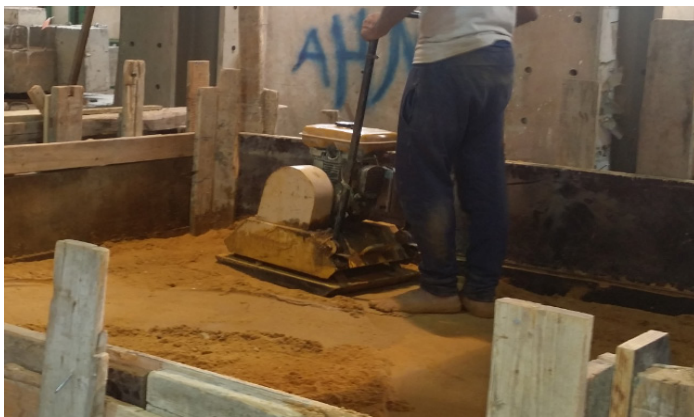
Clean dense sand was used in the laboratory testing. The particle size distribution was determined through sieve analysis ($D_{60}=1$, $D_{30}=0.4$ and $D_{10}=0.2$). The soil can be classified as well graded sand according to the Unified Soil Classification System (USCS) (ASTM Standard D2487, 2011) [16]. The density of the sand placed in the models was 20 kN/m^3 , while the friction angle was 43.9° , the friction was relatively high as the roughness coefficient between soil and concrete footing is responsible for increasing the bearing capacity of soil [17]. The soil was prepared and compacted up in layers of 250 mm thickness with vibrator machine as shown in Figure 7, using 10.5% optimum water content.

Figure 7: Compaction process

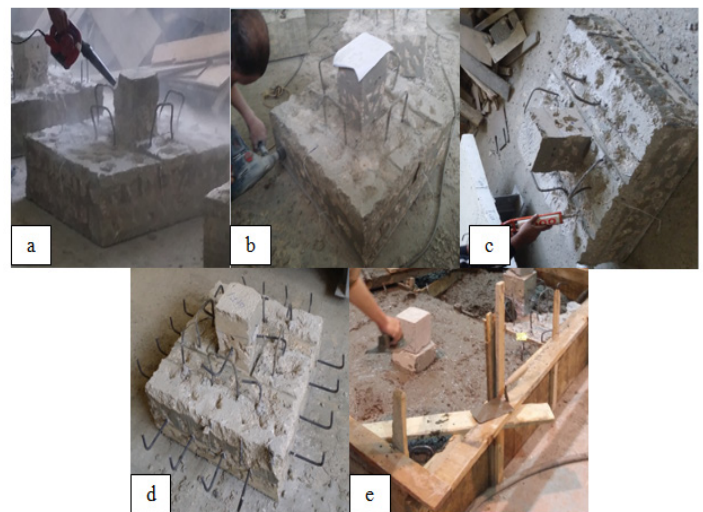
The preparation of the surface was done when the original concrete footing specimens were 35 days old. The surfaces of the RC footings were roughened by hand-chiseling from all sides and top surface. Dowel bars of 10 mm diameter and 250 mm length rod were installed in original footings between the interfaces of the layered construction. These bars were embedded into the initial cast concrete by drilling after 40 days of casting with 100 mm embedded length and were installed using sikadur-31CF (Thixotropic epoxy resin adhesive). Figure 8 shows surface preparation process, dowels drilling and placement in original footing and casting concrete jacketing.

Figure 8: Preparation process (a) Roughening the concrete surface. (b) Drilling. (c) Installing epoxy. (d) Installing and placement dowels. (e) Casting new jacket.

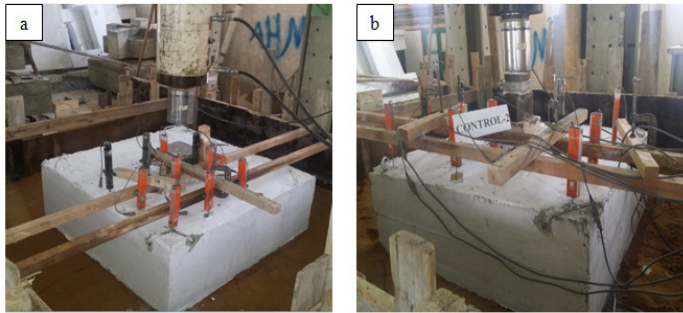
The data acquisition system included two data acquisition modules for all the strains, displacements, and load cells. Ten

LVDTs were used to record the vertical displacement. Figure 9 shows the distribution of LVDTs on group-1 and group-2 respectively.

Figure 9: LVDTs distribution for (a) Group-1. (b) Group-2.

The settlement of the control and strengthened reinforcement concrete footing was determined at the same points along the width of the footing, as indicated in Figures 9 (a& b) for concentric and eccentric footings. The normalized average settlement versus the applied load of the reinforced concrete footing is illustrated in Figure 17. The behaviors of the concentric and eccentric footing were in good agreement until a load level of about 400 kN. After that, due to the eccentricity effect, a clear deviation in measured average settlement between group-1 and group-2 was noticed. Before cracking of the concrete, the settlement of all points along the width of the footing was similar. The rate in increase in average settlement after cracking was higher than that before cracking.

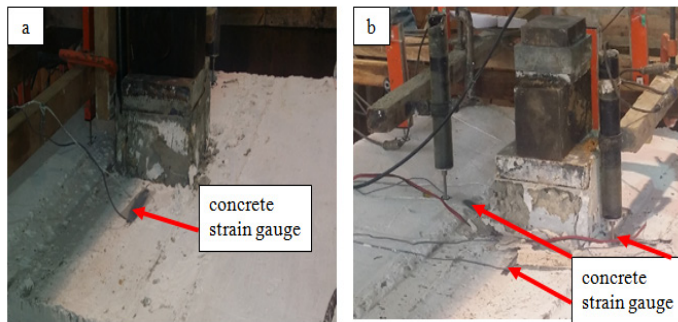
Concrete strain gauges were installed on the upper reinforced concrete footing on one direction only for group-1; strains were placed on to orthogonal direction for group-2 as shown in Figure 10).

Figure 10: Concrete strain gauge distribution on (a) Group-1. (b) Group-2.

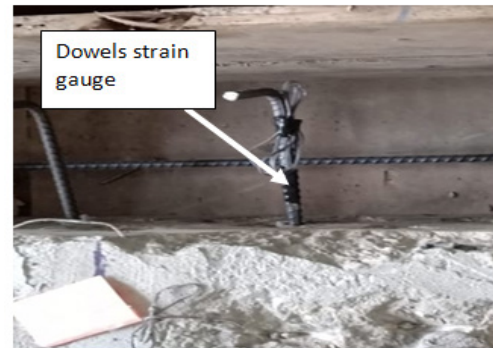
Shear dowels, at typical locations, had strain gauges at their mid-length in longitudinal direction in specimen G1F1, while strain gauges were placed on shear dowels in orthogonal

directions in specimen G2F1. Figure 12 shows a typical layout for strain gauge placed on shear dowels.

Figure 12: Typical reinforcement strain gauge placed on shear dowels.

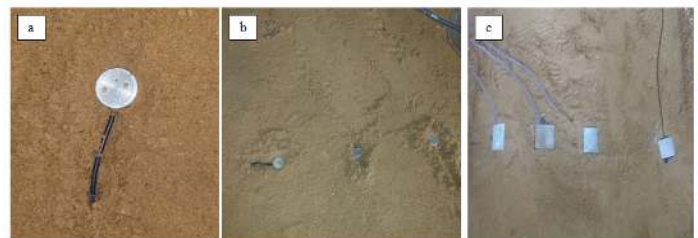
Figure 13(a) shows a TY-350 pressure cell placed between the reinforced concrete footing and the soil surface to determine the contact stress distribution below the footing. Thus, it was decided to cover a pressure cell with thin steel plate to protect the pressure cell from damage. Four soil pressure cells were distributed below the reinforced concrete footing for groups (1&2) are shown in Figures (13) (b & c) respectively.

Figure 13: Distribution of load cell pressures beneath concrete footing (a) Typical TY-350 pressure cell. (b) (Group-1). (c) (Group-2).

The contact Stress distribution below control and strengthened concrete footing using concrete jacket with/without dowels were measured using pressure gauges as shown in Figure 13. Figure 18 shows the shape of contact stress distribution at center line of the footing for group-1 at 50% and 100% of the ultimate load of the control specimen C1.

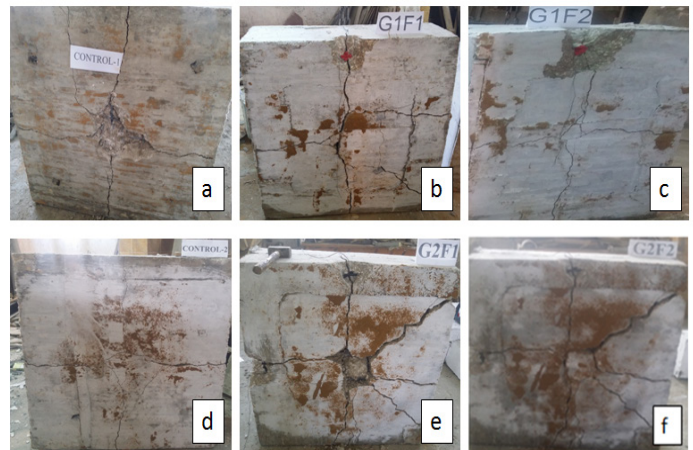
All footings failed in flexure due to steel reinforcement yielding, no brittle failure and debonding for concrete jacketing was observed. All side cracks were observed during test, while cracking on bottom surface of footings were observed at the end of the tests. The stiffness of the footings decreased with propagation of cracks at increased load levels. Figure 14 shows the typical crack patterns at failure for each footing. The behavior of the strengthened Footings G1F1, G1F2, G2F1, and G2F2 was close to the control specimens in terms of the crack initiation, crack pattern and failure modes whilst having different failure

loads. Increased strains in the flexural reinforcement were measured before failure. Experimental failure loads for different groups are listed in Table (2). Side cracks first appeared at bending moment level of about 50 kN.m in all footings and the corresponding load level were in the range of 700 to 800 kN. The theoretical moment at failure load, using the uniform distribution theory beneath footing rested on soil (Force/Area), was calculated as $WL^2/2$. From Table (2), it is noted that the actual moment at failure is equal to 82% of the theoretical moment which means the stress distribution under concrete footing resting on cohesionless soil was not consistent with the uniform distribution stress theory. Furthermore, the load-carrying capacity for all strengthened footing was higher than control samples, and the stress distributions under strengthened footing were the main reason for increasing the footing capacities.

Figure 14: Typical cracking patterns at Failure for footings (a) C1. (b) G1F1. (c) G1F2. (d) C2. (e) G2F1. (f) G2F2.

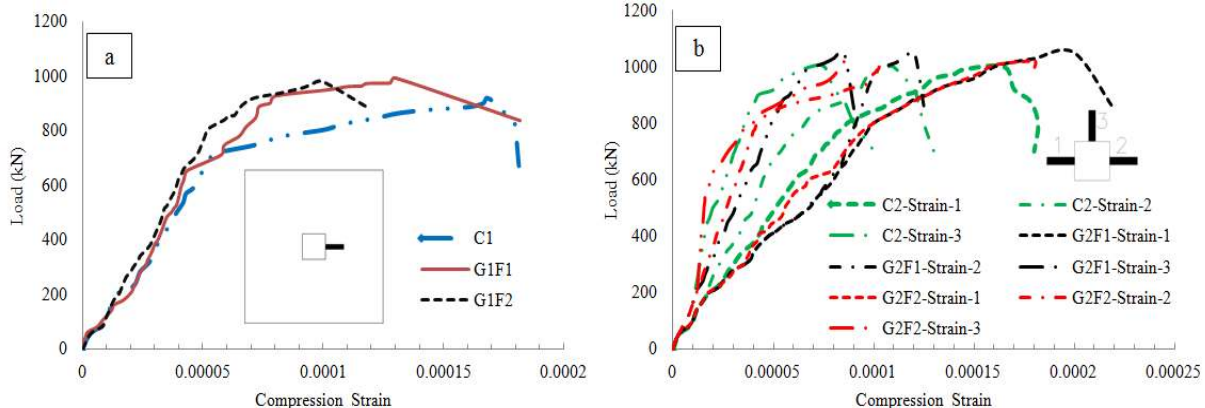
For all footings, compressive strains at the top side of the concrete were measured, in addition to the tensile strains of the lower main reinforcement. Figure 15 shows the applied load vs. the compressive strains of the upper side of the footing beside the column stub, showing a similar behavior for all footings under concentric loads. Regarding eccentric footings, the behaviour of the strains in the eccentric direction was different than that in the perpendicular direction, due to the concentration of stresses in eccentricity direction. Concrete crushing did not occur in all specimens and all compression strains did not exceed the plastic

limit of 0.003. It was also noticed that the load-strain relationship was almost identical in the linear elastic stage.

Figure 15: Applied load versus compressive strain (a) Concentric loading (b) Eccentric loading.

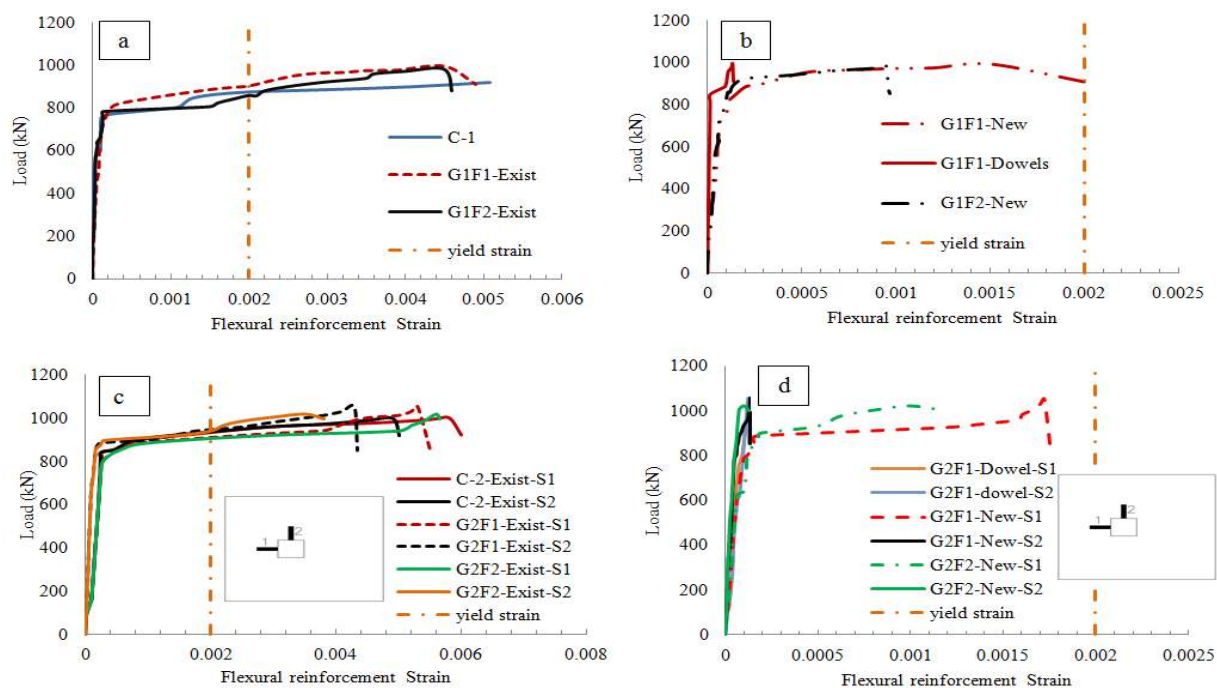
Figure 16 shows the flexural reinforcement strains measured for concentric and eccentric footing. The strain gauges were installed within the column face region. All maximum measured strain values for existing reinforcements were above the yield limit which indicated that the failure occurred due to flexure, while all recorded strain values for dowels were below the yield strain limit, which indicates that the flexural debonding did not occurred during loading process.

Figure 16: Applied load versus Flexural reinforcement strain (a) Existing reinforcement under concentric loading. (b) New reinforcement under concentric loading. (c) Existing reinforcement under eccentric loading. (d) New reinforcement eccentric loading.

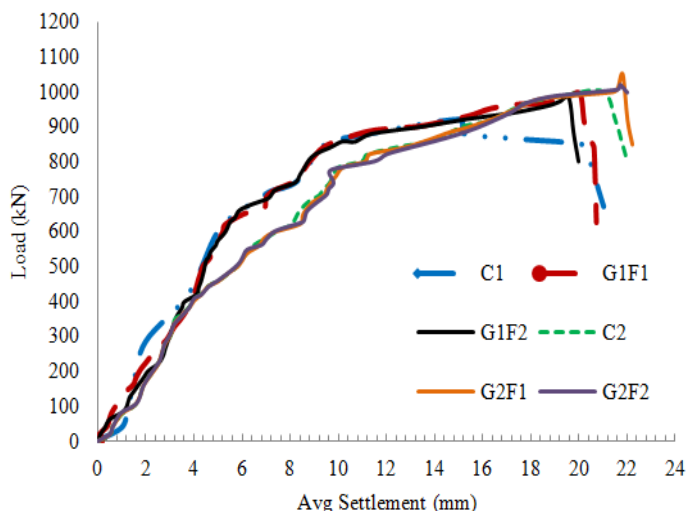
Figure 17: Applied load versus Average Settlement.

For the elastic stage, the behavior of all strengthened and control footings were similar and the elastic stiffness was almost the same according to the linear load-displacement relationship shown in Figure 17. After the concrete cracked, the behavior changed as the stiffness of the reinforced concrete footing decreased and the settlement significantly increased. Average settlements were not affected by using dowels compared with the footings strengthened with epoxy bonding agent only. The maximum settlement at the center of the footings increased with the increase in the contact stresses below the footings as shown in Table 2. The maximum settlement under strengthened footing G1F1, G1F2 were 5% and 7% higher than that of C1 respectively, while the settlement under strengthened footing G2F1, G2F2 were higher than that of C2 by 3% and 4% respectively.

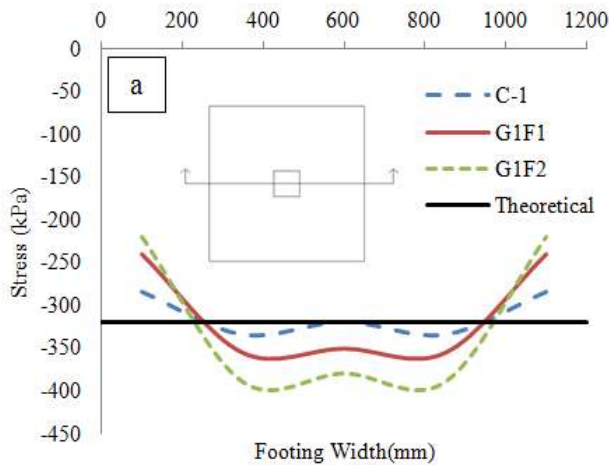
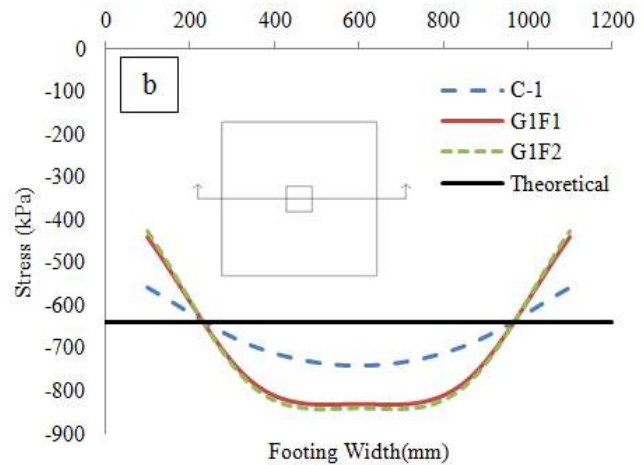
Figure 18 shows the behavior of contact stress pre and post cracking. There was no crack initiation observed at 50% of the failure load of C1. The recorded stress at center line of footing C1 was close to the theoretical uniform stress distribution, but the stress at the edge was less than the theoretical assumption. The stress under center of strengthened footing G1F1 is higher than C1 by 9% and 12% in cases (a) & (b) respectively. Moreover, The stress under edge of strengthened footing G1F1 is lower than C1 by 16% in case (a) and 22% in case of (b) which means the contact surface between existing and new concrete play an important role in stress distribution under strengthened footing.

The stress under center of strengthened footing G1F2 is higher than that of C1 by 18% in case (a) and 13.5% in case (b). While, the stress under edge of strengthened footing G1F2 is lower than that of C1 by 23% and 25% in cases (a) and (b) respectively. The ratio between the center to the edge stress increased with increasing the applied load, which is due to that the effect of cracking. The flexibility of the footing increased with increasing the flexural cracks leading the concentration of the stress to be shifted towards the center of the footing. It is noticed that for the control footings in group-1, the shape of contact stress before cracking was saddle-shaped, but after cracking the shape of contact stress takes place as a parabolic shape for control footing, while the contact stress was a bell shape beneath strengthened footings. Figure 19 shows the shape of contact stress distribution at edge line of the footing for group-1 at 50% of C1 failure load and 100% of C1 failure load.

Figure 18: Contact stress distribution beneath footing center line (group-1) at (a) 50% of C1 failure load (b) 100% of C1 failure load.

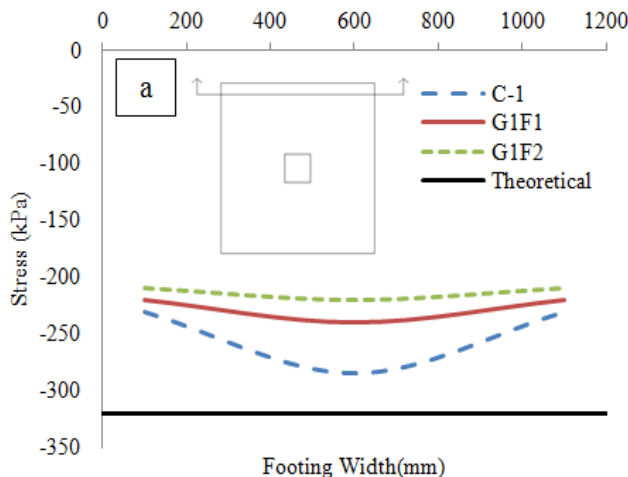
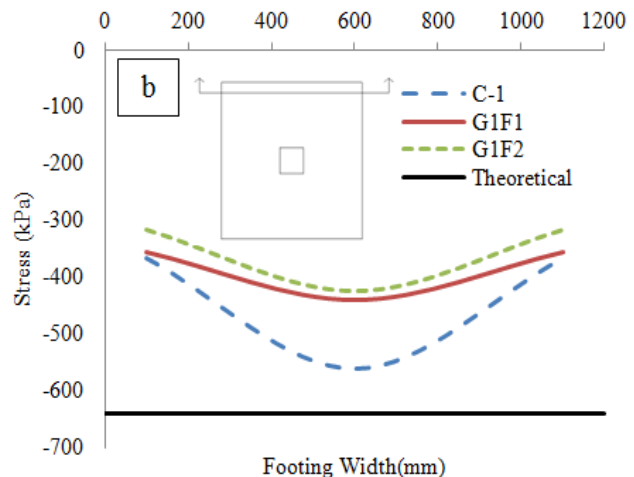
From Figure 19, it is noticed that the recorded stress at center line of C1 seems close to the theoretical uniform stress distribution assumption. The stress under center of strengthened footing G1F1 is less than that of C1 by 16% in case (a) and 22% in case of (b). Additionally, the stress under edge of strengthened footing G1F1 of above figure is lower than that of C1 by 5% in case (a) and 22% in case of (b). The stress under center of strengthened footing G1F2 of the above figure is lower than C1

by 23% in case (a) and 25% in case of (b). Furthermore, the stresses under the edge of strengthened footing G1F2 are lower than that of C1 by 9% and 15% in cases (a) and (b) respectively.

Figure 19: Contact stress distribution beneath footing edge line (group-1) at (a) 50% of C1 failure load (b) 100% of C1 failure load.

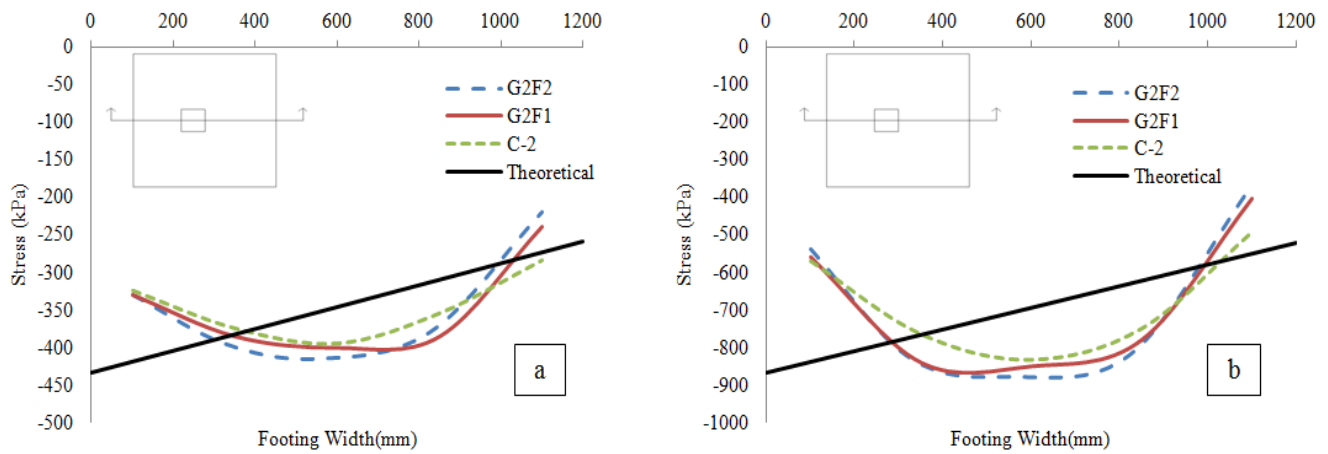
Figure 20 shows the shape of contact stress distribution at the center line of the eccentric footing for group-2 at 50% and 100% of the failure load of the control specimen C2. The stress distribution under eccentric loading is concentrated under the column and completely different than the theoretical assumption (MY/I), these results were in agreement with the experimental results for non strengthened footings by G. U. Muller et al. [11]. The stress concentration under center line of column stub for G2F1 and G2F2 is higher than that of C2 by 1% and 5% respectively for case (a) and 2% and 5.6% respectively for case (b). Moreover, the stress concentration under footing edge at maximum compression zone G2F1 and G2F2 is higher than that of C2 by 1.5% for case (a), while it is lower than that of C2 by 2% and 6% respectively for case (b). The stress concentration under footing edge at minimum compression zone G2F1 and G2F2 is lower than C2 by 16% and 23% respectively for case (a) and lower than C2 by 18% and 25% respectively for case (b).

Figure 20: Contact stress distribution beneath footing center line (group-2) at (a) 50% of C2 failure load (b) 100% of C2 failure load.

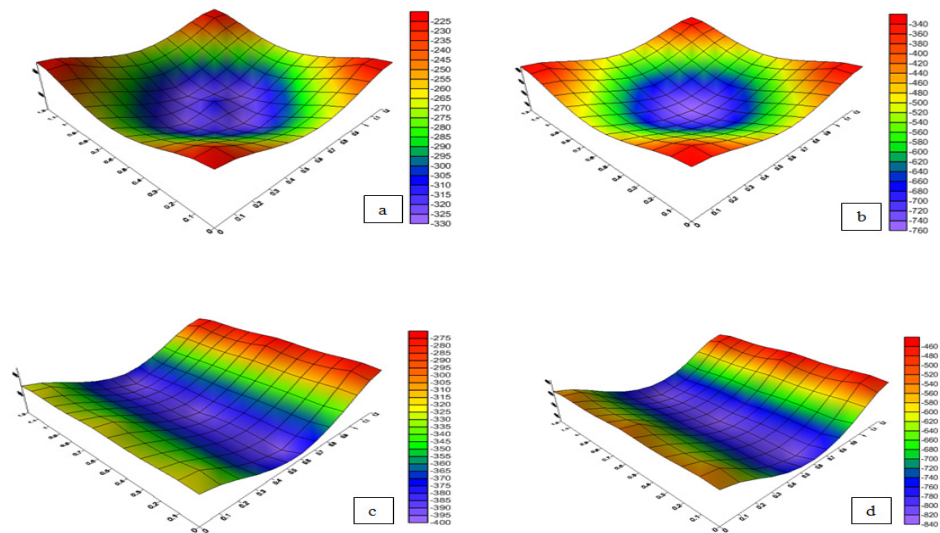
Figure 21 shows 3-Dimensional Contact stress distribution beneath control footings C1 and C2 at 50% and 100% of their failure loads using Surfer maps version 13.

Figure 21: 3-D demonstration the contact stress distribution beneath control footings C1 and C2 (a) 50% of C1 failure load. (b) 100% of C1 failure load (c) 50% of C2 failure load. (d) 100% of C2 failure load.
