EXPERIMENTAL PHASE II OF THE STRUCTURAL HEALTH MONITORING BENCHMARK PROBLEM

Shirley J. Dyke¹, Dionisio Bernal², James Beck³, and Carlos Ventura⁴

ABSTRACT

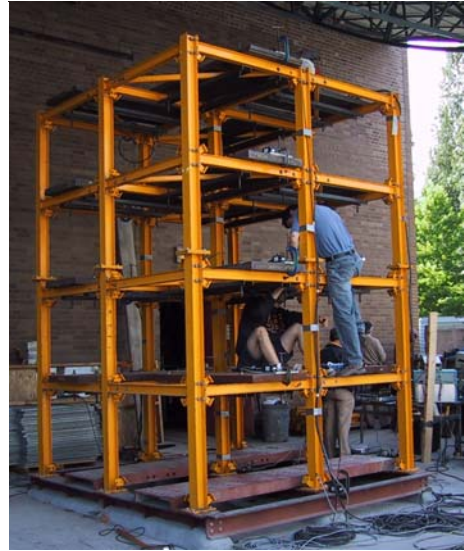
FIGURE 1: STEEL-FRAME SCALED BENCHMARK STRUCTURE.

The subject of the experimental benchmark problem is the 4-story, 2-bay by 2-bay steel-frame scale-model structure shown in Fig. 1. It is located in the Earthquake Engineering Research Laboratory at the University of British Columbia (UBC). For the tests, the structure was mounted on a concrete slab just outside of the structural testing laboratory on the UBC campus to simulate typical ambient vibration conditions. The nine vertical columns are bolted to a steel base frame, and the lower flanges of two of the base beams are encased in concrete, fixing the steel frame to the concrete slab.

The structure is 2.5 m \times 2.5 m in plan and is 3.6 m tall. The members are hot-rolled, grade 300W steel (nominal yield stress 300 MPa (42.6 kpsi)). The sections are specifically designed for this scale model test structure. The columns are B100x9 sections and the floor beams are S75x11 sections. A photograph showing the typical beam-column connection and bracing system is provided in Fig. 2.

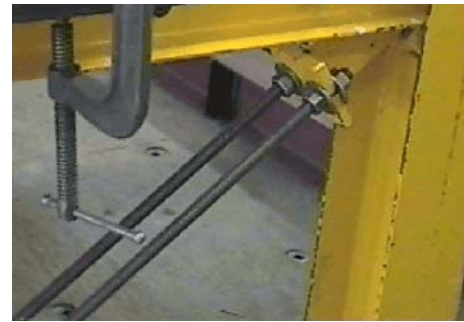
FIGURE 2: CLOSE-UP OF BEAM-COLUMN CONNECTIONS.

In each bay the bracing system consists of two 12.7 mm (0.5 in) diameter threaded steel rods placed in parallel along the diagonal. Note that the fixture connecting the braces to the structure adds a degree of flexibility to the braces. This should be considered by researchers who may consider building analytical models of the structure.

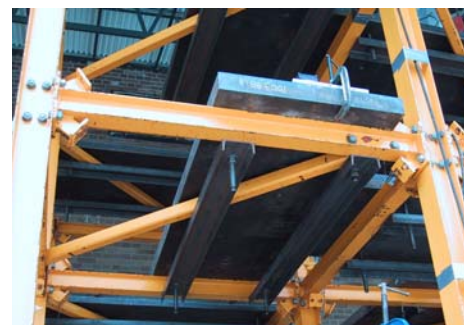
FIGURE 3: PHOTOGRAPH SHOWING MASS PLACEMENT.

To make the mass distribution reasonably realistic, one floor slab is placed in each bay per floor: four 1000 kg slabs at each of the first, second and third levels, four 750 kg slabs on the fourth floor (see Fig. 3). On each floor two of the masses were placed off-center to increase the degree of coupling between the translational motions of the structure. Additionally, the masses are fixed to the structure using two channel sections to bolt each mass to the steel frame. The mass of each channel section is approximately 9.75kg for a total of 19.5 kg per mass for two channels (see Fig. 3).

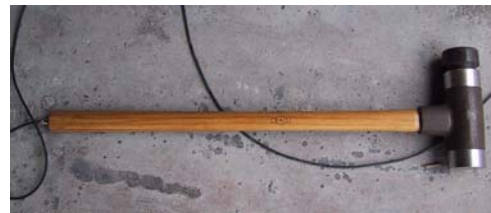
FIGURE 5: IMPACT HAMMER.

In the impact hammer tests, a Dynatron 5803A 12 lbf Impulse Hammer was used. The impact hammer has a force transducer, and this measurement was recorded during the hammer tests. The maximum force that can be provided with this hammer is 5000lbf, and a medium/soft tip was used on the hammer head during the tests. In each test a series of 3–5 hammer hits were recorded. Two impact locations were selected including a hit on the south face in the north direction, and a hit on the east face in the west direction. Both impacts were placed at the first floor of the structure in the southeast corner. See Fig. 6 for a diagram of the hammer impact locations.

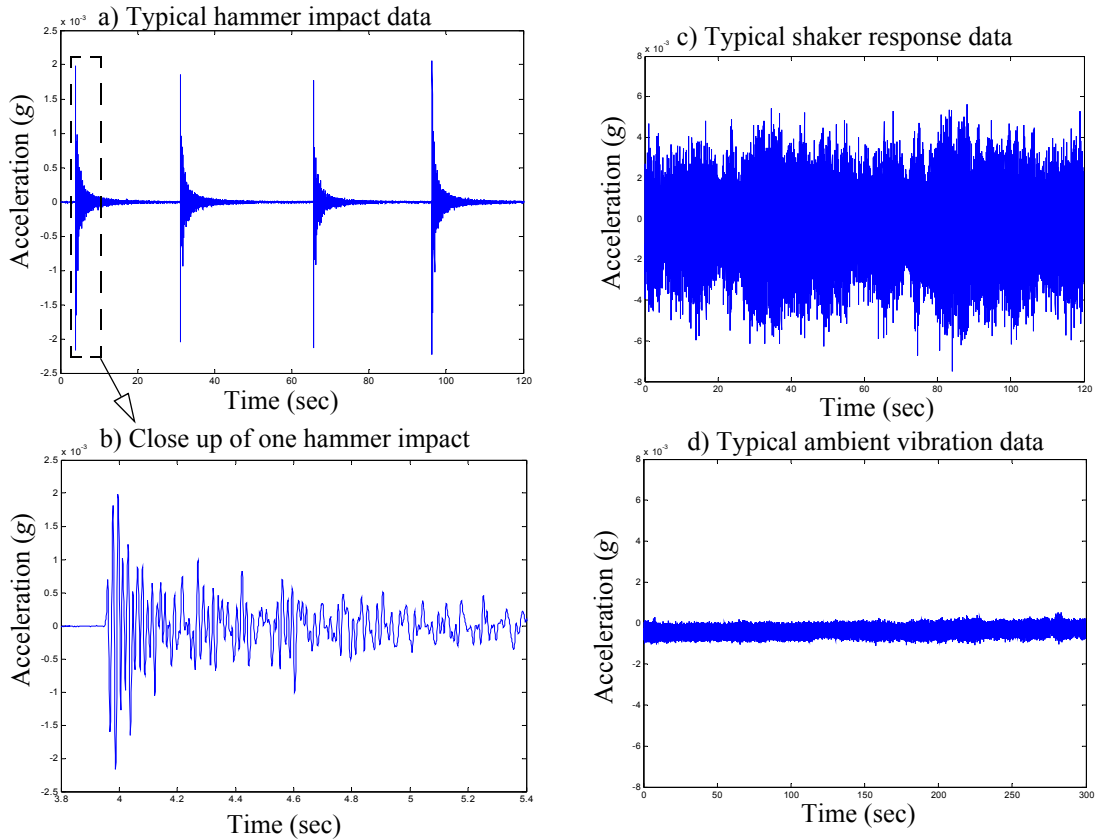
FIGURE 7: PLOTS OF REPRESENTATIVE DATA FILES (4th FLOOR, WEST SIDE, CASE 1).

In this experimental benchmark, the researcher is left to decide which cases to examine. Note that Cases 2 through 9 could each be considered as damage scenarios when Case 1 is viewed as the undamaged case. Alternatively, Cases 8 and 9 could be considered as damage scenarios when Case 7 is viewed as the undamaged case, and there are several other such comparisons that one could make. Plots showing some typical recorded data are shown in Fig. 7.
