## Experimental study of rf pulsed heating on oxygen free electronic copper

David P. Pritzkau\* and Robert H. Siemann†

Stanford Linear Accelerator Center, Stanford University, Stanford, California 94309

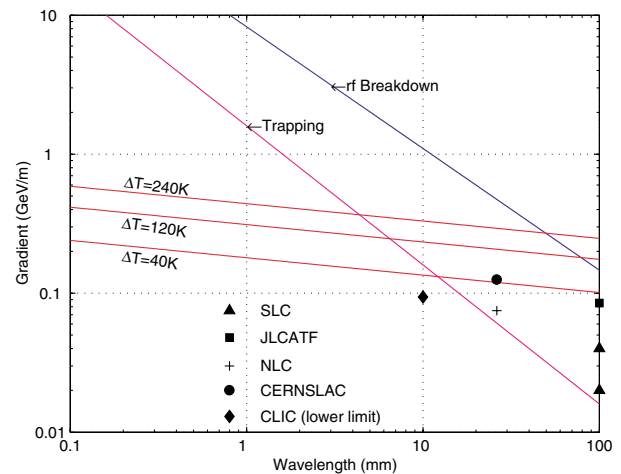
FIG. 1. (Color) Gradient limits due to rf breakdown, dark current trapping, and pulsed heating. The data points represent gradient achieved with reasonable dark current [2]. The gradient limit for pulsed heating assumes a damage threshold of  $\Delta T = 40 \text{ K}$  and is scaled from parameters of the Next Linear Collider (NLC) assuming the filling time scales as  $T_p \sim \lambda^{3/2}$ .

A plot of these limits (Fig. 1) shows that pulsed heating could become the most restrictive phenomenon at short wavelength. Recent experiments have shown that breakdown is a multifaceted phenomenon [3,4], and gradient limits are not as simple as implied by Eqs. (1). Underlying physical phenomena are complex, material properties are important, and details of the structure geometry can matter because local regions of high field or high pulsed heating may determine the overall behavior.

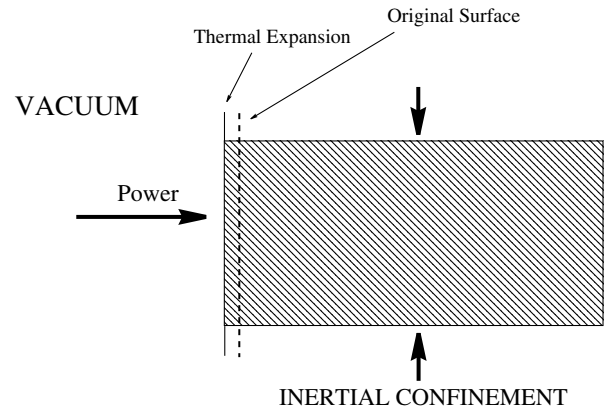
FIG. 2. Metal surface being heated with a fast high-power source [5]. The surface itself expands normally into the vacuum.

Thermal fatigue is cyclic fatigue caused by repetitive heating and cooling. Eddy currents that are developed from tangential magnetic fields on the surface will heat the surface. A simple example is shown in Fig. 2 where a fast high-power source heats the surface [5]. The heating happens quickly enough that the bulk of the metal is inertially confined and cannot expand transversely. Inertial confinement is the mechanical constraint that causes stress to occur on the surface. Using static linear elasticity with the assumptions that the transverse strain and normal stress are zero, the temperature rise at which the stress on the surface exceeds the yield stress  $\sigma_y$  is [5]

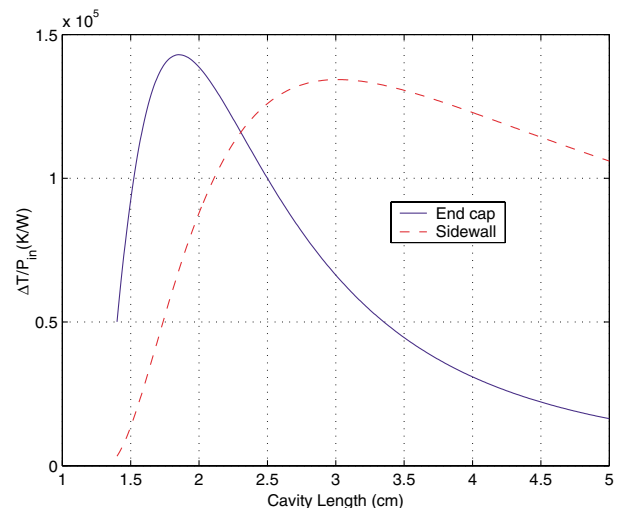
FIG. 3. (Color) Maximum temperature rises on cavity end caps and sidewall normalized to input power as a function of cavity length  $d$  at a fixed resonant frequency of 11.424 GHz. This plot does not include consideration of temperature rise at the coupling iris.

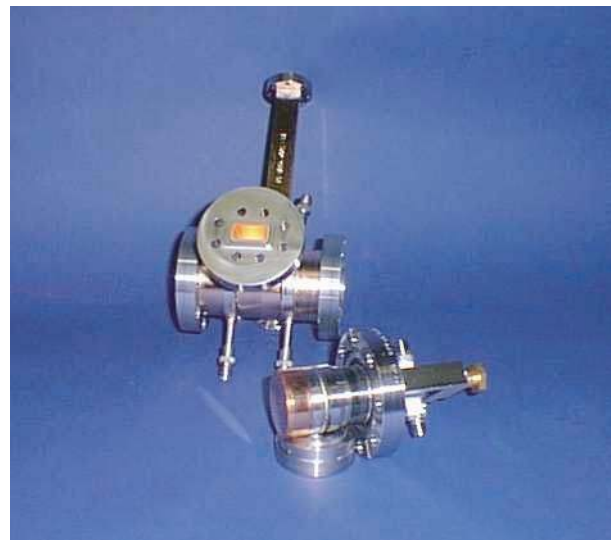
FIG. 4. (Color) A picture of the cavity body with one end cap shown on the outside. The water-cooling pipes can be seen on the bottom of the cavity body.

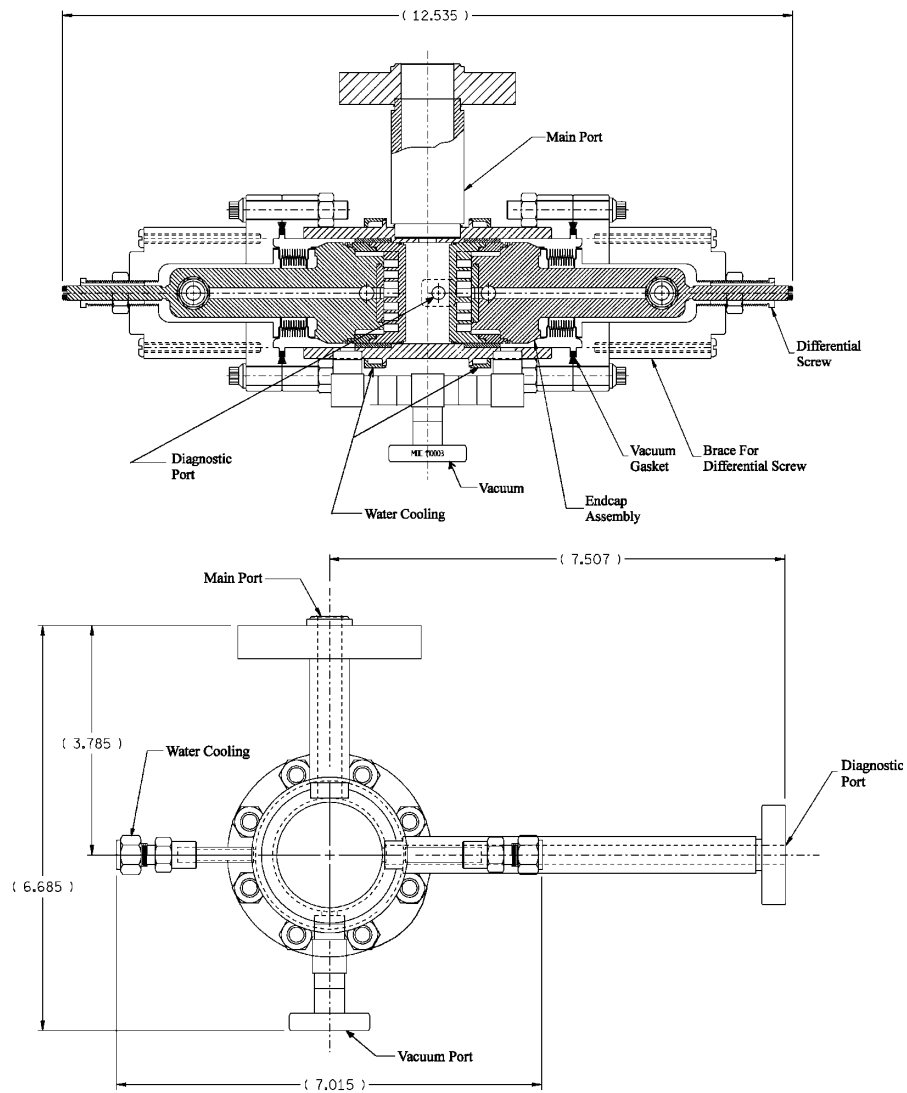
FIG. 5. Assembly schematic of cavity with end caps. The sideview of the cavity is shown on the bottom. All dimensions are in inches.

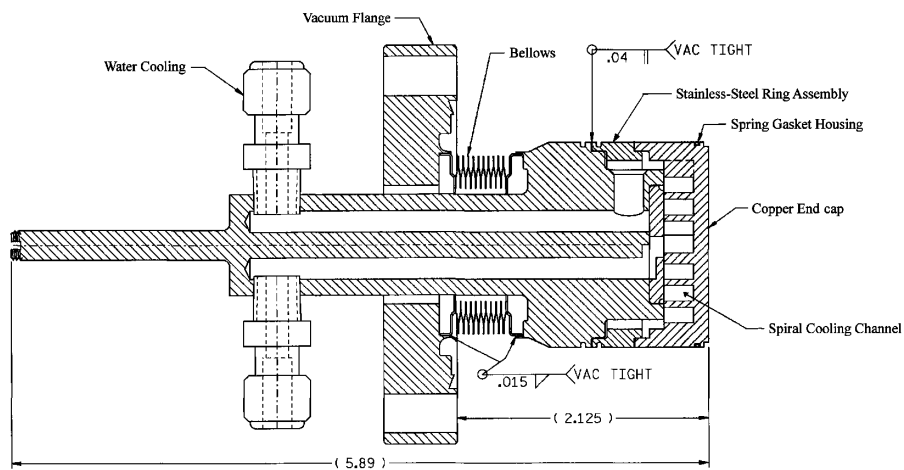
FIG. 6. Assembly schematic of end cap and piston. All dimensions are in inches.

A close-up schematic of an end cap assembly is shown in Fig. 6. The bellows and differential-screw assembly for each end cap allow fine-tuning of the cavity resonant frequency. The copper end cap is mounted onto a stainless-steel piston assembly in order to facilitate the reuse of the assembly for future end caps. A detailed assembly

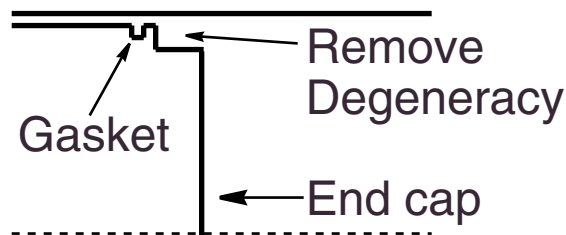
FIG. 7. Close-up of end cap with grooves. Not to scale.

Two grooves are cut along the outer radius of the end caps as shown in Fig. 7. One groove is used to remove the degeneracy between the  $TE_{011}$  mode and the  $TM_{111}$  mode as well as the degeneracy between the  $TE_{012}$  mode and

the  $TM_{112}$  mode. The TM modes require current to cross from the end cap to the cylindrical sidewall, hence their resonant frequencies are shifted by creating a gap. The gap between this groove and the sidewall is 1.1 mm. The depth of the groove was initially set to 1.0 mm. However, at this depth, there were interferences of other modes with the  $TE_{012}$  mode that prevented the temperature diagnostic from being used during the first high-power test. Using a cavity mock-up, the correct depth of the groove was empirically determined to be 2.5 mm to isolate the  $TE_{012}$  mode and this was used for the second high-power test.

The second groove houses a gold-plated stainless-steel spring gasket that becomes an rf short when compressed. The rf short prevents coaxial modes from being excited in the gap along the length of the piston and prevents rf breakdown from occurring in this gap.

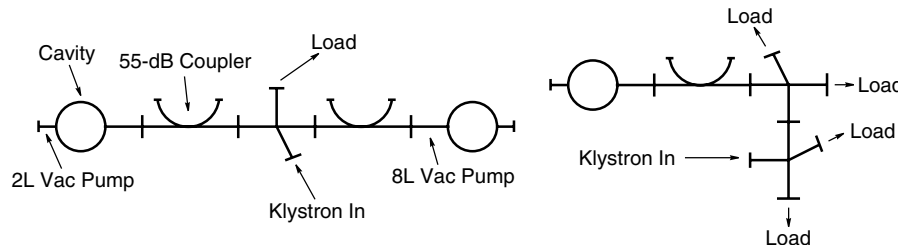
FIG. 8. Schematic of the klystron setups for the first and second high-power tests.

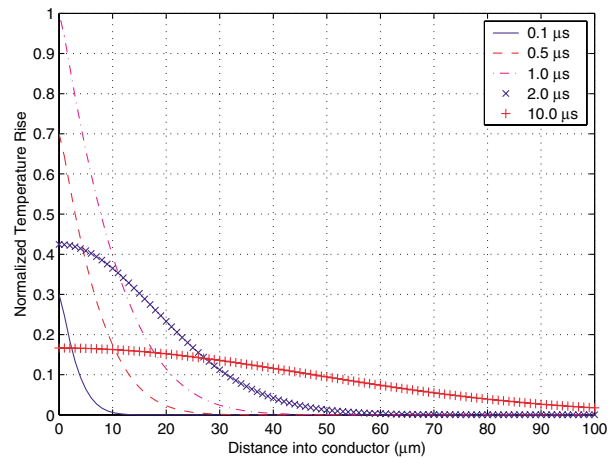
FIG. 10. (Color) The temperature rise at various times in the conductor normalized to the surface temperature at  $t = 1.0 \mu\text{s}$ , for a pulse length of  $t_p = 1.0 \mu\text{s}$ .

This is the same result if we had considered a prescribed surface heat flux  $dP(t)/dA$  with no volume energy generation. For a  $1 \mu\text{s}$  pulse, Fig. 10 shows the temperature rise on the surface normalized to the temperature rise at

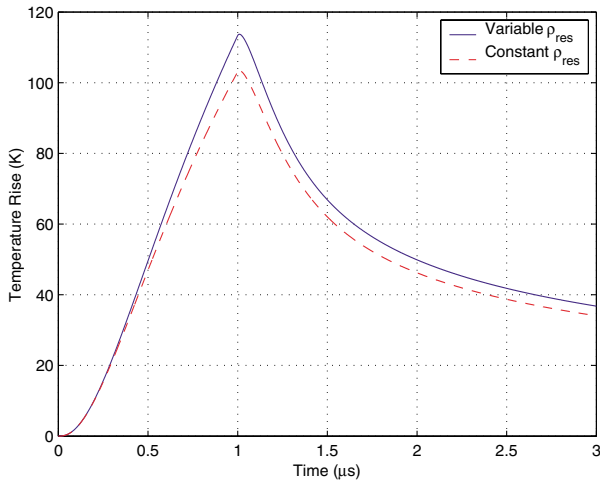
FIG. 12. (Color) Comparison of variable  $\rho_{res}$  with constant  $\rho_{res}$  on the temperature rise of the cavity end caps for a 10 MW, 1  $\mu$ s pulse.

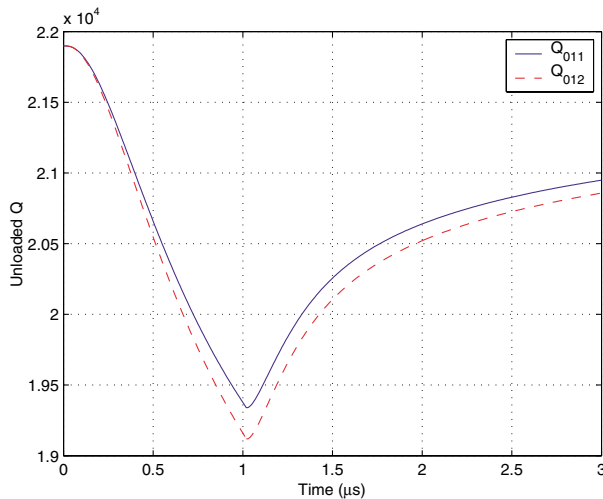
FIG. 13. (Color) Change in  $Q_0$  for both TE<sub>011</sub> and TE<sub>012</sub> modes for a 10 MW, 1  $\mu$ s pulse.

the surface. For the above example, the  $Q$  change for both modes is shown in Fig. 13.

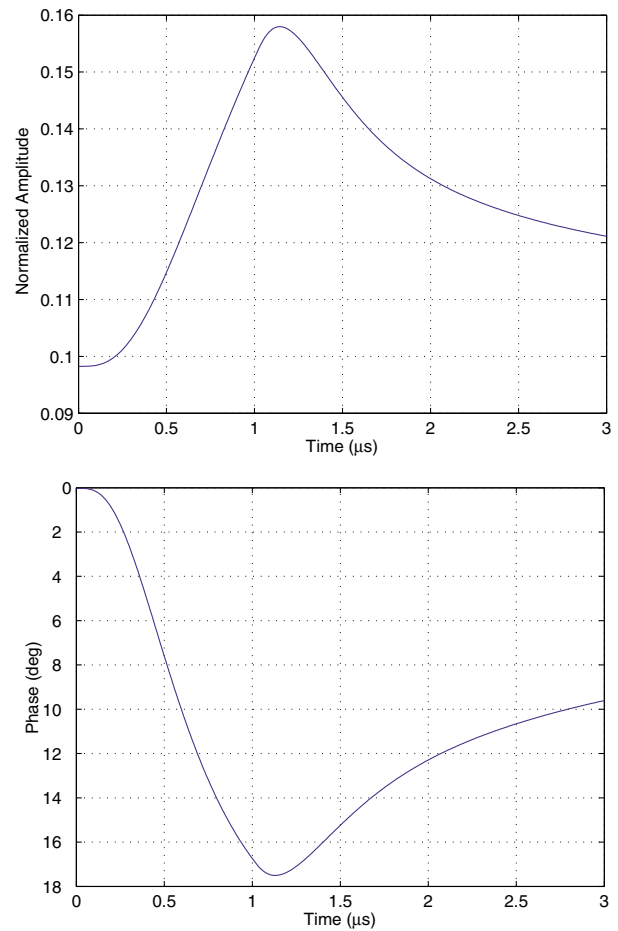
FIG. 14. (Color) Magnitude and phase of the reflected signal with respect to the input signal due to the change in  $Q_0$  of the TE<sub>012</sub> mode.

A calculation of the expected signal looking through the diagnostic port from the TE<sub>012</sub> mode is shown in Fig. 14 for a 10 MW, 1  $\mu$ s pulse. In this case, we have assumed coupling through the diagnostic port of  $\beta = 1$ , and, in addition, leakage out the high-power port with coupling  $\beta = 0.22$ . It is to be noticed that the extrema of these curves occur some time after the pulse shuts off. This lag time is on the order of the cavity fill time.

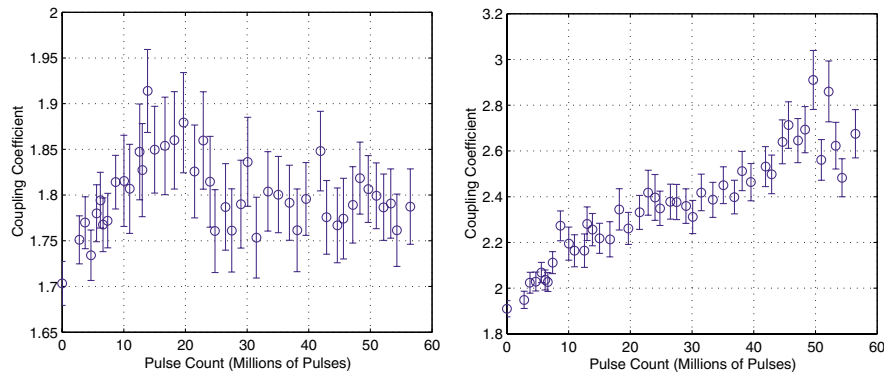
FIG. 15. (Color) Variation of  $\beta$  for cavity 1 (left panel) and cavity 2 (right panel) as a function of pulse count at a 120 K temperature rise on the end cap surfaces. The errors shown are due to random errors only.

full power, become mismatched to each other and, in addition, mismatched to the klystron output cavity. This problem became worse over time as  $\beta$  for cavity 2 increased. These mismatches mixed together the characteristic decays, and the variations of  $Q_L$  and  $Q_0$  during the experimental run could not be determined [17]. However, the trend in Fig. 15 with the data in Table VI shows a clear degradation of  $Q_0$  for each cavity.

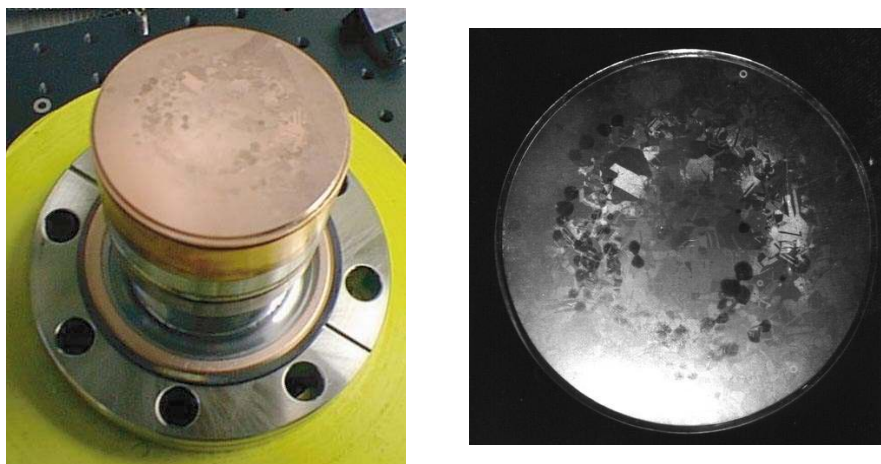
FIG. 16. (Color) Picture of one end cap from the first high-power test. A change in the crystal grains is visible even in the region where the temperature rise was lower by 10%. The region of the end cap nearest the high-power coupler is on the lower left in the right-hand picture. Tarnish from the sputtering of copper is on the lower part of the end cap.

the crystal grains in the region where the temperature rise is maximum, which is approximately halfway between the center and outer radius of the end cap. In this area in which there is high-amplitude cyclic straining, steps may form in crystal grain boundaries with height differences on the order of microns [18]. This would change the direction of light specularly reflected from the surface, which will cause a contrast between the grains in the fatigued area as compared to the rest of the surface.

Also visible on the surface are black patches that appear on the half of the end cap that is closest to the high-power coupling aperture. These patches are most likely due to multipacting as they appear to occur in pairs. Electrons would orbit around the radial magnetic field lines along the end cap. According to GDFIDL simulations, the maximum magnetic field on the end cap at the azimuth of the high-power coupling aperture is 5% higher than the point diametrically opposite of it. Since the

energy of multipacting electrons is restricted, this could explain why the patches occur only on half of the end cap surface nearest the high-power coupling aperture.

There is also a tarnish visible on the surface. The tarnish is thicker at the outer radius and at the azimuth closest to the high-power coupling aperture. As will be shown in the next section, scanning electron microscope studies show this tarnish to be copper globules that were sputtered onto the surface. Because these globules may add to the surface roughness of the cavity, they may contribute to the degradation in  $Q_0$  shown in Table VI.

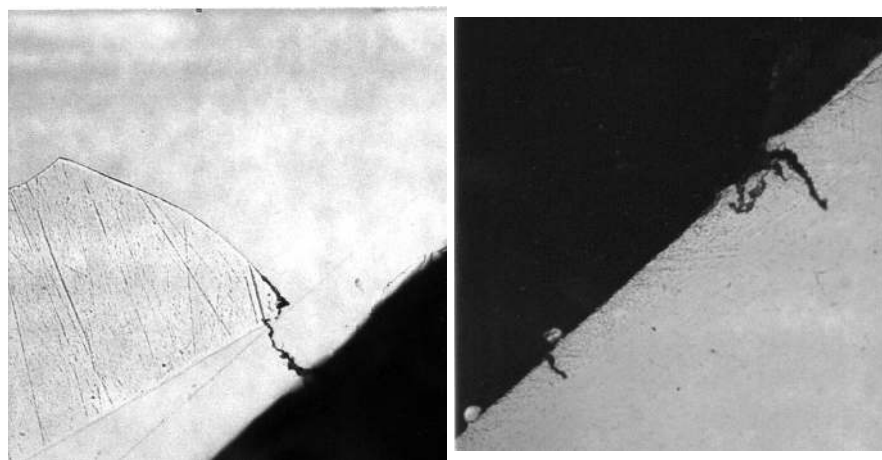
FIG. 17. An internal cross section of one end cap in the region of maximum temperature rise on the surface. The end cap surface is the boundary between the white and black regions of the pictures. The crack on the left propagated  $25\ \mu\text{m}$  into the surface before reaching an internal grain boundary. The crack on the right propagated  $15\ \mu\text{m}$  into the surface.

Cracks nucleated at the surface may propagate into the interior of the metal. One end cap was cut internally along a diameter and polished to view its cross section. Cracks were only found near the area of maximum temperature rise. Less than ten cracks were visible at a microscope magnification of 1000 and only two cracks are longer than  $10\ \mu\text{m}$ . These cracks are shown in Fig. 17. These cracks were first created at the surface and then propagated internally, because higher stresses and strains occur at the surface than in the interior of the metal [19]. Only a few cracks will propagate internally as compared to the amount of cracks that are nucleated at the surface.

Slip will occur when the shear stress along a slip plane is above a critical value [11]. Since the normal stress axis occurs parallel to the end cap surface, the maximum shear stress occurs along a plane inclined at  $45^\circ$  to the surface. Since the end cap is made from polycrystalline copper, only grains that have slip planes oriented close to this angle will show slip if the stress is large enough. The cracks in Fig. 17 begin propagating at roughly  $45^\circ$  to the

surface within the first few microns into the surface, which is known as stage I crack propagation. Also seen to occur is stage II crack propagation in which cracks propagate perpendicular to the surface and perpendicular to the stress axis [18].

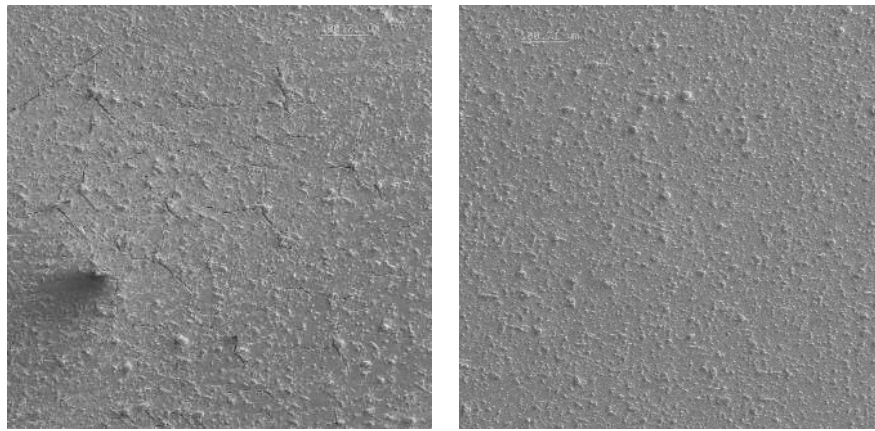
FIG. 18. Comparison snapshot of a region of maximum temperature rise on the left and a region of zero temperature rise on the right for one end cap. The length scale is  $100.7 \mu\text{m}$ .

Each end cap was inspected with a scanning electron microscope using secondary scattering with a 5 kV beam. First, scans were taken along a random diameter of each end cap. Cracks are visible only in the region where the maximum heating occurred at a radius of 10.6 mm. The thickness of this region is approximately 4 to 5 mm for each end cap. No other damage is visible on the surface.

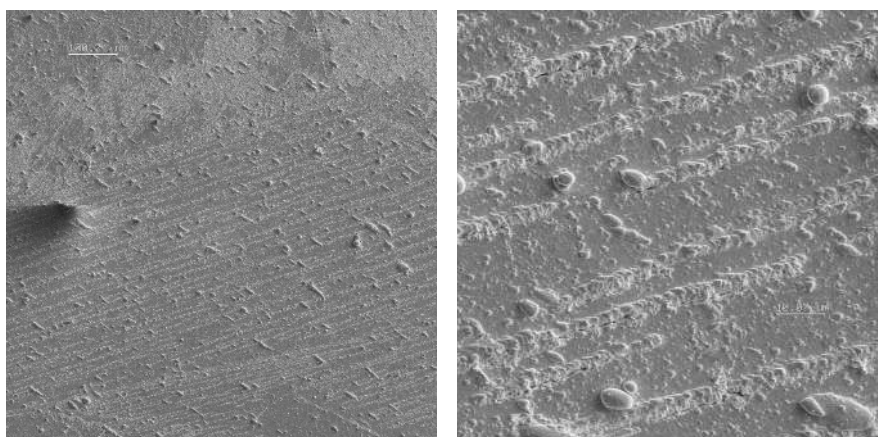
FIG. 19. Fatigue slip bands on a particular crystal grain in the area of maximum temperature rise. The picture on the right is a close-up of these slip bands in which some microcracks are evident at the base of the slip bands. The scale is  $100.7 \mu\text{m}$  on the left and  $10.1 \mu\text{m}$  on the right.

As mentioned earlier, some crystal grains will show signs of slip if they have the proper orientation. Figure 19 shows an example of these slip bands as striations on the surface. Slip bands are created from stress relaxation of the surface due to plastic deformation, which results in

surface intrusions and extrusions. Surface intrusions create a notch effect for possible nucleation of microcracks as demonstrated on the right of Fig. 19 [18]. In general, crack propagation along the surface is perpendicular to fatigue striations [19].

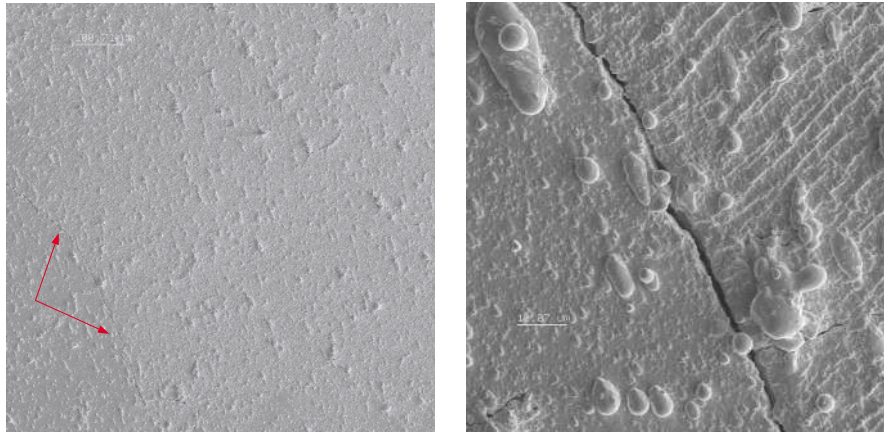
FIG. 20. (Color) Grain-boundary cracks in the area of maximum temperature rise. The grain boundary is the transition between the two different textures on the surface shown by the red arrows. The texture on the right-hand side of the picture on the left is due to slip bands. A close-up of one crack is in the right-hand picture where the grain boundary is clear. The length scales are  $100.7 \mu\text{m}$  and  $10.1 \mu\text{m}$ , respectively.

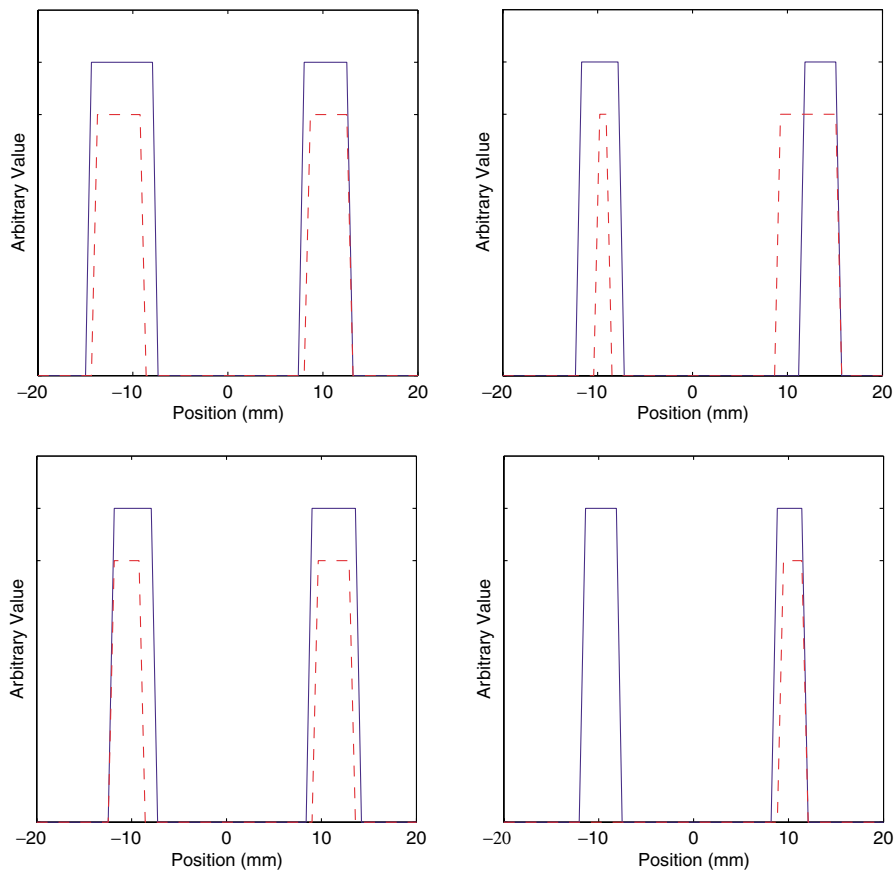
FIG. 21. (Color) Random scans along diameters of each end cap. The solid lines correspond to regions of surface roughening and the dotted lines are for regions that contain cracks on the surface. The centers of the end caps are at position 0 mm.

In general, the scans indicate that surface roughening from fatigue is a precursor for crack nucleation, because most of the regions containing cracks are within the regions of surface roughness. Also, the bands generally surround the expected area of maximum temperature rise at the radius of 10.6 mm. The widths of these regions are listed in Table VII. The variation in the widths of damage reported in Table VII among each end cap is due to the location of the scanned diameter with respect to the azimuth of the high-power coupling aperture. The widths are generally larger when the scanned diameter is closer to the aperture. This feature is largely explained by the

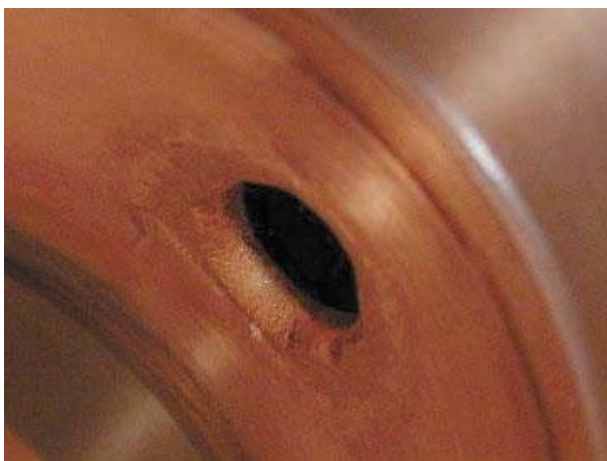
FIG. 22. (Color) A picture of the high-power coupling aperture of cavity 1 after the first high-power test. The aperture has been rounded in the direction of the magnetic field. The electric field has caused pitting to occur on either side of the aperture at right angles to the rounding.

There was damage to the high-power coupling apertures that provided unexpected information about temperature limitations from pulsed heating. Figure 22 shows that significant damage has occurred to the high-power coupling aperture of cavity 1. Simulations using the computer code HFSS [20] show that the strength of the magnetic field on the aperture will cause a temperature rise of 250 K. The magnetic field wraps around the edge of the aperture and is enhanced. The damage on the aperture occurs at this spot. The electric field is generally azimuthal except near the aperture in which it is curved towards the surface. The electric field at the aperture is approximately 85 MV/m, which is sufficient to cause rf breakdown. Pitting has occurred at this spot.

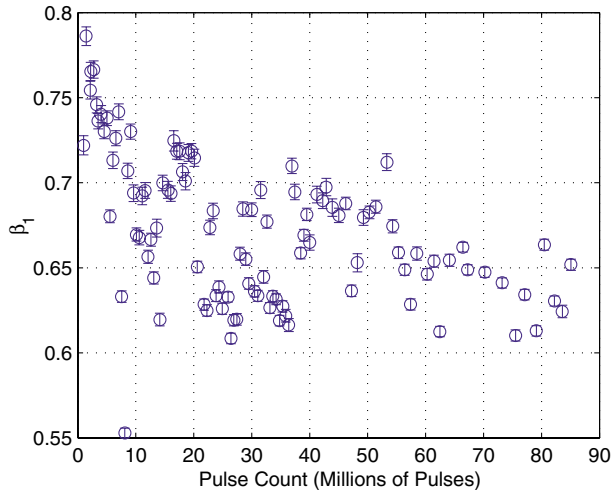
FIG. 23. (Color) Measurement of  $\beta_1$  during the high-power test for the  $TE_{012}$  mode.

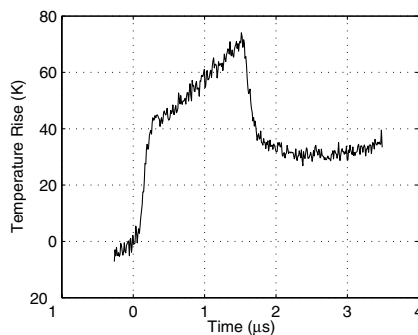
FIG. 24. Measured and theoretical prediction of maximum temperature rise on the end caps during a high-power pulse. Changes in amplitude and phase of the reflected  $TE_{012}$  power are assumed to be caused by temperature rise alone in this measurement. There is discussion of this assumption in the text. The theoretical prediction is based on a 7.3 MW power input. The rf pulse is initiated at time 0  $\mu$ s.

Figure 24 shows the measured maximum temperature rise on the end cap along with the theoretical prediction based on an input power of 7.3 MW. The maximum temperature rise is 72 K. This measurement has random and systematic errors. The random errors are associated with residual noise on the waveforms. The systematic errors arise from the error in the resistivity of the end caps reported in Table XI, and the difference between the shapes of the measured and theoretical temperature rises in Fig. 24. Those differences are as follows.

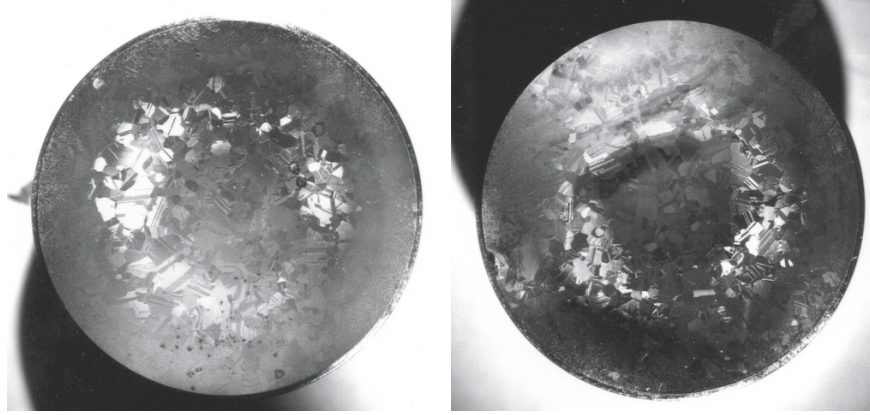
FIG. 25. Surfaces of end caps 1 (left panel) and 2 (right panel) after the second high-power test. The position of the high-power coupling aperture relative to the pictures is the top of end cap 1 and top left of end cap 2.

As with the first high-power test, an obvious visual change in the grains of both end caps is shown in Fig. 25.

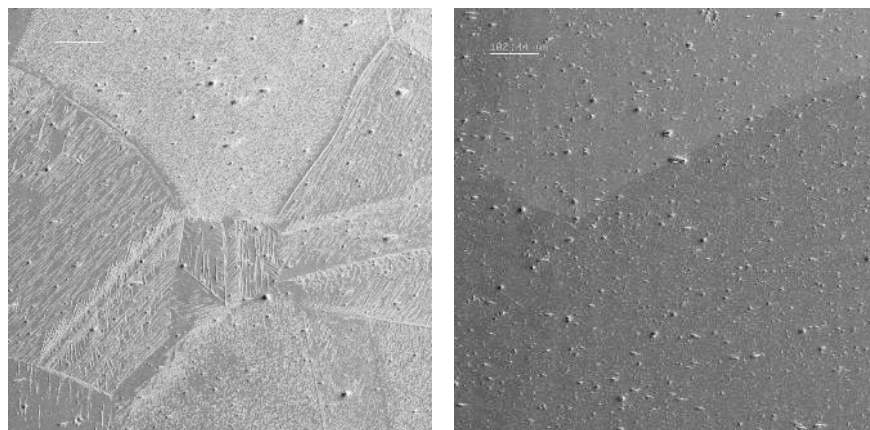
FIG. 26. A comparison between a region in the area of maximum temperature rise (left panel) and the center of the end cap in which the temperature rise is close to zero (right panel). The length scale is 100.7  $\mu\text{m}$ .

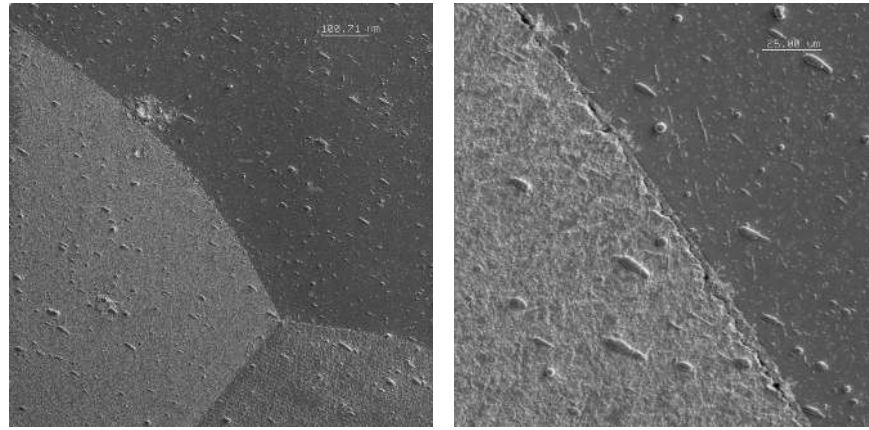
FIG. 27. Grain-boundary cracks in the area of maximum temperature rise. The grain boundary is the transition where the whitening due to slip bands stops. A close-up of one crack is on the right where the grain boundary is clear. The length scales are  $100.7 \mu\text{m}$  and  $25.0 \mu\text{m}$ , respectively.

The results from this experimental run indicate that cracks occur only along grain boundaries. Grain boundaries are clearly seen between areas that contain fatigue slip bands and areas that do not have them. Figure 27 shows such a case in which a crack clearly occurs along a grain boundary in the area of maximum temperature rise. Cracks tend to nucleate at grain boundaries due to

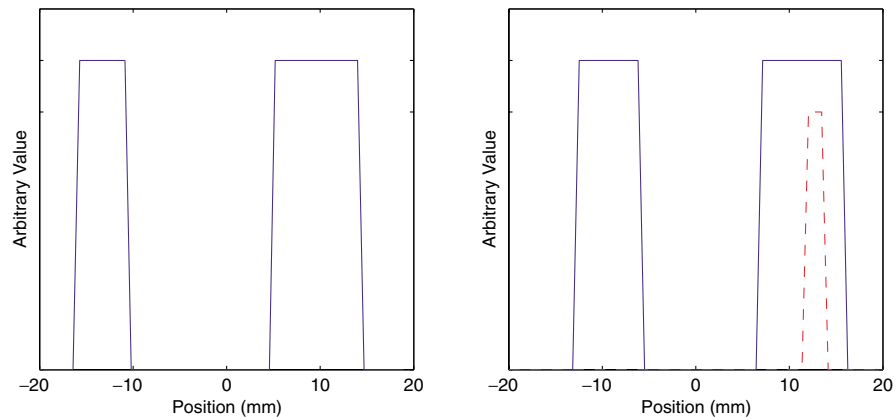
FIG. 28. (Color) Random scans along diameters of each end cap. The solid lines correspond to regions of surface roughening and the dotted lines are for regions that contain cracks on the surface. The centers of the end caps are at position 0 mm.
