Experimental study on the properties of modern blue clay brick for Kaifeng People's Conference Hall

This article presents building assessment research comprising on-site inspections, indoor scientific tests, and material performance studies on the wall blue clay bricks in the Kaifeng People's Conference Hall, objectively developing an enhanced scientific understanding to renovate modern buildings. Using X-ray diffraction (XRD), scanning electron microscopy (SEM), alongside a parametric study of density, moisture content, water absorption, void ratio, frosting, compressive strength, and softening coefficient in assessing the material health of the blue clay bricks and its non-key parts, in developing "appropriate and compatible renovation" to repair contemporaneous buildings. The composition, pore characteristics, weathering degree, and mechanical properties of the blue clay brick samples were analyzed. These parameters showed that blue clay brick fired at less than 1000 °C; the main mineral composition as quartz, followed by albite, mica, and anorthite. Its density was 1.573 g/cm³, less than the 1.70 g/cm³ of ordinary clay brick. According to the standards, the water absorption wa

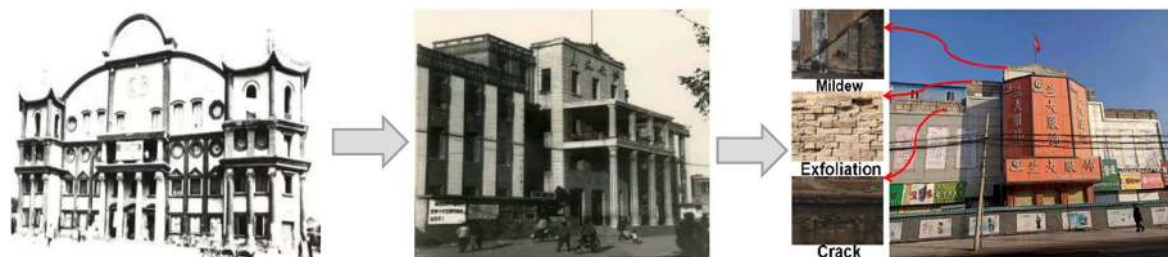
Figures 1–3. **Figure 1** Early completion of construction. **Figure 2** Transformation by posterity. **Figure 3** Expansion of shops outwards.

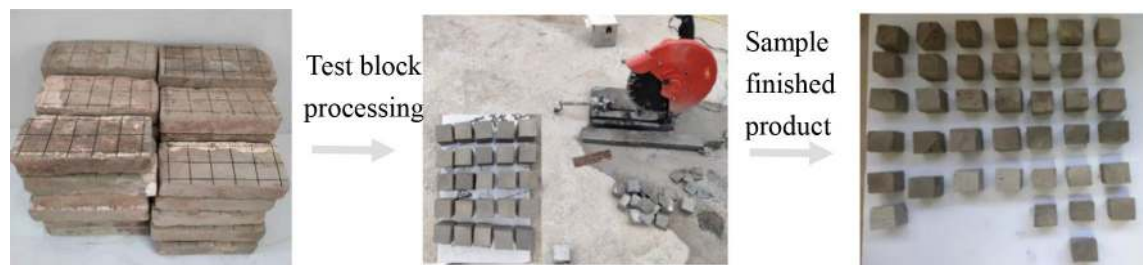
Preparation of the test samples. The samples came from partially blue clay bricks on the walls of the Kaifeng People's Conference Hall. Before performing various basic performance tests, the blue clay bricks were pretreated, and Fig. 4 shows some of these bricks. First, we removed the floating dust and mortar remaining on the brick surfaces, and then using a marker, drew a small grid of 50 mm × 50 mm on the cleaned surfaces. Then, following "Material for maintenance and conservation of historic architecture-Grey brick" (WW/T 0049-2014), the blue bricks were cut along the small grid drawn, using a cutting machine (see Fig. 5). Finally, cut and polished the blue bricks to make 50 mm × 50 mm × 50 mm cube samples (as seen in Fig. 6).

Figures 4–6. **Figure 4** Brick samples. **Figure 5** Specimen cutting and grinding. **Figure 6** Sample finished product.

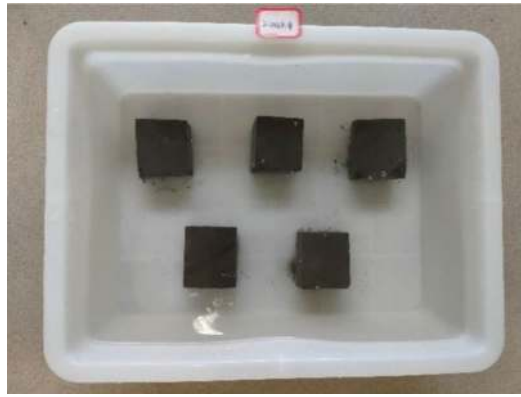
Figure 7. Samples soaking for 24 h.

Experimental method. According to the specifications in “Test Methods for Wall Bricks” GB/T 2542-2012, we took five pieces of 50 mm × 50 mm × 50 mm cube samples, cleaned the samples’ surface with a brush, and numbered them; the numbers were A₁–A₅, respectively. First, we weighed the mass m_0 of each sample in the natural state. Next, placed the sample in a blast drying box set to 105–110 °C to dry to a constant mass m_1 after drying. Next, immersed the dried sample in water at 10–30 °C (as shown in Fig. 7) and took it out after 24 h for repetitive weighing until the difference between three consecutive measurements was less than 0.2% (as shown in Fig. 8), and recorded its mass m_{24} .

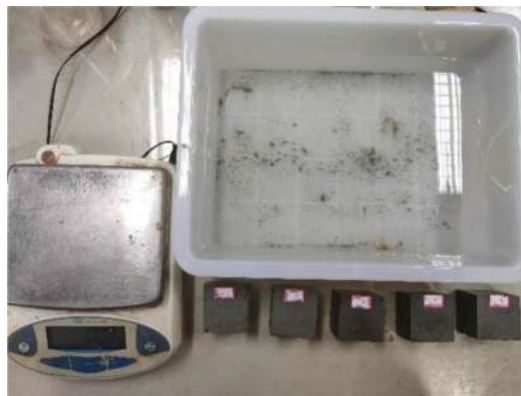
Figure 8. Weighing of test samples.

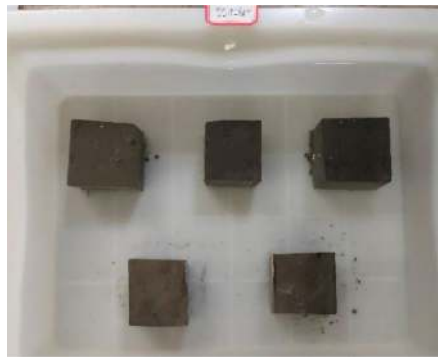
Figure 9. State of dry saturated samples.

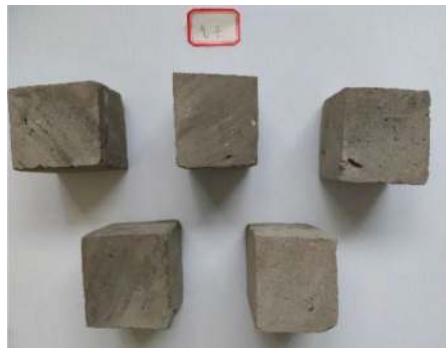
Figure 10. State of air-dried samples.

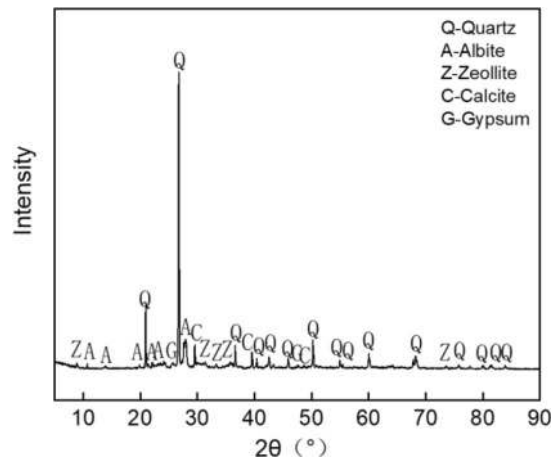
Figure 11. XRD pattern of ordinary sintered red brick.

Phase analysis. We combined the drawing tools to draw the mineral composition diagram (as shown in Figs. 11, 12). Figure 11 indicated that the main mineral composition of ordinary sintered red bricks was quartz, but it also contained albite, zeolite, calcite, and gypsum. Similarly, the annotated Fig. 12 (for blue clay brick) illustrates that quartz's diffraction peaks were 20.8°, 26.6°, 36.5°, 39.4°, 40.3°, 42.4°, 47.5°, 50.1°, 55.3°, 60.9°, 64.0°, 68.1°, 68.3°, 73.5°, 77.6°, 81.2°, 81.5°, and 84.972°. The diffraction peaks for albite were 22.1°, 23.5°, 27.9°, 28.7°, and 29.4°. The diffraction peaks for anorthite were 31.2° and 45.4°. The diffraction peaks for mica were 8.8° and 24.1°. Hence, the main mineral composition of the blue clay brick was also quartz. In addition to quartz, it also contained albite, mica, and anorthite. There were no high-temperature sintered products of mullite and cristobalite; hence the sintering temperature did not exceed 1000 °C^{44–51}.

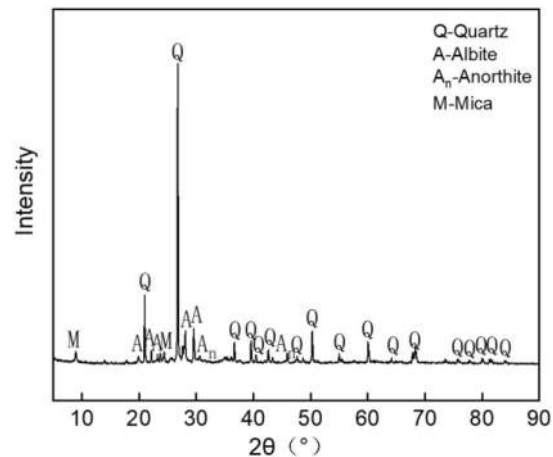
Figure 12. XRD pattern of clay blue brick sample.

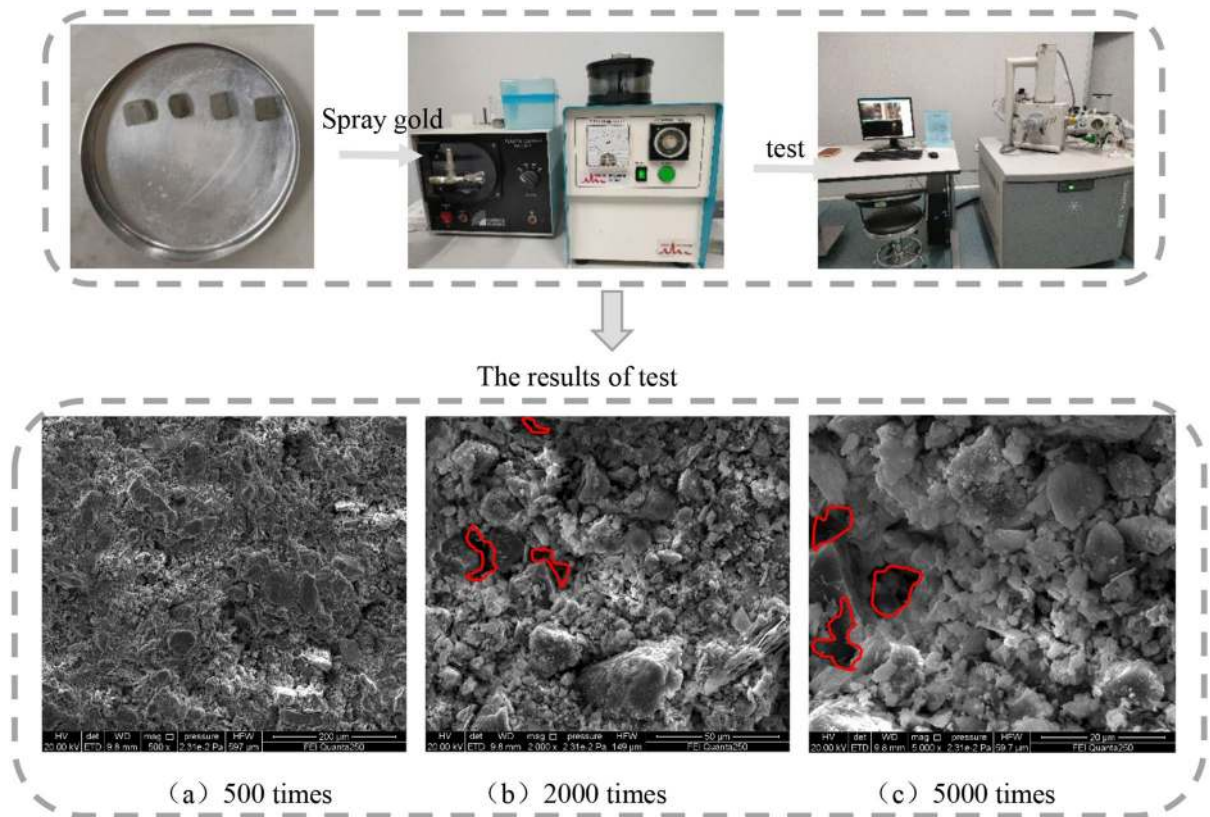
Figure 13. Specimen electron microscopy results.

Characteristics of pore. The pore characteristics of the sample are seen as electron micrographs in Fig. 13, at increasing magnifications of 500×, 2000×, and 5000×. These magnified images of the blue clay sample show that the internal pores have prominent characteristics, mainly the particle structures, and the pores between the structures are significant, as shown by the red outlines. In addition, we observed many fine holes between the particles in the brick body, which are the main internal factors that cause the poor frost resistance and sulfate erosion resistance of the blue bricks. At the same time, it was noted that the internal particles of the sample were of varying sizes, with fewer large particles, significantly more small particles, and higher density. Therefore, based on the above analysis, we saw evidence that the blue clay bricks of the Kaifeng People's Conference Hall wall were of high quality.

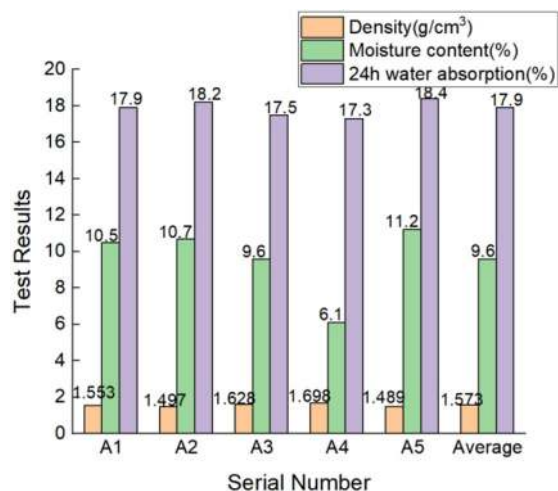
Figure 14. Bar charts of density, moisture content, and water absorption of each sample.

The calculated results for each sample's density, moisture content, and 24 h water absorption are shown in the bar charts in Fig. 14; A1–A5 are the five sample numbers.

The test results in Fig. 14 show that the density for the five samples ranged from 1.489 to 1.698 g/cm^3 , with an average value of 1.573 g/cm^3 . The density of the five samples and the average result was lower than the density value of 1.70 g/cm^3 of standard clay bricks. Under the natural environmental forces on the wall for nearly a 100 years, affected by weathering, there were many pores in the brick body so that the compactness of the sample had slightly reduced. The water content of the five samples was 6.1 – 10.7% , and the water absorption was 17.3 – 18.4% . The water absorption of five samples was partially lower than the average value of “Sintered Ordinary Brick” (GB/T 5101-2017) (18%), but some of them reached more than 18% , with an average value of 17.9% . Although it was close to the average value (18%) of “Sintered Ordinary Brick” (GB/T 5101-2017), the water absorption was slightly higher. In addition, from the bar charts, it was seen that the higher the density for the same sample, the lower the water content and water absorption, which reflected that the denser the material and the smaller the internal porosity of the material.

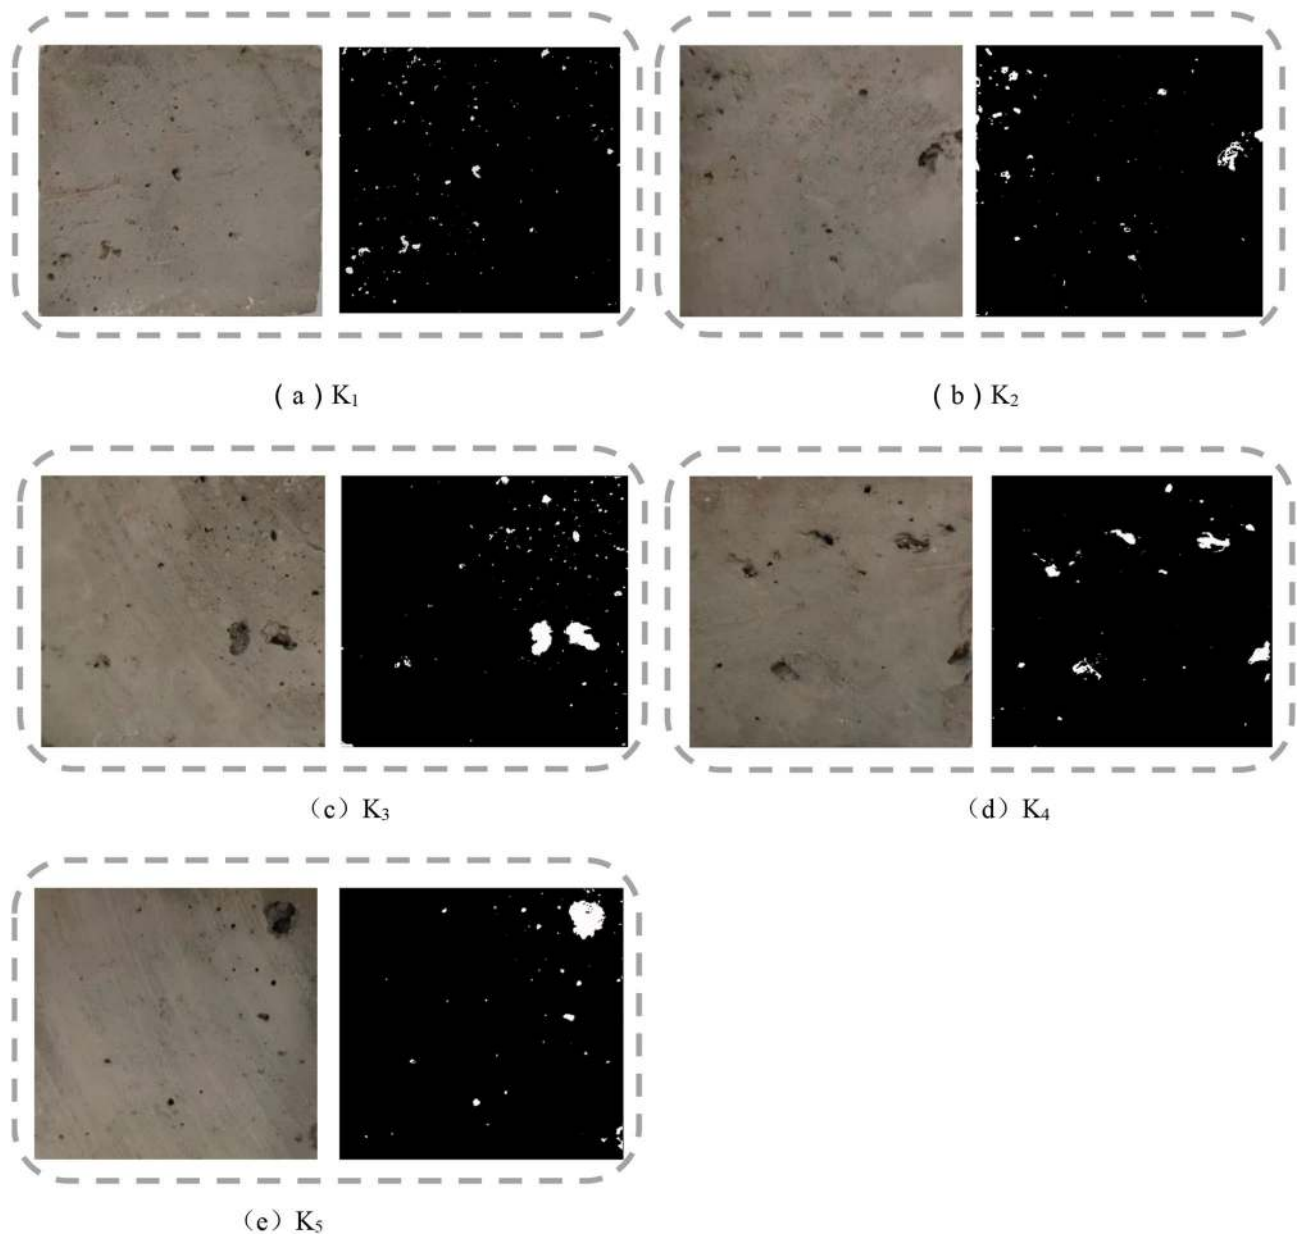
Figure 15. Hole inside the sample.

The measured results were summarized (as shown in Table 1). In addition, the internal pore diagram of the sample (as shown in Fig. 15) are respectively the samples of K₁–K₅. The calculated result of the void ratio for each sample was represented by a bar chart (as shown in Fig. 16).

The first picture shows the surface of the brick sample in Fig. 15a–e. In order to make readers see the holes on the surface of the brick more clearly, the second picture outlines the surface of the brick, highlighting the position and shape of the holes in white.

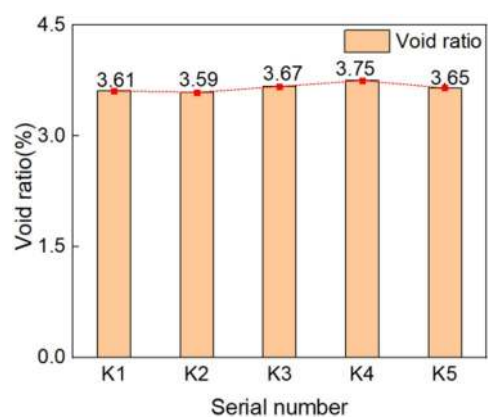
Figure 16. Void ratio histogram.

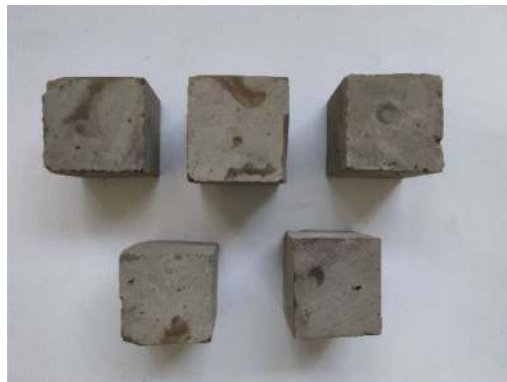
Figure 18. Evidence of sample frosting.

Frost test results and analysis. The frosting test process and test samples are seen in Figs. 17 and 18. According to the “Test Method for Wall Bricks” (GB/T2542-2012), the evaluation standard of the degree of frosting, combined with the test results, we noticed small but yet noticeable frost film appeared on the sample surface, but the surface of the sample was still seen; hence the sample frosting was assessed as ‘slightly frosted’.

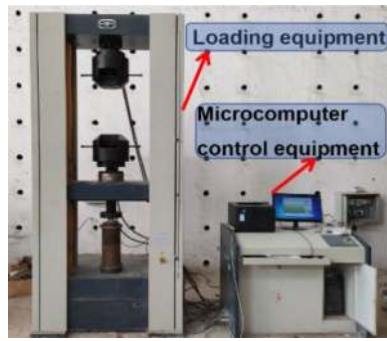
Figure 19. Microcomputer controlled testing machine.

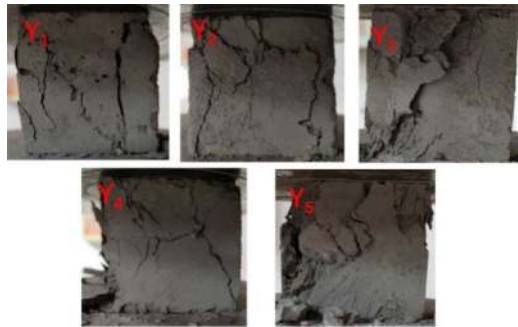
Figure 20. The sample failure forms at ultimate load.

Compressive strength test results and analysis. *Experimental phenomenon.* At the commencement of loading, slight cosmetic cracking appeared at the edges and corners of the test samples. The initial crack direction was mainly vertical or slightly oblique. With the continued increase of the vertical load, the internal stress in the sample concurrently increased, the width of the micro-cracks formed at the initial stage of loading increased, the cracks continued to extend along the direction of the initial cracks, and simultaneously new cracks were gradually formed. When the load was approaching the ultimate load, the vertical surfaces of the specimen began to fall off locally. When the load reached the limit load, the crack width of the sample further increased, the sample’s surface is locally peeled off, the load-bearing capacity dropped rapidly, and the sample failed. The test equipment is seen in Figs. 19 and 20. During the loading process, the sound of the specimen being crushed was audible.

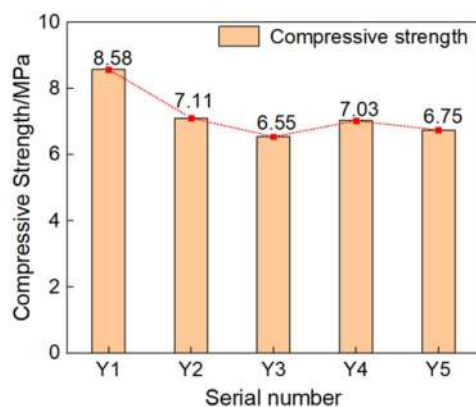
Figure 21. Bar chart of compressive strength of each sample.

The compression test results are in Table 2 and further illustrated as a bar chart in Fig. 21. The stress σ of blue brick material was the load value divided by the cross section area of the sample. That's the forced per unit area. The strain ε of blue brick material was obtained by passing a strain gauge on the side of blue brick. The strain gauge was connected to the strain tested by a half-bridge connection, and the micro-deformation can be obtained through the signal acquisition and data processing of the strain tested. The specific method was that the material strain gauge was respectively arranged at the lateral center point of the uniaxial compression sample. In the process of sample loading test, the relationship between the force and deformation of the brick material was obtained by real-time monitoring. The curve of specific test results is shown in Fig. 22.

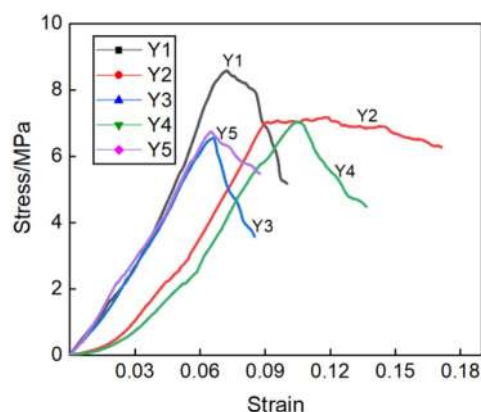
Figure 22. Stress–strain curves of test samples.

Using the slope of the two points on the graph corresponding to 0.6 times the ultimate strength and 0.3 times the ultimate strength in the stress–strain curve, the elastic modulus of the sample was calculated as 789.8 MPa. Test results in Fig. 21 show that the strength grade of the blue clay brick was less than MU10 for standard sintered brick, and the strength did not meet the relevant requirements specified in the current masonry code, nor did it meet the criteria in the masonry seismic code. The current compressive strength value did not indicate the initial mechanical performance indicators of the blue clay brick. The brick-making technology of a hundred years ago was known to be exquisite, but the blue clay brick tested was severely weathered through the long-term

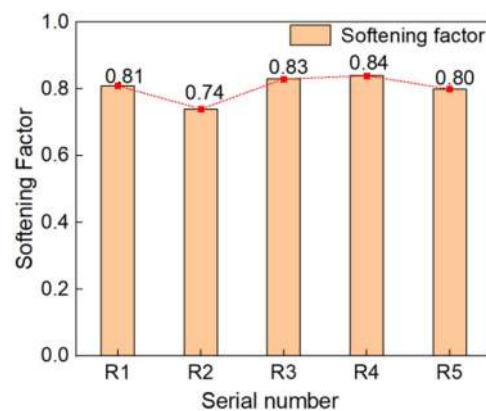
Figure 23. Histogram of softening coefficient of each sample.

Softening coefficient test results and analysis. The results of the softening coefficient of the blue clay brick samples are given in Table 3. The results of the softening coefficient of each test sample were illustrated as a bar chart in Fig. 23. It was evident from the test results that the average softening coefficient of the blue clay brick sample was 0.80, and results ranged between 0.70 and 0.85. Therefore, the water-resistance of the blue clay brick was good. Kaifeng is located in the Central Plains, with rainy summers and cold winters. After nearly a hundred years of wind and rain erosion, the water-resistance of the blue clay brick had remained good. Although the cur-
