Experimental Study on Ultrasonic Monitoring of Splitting Failure in Reinforced Concrete

Abstract This paper investigates inspection of reinforced concrete elements sensitive to the splitting failure. The behaviour of a reinforced concrete specimen subjected to a tensile stress is considered. The damage detection procedure is based on the ultrasonic wave propagation technique. The piezoelectric transducers are located on both ends of the specimen and the measurements are taken periodically during the incrementally increased loading. The features of measured signals in time and frequency domains as well as wavelet transforms before and after the splitting failure are studied. The experimental results show that proposed method can be used for monitoring of damage evolution in concrete elements. The method makes possible detection of the moment just before the splitting failure occurs.

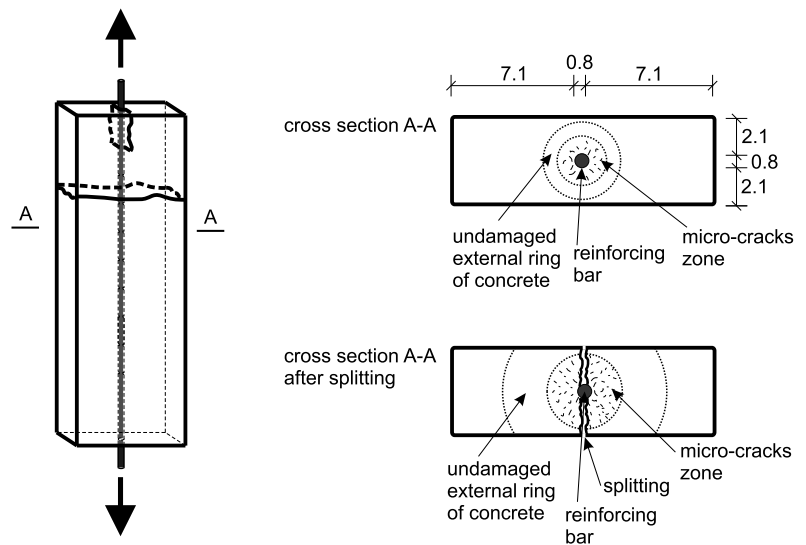
Fig. 1 Considered concrete specimen in tension and sketch of formation of micro-cracks before and after splitting (dimensions shown in cm)

The splitting failure is a complex phenomenon that can lead to a collapse of a whole concrete element. Sensitive to the splitting failure are elements with reinforcement bars in tension with high bound stresses like anchorages with limited transverse pressure, heads of pre-stressed, pre-tensioned thin webbed beams [18]. The splitting failure of concrete elements is caused by a local collapse of the bond between steel bars and surrounding concrete. During loading, at first stage, radial micro-cracks develop in a limited zone around the reinforcement bar. The external ring of undamaged concrete provides sufficient confinement that prevents splitting. At large external loads the undamaged external ring becomes too thin and cracks spread through the element. When the splitting failure occurs the bond between the reinforcement and concrete is lost and cracks are wide open resulting in significant reduction of loading capacity. Problems of the bond and the splitting failure have been investigated by many researchers, e.g. [18–20]. Gambarova et al. [18] carried out tests on the concrete splitting along an anchored bar subjected to a pull-out force. Numerical analyses of the bond splitting failure were conducted by Ogura et al. [19]. Gálvez et al. [20] presented an experimental study on the bond-splitting in precast prestressed concrete during the release of a prestressing force. They examined the longitudinal splitting of the concrete specimens of dimensions $40 \times 6 \times 6$ cm with one wire of diameter 4 mm embedded longitudinally in the specimen. The release of the load in the wire caused the longitudinal splitting of the concrete prism.

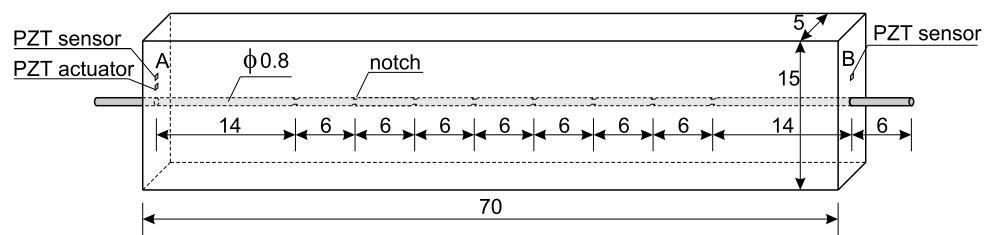
Fig. 2 Geometry and dimensions of the tested reinforced specimen (dimensions shown in cm)

The concrete specimen with cross-section of $5 \text{ cm} \times 15 \text{ cm}$ and length of 70 cm was considered as the testing element. Figure 2 presents the geometry and dimensions of the tested specimen. The ingredients of concrete were: Portland cement type CEM I 42.5R, sand (0–2 mm), fine aggregate (2–8 mm), coarse aggregate (8–16 mm), ash and superplasticizers. The proportion of concrete mix is outlined in Ta-

ble 1. The specimen was reinforced in longitudinal direction with one deformed steel bar of diameter 8 mm. Eight notches were cut on the bar at the distance of 6 cm (Fig. 2). The notches were applied to ensure that the splitting failure occurred within the concrete part of the specimen and to avoid damage of the bar outside of the concrete prism. The large number of notches was cut to cause relatively homogeneous damage zone that can be easily detected by ultrasonic methods.

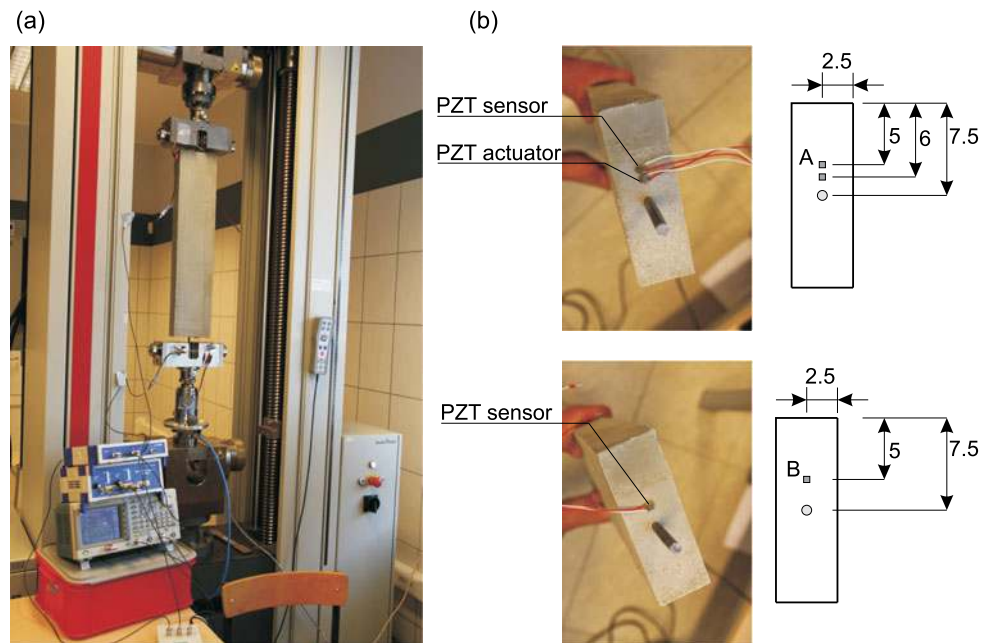
Fig. 3 Experimental set-up for measurements of ultrasonic waves in the reinforced specimen under tensile loading: (a) photograph of instrumentation; (b) details showing location of PZT actuator and PZT sensors on the specimen (dimensions shown in cm)

The concrete specimen was subjected to axial tensile loading applied at both exposed ends of the embedded bar. The tensile tests were carried out in a testing machine Zwick/Roell Z400 using displacement control with the speed of the cross-head of 0.5 mm/min. The photo of the experimental set-up is shown in Fig. 3a.

During the tensile test, ultrasonic elastic waves were generated and propagated through the specimen. The ultrasonic waves were excited in the longitudinal direction by means of a plate PZT actuator Noliac CMAP11 of dimensions 5 mm × 5 mm × 2 mm bonded at the end of the concrete specimen by wax. Two PZT sensors bonded on both ends of the concrete specimen (sensors A and B, as depicted in Fig. 2 and Fig. 3b) were utilized for wave sensing. An arbitrary waveform generator (Tektronix AFG 3022) with a high voltage amplifier (EC Electronics PPA 2000) created an excitation voltage signal applied next to the PZT actuator, which converted it into a mechanical force. As a result of application the voltage amplifier the measured signal was amplified ten times. A digital oscilloscope (ScopeDAQ) was used to collect the A-scan signals with a sampling frequency of 1 MHz. During the tensile test, the ultrasonic wave signals were excited and acquired every 15 s, until the speci-

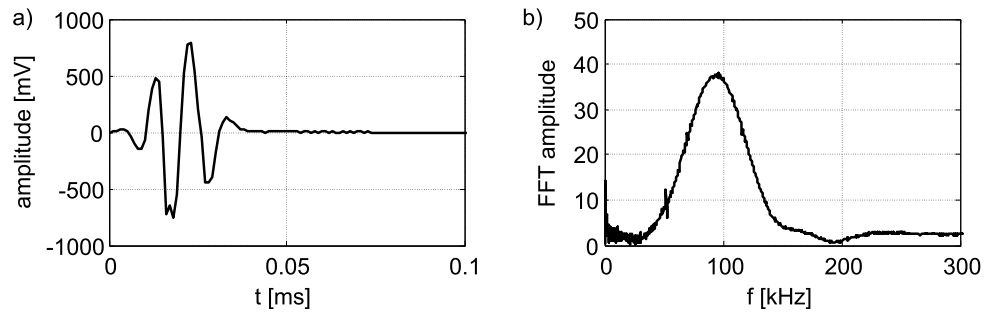
Fig. 4 Excitation signal: (a) in time domain; (b) in frequency domain

The excitation signal considered in this study was chosen as a single-frequency smoothed tone burst (also known as a wave packet) obtained from the multiplication of a sinusoidal function of established frequency by a Hanning function. The Hanning window provides smoothed tone burst in order to reduce the excitation of side frequencies [17]. This aspect of excitation of coherent single-frequency waves is important in the context of ultrasonic diagnostics. The number of cycles in the tone burst has a strong influence on the bandwidth of the input signal. For the established frequency of the sine wave, a large number of cycles is advantageous to obtain a narrow band in the frequency domain. On the other side, too many cycles causes increasing of wave packet length in the time domain. In this study, a four-peak sinusoidal signal with a central frequency of 96 kHz modulated by the Hanning window (Fig. 4) was chosen as a compromise between acceptable level of resolution in the time and frequency domains.

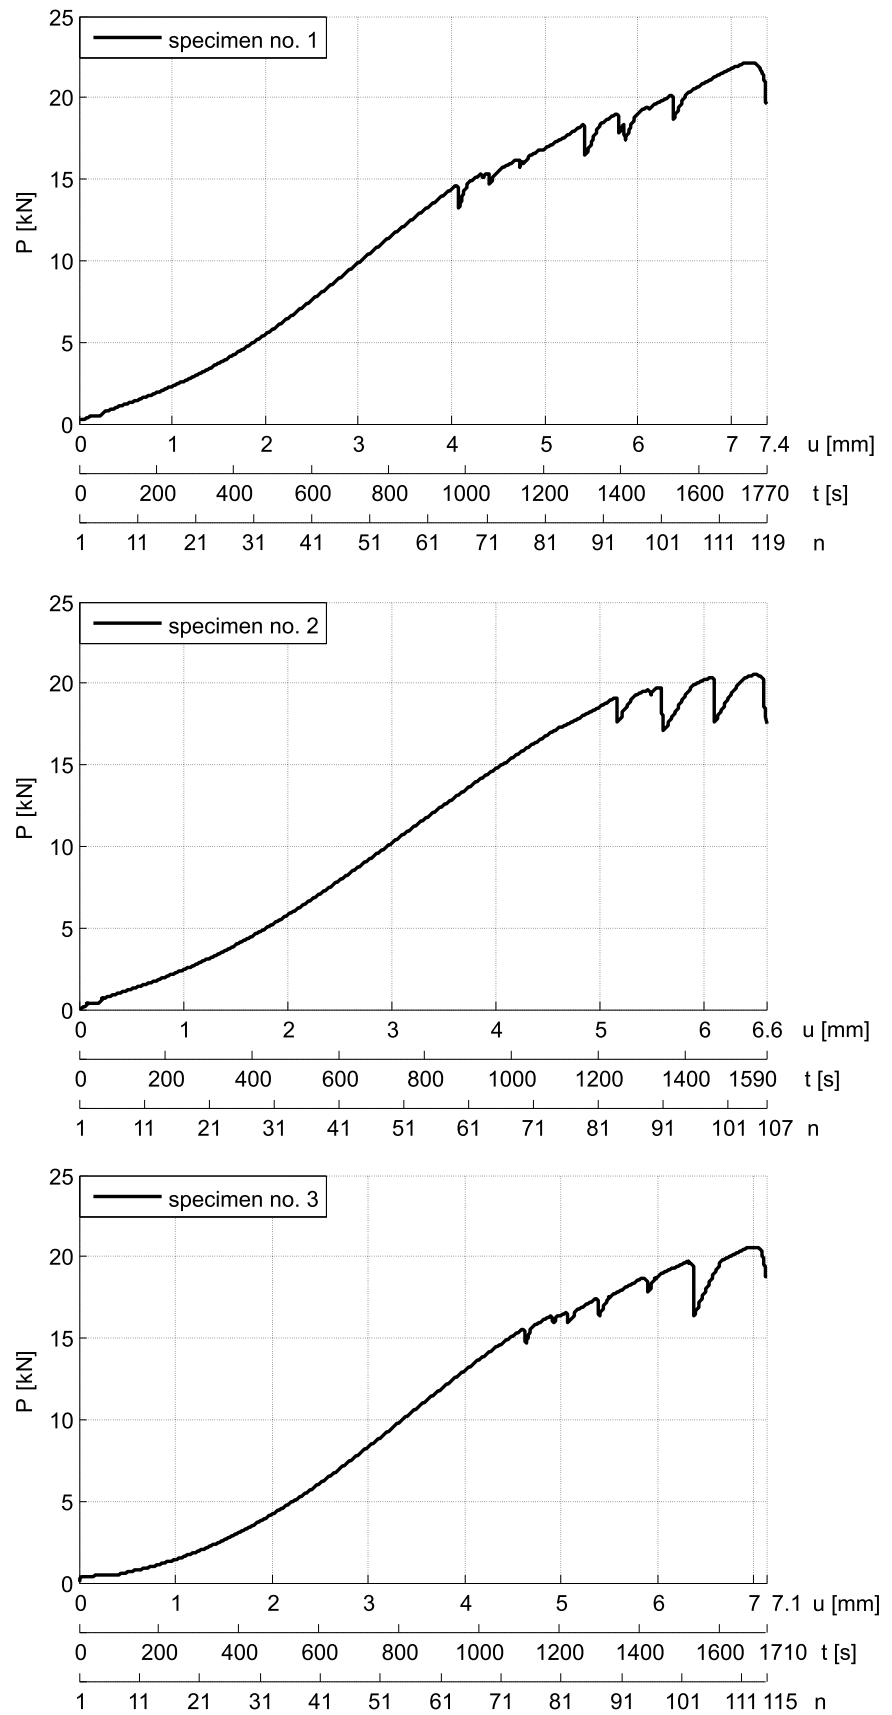
Fig. 5 Experimental load-deflection ($P-u$) and load-time ($P-t$) curves of three reinforced concrete specimens

During the tensile tests, the displacement of the cross-head and the force level were recorded. Figure 5 shows the force-displacement ($P-u$) and the force-time ($P-t$) curves for the tested specimens. There are sudden drops of the force at the moments when the major splitting cracks appear and the load distribution within the specimen alters in time. It was noted that the sizes of the notches were not identical within the given element since they were cut by hand. The time of duration of the tensile test was 1770 s, 1590 s and 1710 s for specimen no. 1, no. 2 and no. 3, respectively. The maximum displacement u_{max} of the cross-head in the longitudinal direction was 7.38 mm, 6.6 mm and 7.12 mm for specimen no. 1, no. 2 and no. 3, respectively. During the tensile test, wave propagation measurements were conducted. Time signals were taken each 15 seconds and each signal was assigned ordinal number n . Parameter n started from $n = 1$

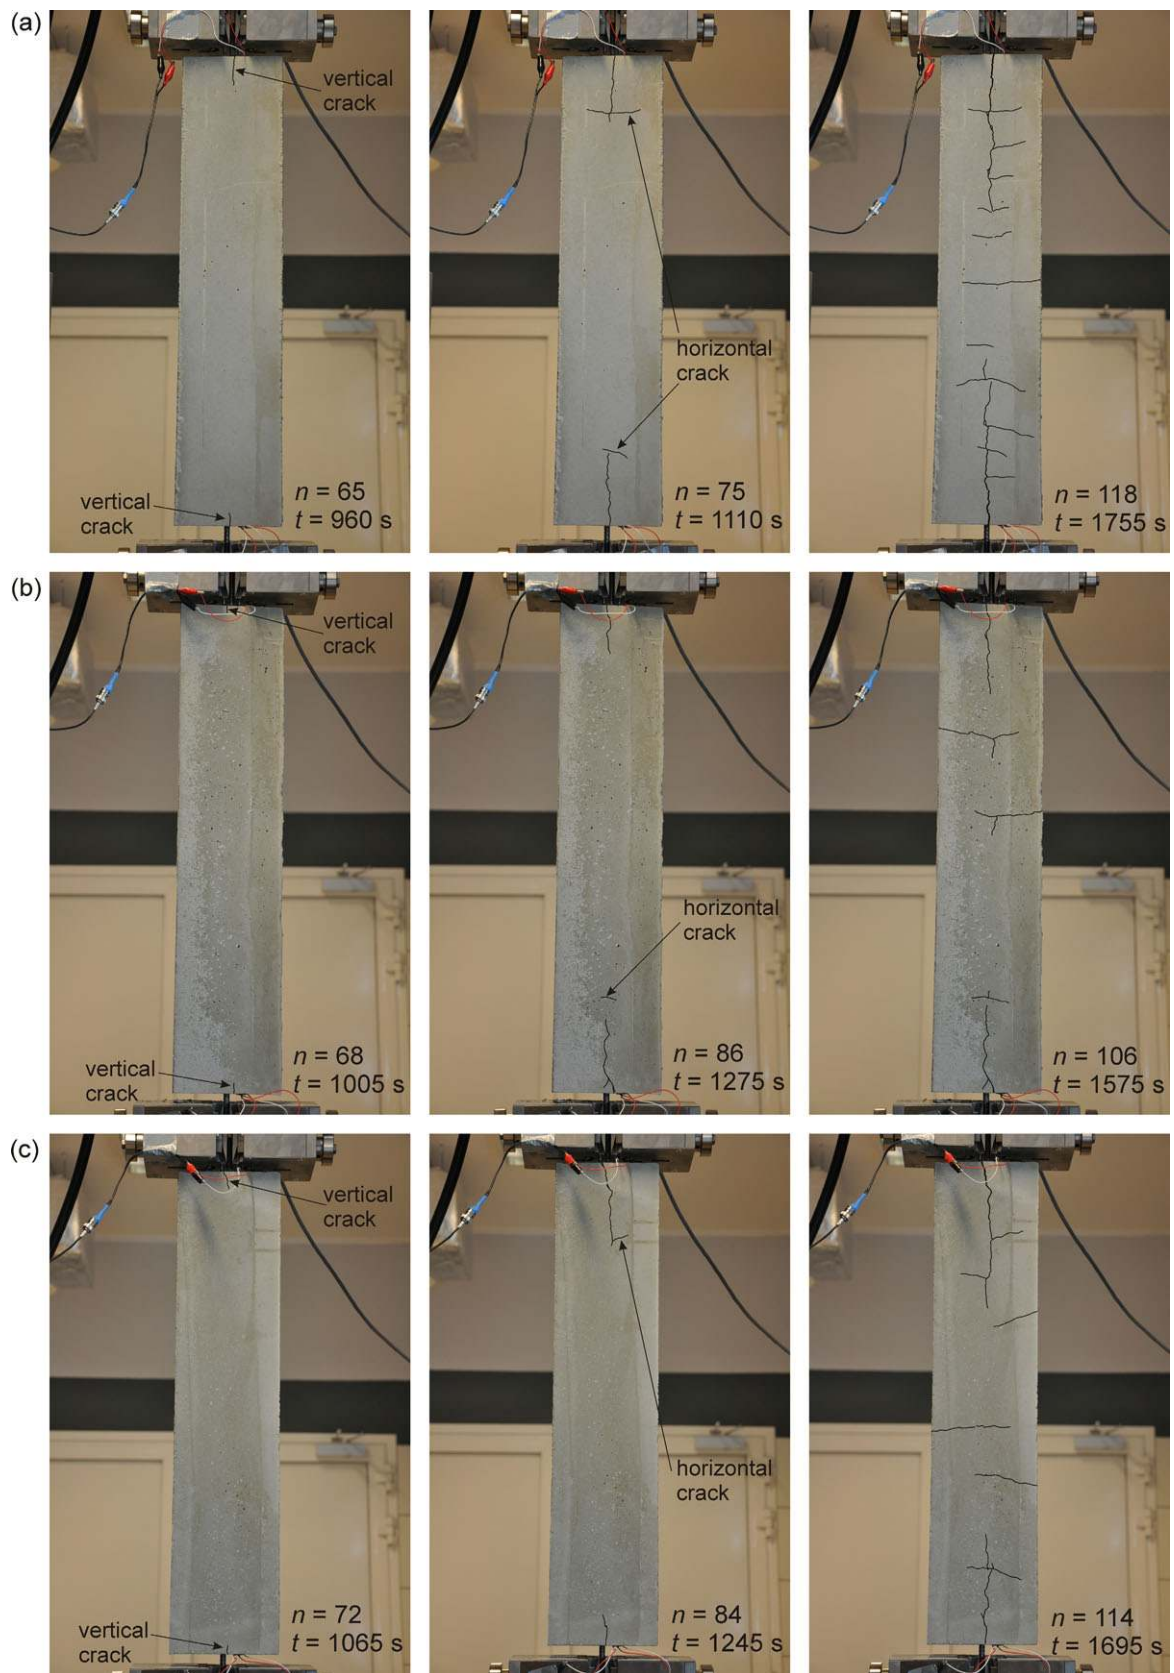
Fig. 6 Experimental damage evolution and crack patterns of three tested specimens (state of initiation of vertical cracks, state of initiation of horizontal cracks, penultimate stage of damage): (a) specimen no. 1; (b) specimen no. 2; (c) specimen no. 3

Figure 6 presents the crack formation and damage evolution in the tested specimens at the increasing load levels. At the first stage of the fracture process, two vertical cracks started to develop at the top and the bottom of the specimen. These cracks were initiated at $t = 960$ s ($n = 65$, $u = 0.54u_{max}$) for specimen no. 1, at $t = 1005$ s ($n = 68$, $u = 0.63u_{max}$) for specimen no. 2 and at $t = 1065$ s ($n = 72$, $u = 0.62u_{max}$) for specimen no. 3 (the first column of photographs in Fig. 6). Next the horizontal splitting of the concrete prism appeared at $t = 1110$ s ($n = 75$, $u = 0.62u_{max}$) for specimen no. 1, at $t = 1275$ s ($n = 86$, $u = 0.80u_{max}$) for specimen no. 2 and at $t = 1245$ s ($n = 84$, $u = 0.73u_{max}$) for specimen no. 3. This stage of damage is illustrated by the second column of photographs in Fig. 6. The penultimate stage of damage is given in the third column in Fig. 6. It occurred at $t = 1755$ s ($n = 118$, $u = 0.99u_{max}$) for specimen no. 1, at $t = 1575$ s ($n = 106$, $u = 0.99u_{max}$) for specimen no. 2 and at $t = 1695$ s ($n = 114$, $u = 0.99u_{max}$) for specimen no. 3. The tensile tests were stopped as a result of the tension failure of the steel bar. Figure 7 shows the details of the concrete specimen after the splitting failure. The prints of the lugs of the reinforcing bar are clearly seen on the piece of damaged concrete. Therefore, the slipping of the steel bar and damage of the bar surrounding concrete by the tips of the rebar lugs did not take place.

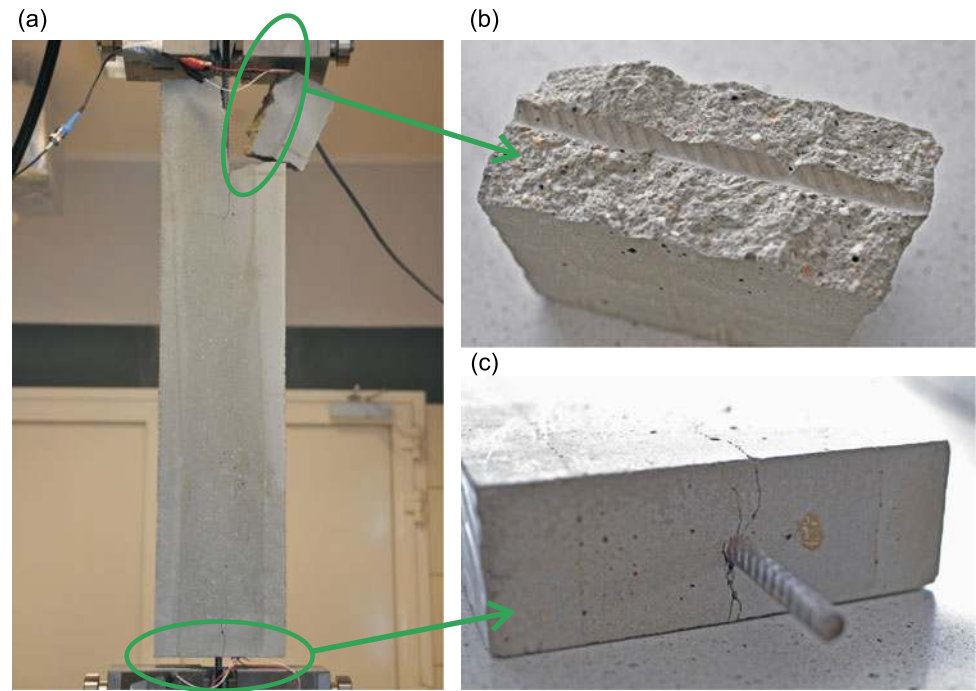
Fig. 7 Specimen no. 3 after damage: (a) the view of the specimen; (b) interface between steel and concrete; (c) splitting cracks on the bottom part of the specimen

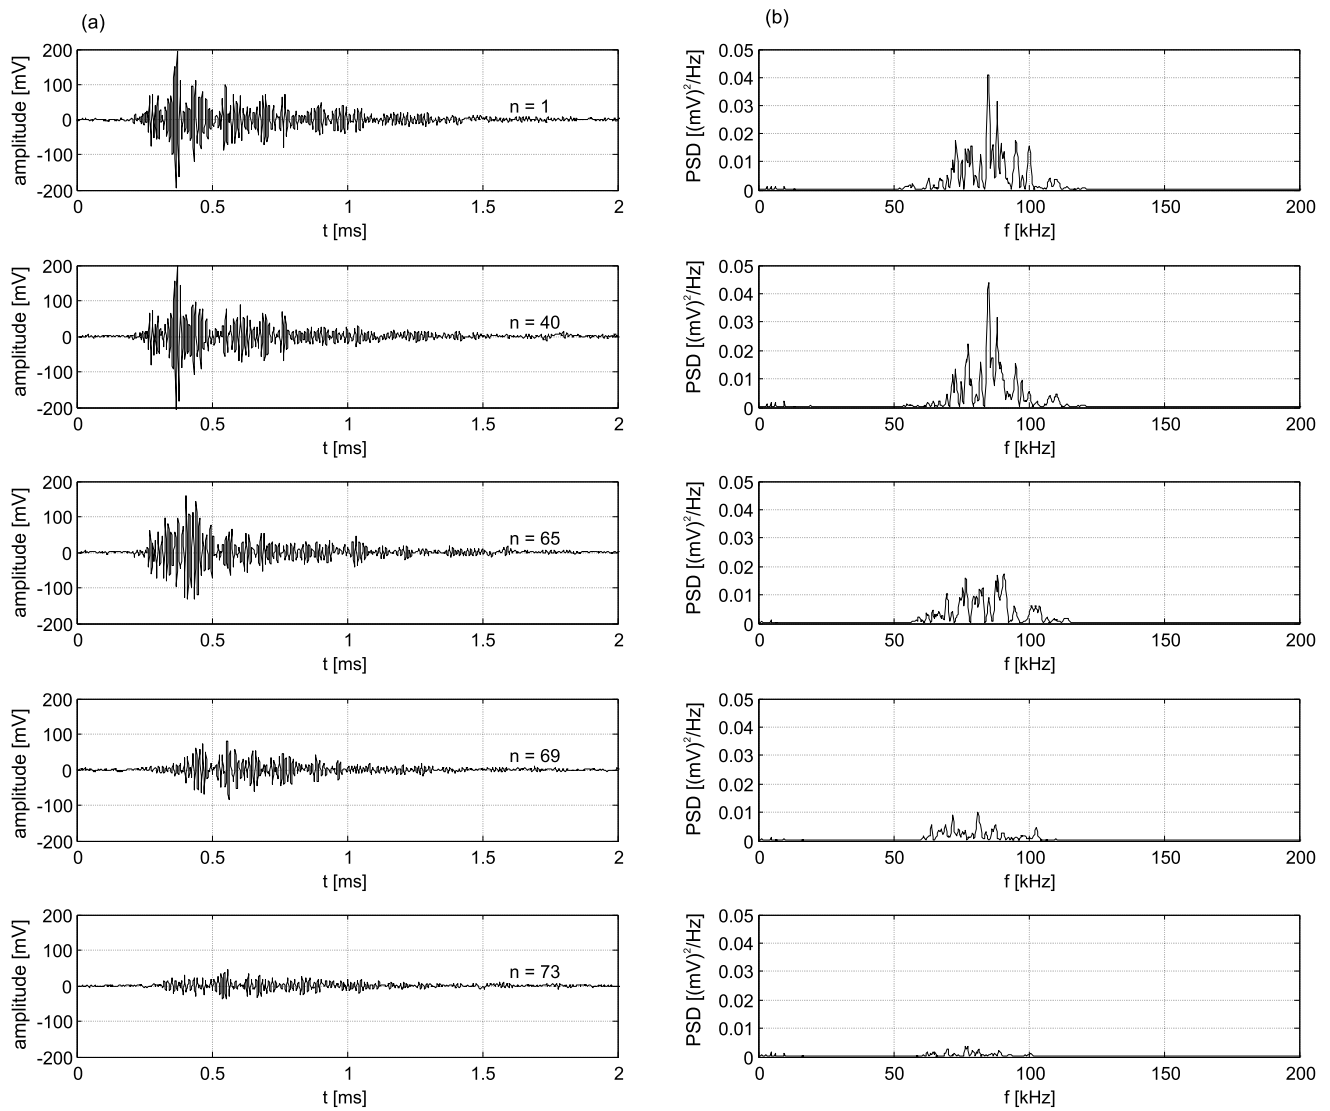
Fig. 8 Ultrasonic signals registered at point B in specimen no. 1 for different load levels: (a) A-scan signals in time domain; (b) power spectral densities of time waveforms

The interpretation of measured signals in the frequency domain was performed by the power spectral density (PSD). The PSD function was used since it shows the signal power that better displays the changes in the wave propagation signals due to material degradation than Fourier transform. The PSD was computed using MATLAB®. The examples of the ultrasonic signals acquired at point B for specimen no. 1 and their power spectral densities are shown in Fig. 8. It can be seen that at the initial stage, no significant differences were visible in the measured time signals (e.g. $n = 1$ and $n = 40$).

The maximum amplitudes of the signals acquired at point B (on the opposite side then the PZT actuator) were practically the same for the signals from $n = 1$ to $n = 65$ and, then they decreased with the increase of the external tensile loading.

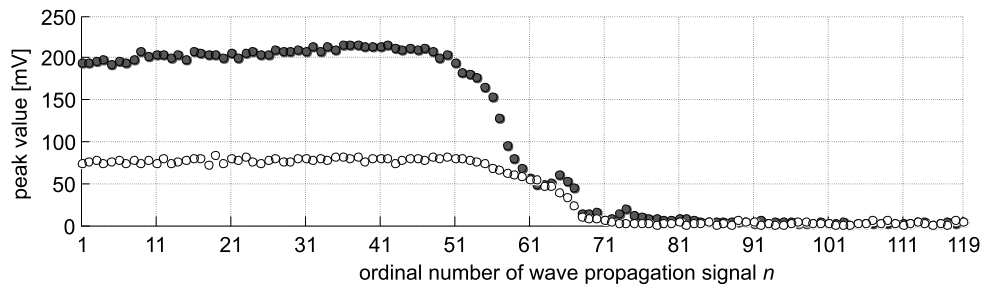
Fig. 9 Peak values of wave propagation signals registered at point B in the specimen no. 1: the first wave packet corresponding to the first pressure wave traveling in the specimen (white dots) and the second wave

packet associated with interference of shearing and pressure waves reflected from the specimen cross-section boundaries (grey dots)

Figure 9 shows the peak values of the signals registered at point B for the specimen no. 1. Data in Fig. 9 are taken from the time signals (so called A-scans) for consecutive measurements of propagating ultrasonic waves. Peak values of the first incoming wave packet for the signals from $n = 1$ to $n = 119$ were plotted with white dots (Fig. 9). The first wave packet corresponds to the first pressure wave traveling in the specimen. The initial value of the peak was of about 80 mV. The first wave packet can be clearly seen for signal numbers from $n = 1$ to $n = 40$ (Fig. 9a). For the time records corresponding to higher signal numbers, the peak values of the first wave packet were determined for the time range $t = 0.27\text{--}0.28$ ms. The peak values of the second wave packet that can be seen at $t = 0.37\text{--}0.38$ ms were plotted in Fig. 9 with grey dots. The initial peak value of the second waveform was of about 200 mV. The second wave packet was associated with interference of shearing and pressure waves reflected from the specimen cross-section boundaries. The recognition which wave packet in the registered signal corresponds to pressure and shear waves was done based on wave velocities.

The amplitudes of the first wave packet were similar for the signal numbers from $n = 1$ to $n = 55$ (Fig. 9). From $n = 56$ to $n = 67$ the amplitudes started to decrease and from $n = 68$ they became close to zero. Small micro-cracked

zones did not significantly affect the first pressure wave, and therefore, the significant drop of the maximum amplitudes was noticed when the first vertical crack appeared (at $n = 65$). The amplitudes of the second wave packet were constant for signal numbers from $n = 1$ to $n = 51$ and the relatively rapid decrease of the amplitudes took place till $n = 61$. At signal number $n = 75$ the maximum amplitudes of the second wave packet became very small. It seems that the change of the peak values of the second wave packet indicated the development of the micro-crack zone before splitting takes place. The vertical splitting cracks were observed for $n = 65$ while the reduction of the amplitudes starts at $n = 51$. Formations of micro-crack zones had relatively large influence on the reflected shear and pressure waves resulting in large attenuation of the second wave packet.

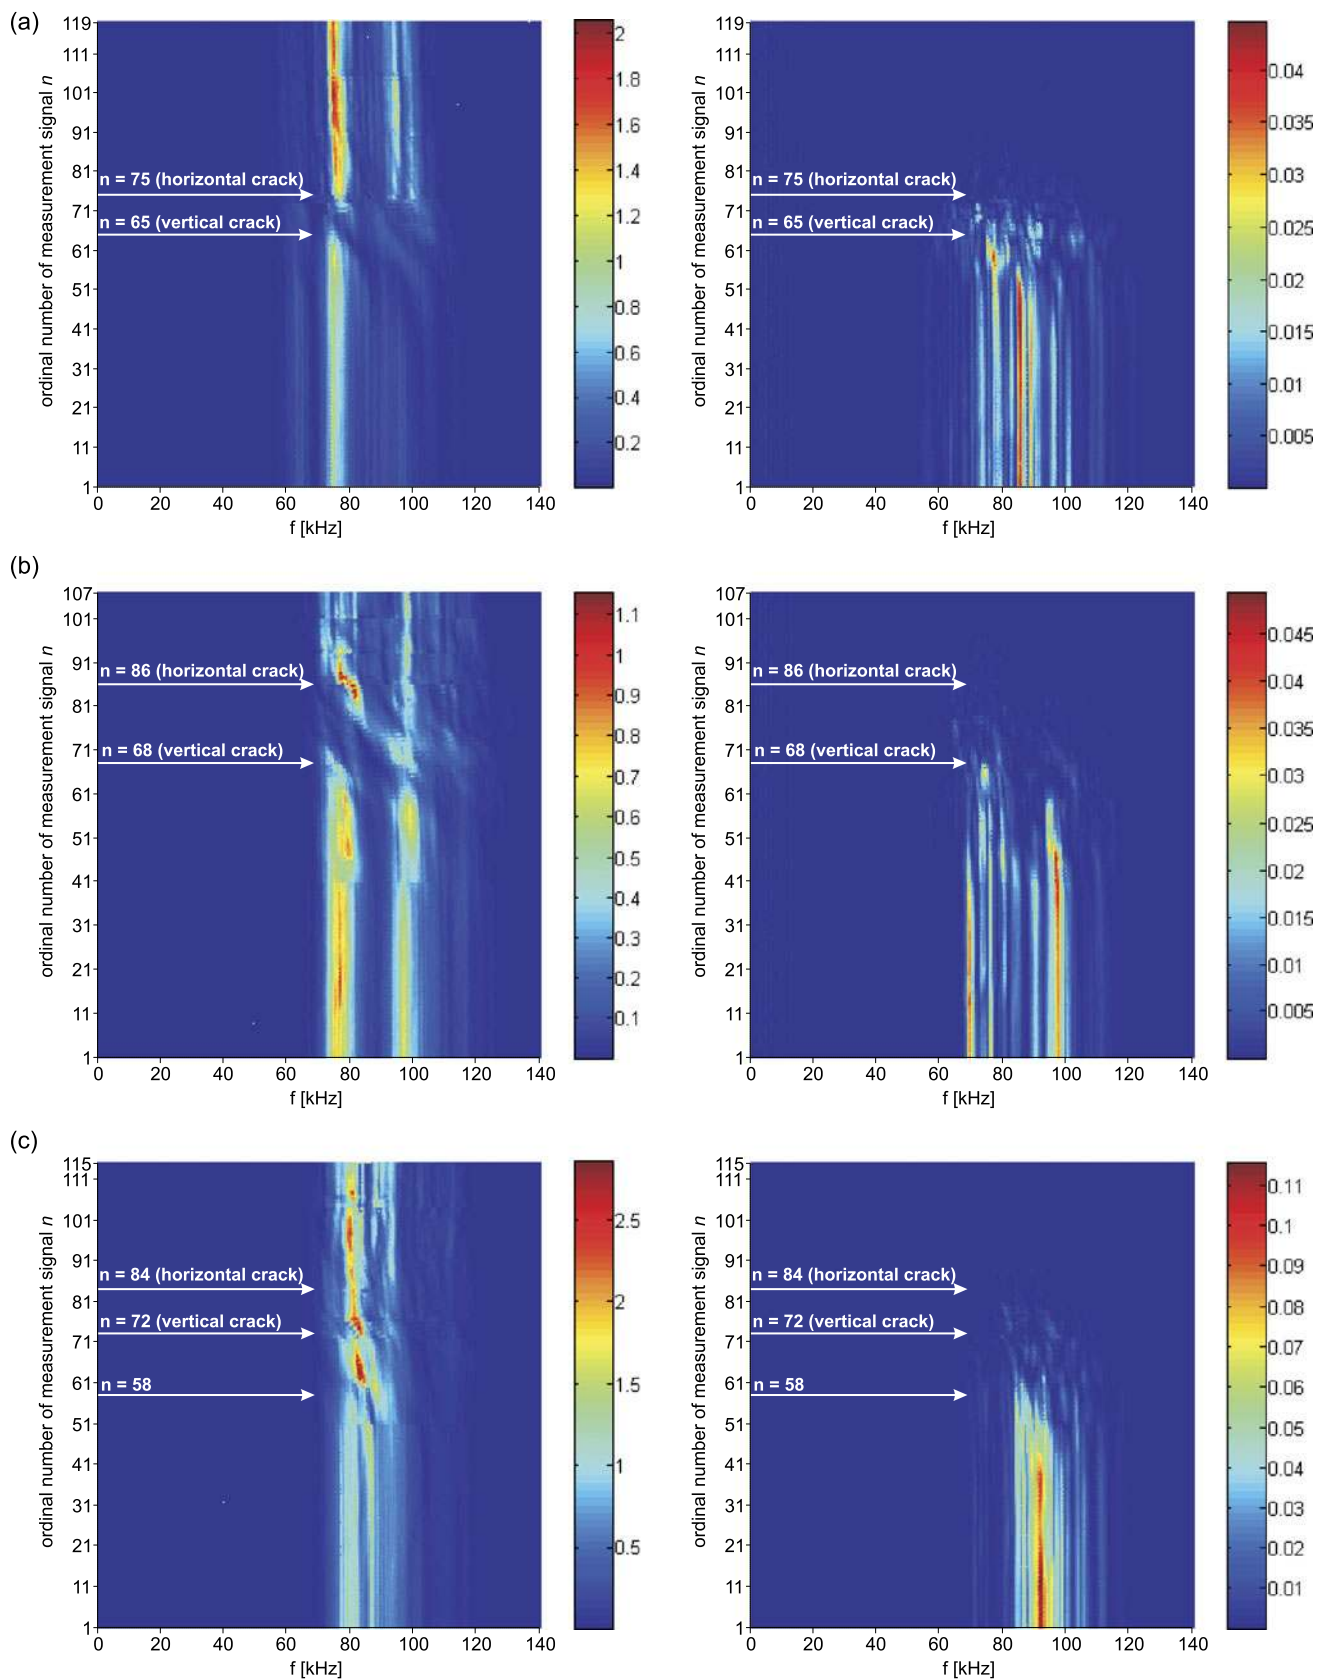
Fig. 10 Power spectral density maps of registered signals at point A (left column) and at point B (right column): (a) specimen no. 1; (b) specimen no. 2; (c) specimen no. 3 (power spectral densities are in units of $(\text{mV})^2/\text{Hz}$)

The evolution of the frequency spectrums in time for specimen no. 1, 2 and 3 are shown in Fig. 10. The power spectral densities of all ultrasonic signals acquired during the tensile test were plotted in the form of maps. White arrows indicate two characteristic measurements for each specimen: the measurement associated with the appearance of the first vertical crack and the measurement associated with the appearance of the first horizontal crack. The right column of Fig. 10 illustrates the power spectral densities of the A-scan signals measured at point B. It can be observed, that the amplitudes decreased with the increase of the damage stage. At the moment of the first vertical crack development, the amplitudes of the PSD revealed sudden change. The decrease in amplitudes occurred in a quasi-

linear way, i.e. first higher frequency components decreased, while lower frequencies decreased at a later stage of damage.

The left column of Fig. 10 presents the power spectral densities of the signals measured at point A. These signals had similar amplitudes during all measurements because of

their close location to the PZT actuator. Clear oblique lines are visible in the PSD maps for all specimens. At the moment of initiation of vertical crack, local decrease in the PSD amplitudes can be observed. It started at $n = 65$ for the specimen no. 1 and $n = 68$ for the specimen no. 2. This local decrease had an oblique line shape, i.e. first higher frequencies are damped, while the lower frequencies are damped at the next time instances. In the specimen no. 3 the first vertical crack was observed for measurement $n = 72$. However, it can be seen at the PSD map, that additional local decrease of amplitudes occurred ($n = 58$), probably as a result of other vertical crack on the opposite side (not monitored by camera).

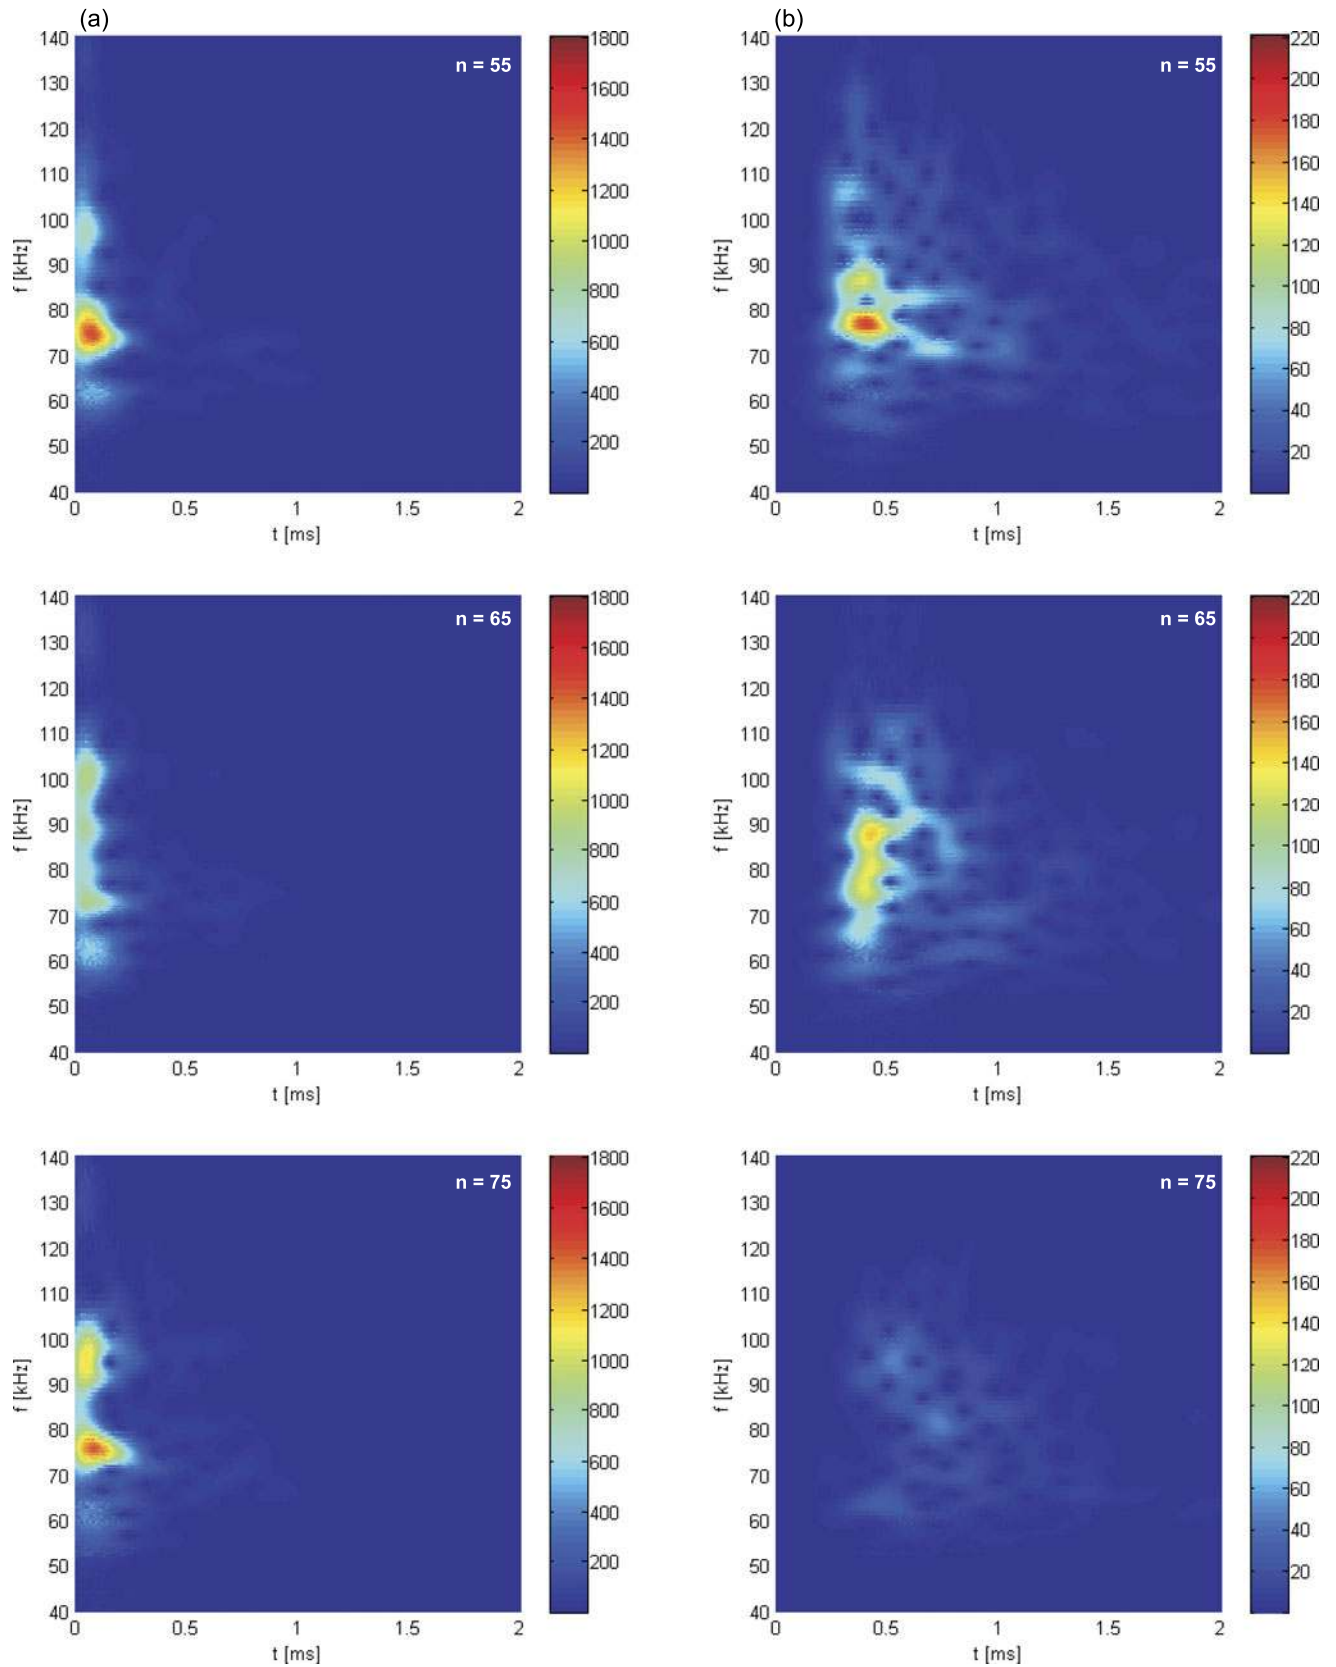
Fig. 11 Wavelet transforms for specimen no. 1 for different load levels: (a) signals registered at point A; (b) signals registered at point B (wavelet transforms are in units of mV)

The wavelet transform results for the selected A-scan signals for specimen no. 1 are presented in Fig. 11. The left column of Fig. 11 shows the wavelet coefficients of the signals registered at point A and the right column depicts the wavelet coefficients of signals registered at point B for time steps corresponding to $n = 55$ (stage before splitting), $n = 65$ (appearance of the first vertical splitting crack) and $n = 75$ (after the splitting failure). For $n = 55$, the elastic waves of frequency 76 kHz travelled through the concrete specimen and they can be observed in both signals measured at points A and B. At the beginning of development of the first splitting crack ($n = 65$), the micro-crack zones were the biggest, causing a significant reduction of the amplitudes of ultrasonic waves at points A and B. Wave packets had frequency range from 70 kHz to 100 kHz. Further increase of

the external loading (e.g. $n = 75$) resulted in the appearance of several large splitting crack and yielding of the steel bar. Plastic deformation of the bar near the notch changed the longitudinal load distribution. Largest deformations were in the areas near the notches. The internal forces in the specimen in the region from its top (the location of point A) to the first horizontal splitting crack were reduced. Therefore, the micro-crack zone became smaller and the waves generated in the neighbourhood of the measurement point A could travel with relatively small damping. Figure 11a (left column) shows large wavelet coefficients at frequency 76 kHz and 96 kHz for the specimen after splitting failure ($n = 75$). The right column of Fig. 11b shows the wavelet coefficients of the signals at point B ($n = 75$). There are no large values of the wavelet coefficients since the specimen have been destroyed by the horizontal splitting cracks that prevented propagation of ultrasonic waves from point A to point B through the concrete.
